PROPERTY INSPECTION REPORT

Concerning: 1214 Pioneer Richmond, Texas 77406
(Address or Other Identification of Inspected Property)

By: Fred Willcox Professional Inspector #160 August 2, 2019
(Name and License Number of Inspector) (Date)

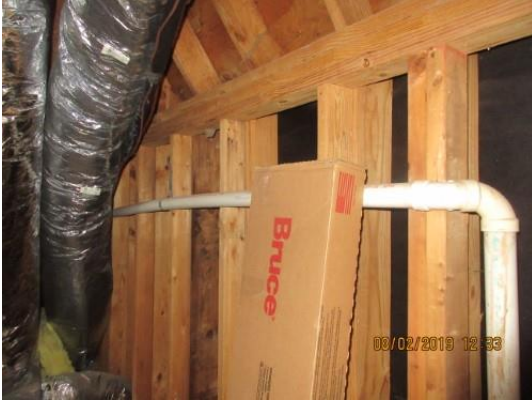
Deficiency: The pony walls in the attic were not tied back to the ceiling joists and framing to prevent the pony walls from rotating.

Information: Pony walls are walls that are not full height that extend above the ceiling joists. The top of the pony wall must be tied back to the framing to overcome the turning moment produced by the horizontal component of the loads produced by the rafters.

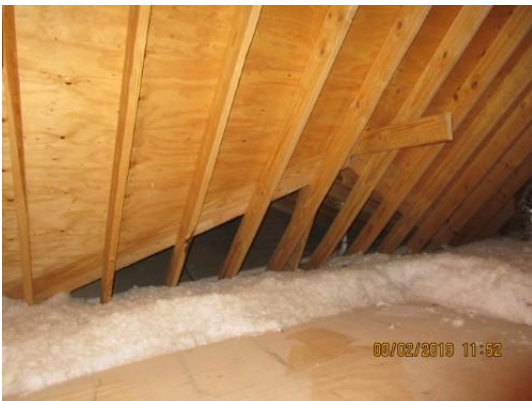
Deficiency: There were “lay down” valley rafters used to support some of the valley rafters of the addition.

Information: A lay down rafter is improper for several reasons. The use of the lumber under this type framing is thought to be considerably weaker than the use of a valley rafter as the board is laid on its wide side and resists bending on its narrow side. The stiffness of a structural member is primarily determined by its depth, not its width. Section R802.3 of the International Residential Code (IRC) requires that all valley rafters be constructed as beams. Second, a common rafter cannot be used to support another common rafter, which is what happens with this type valley. Third, the system is structurally indeterminate. The forces cannot be resolved or their magnitude evaluated. Properly constructed valley rafters should be installed.

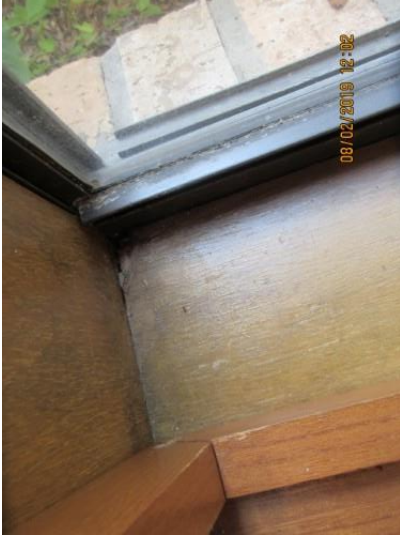
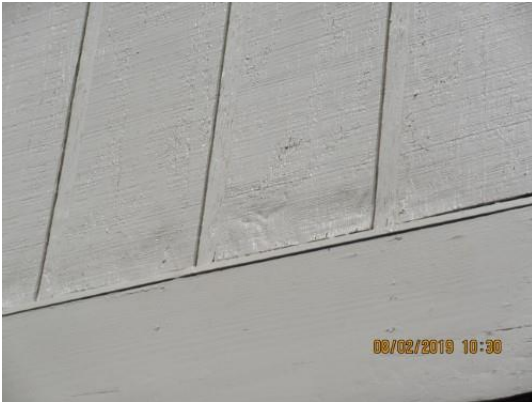
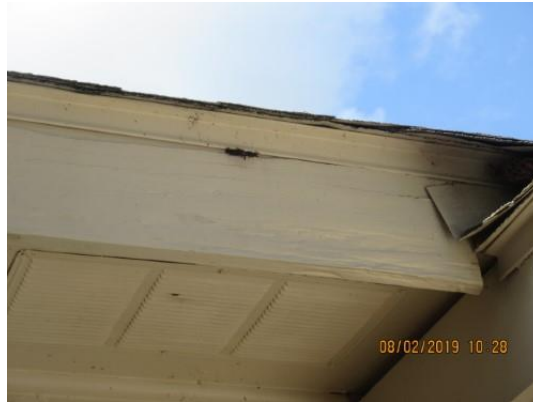
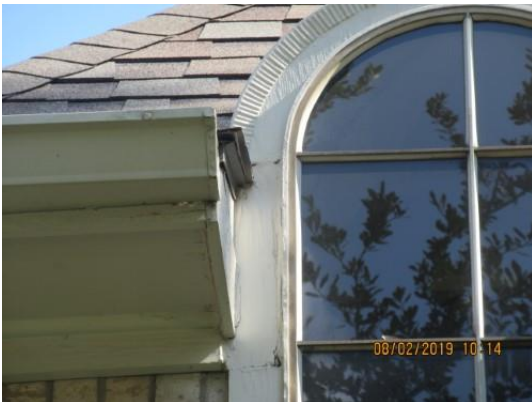
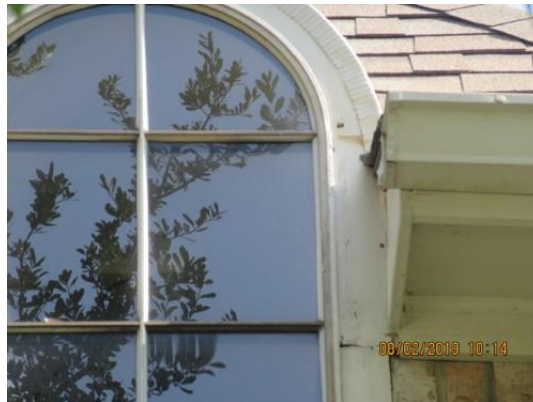
Deficiency: Deteriorated wood was found on the interior window frames in the living room and dining room, and on the exterior siding, trim and fascia, etc.

Information: The presence of deteriorated or decayed wood indicates the need for an examination by a qualified licensed pest control inspector. Presence or damage from termites, rot or other wood infesting organisms is not part of this report. Detection of wood infesting organisms is reserved by Texas Law to a person licensed to perform wood destroying insect inspection. Where deterioration was found on the interior of the house, it is strongly recommended that the wall covering materials be removed and the structural

framing materials be inspected for the presence of deteriorated members. All deteriorated material, regardless of the cause, should be removed and replaced with sound new lumber finished to match the existing structure. The presence of deteriorated wood and water penetration indicates the possibility of the presence of microbial organic organisms, which may include toxic molds or fungi. The indoor air quality should be tested to determine if a hazard exists.

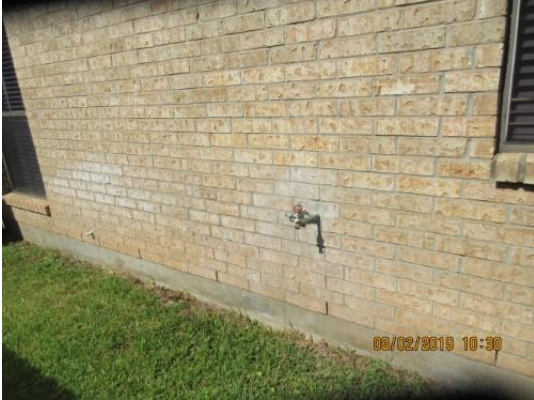
Deficiency: There were minor cracks in the brick veneer.

Information: The cracks should be repointed by a skilled mason to match the existing structure.

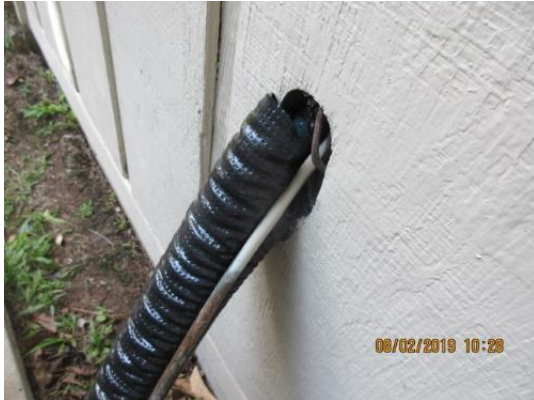
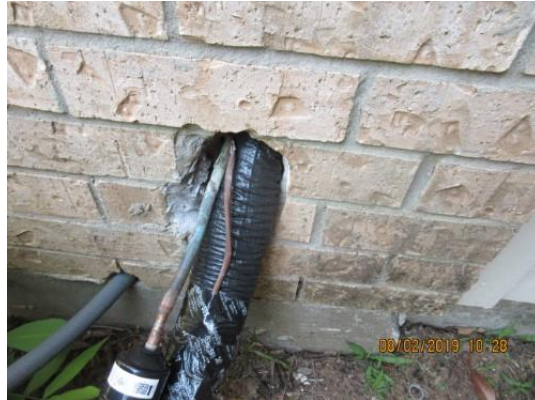
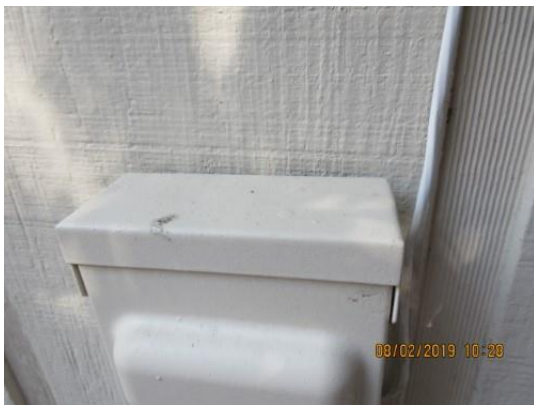
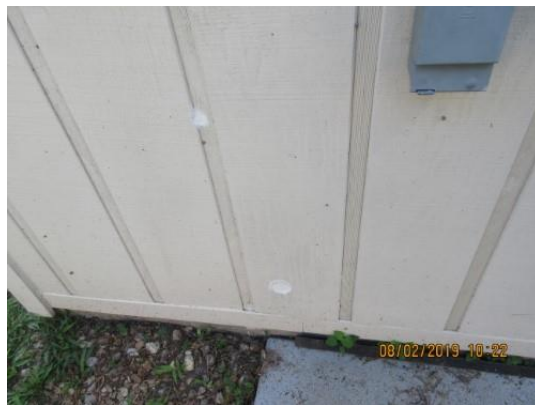
Deficiency: All penetrations through the wood or wood fiber products cladding materials had not been sealed, flashed or drained.

Information: Any and all penetrations are required to be sealed and/or flashed in such a manner as to prevent water penetration through the cladding materials. All wall penetrations should be properly flashed and sealed.

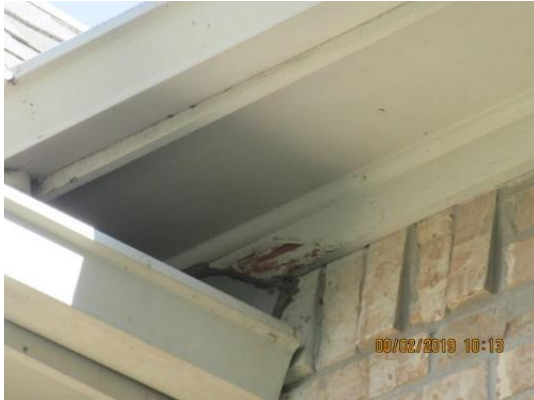
Deficiency: Siding and trim components had been damaged by rodents.

Information: The damaged cladding materials should be replaced. The new siding components should be painted to match the existing structure.

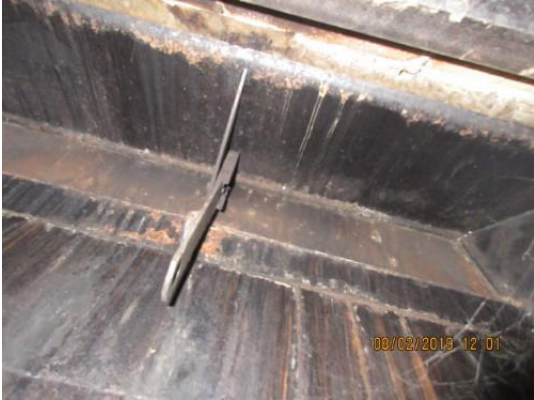
Information: Water penetration damages the fire brick and can make the fireplace dangerous to use. The source of the water penetration should be determined and corrected. The damage to the brick and the safety of the brick should then be determined.

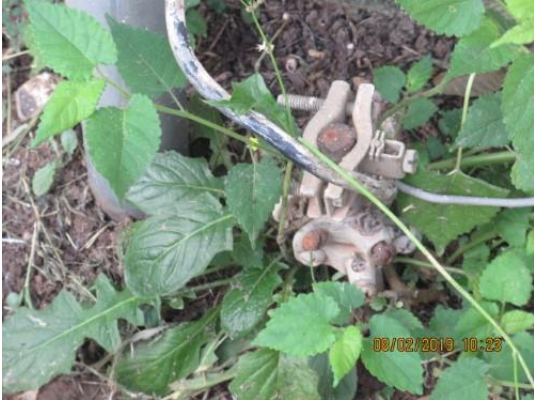
Deficiency: An improper electrical clamp was used on the grounding electrode.

Information: The clamp was a pipe clamp not a clamp designed for electrical conductivity. Proper electrical clamps are in contact continuously around the electrode and the conductor. Proper clamps should be used to insure proper electrical current flow.

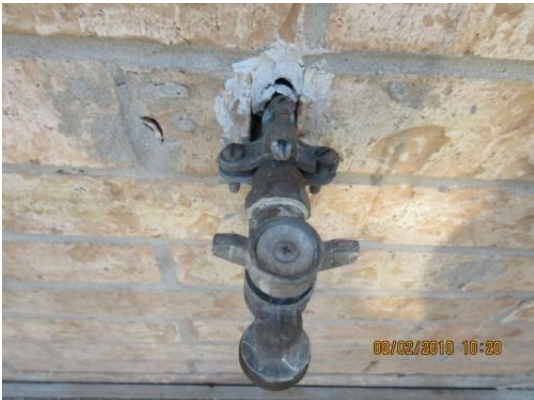
Deficiency: A grounding conductor was connected to an exterior faucet on the west side of the house.

Information: This conductor may serve as a bond on the copper water pipes but cannot be the service grounding system as defined by the National Electric Code. As the main water shut off valve was in the laundry room, the bonding conductor connection to the exterior faucet could not have been within five feet of where the water main pipe entered the structure. A second proper earth grounding made electrode should be installed for safety.

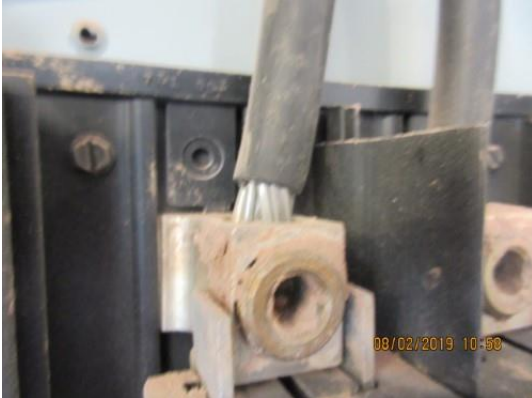
Information: The service entrance conductors between the meter and the breaker panel were aluminum conductors, as are almost all service conductors throughout this area. The conductors between the meter can and the transformer are also most likely aluminum. All aluminum terminals should be properly treated. The aluminum conductors should be cleaned and properly treated with an anti-oxidizing compound. Proper treatment with an anti-oxidizing compound means that the conductors were dipped in the mastic, not dabbed with mastic. Electricity tends to flow on the surface of a conductor and aluminum oxide is a worse conductor than aluminum. The presence of aluminum oxide increases the resistance of the conductor, which increases the heat in the conductor and forces an increase in electrical flow in order to maintain the electrical service, all of which increases electrical use and your cost for electricity. While the metals used for the connectors for the panel are compatible for use with aluminum wiring as far as thermal expansion is concerned, the possibility of galvanic action remains. The anti-oxidizing mastic should be replaced as it dissipates.

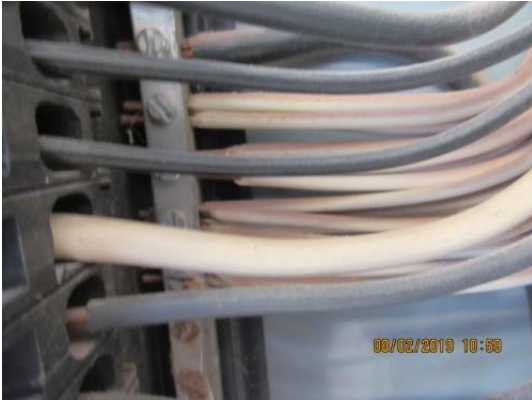
Deficiency: Multiple grounded (neutral) conductors were connected under one screw on the bus bars.

Information: The IRC (International Residential Code) and the National Electric Code provide that all current carrying conductors be connected to any and all electrical component by only one screw. As electricity travels on the surface of a conductor, poor contact at the connection points reduces the surface area of the contact point and can result in damage to the conductor. The grounded conductors should be separated so that only one conductor is connected to each port of the bus bars.

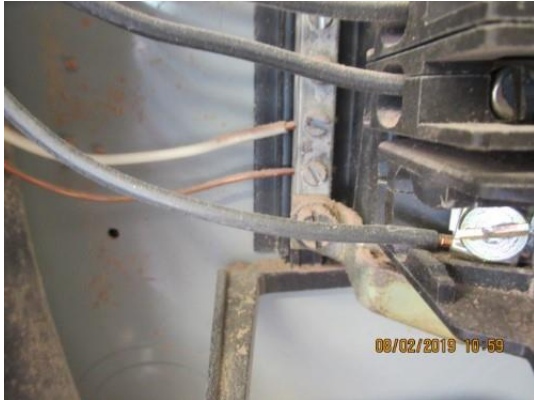
Information: This condition can put electrical potential on the electrical equipment and/or the equipment grounding conductors which can result in an electrical shock or fire hazard. The neutrals and equipment grounding conductors must be completely separated, the neutrals must be solely attached to the neutral bus bars and neutral conductors, the equipment grounding conductors to the grounding bus bar and grounding electrode conductors and the grounding bus bar must be bonded to the sub panel housing. The main panel and sub panel should be bonded for safety.

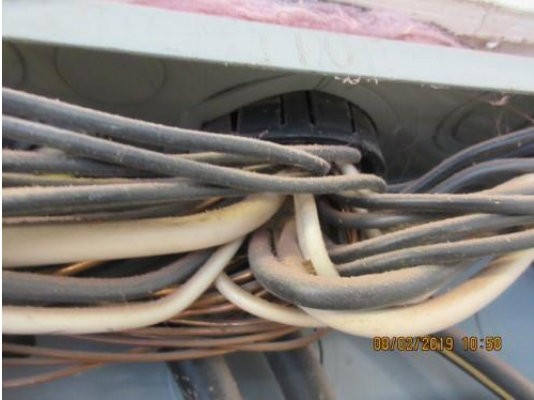
Information: Section 312.5 (C) of the National Electric Code (NEC) provides that each cable shall be secured to the cabinet. The section prohibits the installation of several cables bunched together through a knockout or chase unless specific rules are followed under the exception. Bundling of the conductors eliminates air space and restricts the diffusion of heat. The conductors entering the panel board should be separated for safety.

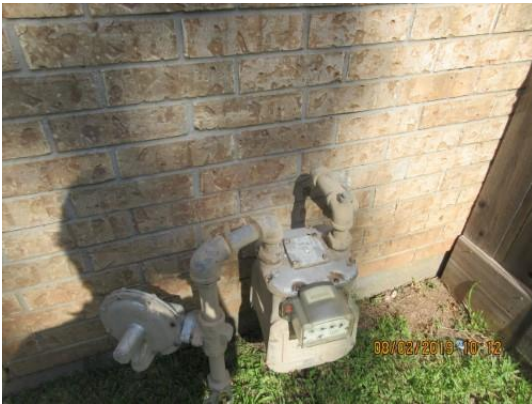
Deficiency: The CSST (Corrugated Stainless Steel Tubing) flexible gas connectors to the gas fired appliances were not observed to be electrically grounded/bonded the full length of the gas line per the manufacturer.

Information: There has been litigation with CSST gas lines caused by fires/lightning. Even if properly bonded the manufacturer does not warrant that the material will perform if lightning strikes directly on or near a structure. Refer to the manufacturer installation instructions and any “Google” articles on CSST litigation and for news articles on CSST. All metal components must be properly bonded and grounded for safety. All CSST should be replaced with a different flexible gas pipe connector in my opinion.

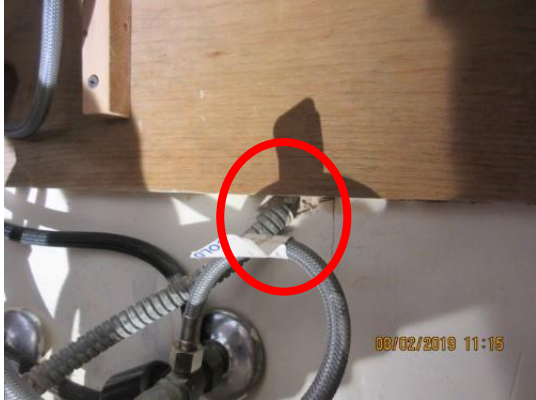
Deficiency: Unsafe electrical conditions were found under the kitchen sink.

Information: These unsafe conditions include the electrical conductors that were not properly installed in metal conduit to protect the conductors from physical harm or from water. The conduit must be fastened to the structural framing and to the appliance to properly protect the electrical cable. All unsafe conditions should be remedied.

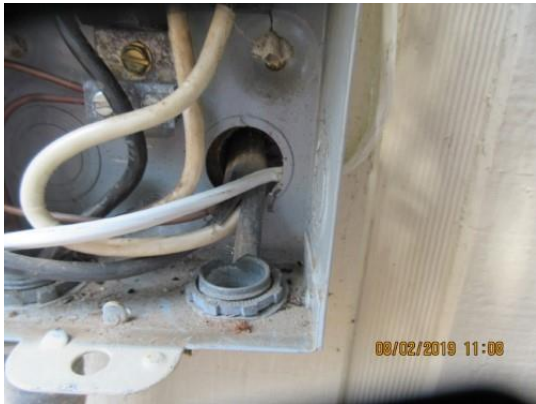
Deficiency: Cable clamps were missing from the air conditioning condensing unit's mechanics disconnect boxes.

Information: Cable clamps protect the insulation on the conductors as they pass through the metal box. Cable clamps should be installed for safety.

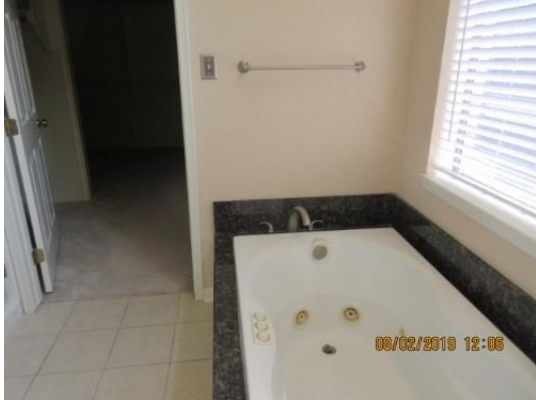
Deficiency: An electrical toggle switch was accessible from the master bathroom bathtub.

Information: Electrical components such as lighting fixture and exhaust fan toggle switches are not supposed to be installed where they can be accessed from a tub or shower per Section E3901.7 of the IRC. The toggle switches should be relocated for safety.

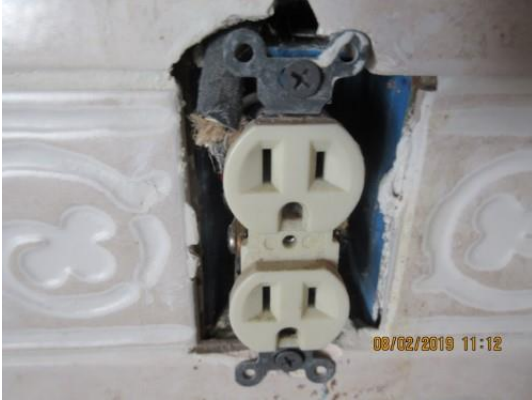
Deficiency: Electrical outlet box extenders were not installed on electrical wall outlets and lighting switch outlet boxes installed through additional wall covering surfaces in the kitchen and bathrooms, etc.

Information: The electrical outlet boxes were fastened to the wall framing and there are spaces existing between the front of the outlet box and the cover plate. When outlet boxes and switch boxes are installed through additional wall covering materials, such as tile or cultured marble, etc. an outlet box extender is required to be installed to seal the opening between the outlet box and the cover plate. See section E3806.5 of the International Residential Code.

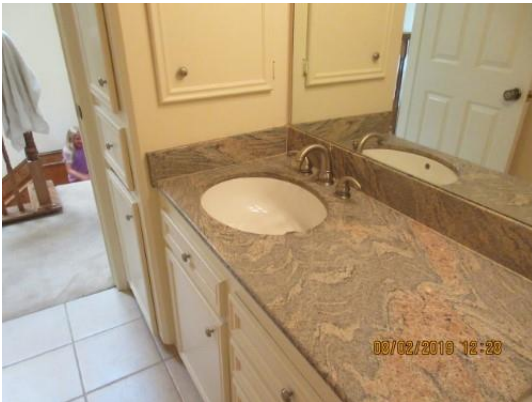
Deficiency: There was no accessible electrical wall outlet for one of the lavatories.

Information: The National Electric Code requires that an electrical wall outlet be installed within 36 inches of the outside edge of each lavatory. A new electrical wall outlet should be installed near the lavatory.

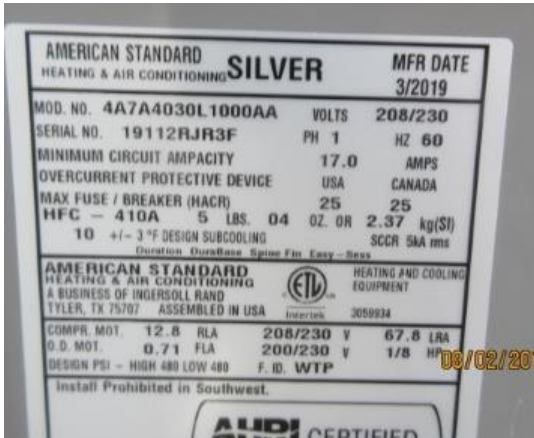
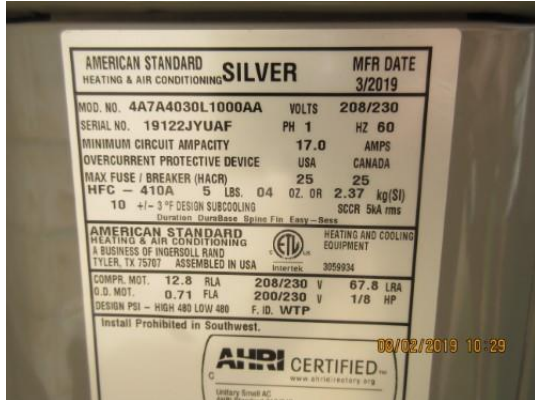
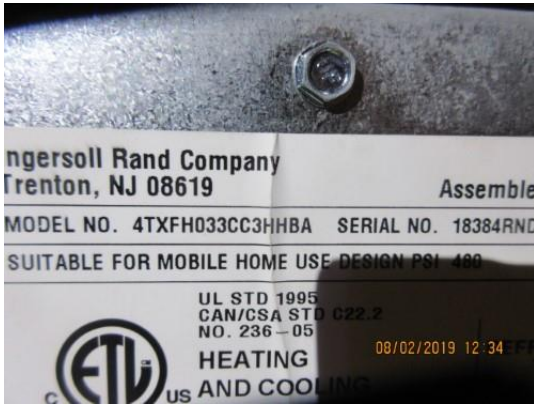
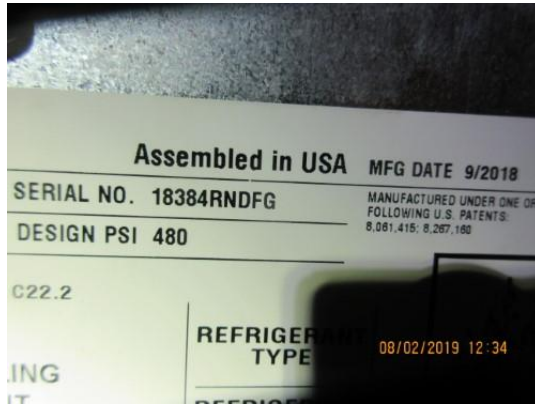
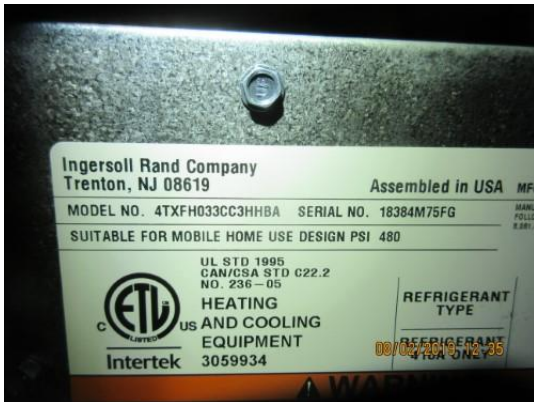
Deficiency: The temperature drops across the evaporator coils were inadequate. All three units were new.

Information: The drop should be in the range of 16 to 20 degrees Fahrenheit. The temperature drop measured across the main downstairs coil was 11.9 degrees. The temperature drop measured across the addition coil was 13.0 degrees. The temperature drop measured across the upstairs coil was 16.9 degrees. This may be a sign, although not the only reason, that the units were low on refrigerant and were in need of service. If the units are low on refrigerant it is likely that there is a refrigerant leak in either the evaporator coil, condensing coil or in the refrigerant pipe. These leaks can cause a coil to be replaced and can be expensive to find.

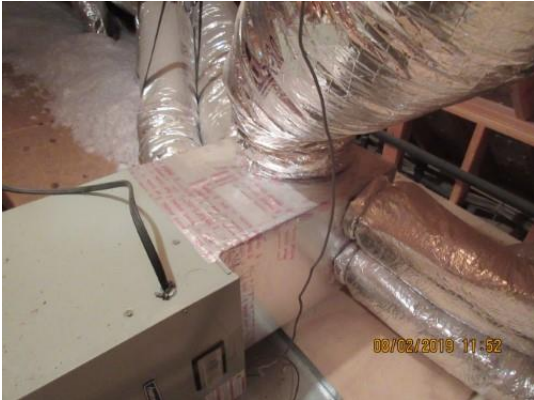
Deficiency: The addition plenum appeared to be improperly sized.

Information: To develop proper air pressure and flow air should be pressurized in the plenum and then force conditioned air through the conditioned air ducts. The plenum should extend at least a foot beyond the connection to the evaporator coil and at least 6 inches beyond the last duct connection to develop proper pressurization of the conditioned air system according to industry recommendations.

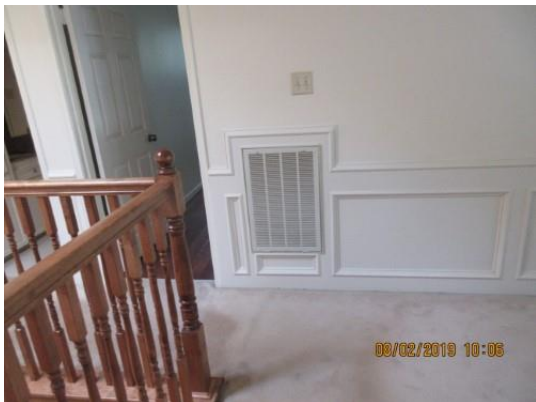
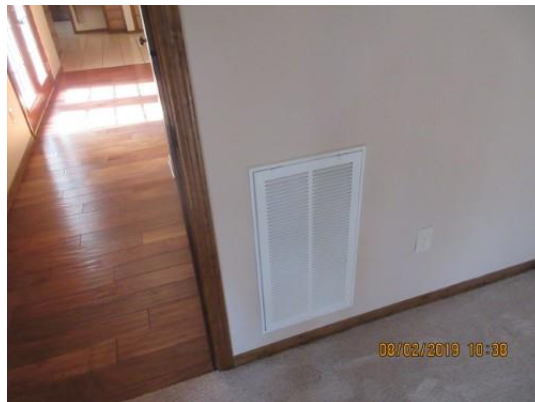
Deficiency: Some of the return air openings were located on the lower parts of the walls.

Information: While this type installation was once required for fire safety it is a poor installation for the refrigeration system. Cold air is more dense or “heavier” and settles to the floor. Warm air rises to the ceiling. For the best mechanical efficiency and for better air circulation the warm air should be taken into the refrigeration system from the ceiling. This creates better air flow and reduces the latent and actual heat in the house.

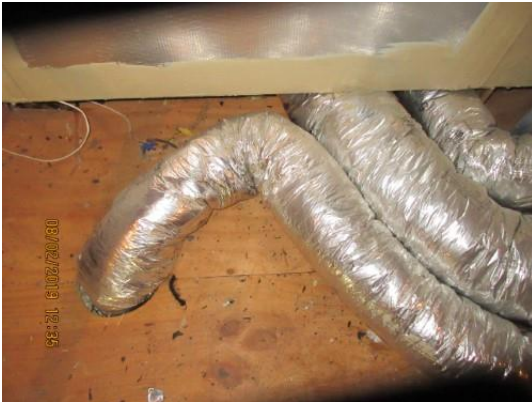
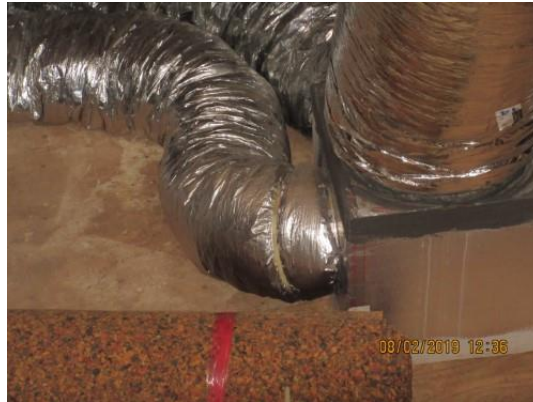
Deficiency: Pinched and misshapen flexible ducts were noted throughout the attic.

Information: It is well known that reducing or changing the shape of a pipe or channel causes turbulence which increases the pressure in the pipe or channel but reduces flow through the pipe, a phenomenon that you may have used in pinching a garden hose to reduce or eliminate water flow from the hose. For some reason, HVAC contractors contend that this well-known and documented fact does not occur in flexible air ducts. It does. The ducts should be properly aligned and supported. The turns in the ducts should be gradual so that the duct is bent and distorted as little as possible. This will help increase the volume of air flowing into the house and may relieve the pressures on the air conditioning equipment. The temperature and humidity levels should be consistent throughout each story of the house.

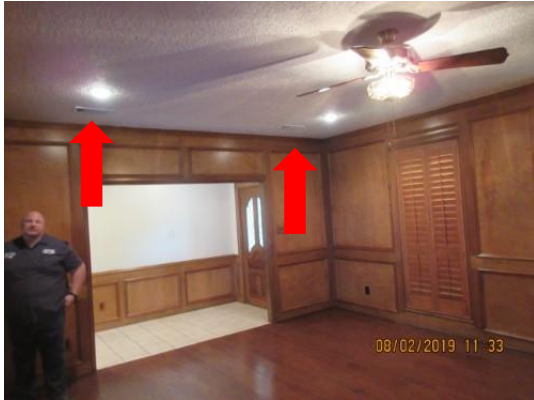
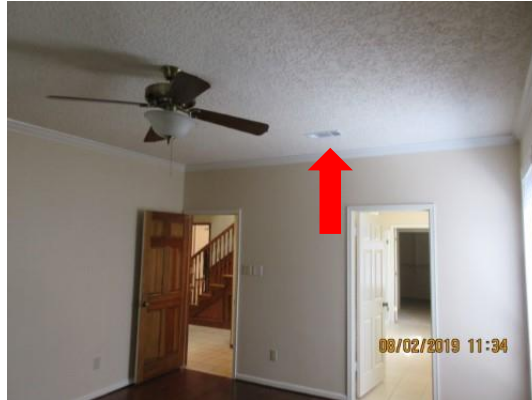
Deficiency: The air registers in various rooms were not located at the end of the room farthest from the return air system and some of the registers were too far from the exterior walls to properly dry the walls.

Information: HVAC installation contractors talk about how far registers will “throw”. That means where the conditioned air hits the floor, not how far the conditioned air travels on the ceiling. Below is an image from a thermal imaging camera that shows where heater air hits a wall. The registers, shown in the yellow box, is 6 feet from the exterior wall. The top of the heated air is hitting the wall more than 2 feet below the ceiling as shown by the blue line. Refrigerated air is more dense, “heavier”, and falls quicker than does heater air. For proper air flow and uniform cooling and drying of the air, all of the air space in each of the various rooms must be involved in the circulation pattern. When the registers are installed near the doorway, the air at the far end of the roof is not included in the circulation pattern. When the registers are located too far from the exterior walls the conditioned air is drawn back into the circulation pattern without reaching the exterior walls. This prevents the exterior walls from drying properly which means that the water in the wall cavities enters the house as water vapor. This increases the relative humidity in the house and promoted microbial organic growths. The lack of conditioned air flow at the exterior walls can usually be felt by you if you stand close to the walls while the refrigerated air is blowing. You can feel where the colder air sinks to the floor.

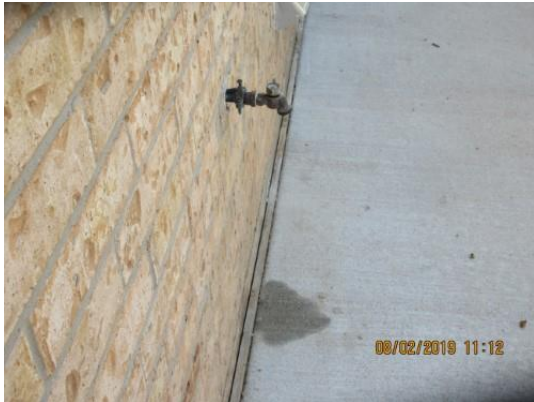
Deficiency: One of the outside faucets dripped.

Information: The faucet valve should be repaired or replaced.

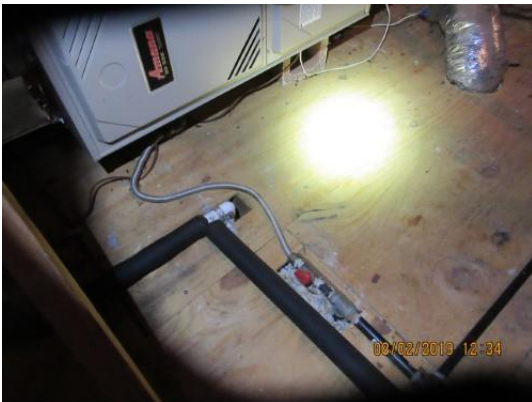
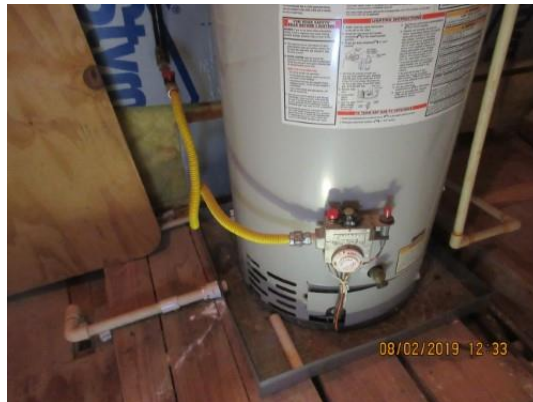
Deficiency: There were no sediment traps or “dirty legs” installed on the natural gas distribution pipes prior to the connections to the gas fired heaters and water heater.

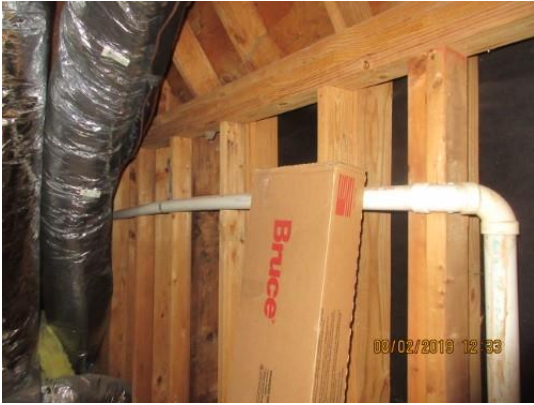
Deficiency: Some of the sewer vent pipes in the attic contained horizontal or reversed sloped runs.

Information: The purpose of the vent is to allow air into the drain system so that a vacuum does not form. A vacuum would greatly reduce the speed at which the fixtures drain. It can also prevent the fixtures from draining. A horizontal run means that the flow of air has been effectively stopped due to atmospheric pressure. The pipes must maintain a slight upward slope, at a minimum.

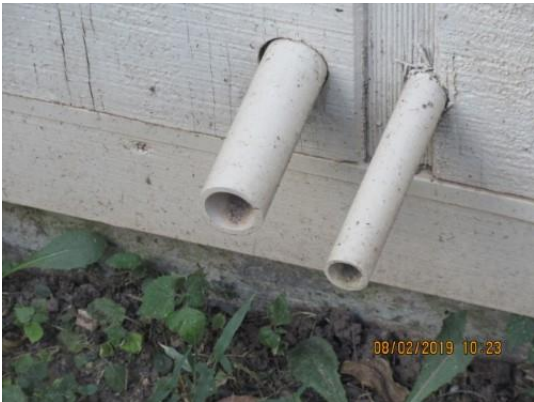
Deficiency: There were no elbows on the terminations of some of the drain pipes.

Information: Elbow terminations should be installed on all drain pipe terminations so that the terminations point at the ground.

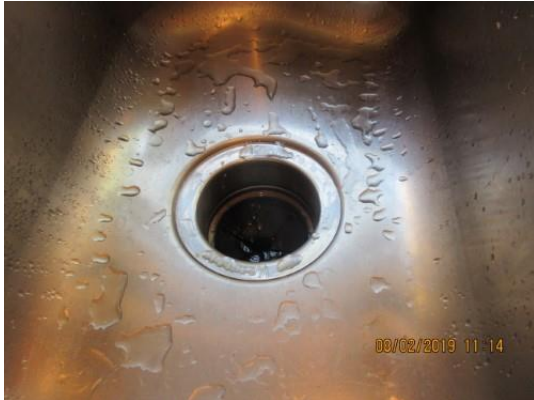
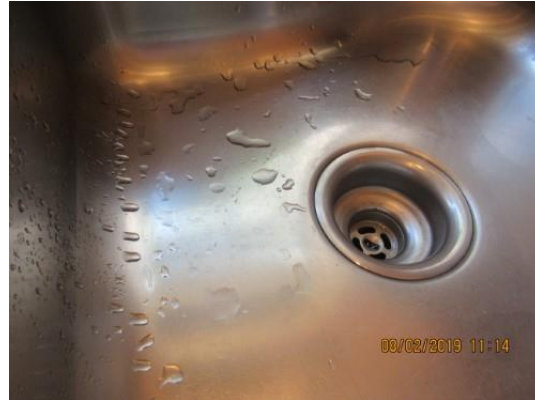
Deficiency: The kitchen sink was not properly or adequately sloped to drain all water from the sink.

Information: The tub should be adjusted to drain completely per chapter 27 of the IRC. If the sink is improperly manufactured the sink should be returned to the manufacturer for replacement.

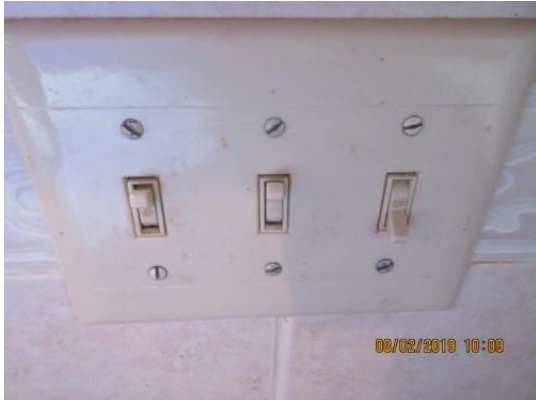
Information: All electrical control devices are required to be identified unless the purpose of the control device is clear. The toggle switch should be labeled to prevent a repairman from being called when the dishwasher is not operating and the switch is simply turned off.

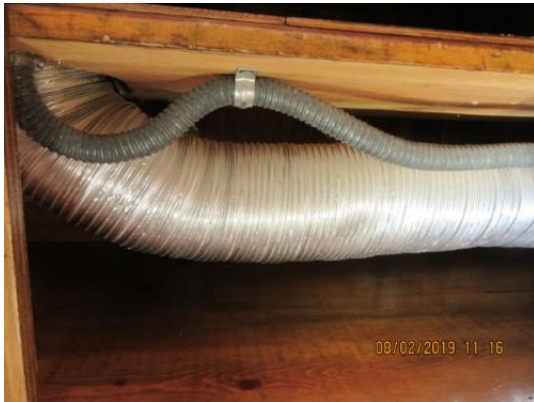
Deficiency: Most of the range vent pipe was made of inadequate material.

Information: The purpose of the vent pipe is twofold. The first is to remove odors and contaminants. The second is to contain a grease fire should one begin. The material used is not approved by the American Society for Testing and Materials (ASTM) to contain a fire. The vent pipe should be seamless galvanized steel, stainless steel or copper pipe.
