Advantage Inspections Plus

12219 Rocky Knoll
Houston, TX 77077
Prepared for:
Dalton & Jolie Schafer
Monday, December 21, 2020

PROPERTY INSPECTION REPORT

Concerning: 12219 Rocky Knoll, Houston, TX 77077
(Address or Other Identification of Inspected Property)

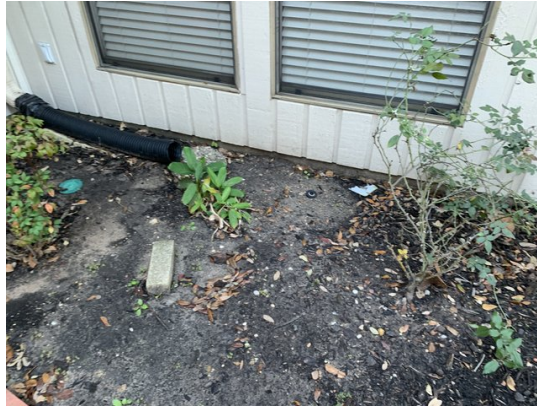
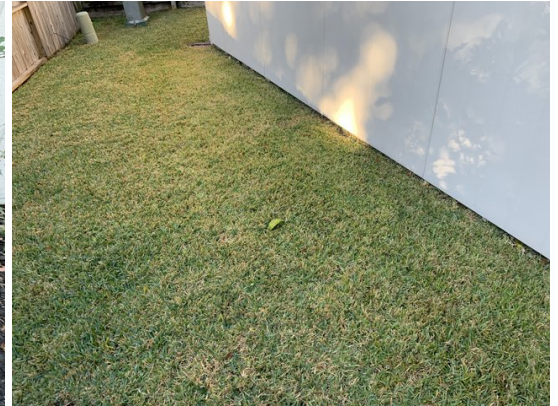
The lack of the exposed concrete makes it difficult to detect wood destroying insects and other insects.

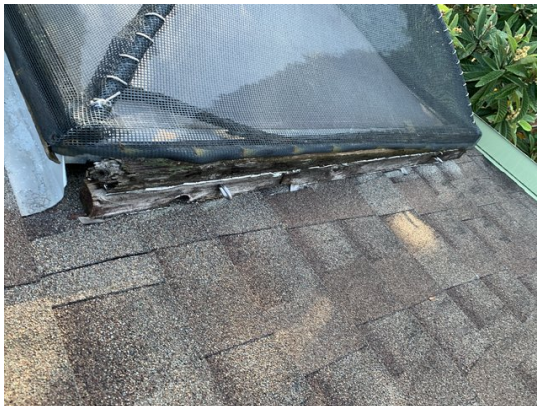
9. Some wood trim close to the primary bathroom skylight is rotting.

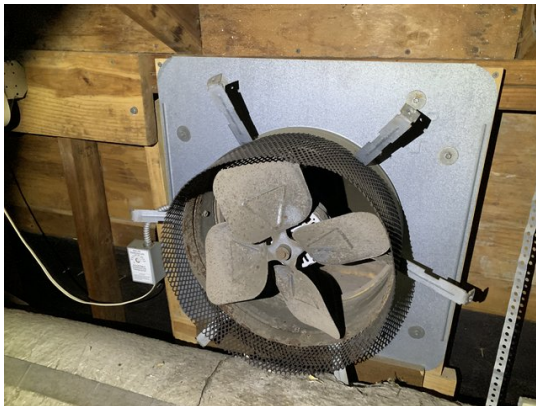
- The fan shroud/protector needs to be installed (or a safe alternative is needed).

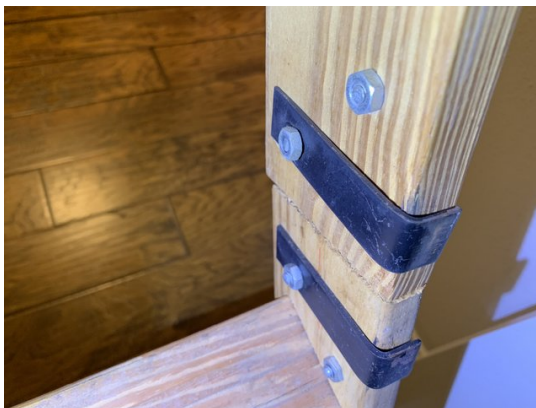
5. Attic access stairway is not installed properly. Manufacturers recommend shims be installed between the wooden frame and the ceiling joists. There should be 16 lag screws or 16d nails, and these fasteners should go through the holes in the metal brackets by the hinge and pivot point.

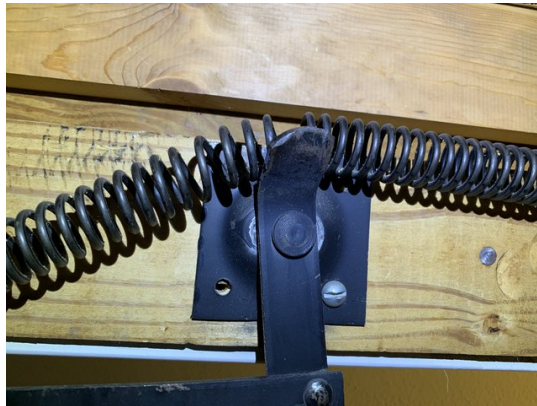
- Some nails are missing from the brackets.

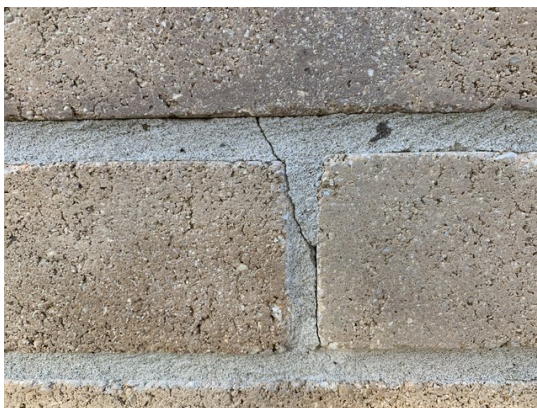
2. There are a few areas that have cracked bricks. This is not uncommon and is generally considered a cosmetic issue. With the foundation repair noted, this may be a symptom of a problem or a result of the repair.

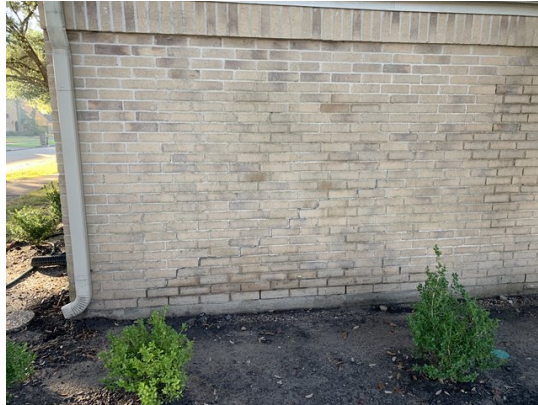
- Some of the bricks are out of plane.

- While not uncommon, cracked bricks may indicate problems with the foundation. Check to see if this was addressed in the engineer's foundation report.

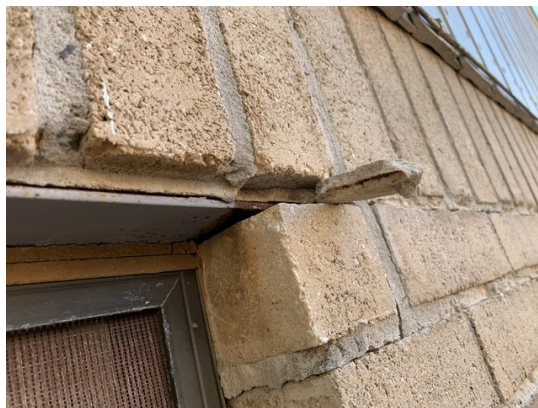
3. Some repairs are noted in the brick walls.

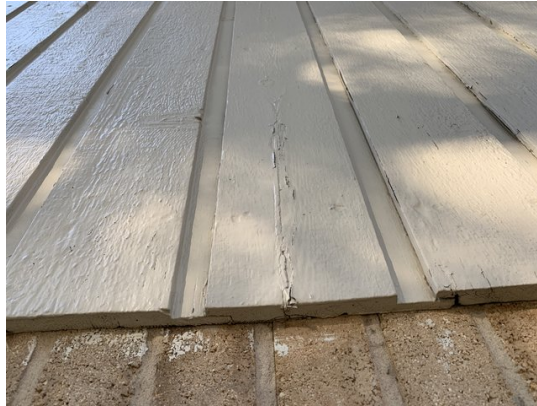
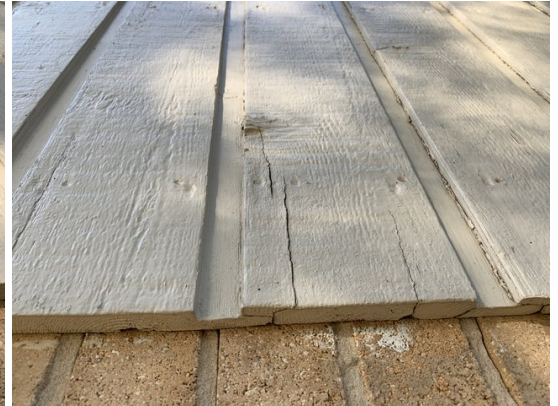
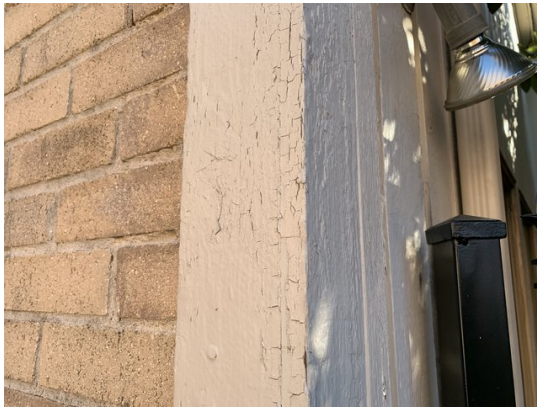
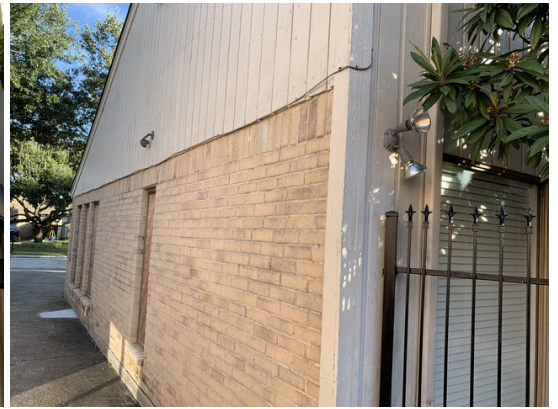
4. There are a few pieces of siding or trim that are rotten or starting to rot. Consider replacing it with a more durable, modern product that requires less maintenance.

- Cement fiberboard is a very popular option. It is durable and fire resistant but brittle. Hardieplank is a popular brand, but there are other manufacturers now. Visit <https://www.jameshardie.com/products> for more information.

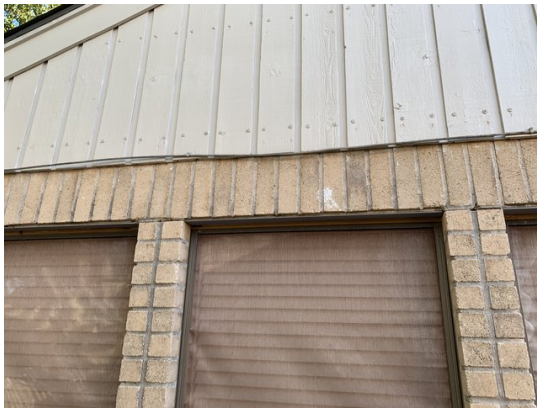
5. Weep holes are missing in the lintels over the windows. Weep holes are found on the bottom course of bricks, and they allow moisture that has soaked through the brick wall to drain. When this house was built, weep holes over the windows were most likely not required.

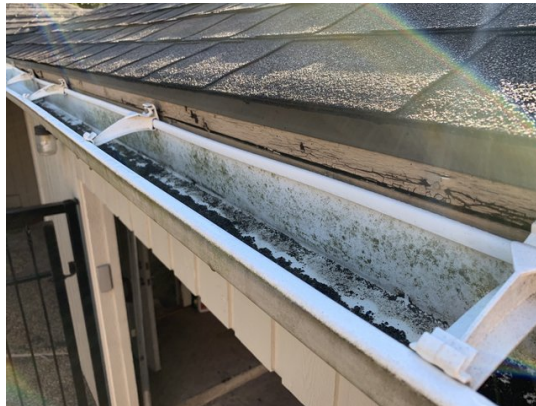
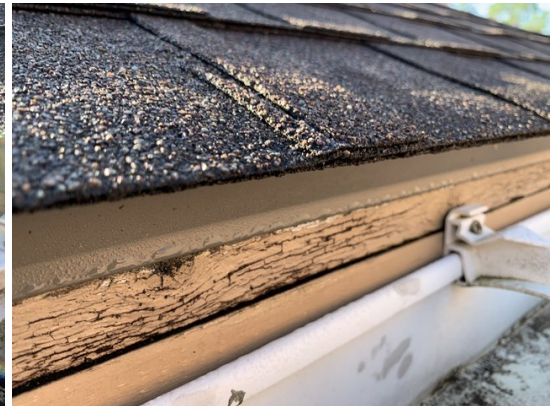
6. There is damage to the wood behind the gutters. The gutters should have been installed higher so the wood was not exposed.

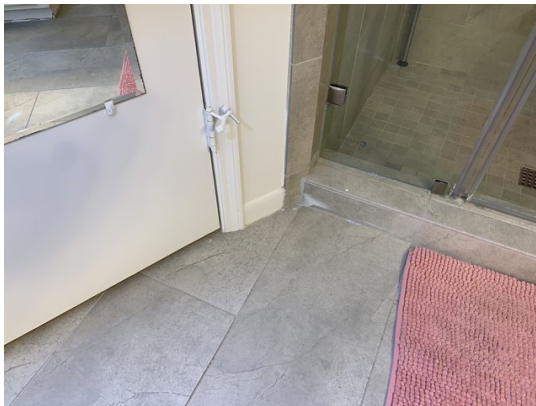
7. Some over spray is noted on the shower tile. This indicates the house may have been recently painted.

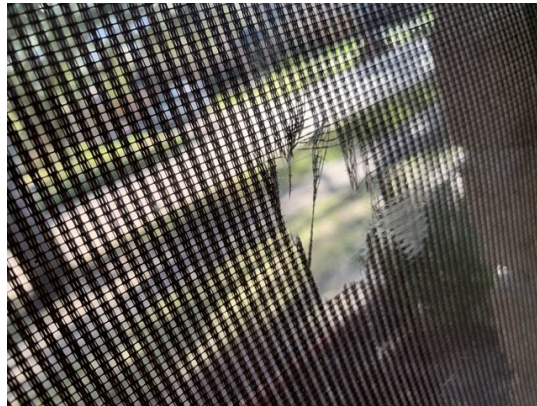
1. There are single pane aluminum frame windows present in the house that are single hung, horizontal slider and fixed pane (does not open).
2. There are solar screens on the exterior of the house. Some are faded from exposure to sunlight over time and damage is visible.

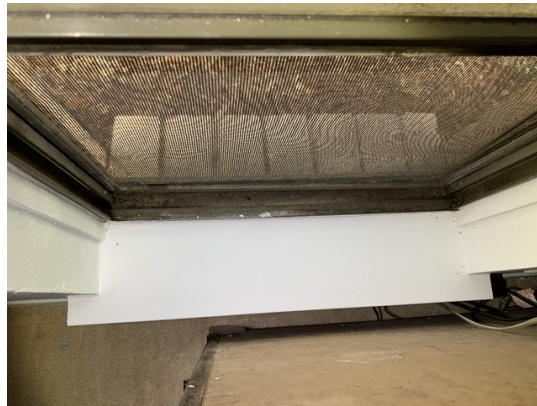
3. The window sills need to be cleaned as part of normal homeowner maintenance.

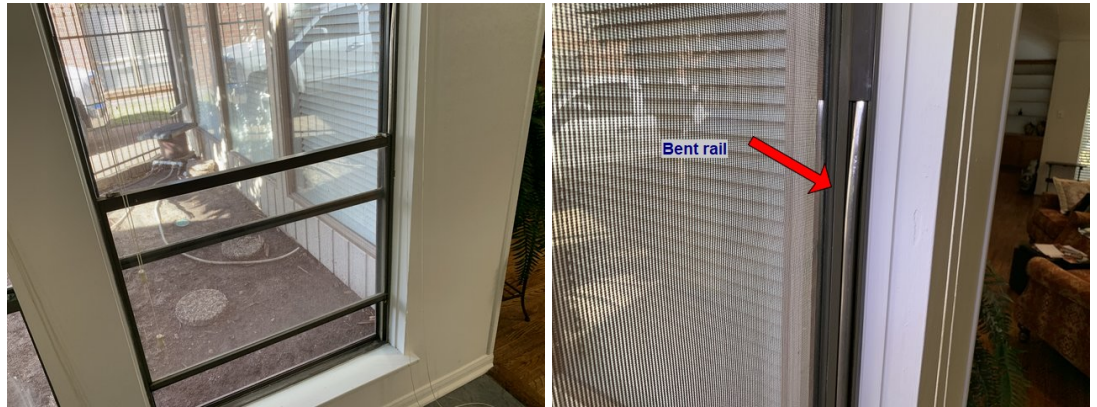
4. Many of the windows would not stay up when operated. There is usually a spring that keeps

the windows up (called a ballast spring).

- Some of the rails appear to be bent.

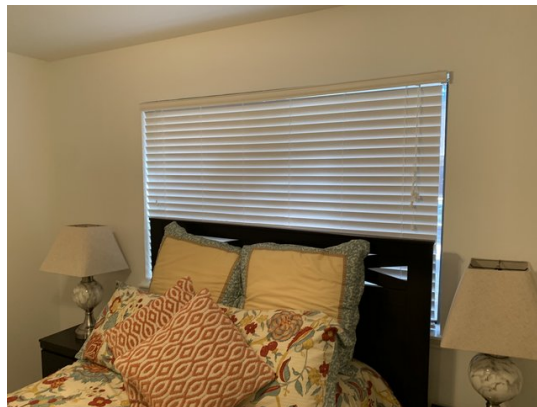
5. Some of the windows were not accessible for inspection. Windows in bedrooms are the secondary egress (emergency exit). They should be checked so they open and close without issue.

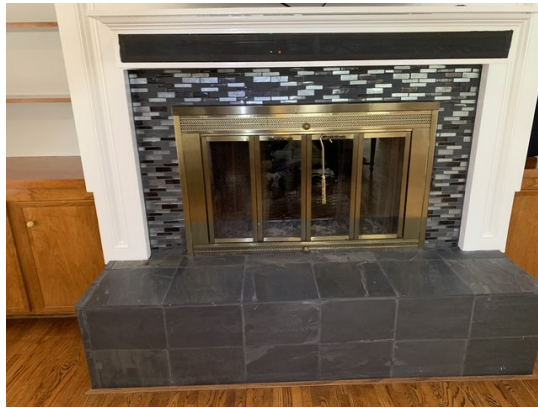
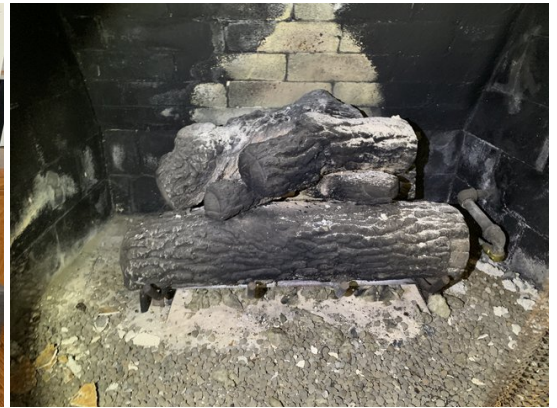
1. The fireplace is a wood burning, masonry fireplace.

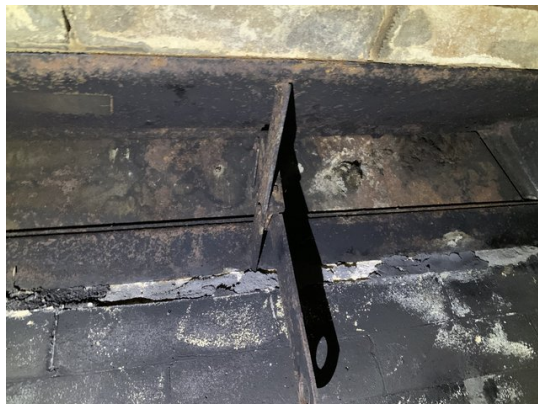
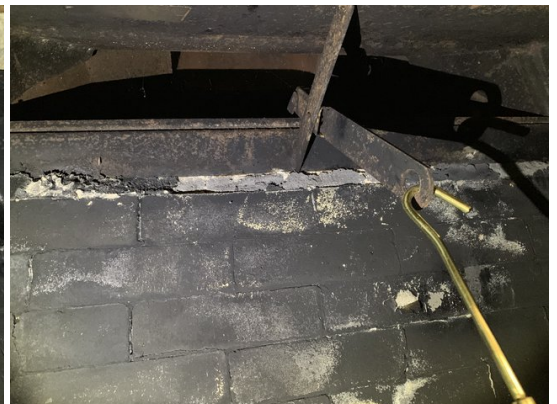
2. Ceramic logs are present in the fireplace.

-Keep damper open to minimize carbon monoxide poisoning. If the damper is closed, carbon monoxide can build up inside the home, which could lead to carbon monoxide poisoning. (When burning wood, if the damper is left closed, the house will fill with smoke and it will be obvious. Carbon monoxide is colorless and odorless. This creates a very dangerous carbon monoxide poisoning risk).

- A disabler should be installed on the damper to keep it from being closed.

- Consider installing carbon monoxide detectors.

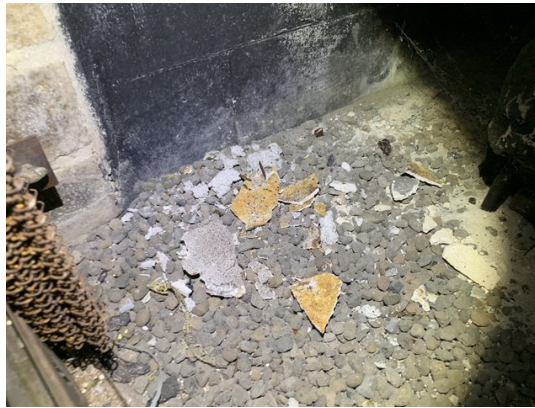
- Clean up trash located inside the firebox.

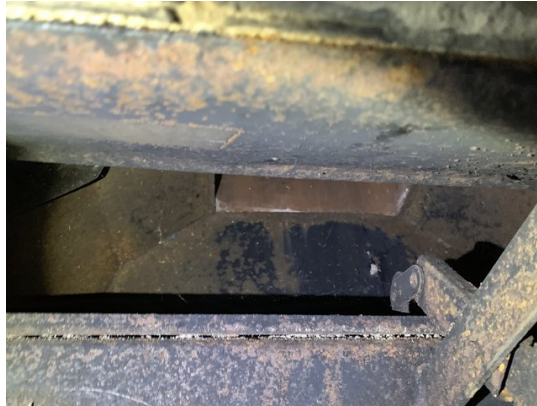
8. The ember screen has separated in one spot.

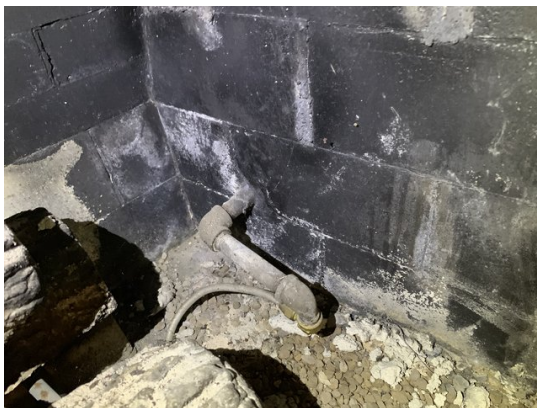
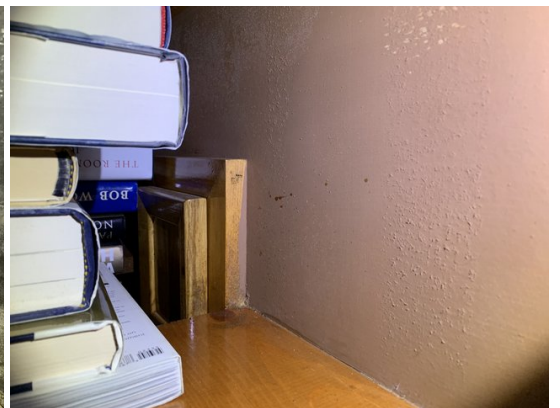
- Though not visible, when this house was built the gas valves were typically not operated with a key. The valves were often operated by a simple lever. Check to see if it needs to be secured when the house is emptied.

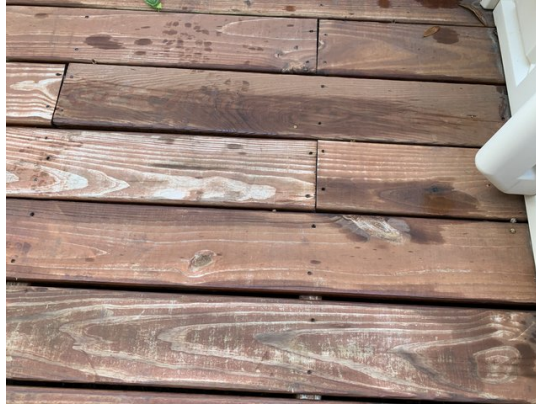
1. The decking needs to be refinished in some areas before there is damage from exposure to the elements.

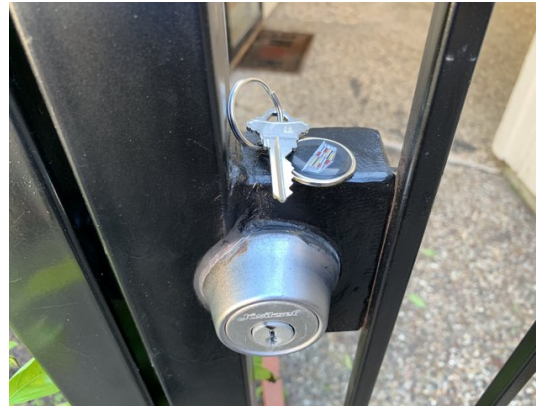
2. The house key does not operate the dead bolt on the side gate.

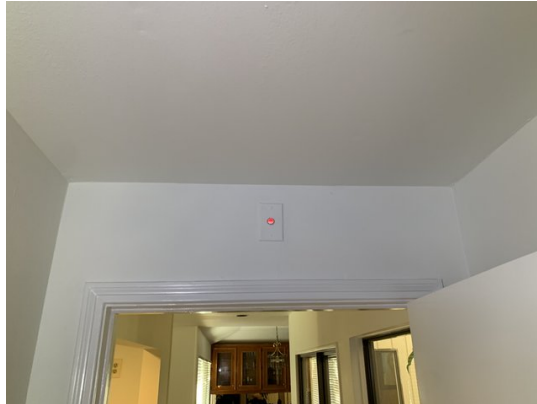
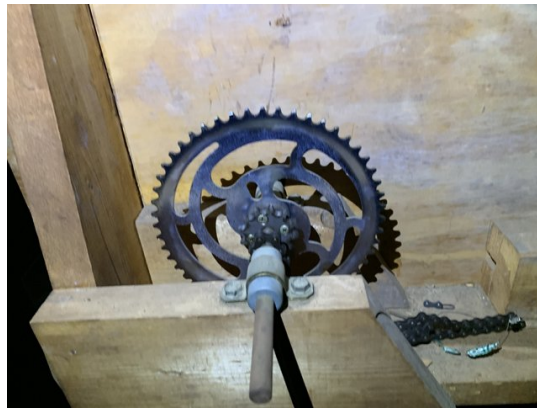
8. There is a mechanical device powered by a garage door opener that opens and closes one set of the atrium windows.

- Use caution as this is site built utilizing parts/machines in a way they are not designed to be used. It could not be operated/inspected for that reason.

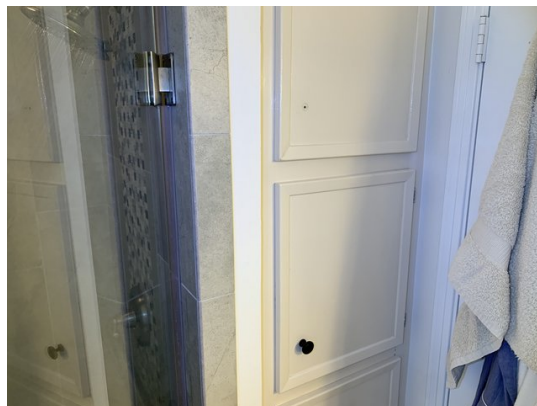
9. The primary bathroom has drawer that cannot be opened completely. It is a higher drawer than typical and is missing the drawer pull found on adjacent cabinets.

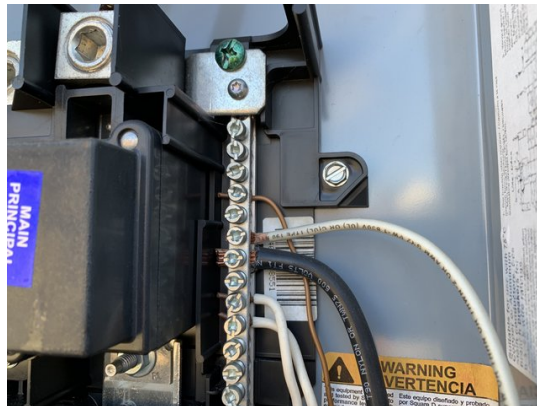
6. The electrical panel is poorly labeled. Determine which breakers protect specific circuits and that they are properly sized.

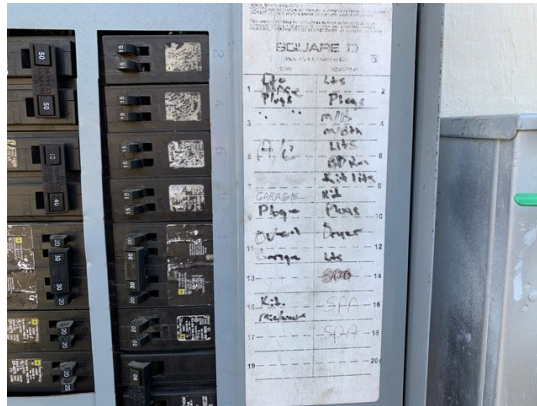
7. The breaker panel cover is missing a screw that holds it in place. Panel screws need to be flat tipped specifically for electrical panel covers.

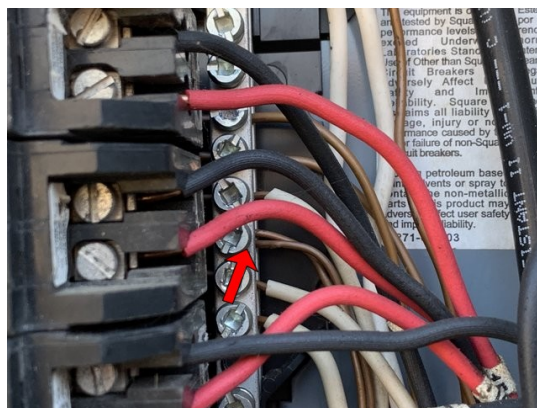
8. The ground wire bus bar contains double-lugged grounding wires. It is noted that this is common practice, but it may not be within the requirements of the manufacturer of the panel. Each manufacturer has different specifications.

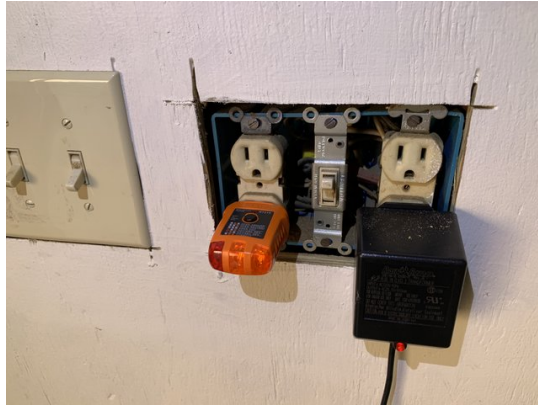
4. The electrical conductor (Romex wiring) should be concealed in the wall cavity or should be protected with conduit.

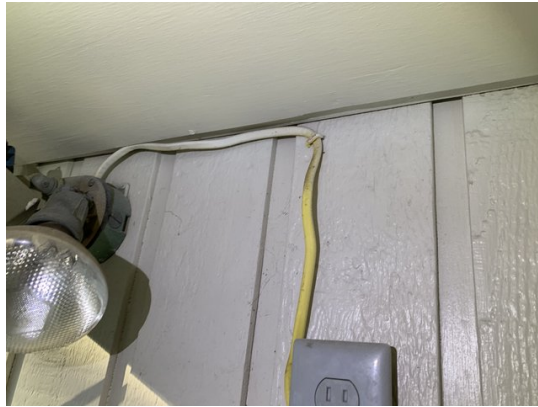
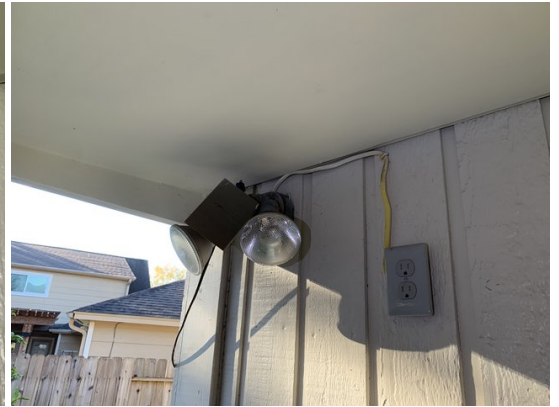
5. Some junction boxes are missing cover plates. These protect the electrical wiring connections and are required.

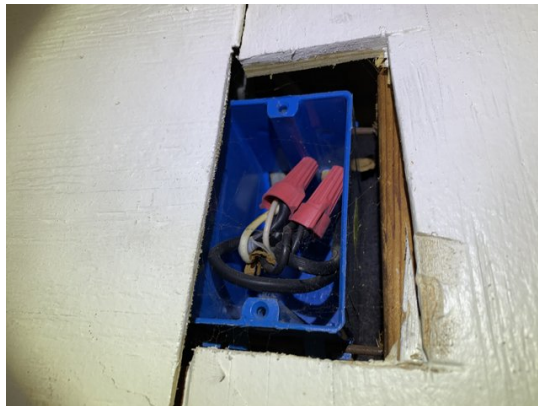
6. There are outlet covers that are missing. This is not uncommon, especially when remodeling. A missing cover may also indicate a loose outlet. Be sure the outlet is properly installed and consider purchasing "unbreakable" outlet covers that are nylon and much stronger.

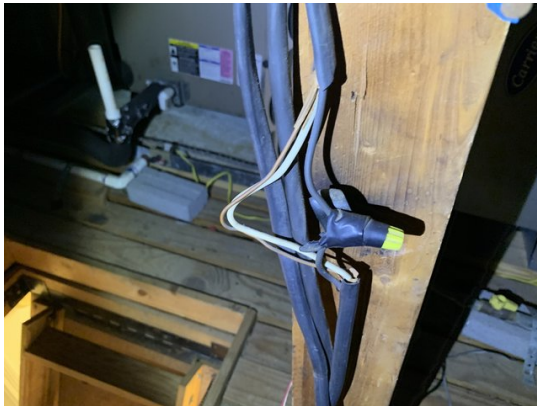
11. There are electrical connections that are not in junction boxes. An electrical connection should be in an electrical junction box, should have wire nuts that secure the connection, and the junction box should have a cover plate that is secured.

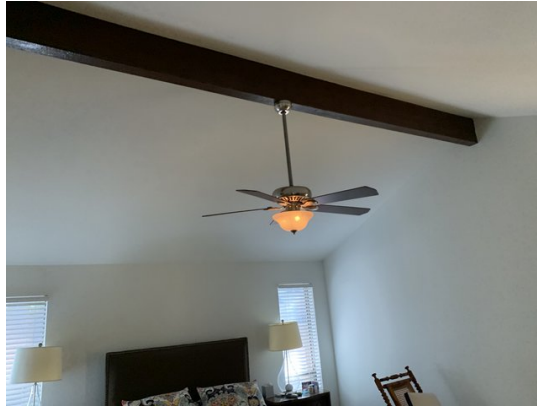
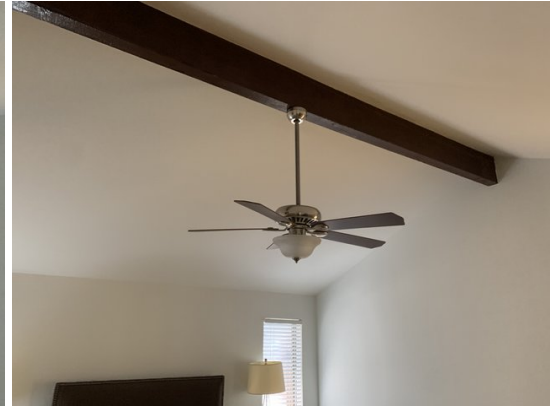
13. The light on the ceiling fan in the primary bedroom does not function properly.

- When the switch is turned on, the light stays on a few moments but then shuts off quickly.

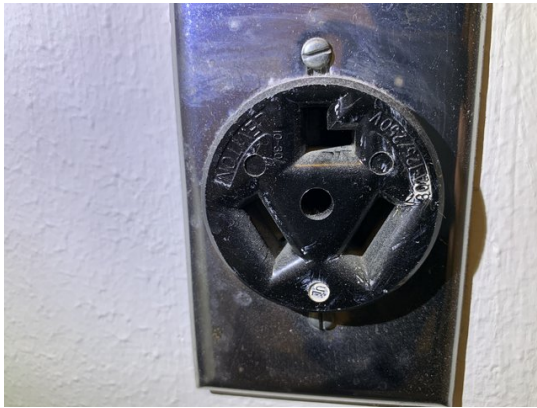
14. The electrical dryer outlet is a three prong outlet. It has two hot wires; the ground and the neutral share a wire. Modern codes require a four prong plug, where there are two hot wires (usually black and red), one neutral (white) and one bare copper wire that is the ground wire.

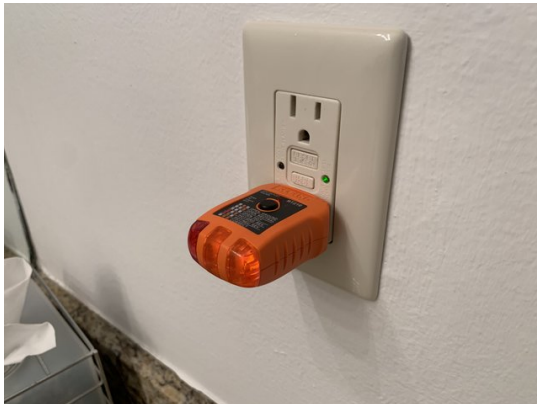
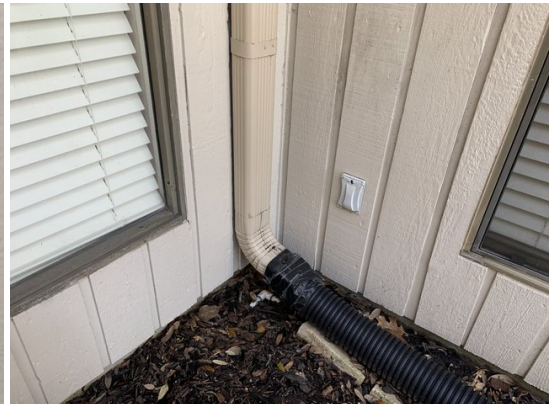
15. The hall bathroom GFCI outlet is also protected by the GFCI outlet on the front right section of the porch. Before this can be reset, the exterior outlet will have to be reset.

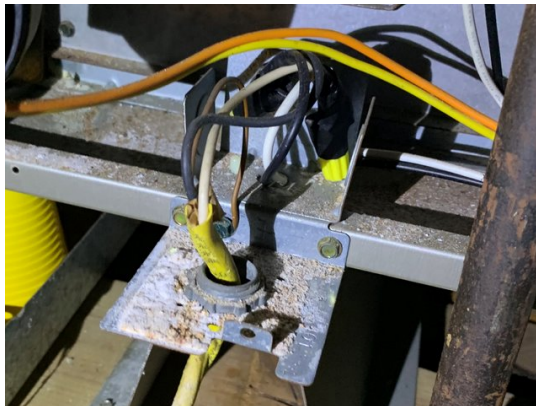
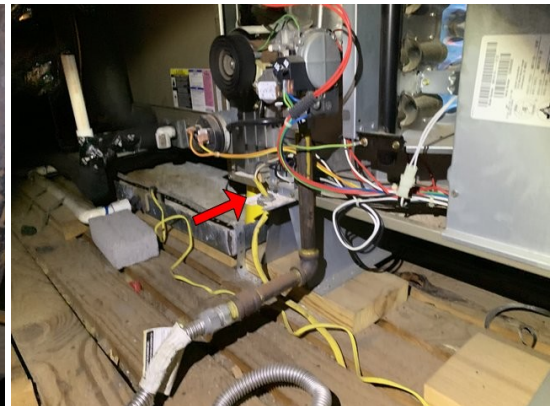
3. The internal junction box is missing the cover. This is an area where the power from the house is connected to the internal power supply line for the furnace. The manufacturer includes a cover to isolate this area from the rest of the furnace.

- Since the furnace has a cover that protects this area the risk of an electric shock or other issue is lower.

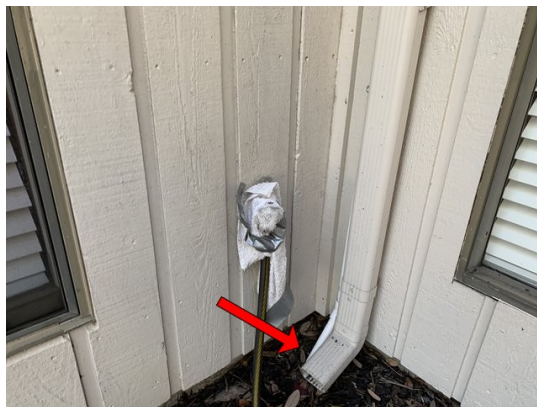
- The AC is manufactured by Carrier. The label indicates the unit is a 4 ton unit.
2. The AC differential should be between 15-20 degrees. This refers to the temperature of the air that goes into the return air duct and the different temperature of the cooled air that comes out of the supply duct in the various rooms.
 - The return air was 63 degrees and the lowest register was 51 degrees.
 - The differential on this unit was 12 degrees. It needs to be serviced.
 3. The primary condensate drain line drains onto the ground by the foundation. This is noted in to the left side of the entry door. It is a pipe hidden behind the downspout that is not attached to the gutters.

- As the air conditioning runs, it removes humidity from the air. This humidity then has to be disposed of properly. Modern construction techniques tie the primary condensate drain into the plumbing drain line, typically under a bathroom sink.
- The excess moisture drained into one area by the foundation can cause the ground to swell in the front porch area and lead to foundation problems.

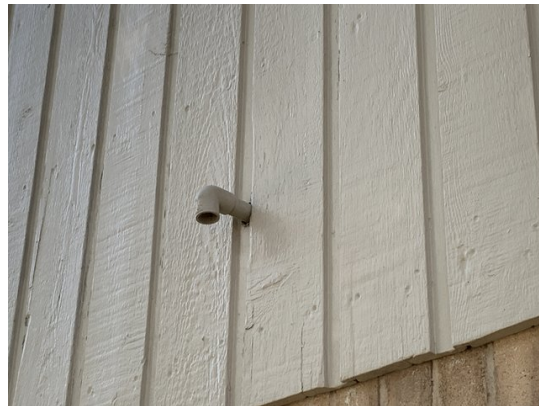
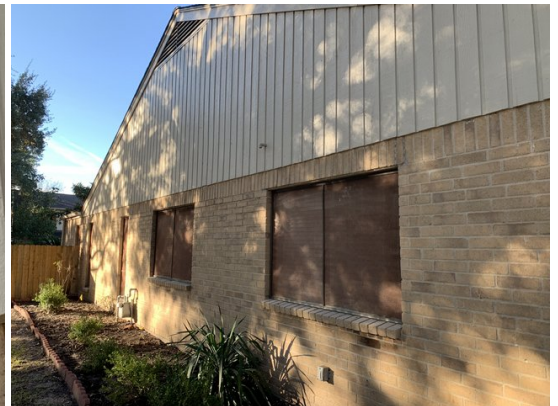
- It appears the original primary condensate drain line was drained into one of the vents in the attic.

- The pipe sticking out of the soffit material (horizontal material between the edge of the roof and the brick/siding) is the secondary or emergency condensate drain line. If water is coming out of this pipe, there is an issue with the AC.

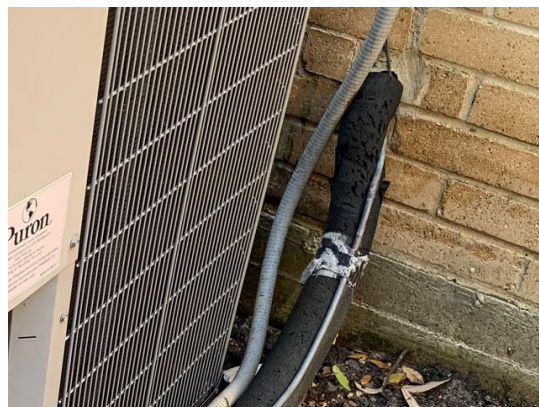
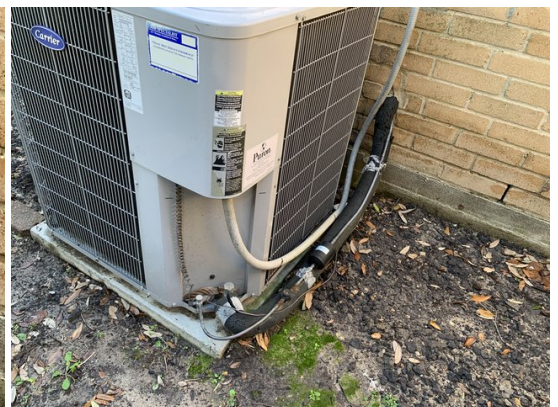
4. The exterior refrigerant line is poorly insulated. The lack of adequate insulation will allow for parasitic heat gain and make the unit less efficient. This effect will be worse the higher the exterior temperature.

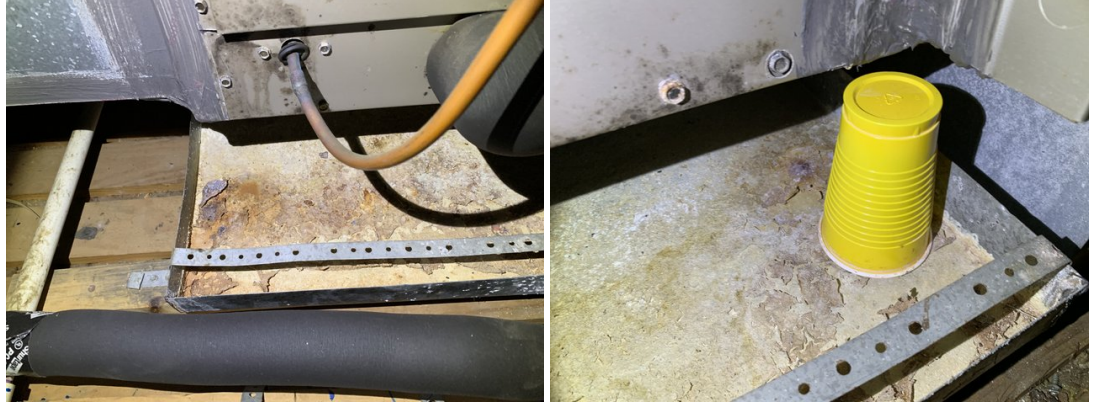
6. Rust and water stains are visible in the secondary condensate drain pans.

- Remove the trash from the pan as well.

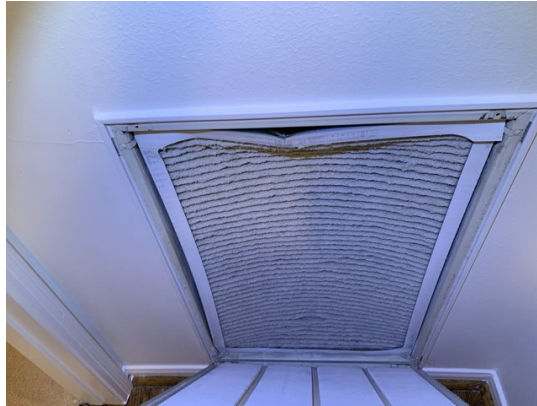
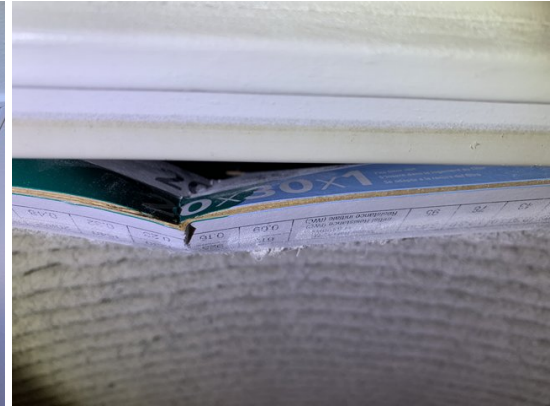
2. The filter is dirty and needs to be changed. This is part of normal homeowner maintenance and should be done every month.

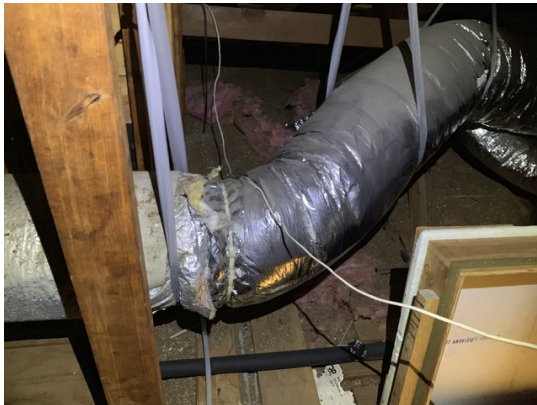
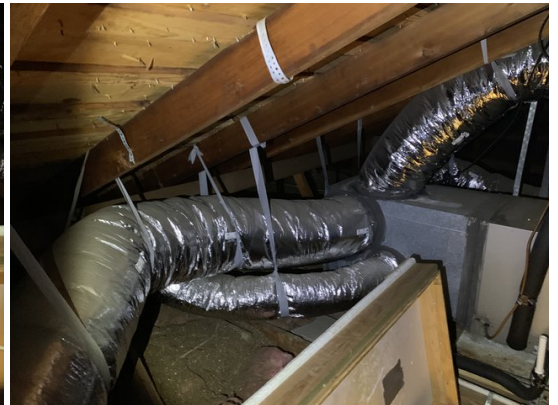
3. The HVAC filter size is 20 x 30.
4. The return air filter is damaged. Because the AC has been running without an adequate filter, this unit needs to have the evaporator coils cleaned.
5. There are repairs noted to the ducts. Monitor these for signs of leaks. Because of the nature of the insulation shroud around the duct, the union of the inner duct cannot be evaluated.

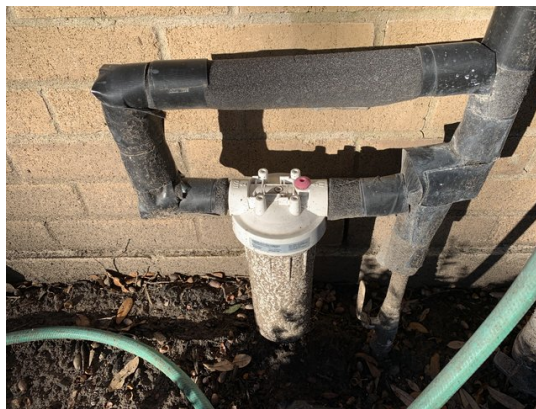
2. At least one of the anti-siphon devices is missing from the exterior hose bibs.
 - An anti-siphon device is designed to protect the home drinking water supply from contaminants. Hose bibs, dishwashers, sprinkler system and pool supply lines are required to have them.
 - The entry hosebib is wrapped for protection against freezing.
3. There is a whole house filtration system noted by the supply shut off.

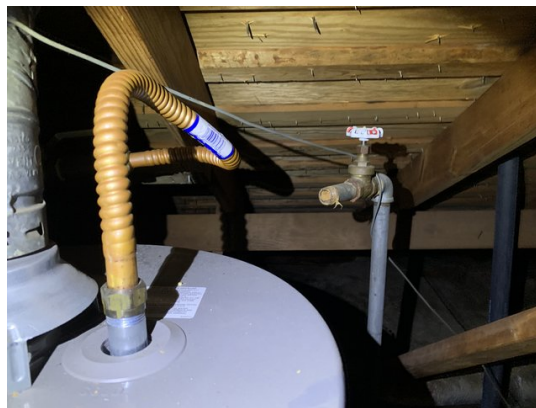
5. It appears the original galvanized steel pipes have been abandoned. Verify the pipes were removed

- Rust in the water of the hall bathroom tub indicates there is some steel pipe present close by it.

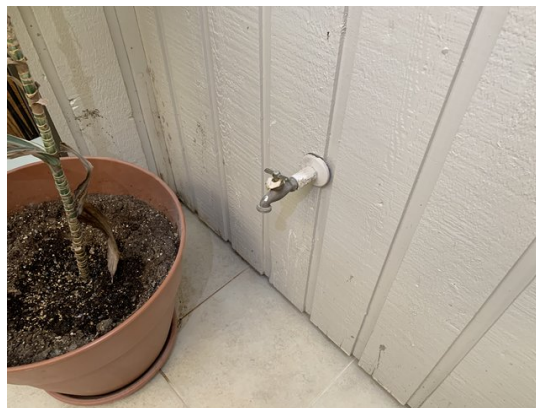
6. The hose bib in the atrium did not have any water pressure. Find out if it is abandoned.

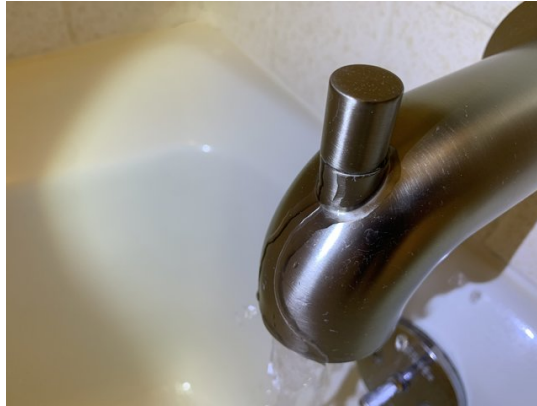
11. Water drops are visible on the hall bathroom tub/shower plumbing lines.

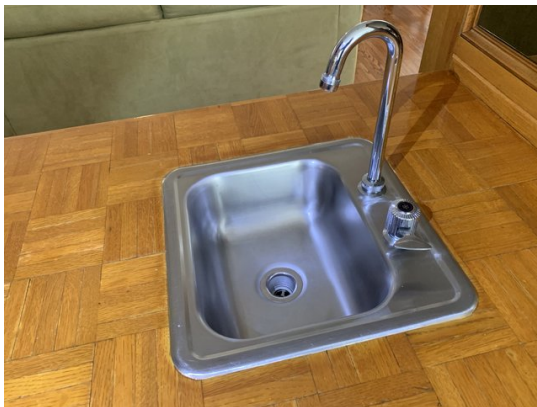
13. The drain for the primary bathroom is operated by rotating the knob by the water over flow. Pushing down on the mechanism can damage the stopper.

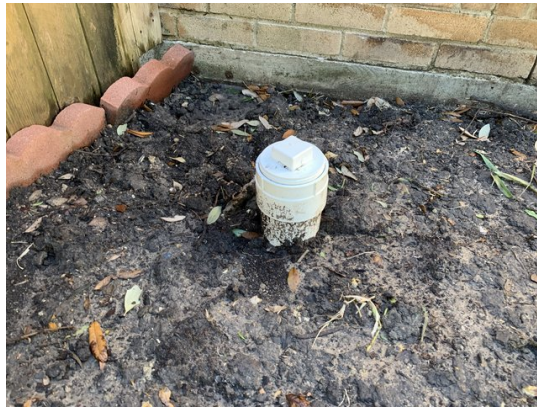
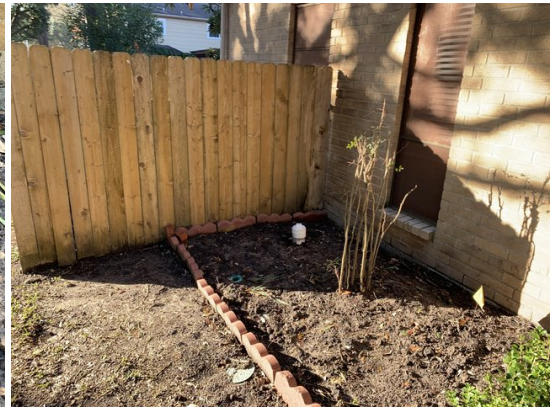
1. The sewer clean out is on the exterior left of house.

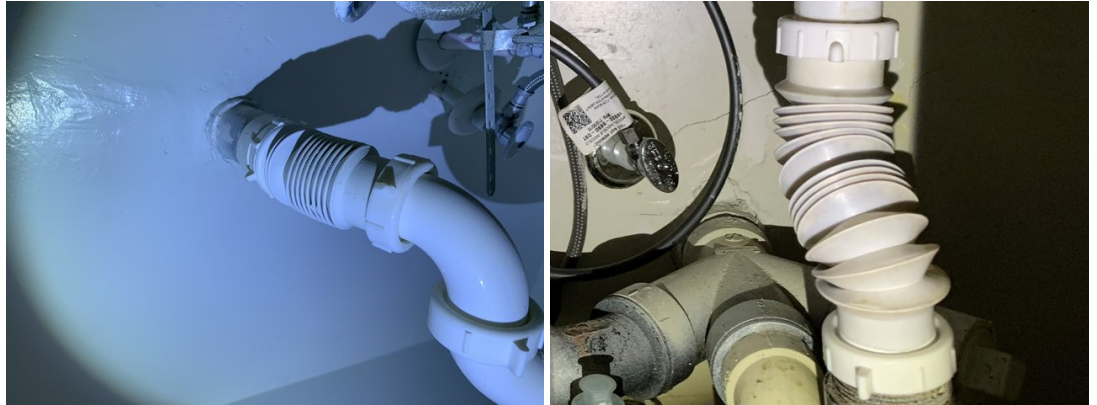
3. The sewer clean out needs to be lowered so it will allow a relief valve to function as efficiently as possible.
4. There is a strong odor of sewer gas noted in the attic. Check for a broken/disconnected vent in the attic.
5. Corrugated drain lines are not permitted. This makes it easier to attach the drain line. The non-smooth wall, however, make it more likely to get clogged.

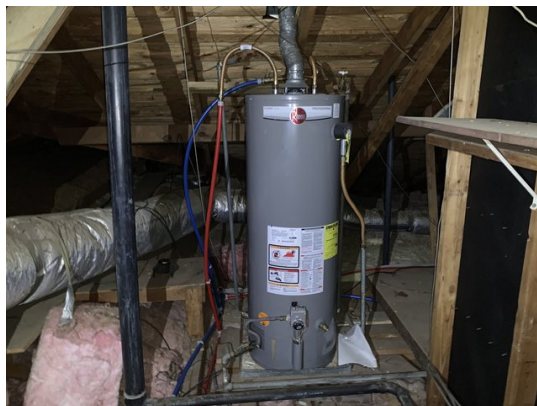
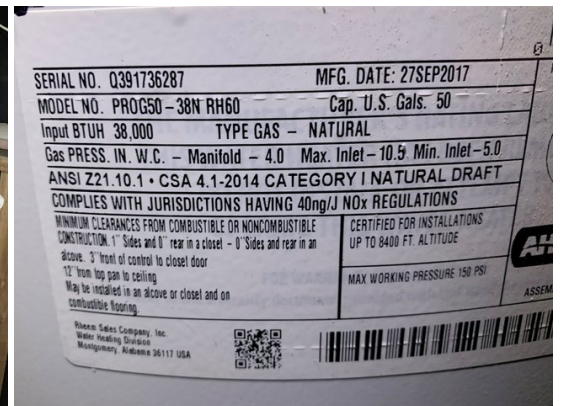
1. The water heater is located in the attic.

- The water heater is manufactured by Rheem.

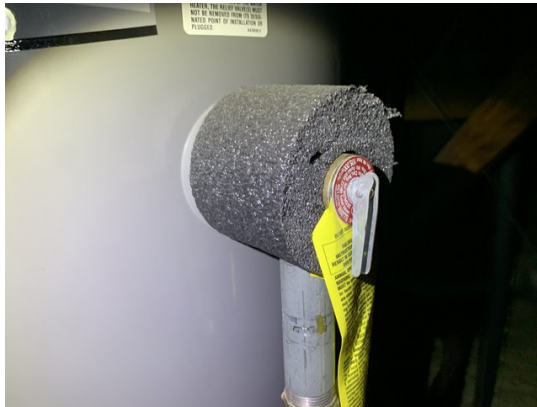
2. The TPR (temperature pressure relief) valve is a device that will release pressure in the event of a malfunction. It prevents water heaters from exploding. The drain should discharge to the exterior of the house or to a proper drain line. It should terminate no more than six inches from the ground, be gravitational drained and not have threads on the end of the

- TPR valve discharge drain line does not terminate within six inches of the final grade on the exterior of the house.
- For future reference, if water is coming out of the exterior drain line, there is an issue with the water heater.
- To see the Mythbusters experiment on water heaters, visit: <https://www.youtube.com/watch?v=jbreKn4PoAc>. Please note their water heater is only a 30 gallon water heater.

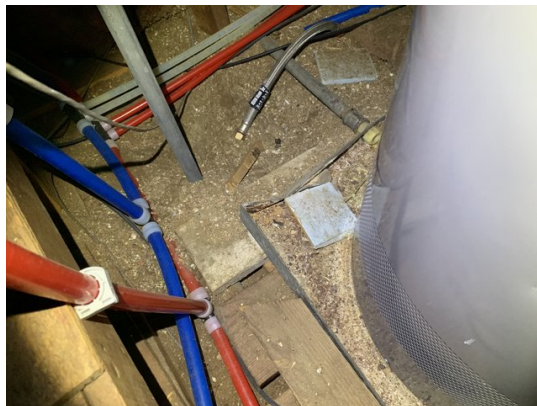
- The pan may be broken.
4. The temperature of the water is too hot. It should be no more than 120 degrees, but this water heater registered at 134 degrees.
 - Because the attic is not a conditioned space, its temperature is affected by the exterior temperature. This temperature fluctuation can affect the water heater temperature. It may need to be adjusted, depending on the season (turned up in the winter and down in the

3. Remove debris from the water heater safety pan (insulation and trash). This can cause the drain line to clog in the event of a leak.

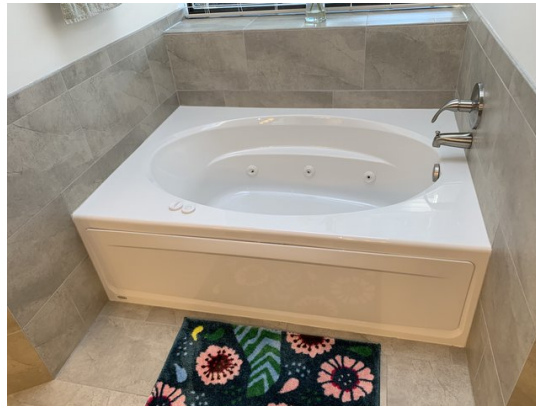
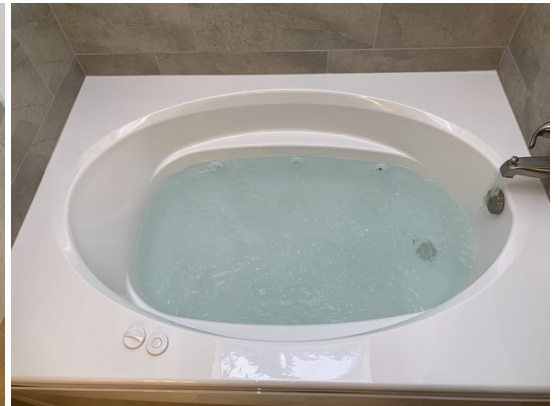
1. There should be access to the underside of the jetted/whirlpool tub. This model of jetted tub is built out of a molded form.

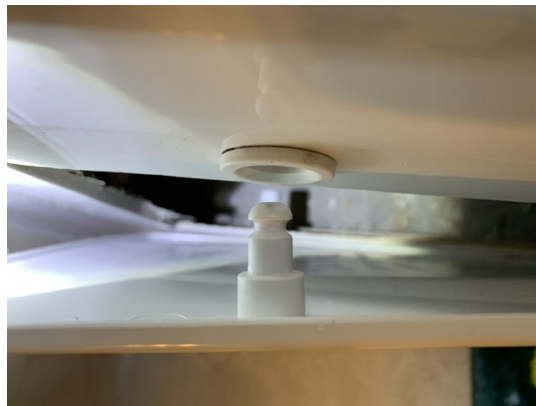
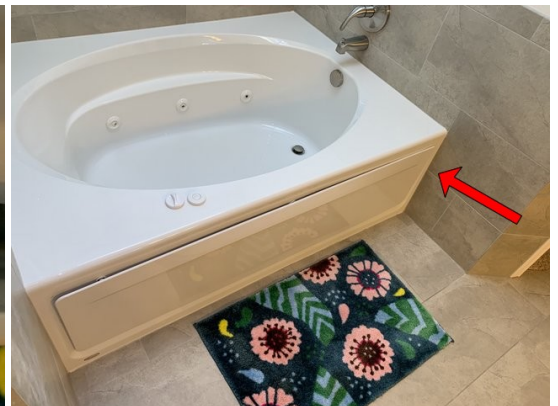
- The access panel would not detach on the right side of the panel cover when reasonable force was used. There is no access to the underside of the tub during the inspection. Use a couple of flat pry bars on each side of the fastener with even pressure to minimize the risk of breaking this plastic fastener.

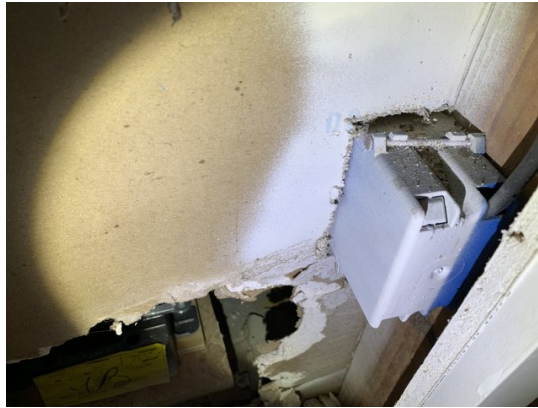
2. The GFCI reset button that protects the jetted tub is located not located during the inspection. It appears to be on the underside of the tub, but could not be verified.

- If it is not located, one should be installed.

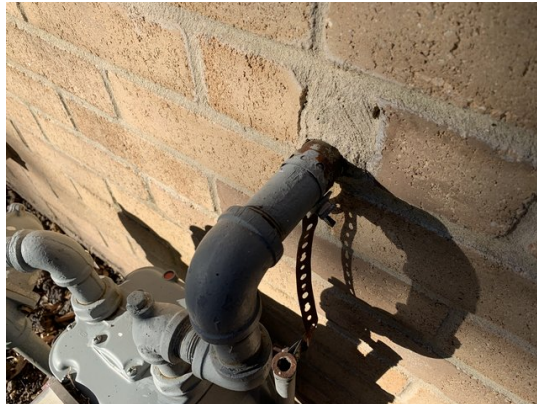
6. The gas line should have a sleeve or be wrapped so the gas line is not in contact with the mortar/bricks/masonry. When this house was built, this was most likely not required.

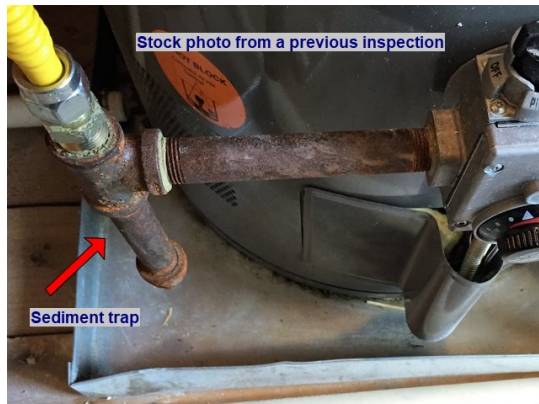
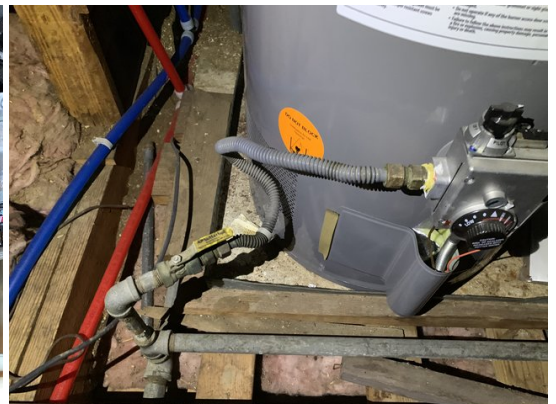
7. Gas appliances missing debris/sediment trap. This is a vertical piece of iron pipe that catches any particles that may be in the gas line. The water heaters and furnaces require them now, but when this house was built it may not have been required. It is not uncommon to see houses without these devices.

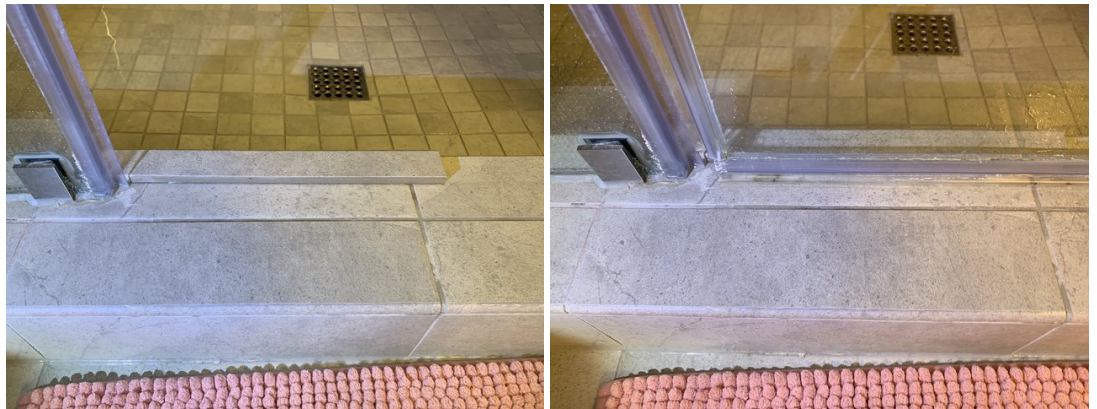
8. A piece of tile has been installed in the primary bathroom shower to act as a door stop.

- It is difficult to see, use caution to not trip on it or drag feet across it.

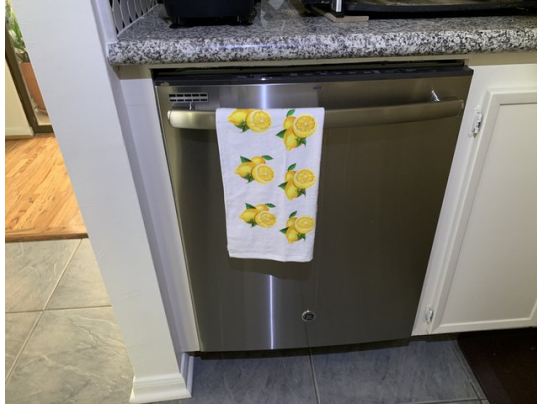
1. The dishwasher was started and ran without issue.

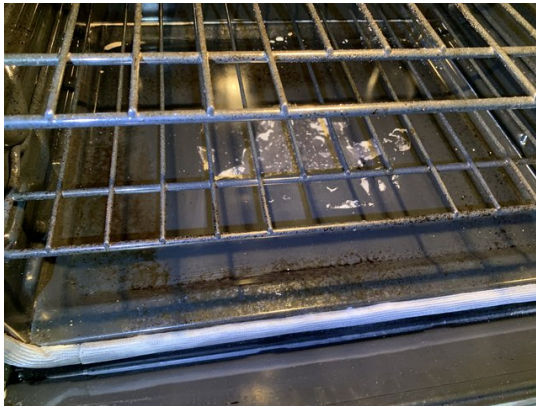
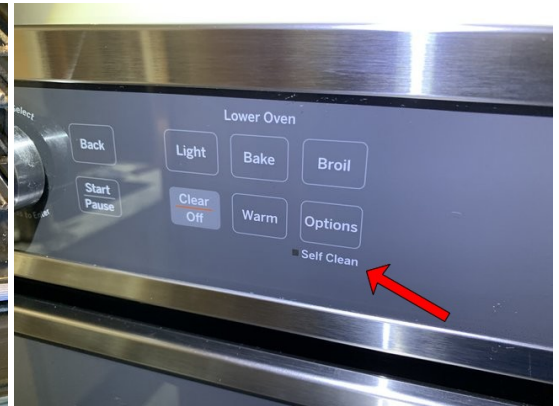
4. The oven needs to be cleaned. Do not use self-cleaning mechanism. This causes excessive heat and can damage electrical components. Modern chemical oven cleaners are less corrosive than previous cleaners and very easy to use.
