Advantage Inspections Plus

12219 Rocky Knoll
Houston, TX 77077
Prepared for:
Dalton & Jolie Schafer
Monday, December 21, 2020

PROPERTY INSPECTION REPORT

Concerning: 12219 Rocky Knoll, Houston, TX 77077
(Address or Other Identification of Inspected Property)

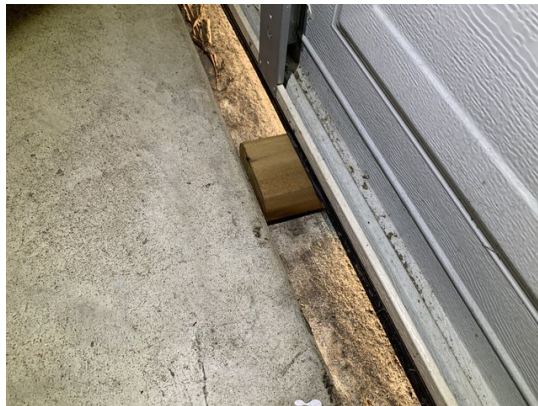
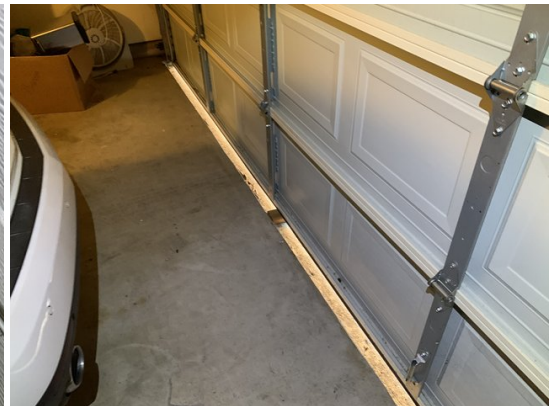
1. The garage door force sensor needs to be adjusted. It is tested (auto-reverse block test) as follows:
 - Open the garage door opener.
 - Place a 2X4 flat on the ground.
 - Close the garage door on the 2X4 (placed flat on the ground).
 - Opener should recognize the object and automatically reverse to the full open position.

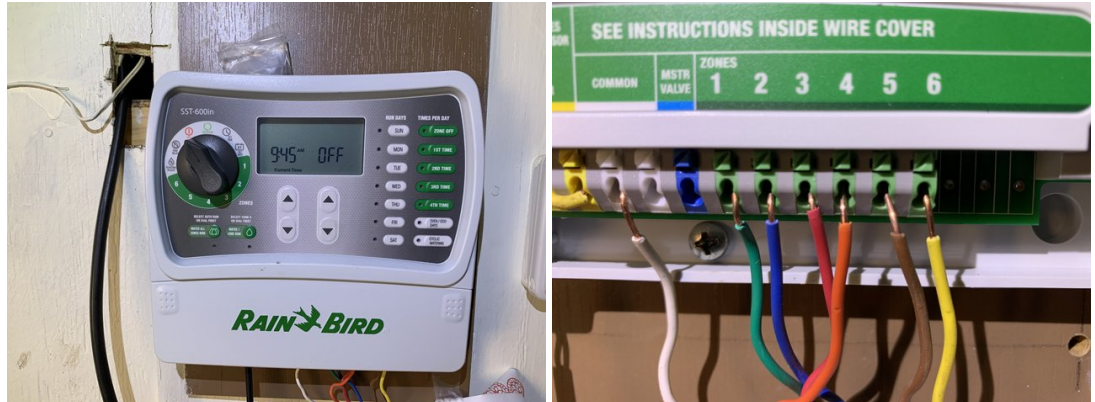
1. The sprinkler system is a Rainbird that has six sprinkler zones.

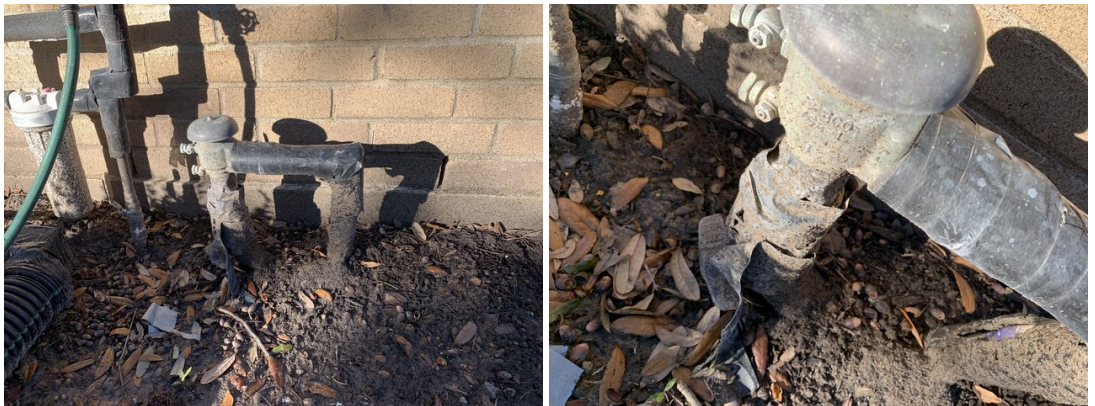
- The PVB isolation valves are not visible (most likely covered with insulation).
- For specific information on this procedure from the manufacture visit:

2. While the Houston area is relatively warm in the winter, there are occasional cold fronts that produce freezing temperatures. Take the necessary precautions to protect the sprinkler system from freezing. There are internal components that will break if there is freezing weather. Go to the PVB valve (pressure vacuum breaker valve- the top kind of looks like a bell) and shut off the valves on the water lines. Then, open the valves that are attached to the PVB. This will drain the water on the interior. As an extra precaution, wrap the entire unit in an old towel or small blanket to prevent freezing.

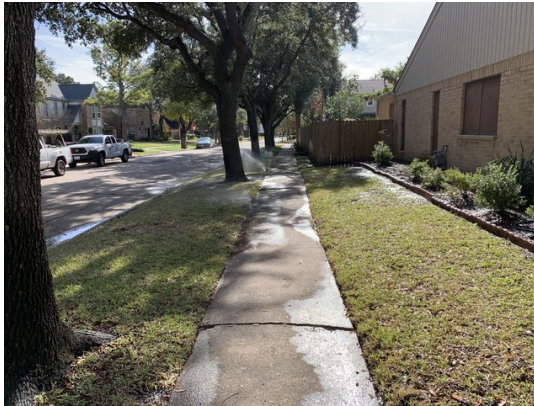
4. One of the valves is stuck and kept the same sprinklers on for zones 4, and 5.

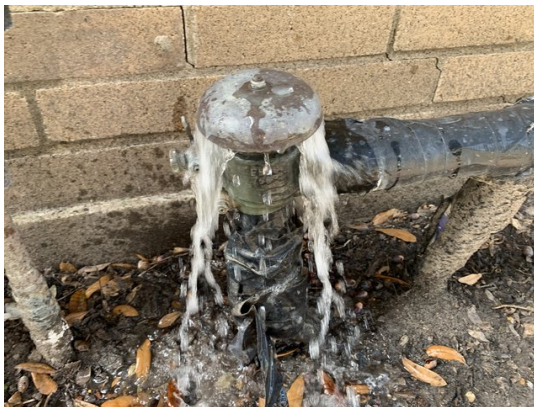
5. The anti-siphon device leaked at the valve for a few minutes. Once pressure was released (changed zones) it operated without issue.

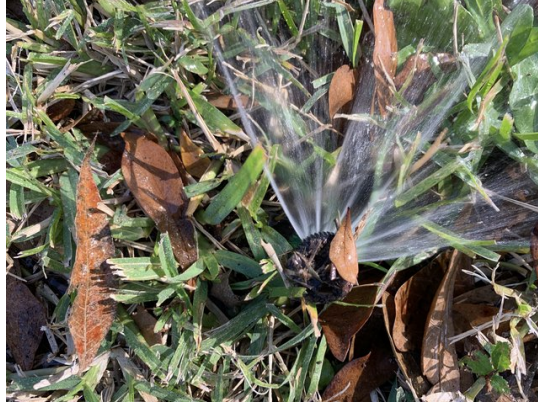
- Some heads need to be adjusted at this time.

thicker. There are extensions that can be installed to raise the heads slightly.

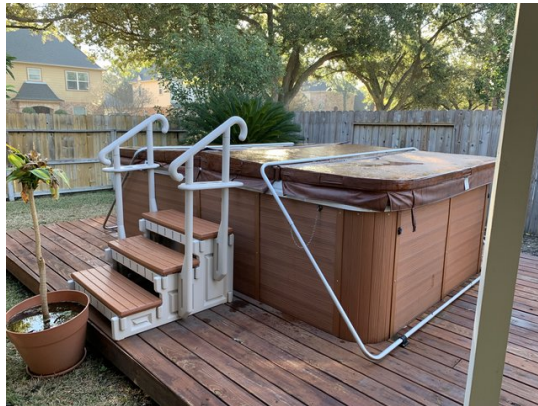
1. There is a stand alone spa noted on the back patio.
