# *Texan Inspection Services LLP*

## **Property Inspection Report**

511 Quintana Roo Place, Seabrook, TX 77586  
Inspection prepared for: Zachary Colander Kristen Colander  
Real Estate Agent: Spencer Mulgrew - Creekview Realty

Date of Inspection: 6/21/2019 Time: 1:00 PM  
Age of Home: 2018 Size: 3567  
Weather: Cloudy/ 92 Degrees  
New Construction

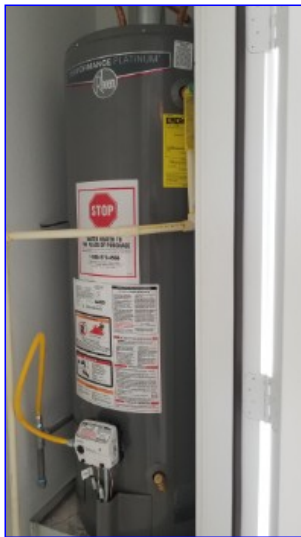
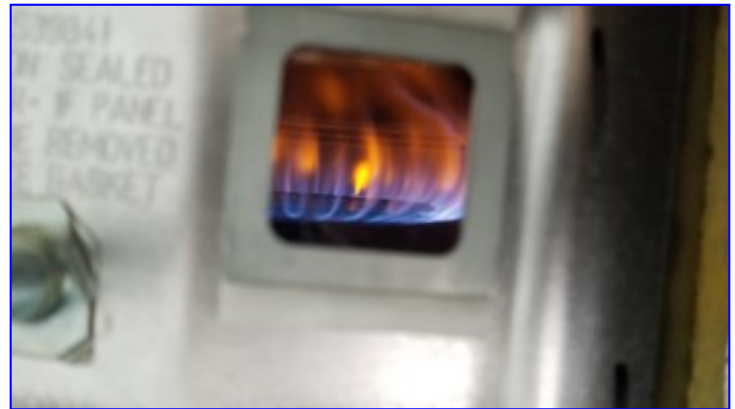
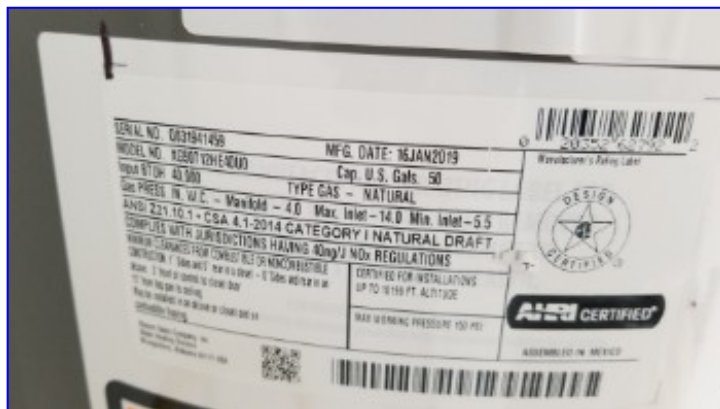
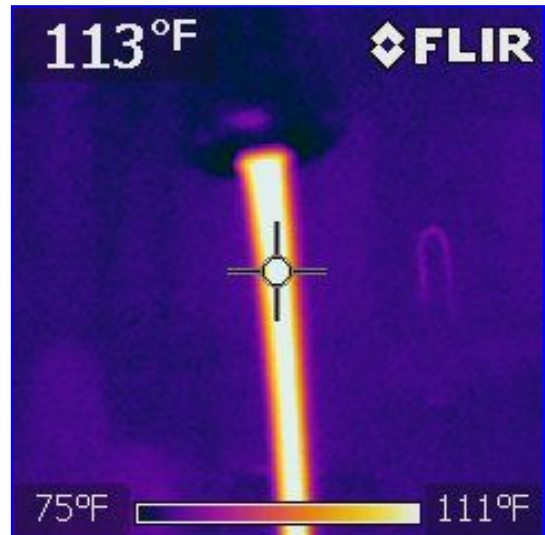
- The water heater was visually inspected for defects and operated. The unit performed as intended and was properly vented/connected to the exterior of the structure at time of inspection. Hot functions were verified at all plumbing fixtures.

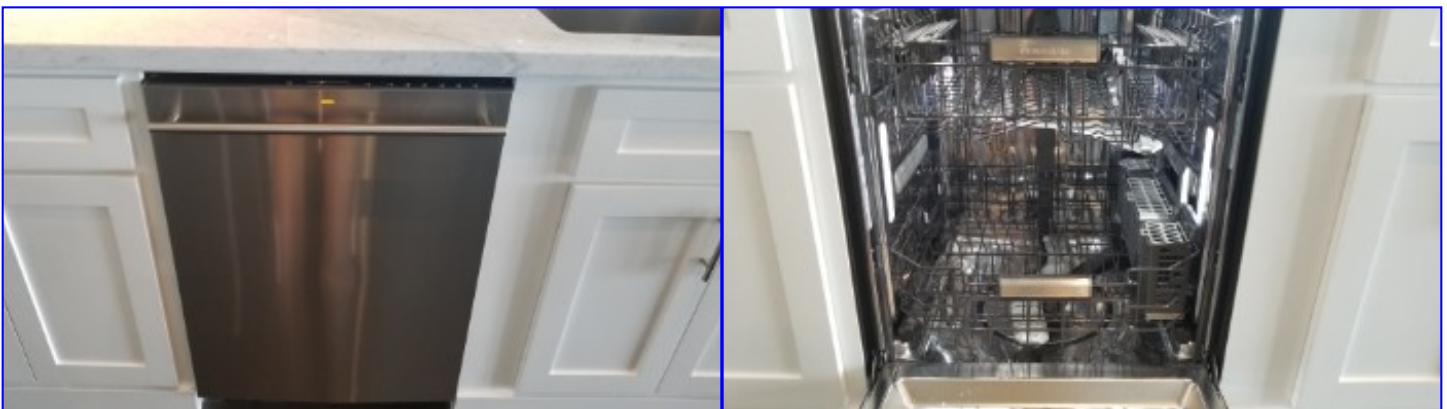
- Dishwasher was run through a normal cycle and operated/drained properly during inspection.

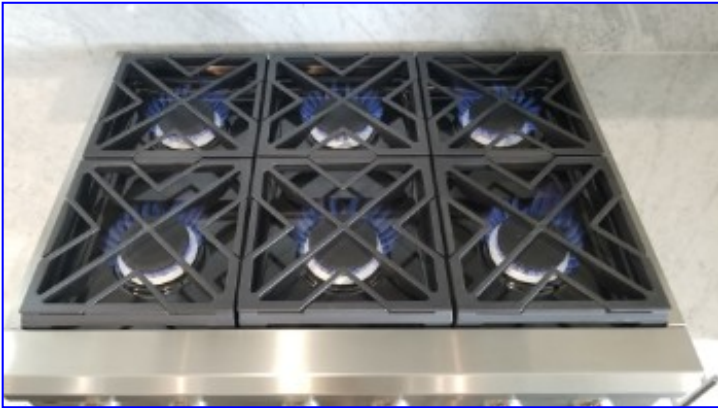
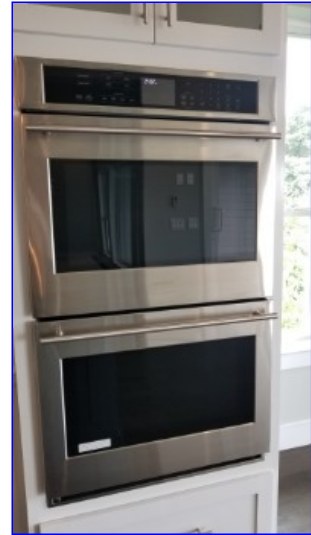
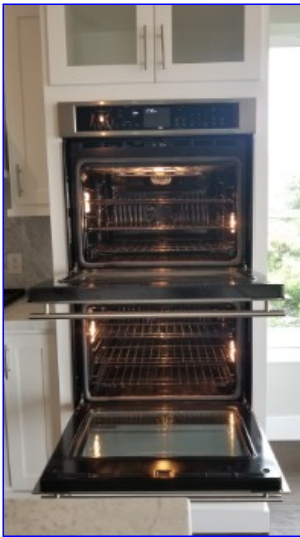
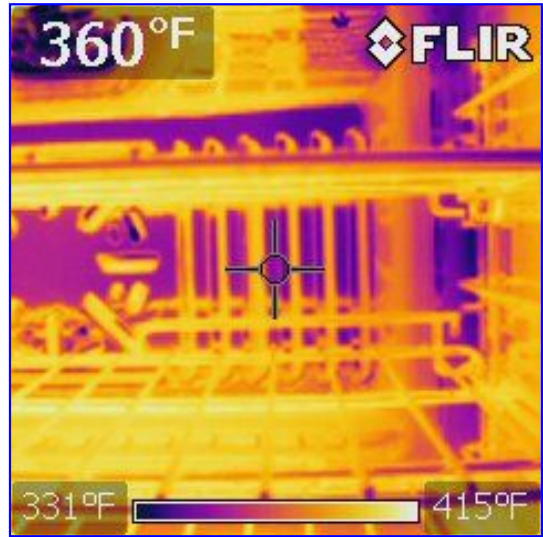
- The cook-top operated properly during inspection. No deficiencies noted.
- The oven(s) operated properly during inspection. No deficiencies noted.

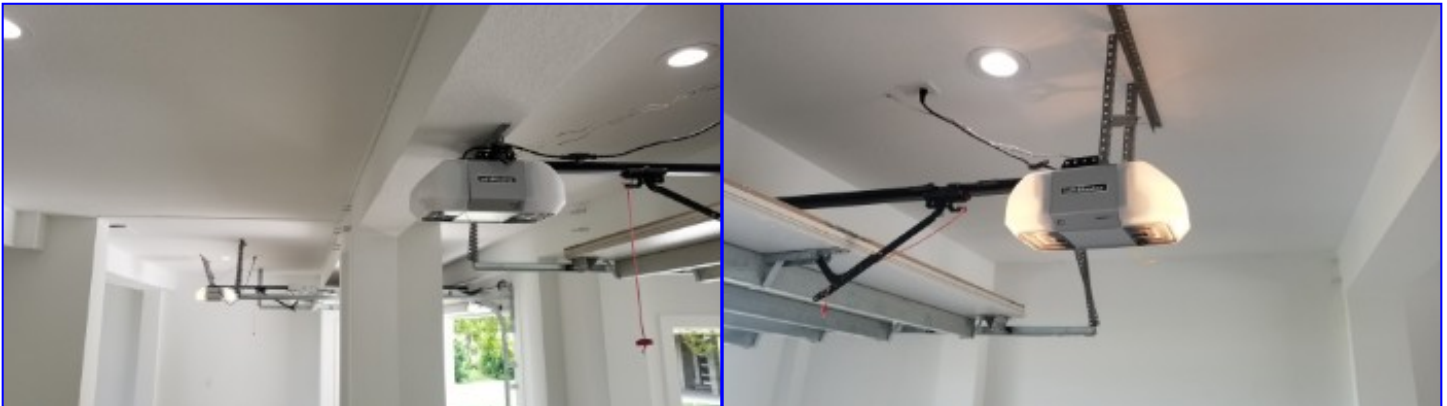
Comments:  
 • Manual operation of the door was performed. The unit and it's components appear to be properly installed and performing at this time.  
 • The reversing functions (photo electric sensor/resistance) for the automatic opener operated properly at time of inspection. No deficiencies noted.
