RESIDENTIAL INSPECTION REPORT

9400 Doliver Dr 78
Houston, TX 77063

PROPERTY INSPECTION REPORT FORM

| Susan McDaniel <i>Name of Client</i> | 05/26/2023 9:00 am <i>Date of Inspection</i> |

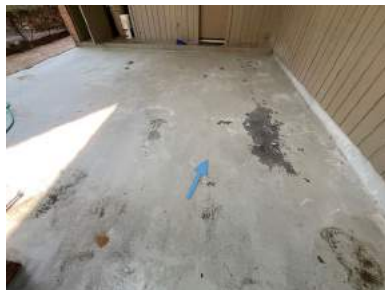
Carport

These conditions are typically cosmetic and not associated with structural movement. Examples include, but are not limited to, shear cracks, corner pops and minor cracks.

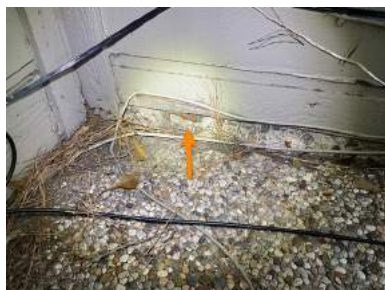
Rear Exterior

Reinforcing steel (rebar) was exposed along the perimeter of the foundation. Evaluation and remediation is recommended.

Recommendation: Contact a qualified professional.

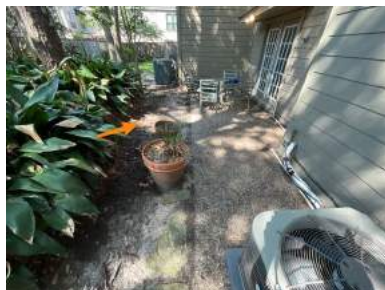
Low spots, ruts, soil erosion, negative grading, standing water and/or damaged sod were present at the time of inspection. Evaluation and remediation by a qualified landscaping contractor or foundation contractor so that water flows away from the home is recommended.

Negative Grading - Rear Exterior

Recommendation: Contact a qualified landscaping contractor

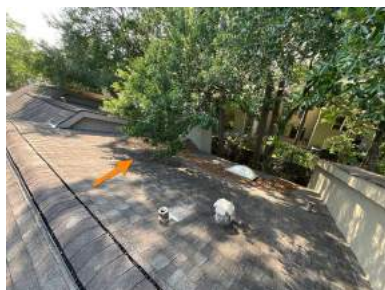
Tree limbs that were in contact with roof or hanging near roof should be trimmed to prevent damage to the roofing materials. Evaluation and remediation is recommended.

Recommendation: Contact a qualified professional.

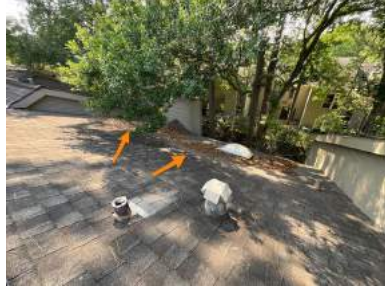
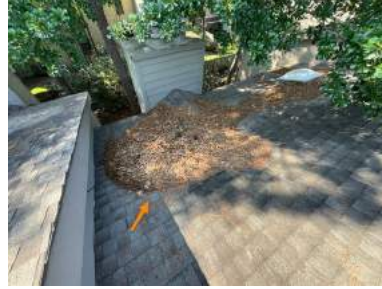
Debris was present on roof surface. The condition of the roof covering underneath could not be determined. Removal of debris and evaluation of the roofing materials underneath is recommended.

Recommendation: Contact a qualified professional.

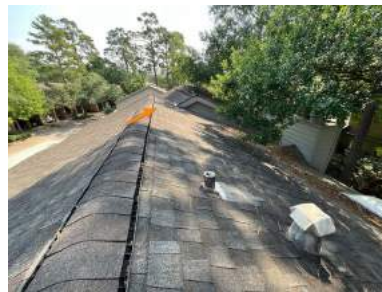
Areas of the roof were wavy or sagging, indicating possible sheathing or framing deficiencies. Evaluation and repair by a qualified roofing professional is recommended.

Recommendation: Contact a qualified roofing professional.

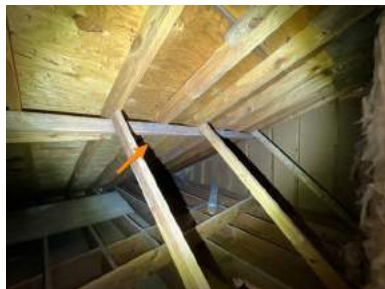
Purlins should share the same dimensions as the rafters that they help to support and be braced every 4' on center according to current building standards. Further evaluation and remediation by a qualified roofing contractor is recommended.

Recommendation: Contact a qualified roofing professional.

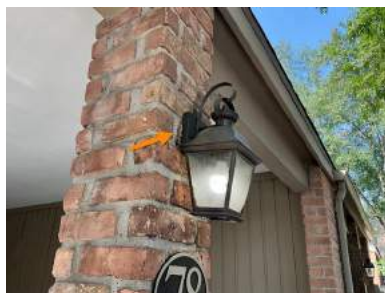
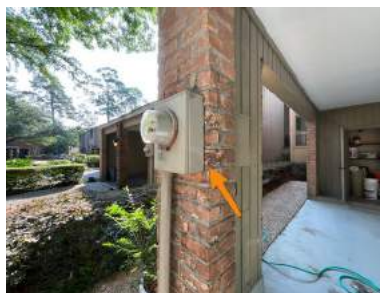
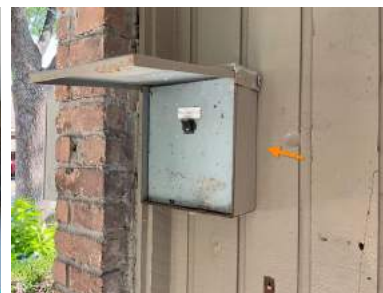
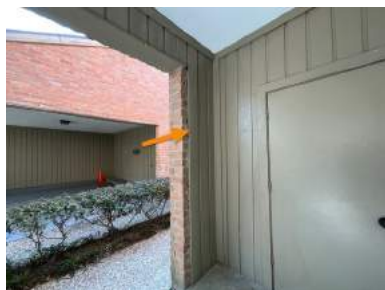
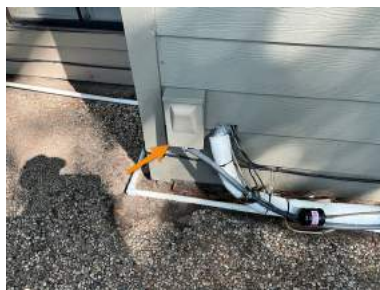
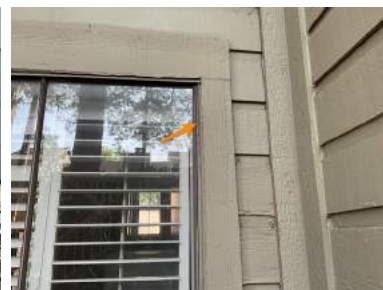
One or more areas were not properly sealed/caulked. Most exterior sealants have a lifespan of 5 to 8 years and should be regularly maintained with that lifespan in mind. Evaluation and remediation is recommended.

Recommendation: Contact a qualified professional.

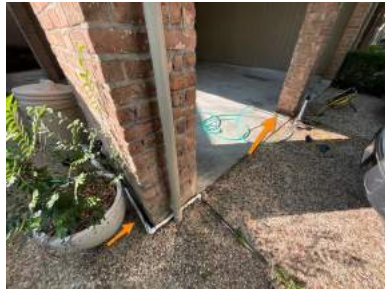
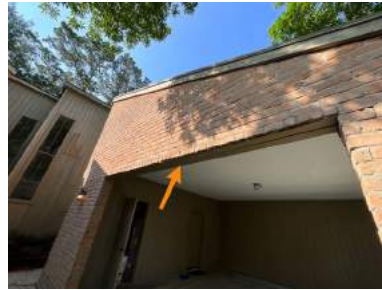
Weep holes in the brick were blocked or missing, either at the base of the wall or above steel lintels. Weep holes permit moisture to drain from behind the brick and prevent moisture from being trapped within the walls, which could cause structural problems. Evaluation and remediation is recommended.

Recommendation: Contact a qualified professional.

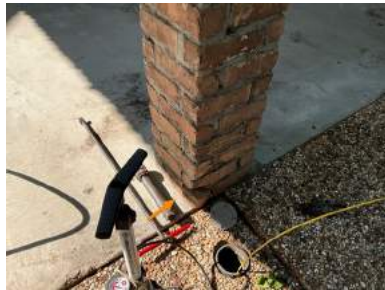
Front Exterior

There was deteriorated or damaged brick/masonry. Evaluation and remediation is recommended.

Recommendation: Contact a qualified masonry professional.

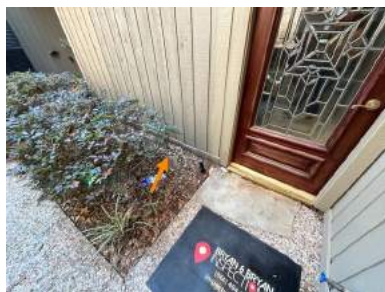
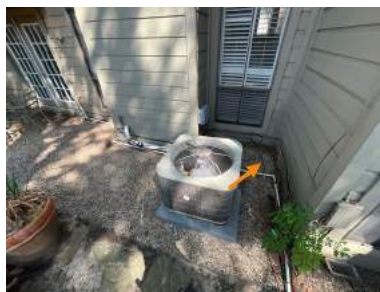
5: Exterior Walls: Inadequate Clearance

Evaluation and remediation is recommended.

Recommendation: Contact a qualified professional.

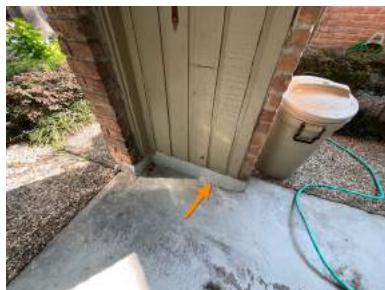
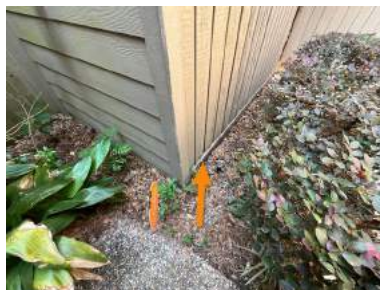
Wood rot/deterioration was observed. Evaluation and remediation is recommended.

Siding - Front Exterior

Recommendation: Contact a qualified professional.

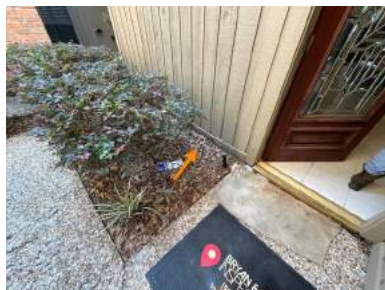
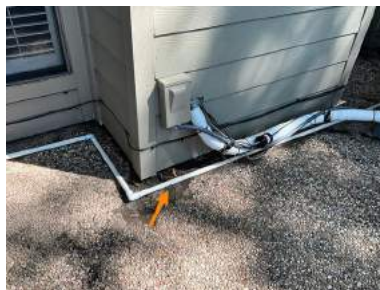
A high soil level was observed. The foundation should have at least 4 inches of exposure. Evaluation and remediation is recommended.

Recommendation: Contact a qualified landscaping contractor

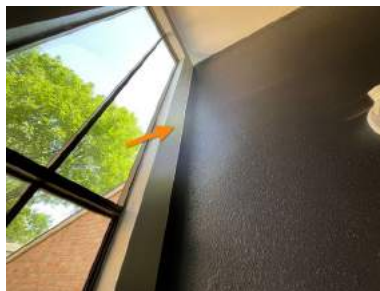
Stairway

Wrinkled tape joints can be evidence of current and/or previous structural movement. Evaluation and remediation is recommended.

Recommendation: Contact a qualified professional.

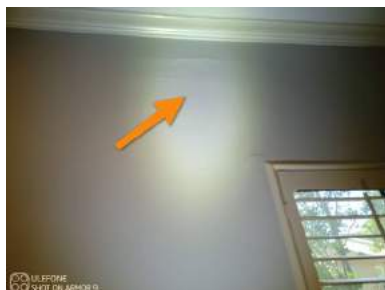
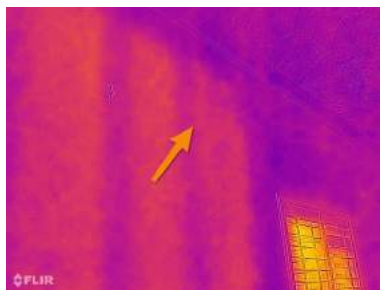
Living Room

Damaged wall coverings were observed. Evaluation and remediation is recommended.

Recommendation: Contact a qualified professional.

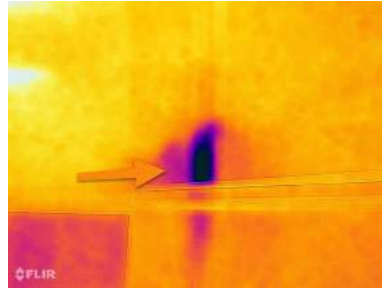
Primary Bathroom Closet 2/2

Wall structure showed signs of water intrusion. Tested positive for moisture at the time of the inspection. Evaluation and remediation is recommended.

Recommendation: Contact a qualified professional.

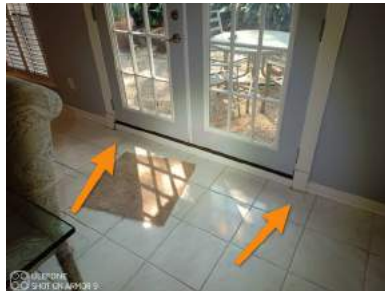
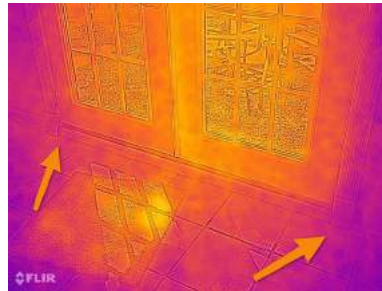
11: Interior Walls: Evidence of Previous Moisture Contact

Wall structure showed signs of previous water intrusion. Tested negative for moisture at the time of the inspection. Evaluation and remediation is recommended.

Recommendation: Contact a qualified professional.

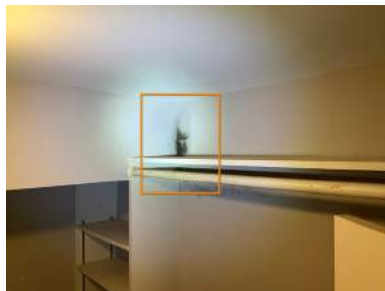
Primary Bathroom Closet

12: Interior: Possible Microbial Growth

Observed signs of possible microbial growth indicating prior moisture intrusion. It is recommended that the source of any moisture intrusion be identified, and the issue remediated.

Recommendation: Contact a qualified professional.

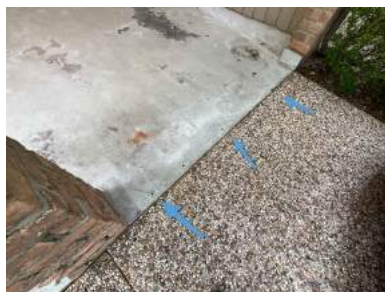
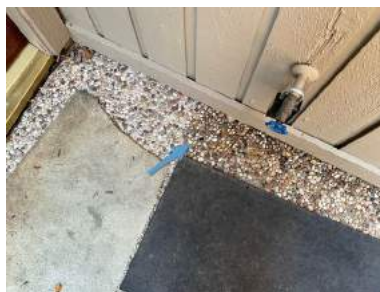
13: Evidence Of Previous Termite Treatment

Previous termite treatment evidence was observed. Inquire with seller for more information.

Recommendation: Contact the seller for more info

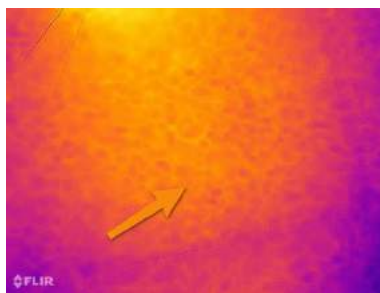
Utility Closet 2/2

1: Ceiling: Evidence of Previous Moisture Contact

Ceiling showed signs of previous water intrusion. Tested negative for moisture at the time of the inspection. Evaluation and remediation is recommended.

Recommendation: Contact a qualified professional.

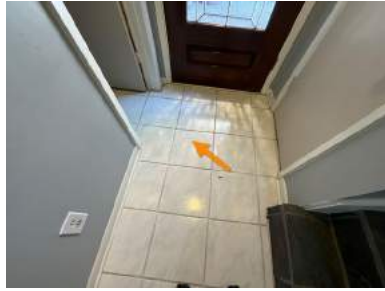
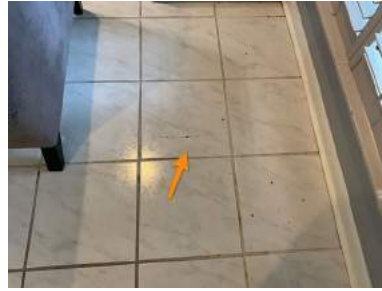
2: Flooring: Tiles Cracked/Chipped

Floor tiles were cracked or chipped. Evaluation and remediation is recommended.

Recommendation: Contact a qualified professional.

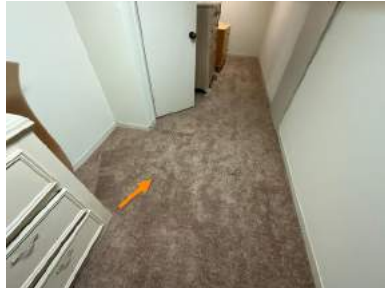
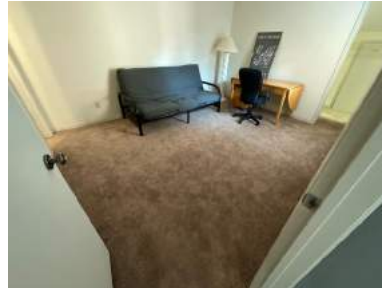
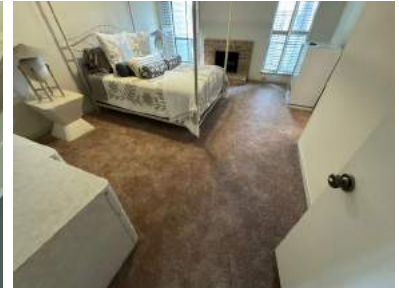
3: Flooring: Sloped

The floor noticeably sloped. Evaluation and remediation is recommended.

Recommendation: Contact a qualified professional.

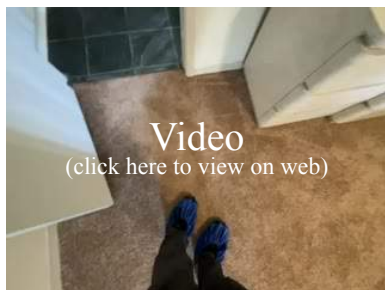
4: Flooring: Squeaky Subflooring

Squeaky subflooring is not uncommon and is usually caused by wood subflooring that isn't properly attached to the joists. These can generally be repaired by a flooring contractor. Evaluation and remediation is recommended.

Recommendation: Contact a qualified professional.

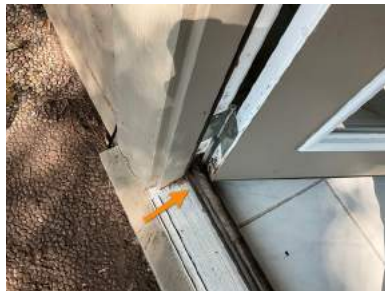
Rear Entry

1: Doors: Wood Rot at Base of Frame/Door

Wood rot was observed at the base of a door frame/door. Evaluation and remediation is recommended.

Recommendation: Contact a qualified professional.

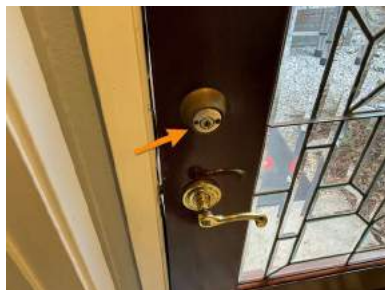
Front Entry

2: Doors: Keyed Deadbolts

Double cylinder deadbolts are generally prohibited due to fire-code restrictions. Essentially, people can be entrapped in a house in the event of an emergency if they don't have the keys to double cylinder deadbolts. Evaluation and remediation by a qualified professional is recommended.

Recommendation: Contact a qualified professional.

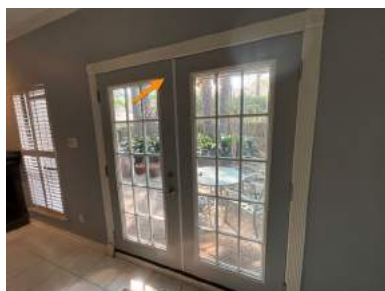
3: Doors: Sticks/Difficult to Operate

The doors were sticking and/or were difficult to operate. Evaluation and remediation is recommended.

Recommendation: Contact a handyman or DIY project

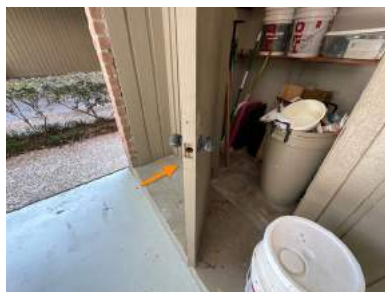
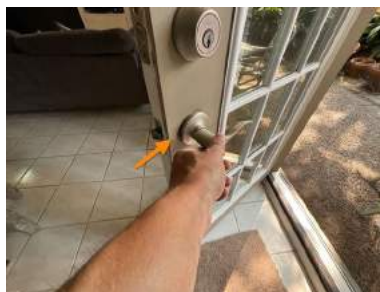
4: Door Hardware: Missing/Damaged Hardware

One or more doors had missing or damaged hardware. Evaluation and remediation is recommended.

Recommendation: Contact a qualified professional.

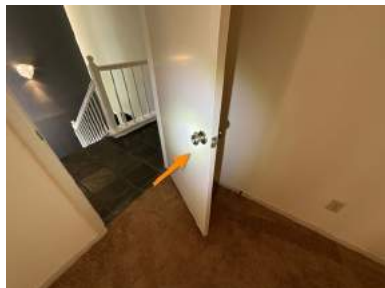
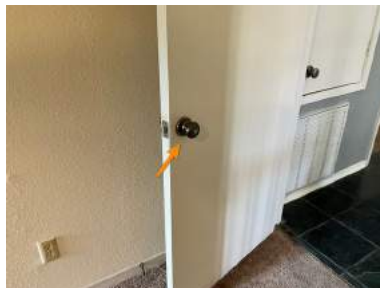
5: Door Hardware: Lock Installed Improperly

The door lock was placed on the outside of the door. Persons' can be locked in the room due to this condition. Evaluation and remediation is recommended.

Recommendation: Contact a qualified professional.

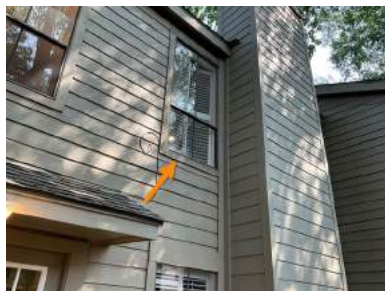
Rear Exterior

1: Windows: Missing/Damaged Screens

One or more windows were missing a screen or had a damaged screen. Evaluation and remediation is recommended.

Recommendation: Contact a qualified window repair/installation contractor.

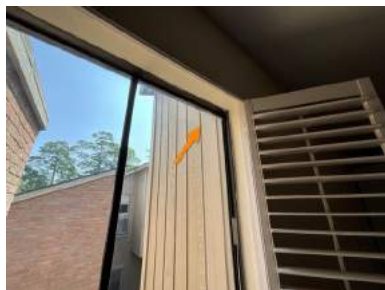
2nd Floor Bedroom

2: Windows: Cracked/Broken Glass Panes

Cracked or broken glass panes were present. Evaluation and remediation is recommended.

Recommendation: Contact a qualified window repair/installation contractor.

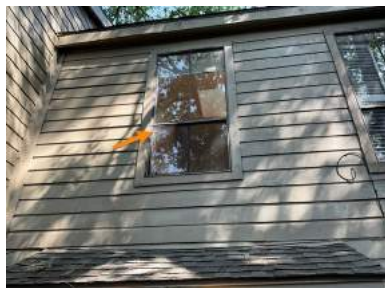
Rear Exterior

3: Windows: Plastic Trim Damaged/Missing

Plastic trim around windows was either damaged or missing. Evaluation and remediation is recommended.

Recommendation: Contact a qualified window repair/installation contractor.

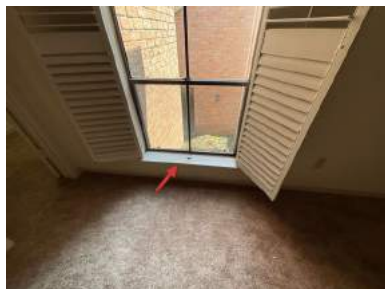
For Example: 2nd Floor Bedroom

4: Windows: Safety Glass Not Installed

Windows With Sill Height Less Than 18" Above the Floor -
Safety glass with a tempered stamp should be installed in all hazardous locations, such as:

- within 24 inches of doors
- within 60 inches of the floor of a tub
- within 60 inches of a stair landing
- within 60 inches vertically and 60 inches horizontally of a pool
- at door glazing
- windows with sill height less than 18" above the floor

Recommendation: Contact a qualified window repair/installation contractor.

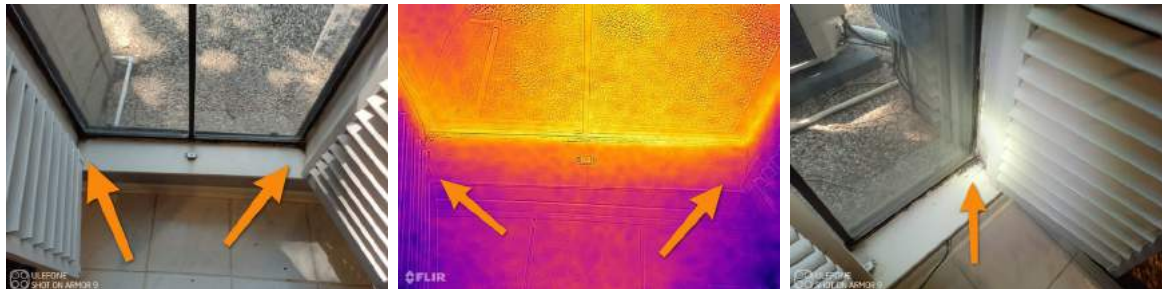
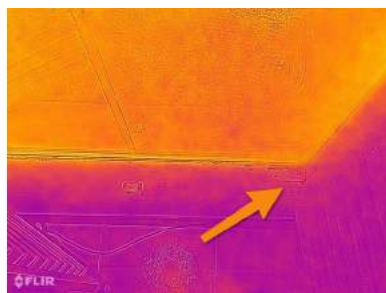
5: Windows: Evidence of Previous Moisture Contact

Window showed signs of previous water intrusion. Tested negative for moisture at the time of the inspection. Evaluation and remediation is recommended.

Recommendation: Contact a qualified professional.

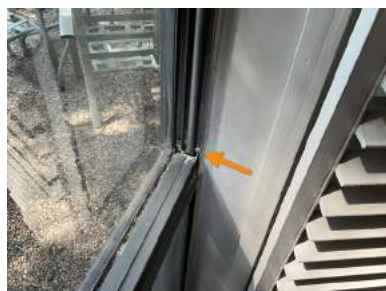
Living Room

6: Windows: Drill Holes in Frames

The windows had drill holes in the frame for installation of the security system window contacts. Confirmation from the window manufacturer stating that these drill holes will not affect the warranty is recommended.

Recommendation: Contact a qualified window repair/installation contractor.

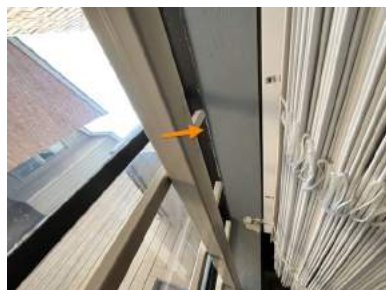
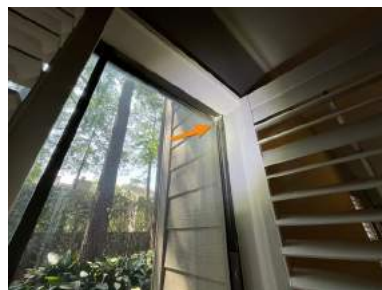
7: Windows: Caulking Missing/Damaged

Caulking around window frames was missing or deteriorated. Most sealants have a lifespan of 5 to 8 years and should be regularly maintained with that lifespan in mind. Evaluation and remediation is recommended.

Recommendation: Contact a qualified professional.

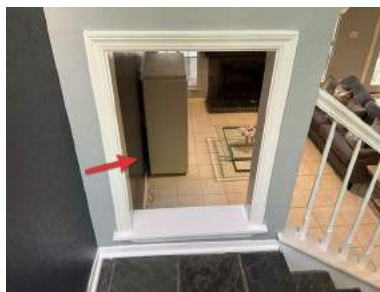
1: Handrails/Guardrails: Inadequate

Does Not Turn Into Wall, Missing, Spindle Gap Too Wide -

Missing Spindles

Recommendation: Contact a qualified professional.

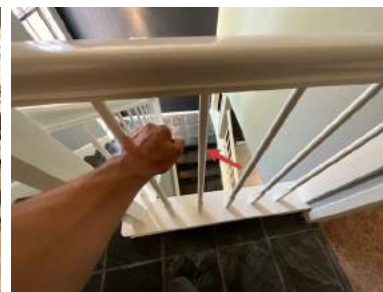
Too Wide

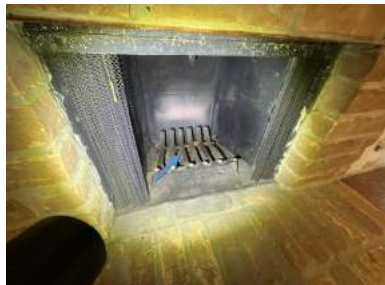
Primary Bedroom

1: Cleaning of Fireplace is Recommended

The firebox was dirty at the time of inspection. Cleaning of the firebox is recommended before use.

Recommendation: Contact a qualified chimney sweep.

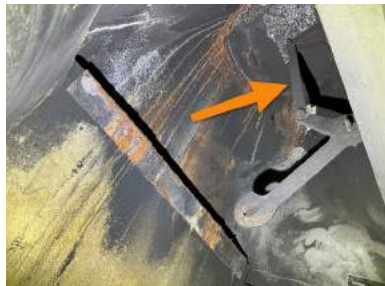
2: Damper: Arm Missing/Damaged/Difficult

The damper arm was missing, damaged or difficult to operate. Evaluation and remediation is recommended.

Difficult To Operate - Living Room

Recommendation: Contact a qualified professional.

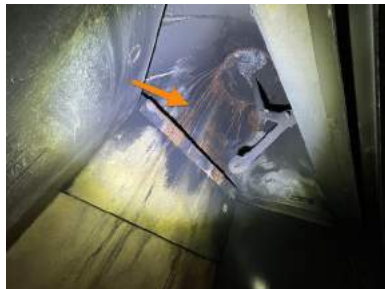
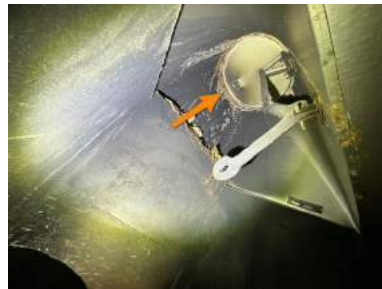
3: Firebox: Corrosion

Corrosion was observed inside the firebox. This indicates possible prior moisture contact. Evaluation and remediation is recommended.

Recommendation: Contact a qualified professional.

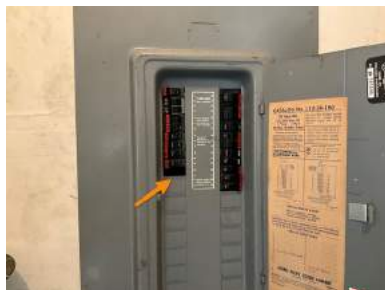
2: Circuits Not Labeled

Circuits in the distribution panel were not properly labeled. Evaluation and remediation is recommended.

Recommendation: Contact a qualified electrical contractor.

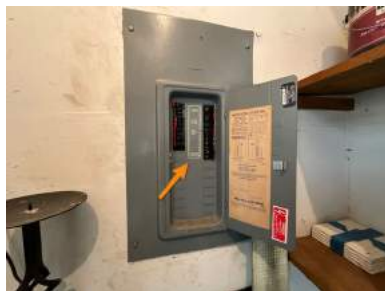
3: Missing Knockouts

Safety "knockouts" were missing from the panel cover. Evaluation and/or remediation by a licensed electrician is recommended.

Recommendation: Contact a qualified electrical contractor.

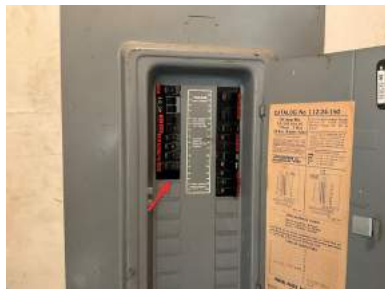
4: Pointed Screws Improper

Sharp tipped screws were used on the panel cover. Blunt tipped screws designed for this application are recommended to prevent puncturing electrical wiring insulation. Evaluation and remediation is recommended.

Recommendation: Contact a qualified electrical contractor.

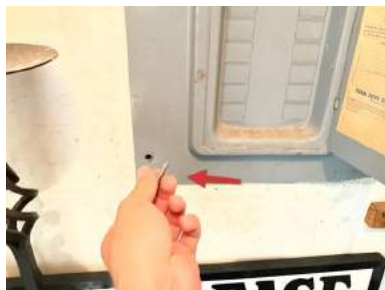
5: Missing Panel Screws

Screws that mount the cover to the electrical panel were missing. Evaluation and remediation is recommended.

Note: Blunt tipped screws designed for this application are recommended to prevent puncturing electrical wiring insulation.

Recommendation: Contact a qualified electrical contractor.

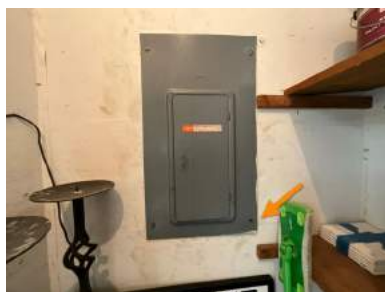
6: FPE/Zinsco/Sylvania/Challenger Panel

A Zinsco, Sylvania-Zinsco, Challenger, or FPE (Federal Pacific) brand electrical panel was installed in this building. Although once widely used, these panels are no longer manufactured due to a poor history of performance. This includes the possibility that the circuit breakers may not trip when needed, or other possible electrical hazards. Evaluation and/or remediation by a licensed electrician is recommended.

Recommendation: Contact a qualified electrical contractor.

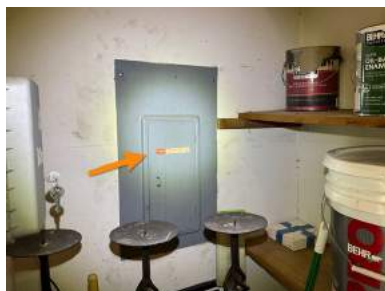
7: Panel: Corrosion

The extent and cause of this condition could not be fully determined. Evaluation and remediation is recommended.

Recommendation: Contact a qualified electrical contractor.

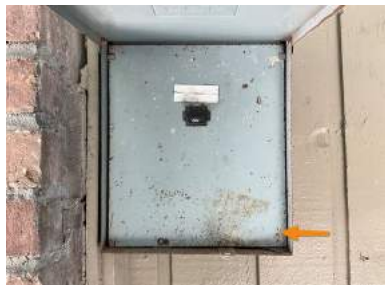
8: Ground Wire Problems

The ground wire was missing or not connected properly to the grounding rod. Evaluation and remediation is recommended.

Recommendation: Contact a qualified electrical contractor.

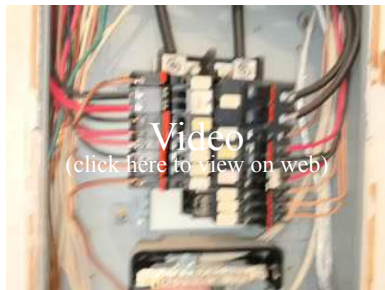
10: Abandoned Breaker

Abandoned components were observed in the panel. Evaluation by a qualified electrical contractor is recommended.

Recommendation: Contact a qualified electrical contractor.

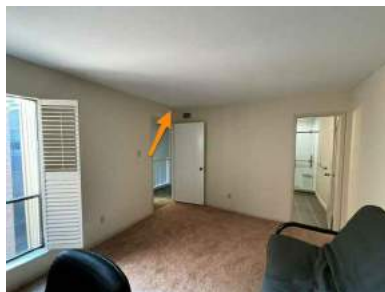
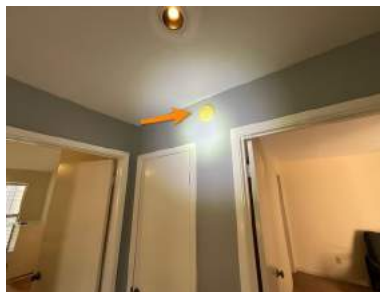
Bedrooms

1: Smoke/Carbon Monoxide Detectors Defective

As gas appliance(s) were installed in the living portion of the home, installation of carbon monoxide detectors is recommended for safety. Evaluation and remediation is recommended.

Recommendation: Contact a qualified professional.

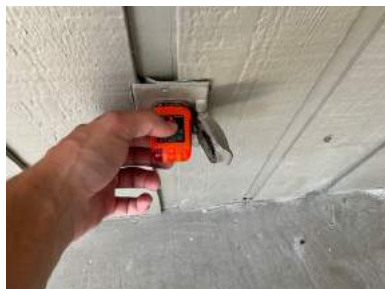
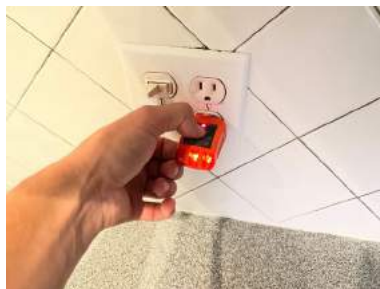
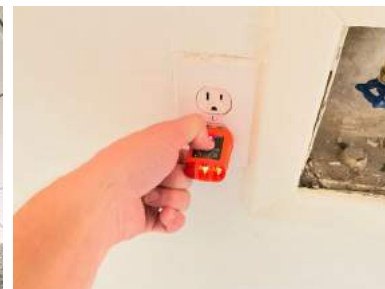
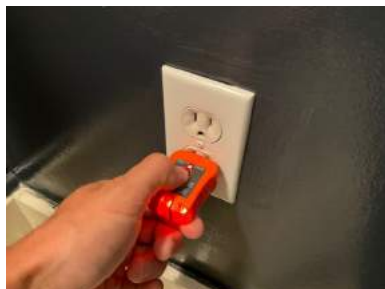
2: Receptacles: GFCI Protection Inadequate/Missing

GFCI protection was inadequate or missing. Current building standards recommend the installation of ground fault protection:

GFCI protection was not present in one or more of these locations. Evaluation and remediation is recommended.

Recommendation: Contact a qualified electrical contractor.

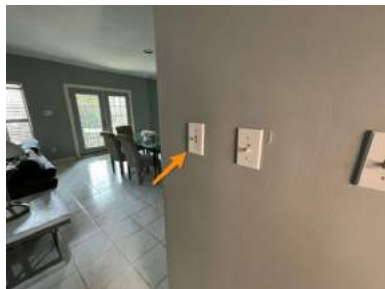
Living Room

3: Receptacle/Switch Covers: Missing, Loose or Damaged

One or more receptacle/switch cover plates were missing, loose or damaged. Replacement of cover plates is recommended for safety. Evaluation and remediation by a qualified electrical contractor is recommended.

Recommendation: Contact a qualified electrical contractor.

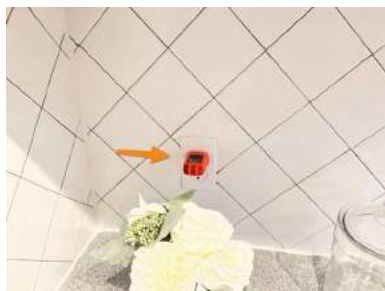
Kitchen

4: Receptacles: No Power

Receptacles had no power. Evaluation and remediation is recommended.

Recommendation: Contact a qualified electrical contractor.

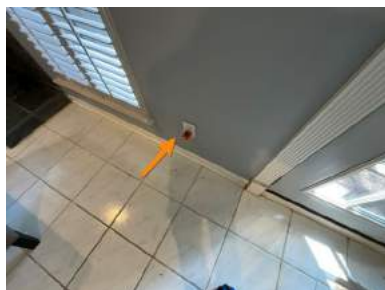
Living Room

5: Receptacles: Improper Wiring

Receptacles are not wired correctly. Evaluation and remediation is recommended.

Recommendation: Contact a qualified electrical contractor.

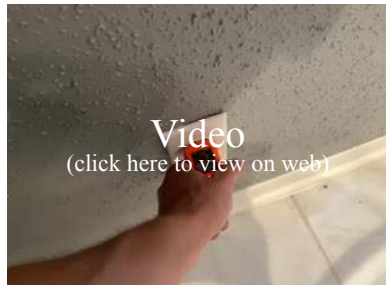
6: Receptacles: Loose/Damaged/Scorched

For Example: Loose - Kitchen

One or more receptacles were loose, damaged or scorched at the time of inspection. Evaluation and remediation is recommended.

Recommendation: Contact a qualified electrical contractor.

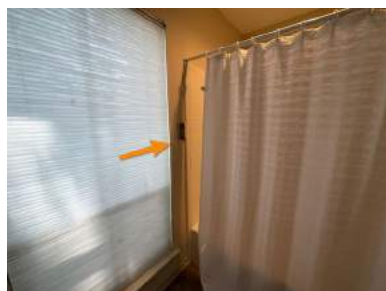
Primary Bathroom

Close proximity of a light switch or electrical receptacle to a tub or shower is prohibited by current building standards. Evaluation and remediation is recommended.

Recommendation: Contact a qualified electrical contractor.

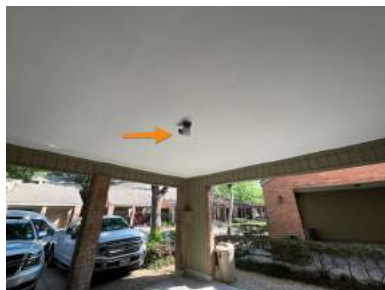
Carport

9: Lights: Inoperative

One or more light fixtures were not operating at time of inspection. Cause was not determined. Evaluation and remediation is recommended.

Recommendation: Contact a qualified electrical contractor.

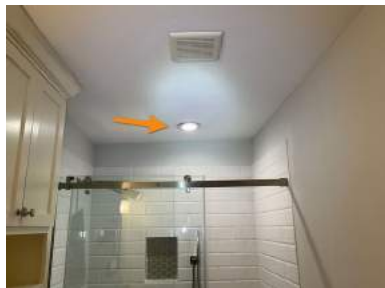
2nd Floor Bedroom Bathroom

10: Lights: Fixtures or Globes Damaged/Missing/Loose

Light fixtures or globes were missing, damaged or loose. Evaluation and remediation is recommended.

Recommendation: Contact a qualified electrical contractor.

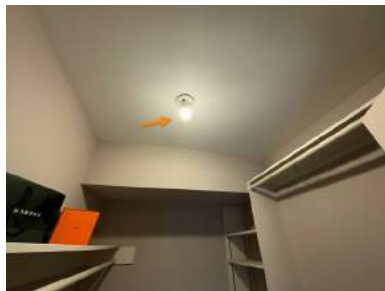
Primary Bathroom Closet

11: Lights: Unprotected Bulbs in Clothes Closets

Exposed or partially exposed bulbs are not allowed in closets. While once common, utility light fixtures with bare bulbs in a socket in closets are no longer allowed. All light bulbs must be fully enclosed in a globe or other housing. Evaluation and remediation is recommended.

Recommendation: Contact a qualified electrical contractor.

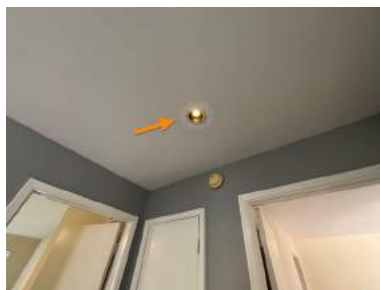
Stairway

12: Lights: Flickering Lights

One or more flickering lights were observed. Recommend evaluation by a licensed electrician.

Recommendation: Contact a qualified electrical contractor.

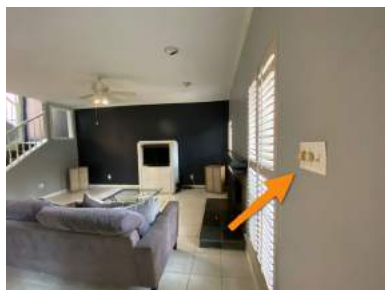
Living Room

13: Dimmer Switches: Not Rated For Fan

The dimmer control switches were not rated for ceiling fan control. Evaluation and remediation is recommended.

Recommendation: Contact a qualified electrical contractor.

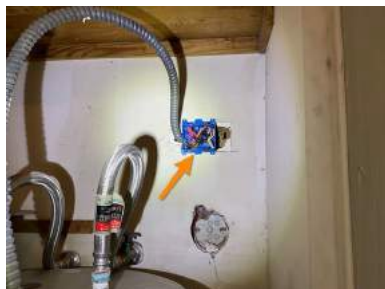
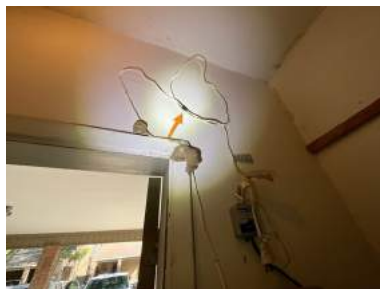
14: Wiring: Exposed Ends & Splices

Exposed wire connections, splices, and ends were present. All wire connections and charged wires with exposed ends and splices should be covered in junction boxes for safety. Evaluation and remediation by a licensed electrician is recommended.

Recommendation: Contact a qualified electrical contractor.

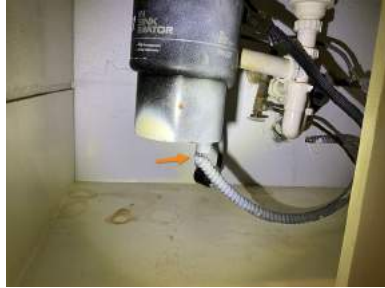
Kitchen

15: Wiring: Gaps in Conduit

There were gaps in conduit. Evaluation and remediation is recommended.

Recommendation: Contact a qualified electrical contractor.

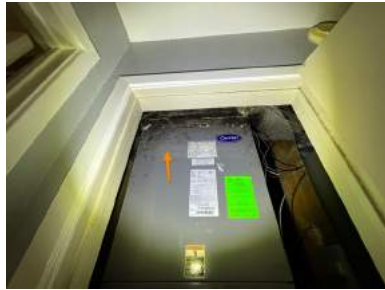
Signs of microbial growth were observed indicating prior moisture contact or condensation issues. Evaluation and remediation is recommended.

Recommendation: Contact a qualified HVAC professional.

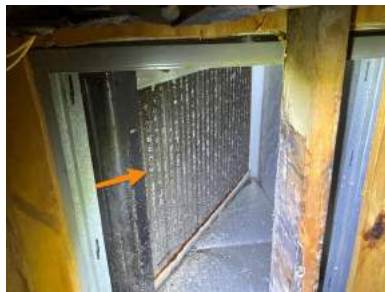
3: Evaporator Coil: Damaged/Dirty Fins

Internal fins on the evaporator coil were damaged or dirty. Evaluation and remediation by a licensed HVAC contractor is recommended.

Recommendation: Contact a qualified HVAC professional.

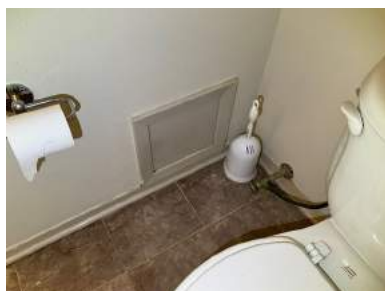
There was not an access panel at one or more bathrooms to observe bath drain lines.

Painted Shut

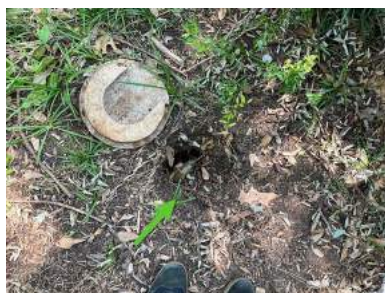
Water Meter Blocked By Debris:

The water meter was not accessible to inspect due to debris in the meter box.

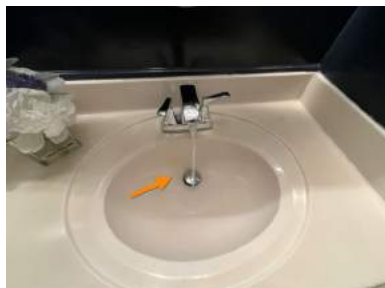
Half Bathroom

1: Fixtures: Drain Stops Missing, Damaged or Ineffective

Drain stops had issues that prevented them from working properly. Evaluation and remediation is recommended.

Recommendation: Contact a qualified plumbing contractor.

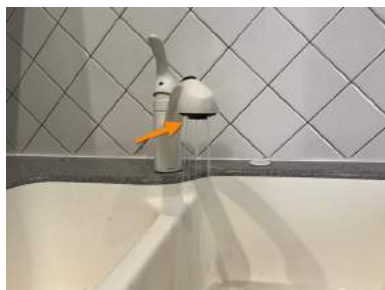
Kitchen

2: Fixtures: Aerators Damaged/Missing

Evaluation and remediation is recommended.

Recommendation: Contact a qualified plumbing contractor.

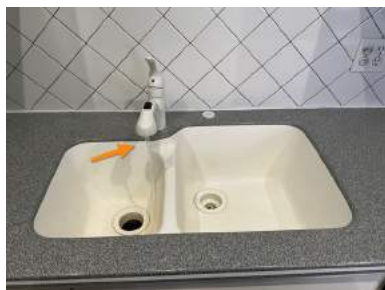
Kitchen

3: Fixtures: Poor Flow/Water Pressure

Fixtures had poor flow/water pressure. Cause was not determined. Further evaluation by a qualified plumbing professional is recommended.

Recommendation: Contact a qualified plumbing contractor.

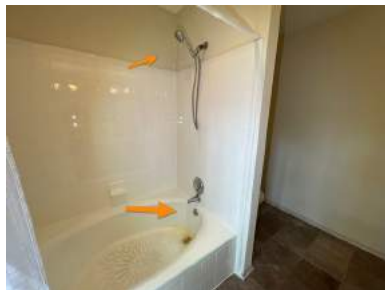
Primary Bathroom

4: Fixtures: Diverters Not Functioning Properly

Water did not completely stop coming out of the faucet spout after the shower diverter was activated. Evaluation and remediation is recommended.

Recommendation: Contact a qualified plumbing contractor.

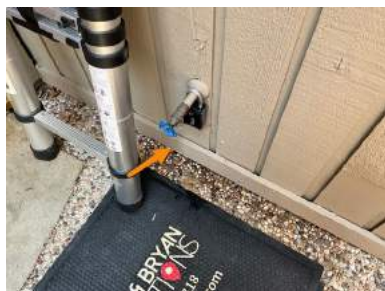
Front Exterior

5: Fixtures: Dripping

Faucets were dripping. Evaluation and/or repair by a licensed plumber is recommended.

Recommendation: Contact a qualified plumbing contractor.

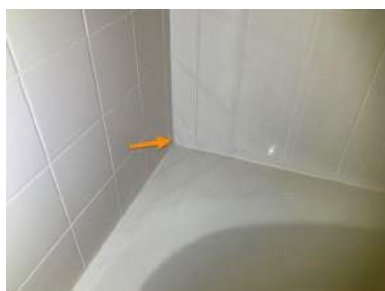
Primary Bathroom

6: Shower: Loose/Cracked Tiles

One or more tiles were loose/cracked in the shower enclosure. This can result in possible water intrusion behind the tile. Evaluation and remediation is recommended.

Recommendation: Contact a qualified professional.

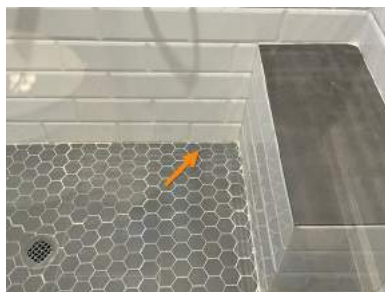
2nd Floor Bedroom Bathroom

7: Shower/Tub: Missing/Deteriorated Caulking or Grout

Evaluation and remediation is recommended.

Recommendation: Contact a qualified professional.

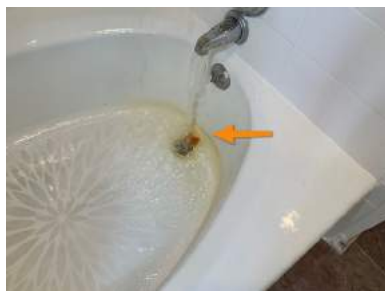
Primary Bathroom

8: Shower/Tub: Surface Defects

Defects were observed on the shower/tub surface. Evaluation and remediation is recommended.

Recommendation: Contact a qualified professional.

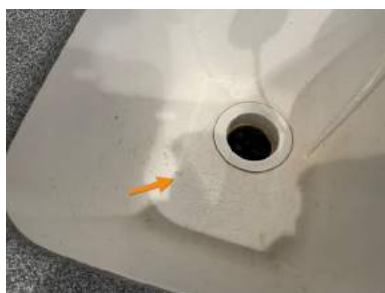
Kitchen

9: Sink: Surface Defects

Surface defects in one or more sinks were present at the time of inspection. Evaluation and remediation is recommended.

Recommendation: Contact a qualified professional.

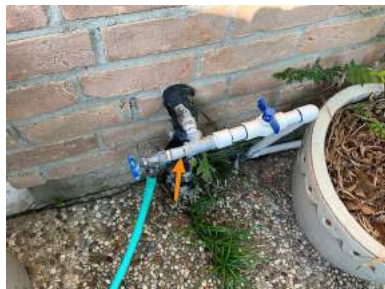
Left Exterior

10: Supply Piping: Corrosion on Galvanized Pipes

Galvanized water supply piping was corroded. The extent of rusting on the piping is not determined. Evaluation and/or remediation by a licensed plumber is recommended.

Recommendation: Contact a qualified plumbing contractor.

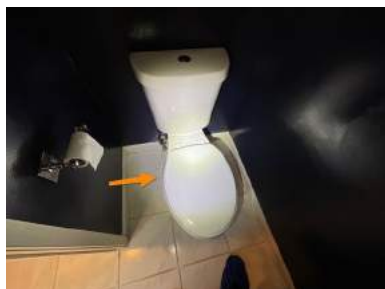
Half Bathroom

11: Toilet: Runs Continuously

Evaluation and remediation is recommended.

Recommendation: Contact a qualified plumbing contractor.

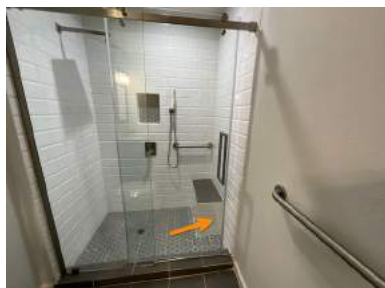
2nd Floor Bedroom Bathroom

12: Shower Door: Does Not Close Properly

The shower door didn't stay closed when shut. Evaluate and remedy as needed.

Recommendation: Contact a qualified professional.

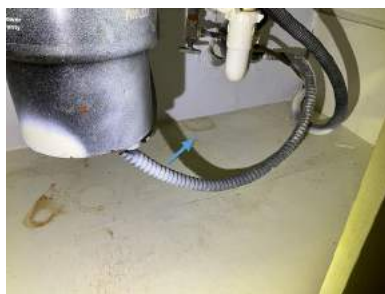
Kitchen

1: Evidence of Previous Leaks

Evidence of previous leaks were noted. No leaking occurred at time of inspection and the area remained dry.

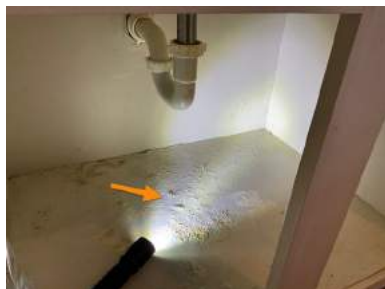
Primary Bathroom

2: Drain Piping: Leaks

Leaking was observed at time of inspection. Evaluation and/or remediation by a licensed plumber is recommended.

Recommendation: Contact a qualified plumbing contractor.

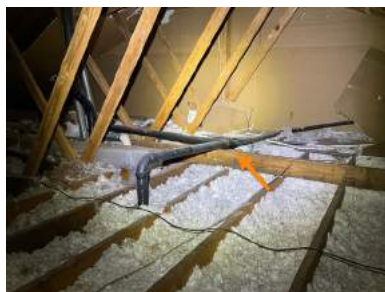
Attic

3: Drain Piping: Poorly Sloped

The drain piping was poorly sloped. A proper slope is needed to ensure proper drainage. Pipes that have too steep of a slope will allow the water to drain without the solids, and pipe that is too shallow or bellied will clog constantly or even hold water. Evaluation and/or remediation by a licensed plumber is recommended.

Recommendation: Contact a qualified plumbing contractor.

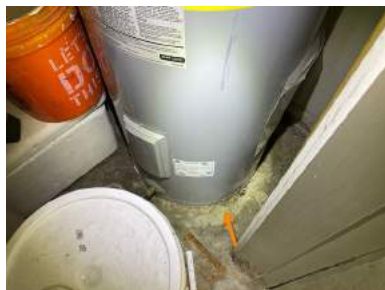
2: Tank: Missing Drain Pans

Evaluation and remediation is recommended.

Recommendation: Contact a qualified plumbing contractor.

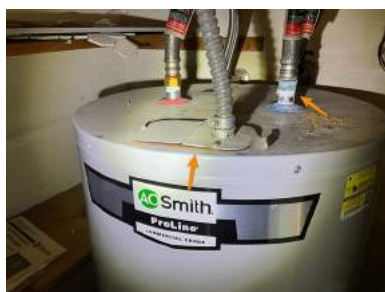
3: Tank: Corroded/Damaged Tank

The water heater tanks and/or fittings had corrosion and/or damage. Evaluation and remediation is recommended.

Recommendation: Contact a qualified plumbing contractor.

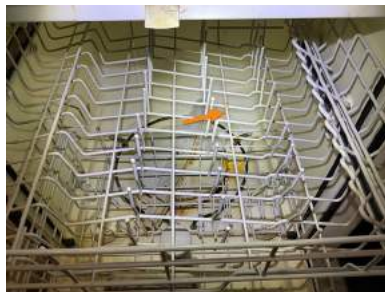
2: Corroded Dish Racks

There was evidence of corrosion on dishwasher racks. Evaluation and remediation is recommended.

Recommendation: Contact a qualified professional.

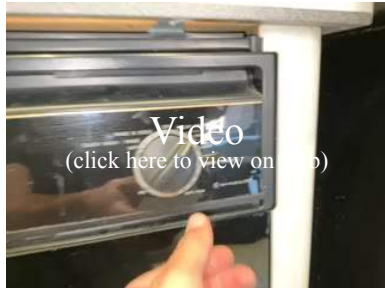
3: Inoperative

The dishwasher did not operate when tested. Evaluation and remediation is recommended.

Recommendation: Contact a qualified professional.

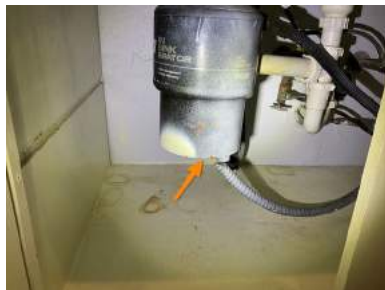
1: Corrosion

There was evidence of corrosion on or in the disposal. Evaluation and remediation is recommended.

Recommendation: Contact a qualified professional.

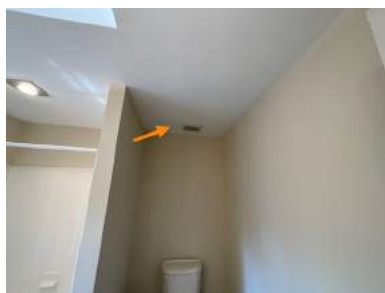
Primary Bathroom

Vent fans were noisy during operation. Evaluation and remediation is recommended.

Recommendation: Contact a qualified professional.

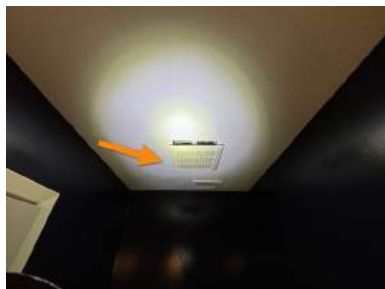
Half Bathroom

2: Dirty/Loose Vent Covers

Cleaning or resealing of the exhaust vent cover is needed to ensure proper air flow. Evaluation and remediation is recommended.

Recommendation: Contact a qualified professional.

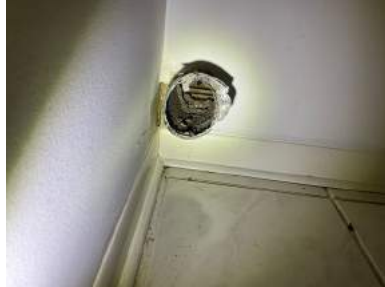
1: Cleaning Vent Recommended

Cleaning of the dryer exhaust vent is recommended as normal maintenance and to prevent excessive lint build-up in the line.

Recommendation: Contact a qualified professional.

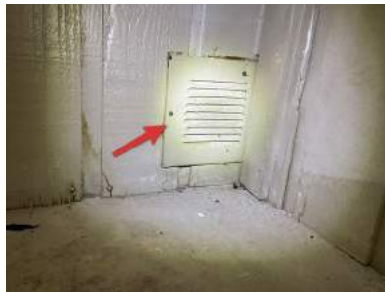
The dryer vent termination was covered by a screen. This arrangement can cause lint to build up on the screen and create an airflow blockage. Evaluation and remediation is recommended.

Recommendation: Contact a qualified professional.

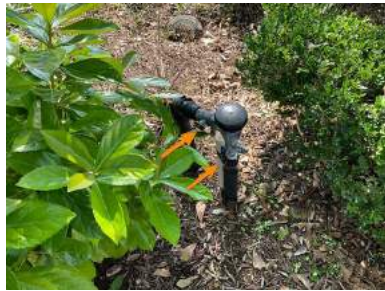
1: Corroded Valve Handles

One or more valve handles were corroded. Evaluation and remediation is recommended.

Recommendation: Contact a qualified professional.
