TEXAS RESIDENTIAL INSPECTION

9200 Westheimer Rd 1005 Houston, TX 77063

PROPERTY INSPECTION REPORT FORM

Zainab Tarique Name of Client 9200 Westheimer Rd 1005, Houston, TX 77063	08/15/2023 12:00 pm Date of Inspection
Address of Inspected Property John Lohmann, Marcella Lohmann Name of Inspector	Pro. Inspector #23629, Pro. Inspector #24035 TREC License #
Name of Sponsor (if applicable)	TREC License #

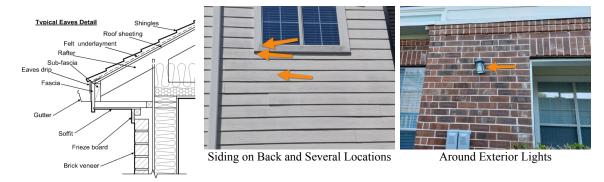
Eaves Detailed Diagram

There were areas in the exterior envelope of the home that were not sealed to prevent moisture and insect intrusion.

These did not appear to affect the structure of the house at the time of inspection unless otherwise noted.
