PROPERTY INSPECTION REPORT

Prepared For: Richard Whitaker
(Name of Client)

Concerning: 2001 Bayleaf Manor Dr., Manvel, TX 77578
(Address or Other Identification of Inspected Property)

By: Chad Langston, Lic #7946 07/16/2021
(Name and License Number of Inspector) (Date)

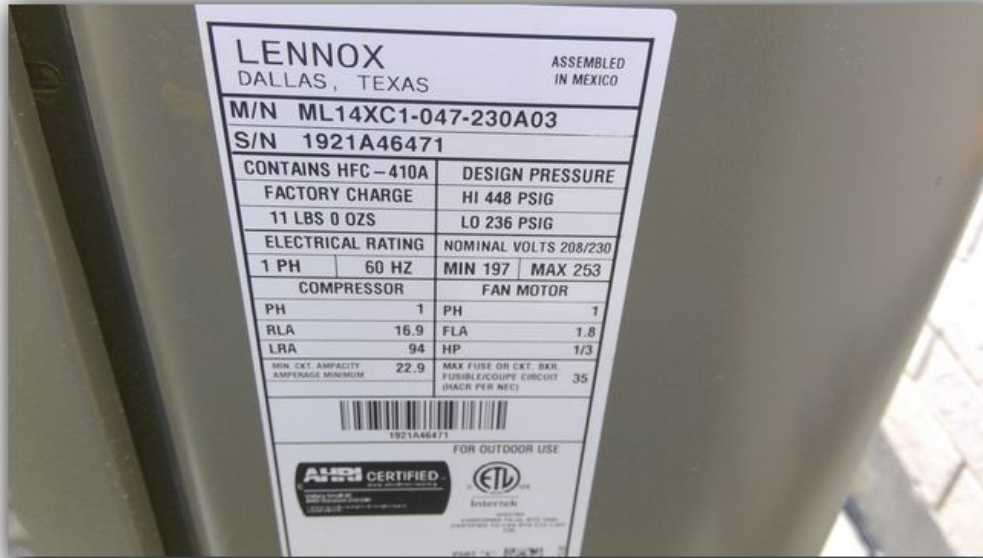
It is the opinion of the inspector that this system was functioning as intended at the time of inspection. No significant deficiencies were observed.
