Thorough-Fair Inspections, PLLC  
3706 Indian Mound Ct.  
Crosby, TX 77532  
713-504-2768

## PROPERTY INSPECTION REPORT

Prepared For: Taylor and Kelly Magorien

Concerning: 15807 Sunlit Falls Dr., Humble, TX 77396

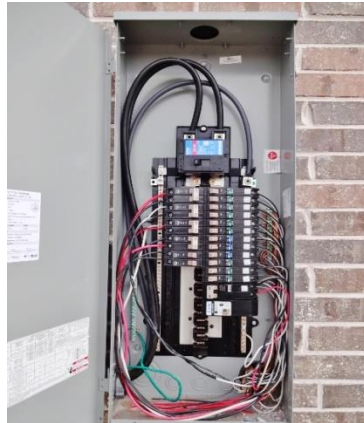
*Comments:* Service conductor = # 2/0 AWG Aluminum, 150 AMP main disconnect. Main load center with a disconnect is located at the left side exterior wall at the house. Eaton brand equipment.

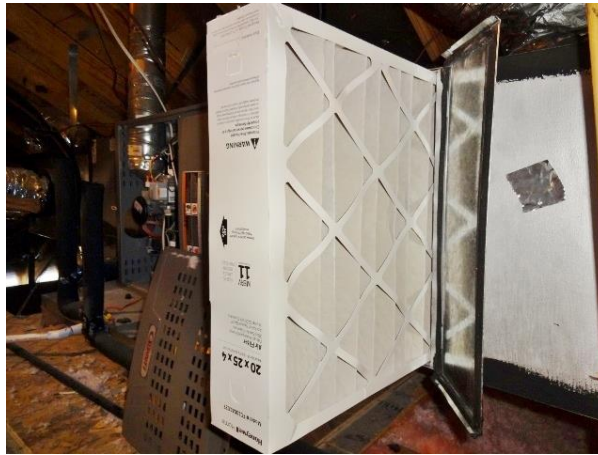
- Observed media filters have been incorporated in the HVAC systems and are located adjacent to the return air side of each unit. The filter elements appeared to be reasonably clean and serviceable at the time of the inspection.

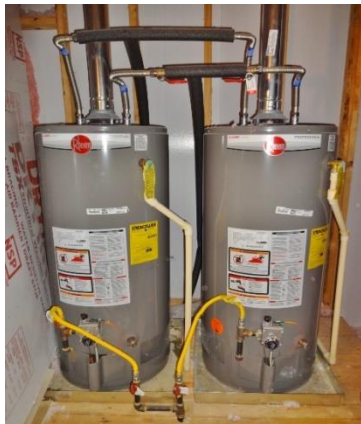
*Comments:* (2) Rheem brand units located in the walk-in attic space adjacent to the media room. Both units were manufactured in July, 2021.

- Observed these appliances appeared to be performing normally (providing hot water) at the time of the inspection.
