Property Inspection Report

**Jay Bertrand 23607
Noble Inspection LLC**

2202 Hilshire Trails Drive

Date of Inspection: 8/7/2023

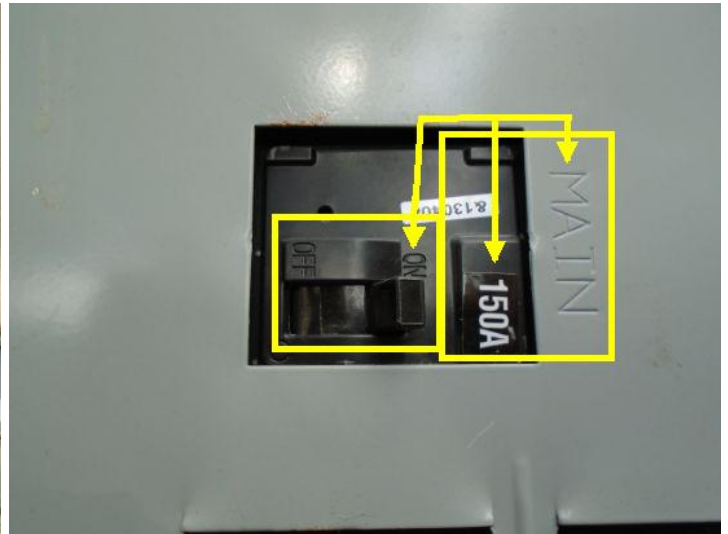
The main breaker is rated at 150 Amps and was working as intended.

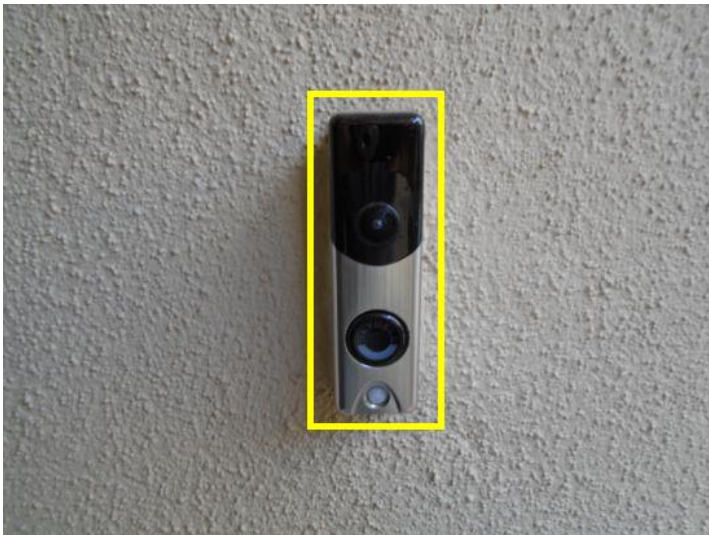
Front Doorbell was working as intended.

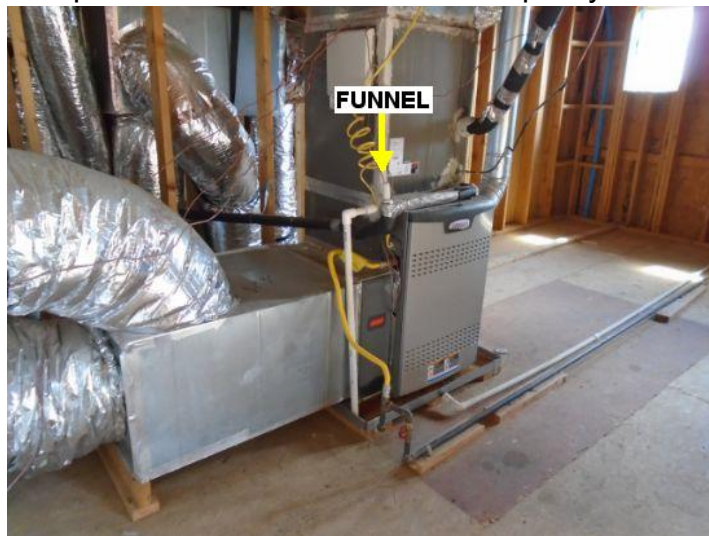
In attic and connected to the air handler is a vertical PVC pipe that has an exposed open end, twice a year (at time change) - pour 2 cups of Clorox Bleach to mitigate algae build up in this drain / vent pipe.

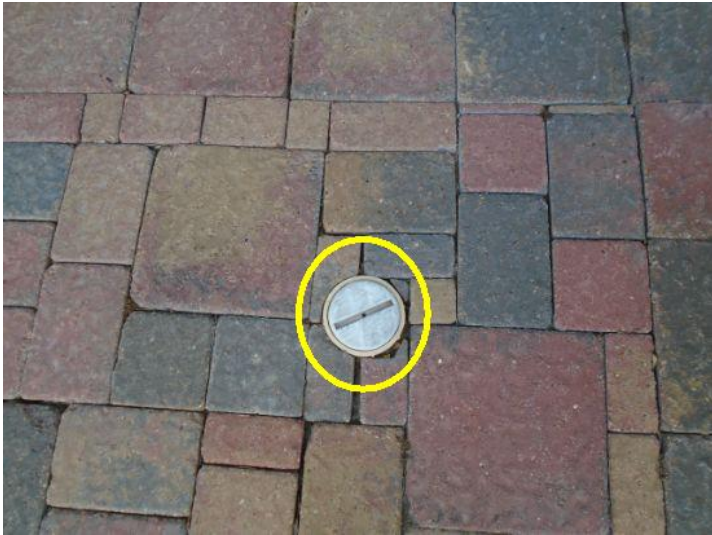
Main 4" plumbers clean out pipe is located in the front of the home.
