RESIDENTIAL HOME INSPECTIONS

PROPERTY INSPECTION REPORT

Concerning: <u>749 Sierra Dr</u>, Port Neches TX 77651 (Address or Other Identification of Inspected Property)

06/28/2021 8:30 am (Date)

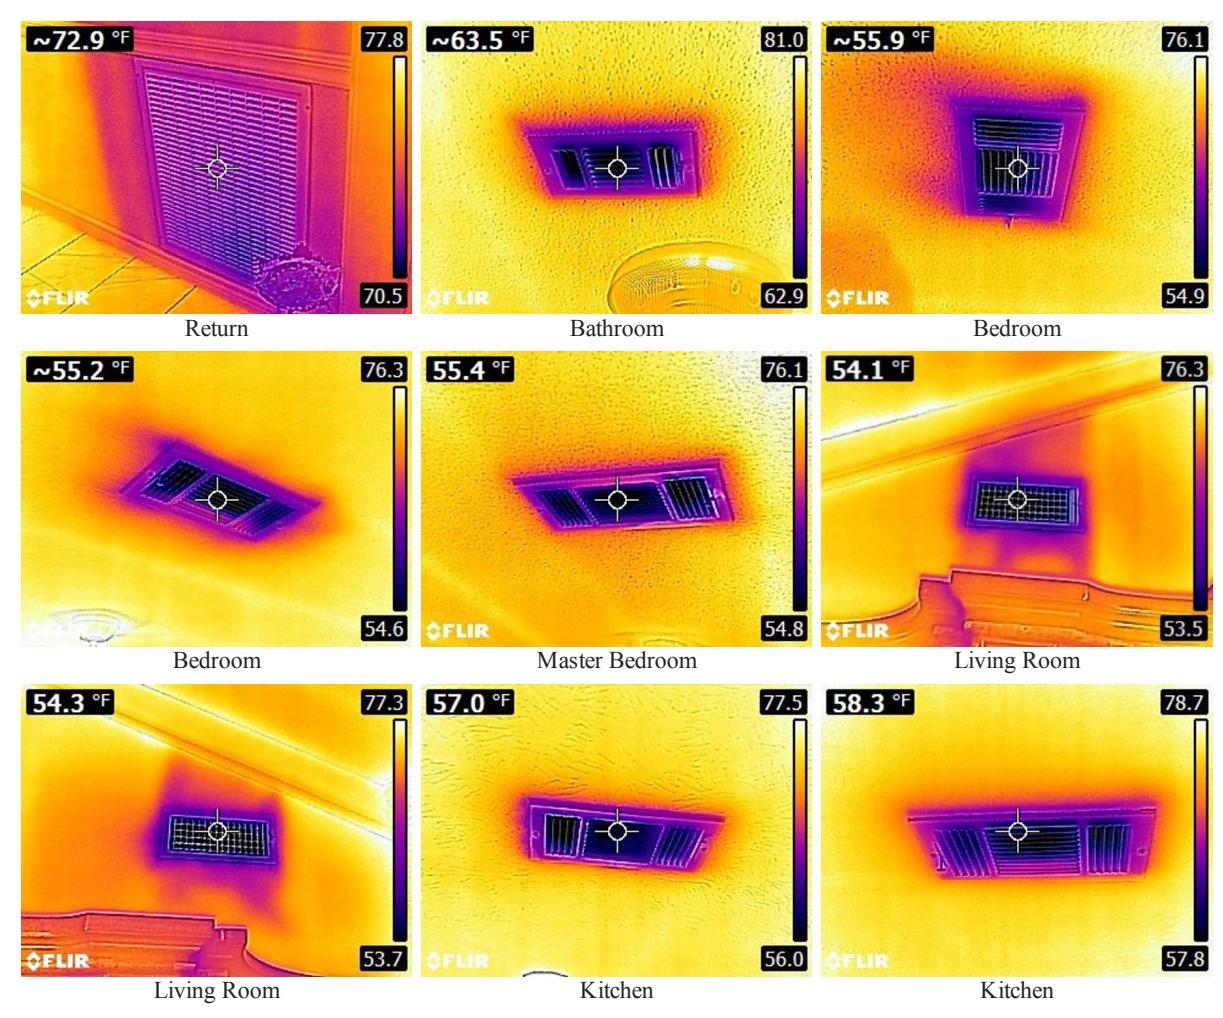
1: Duct Damaged Recommendation

Air supply ducts were damaged and should be repaired or replaced by a qualified HVAC contractor.
