# Property Inspection Report

LOCATED AT:  
12 Quintana Dr  
Galveston, Texas 77554

INSPECTED ON:  
Tuesday, June 20, 2023

Inspector, Terry May TREC#23696  
May Home Inspection

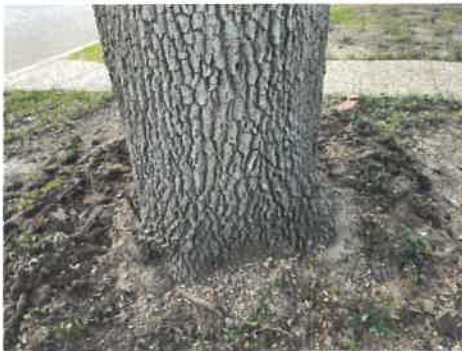
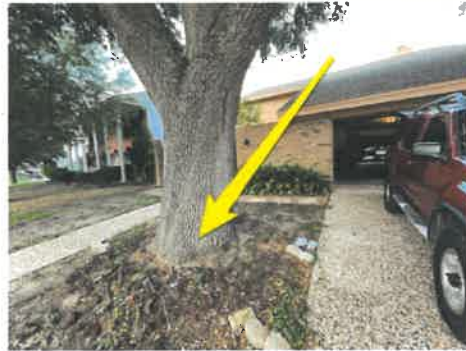
There are trees in close proximity to the foundation. This can pose risks to the foundation, walls and roof. If any foundation issues are suspected, consult a qualified foundation expert.

Tree in close proximity of structure

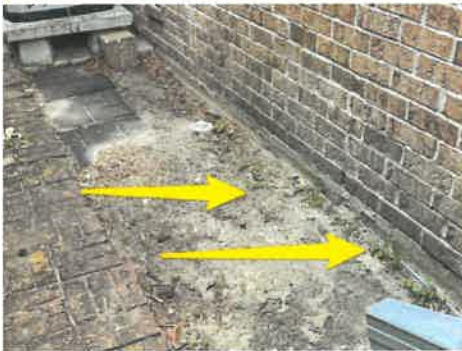
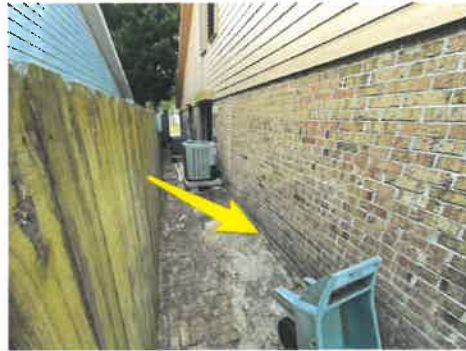
**WARN** Grading is sloped toward the structure in some areas. Low spots and negative grading promote water accumulation near the slab or in the crawl space (if present).

Right: negative grade

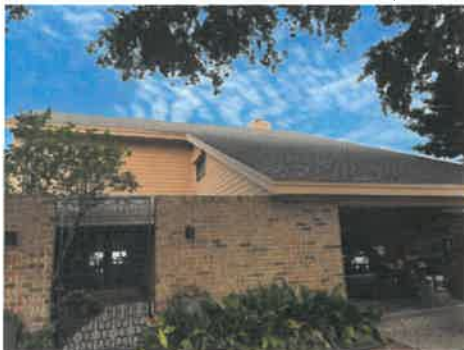
Gutters recommended: gutter system is recommended on the structure to help divert surface runoff water from roof and the way from foundation and structure.

Gutter system recommended

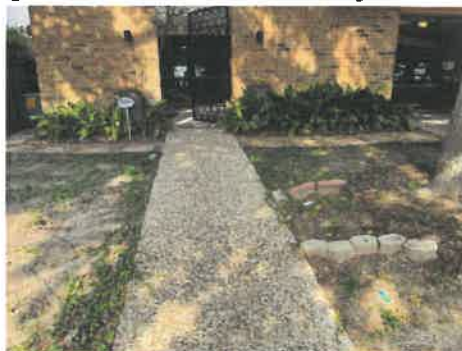
Walkway OK

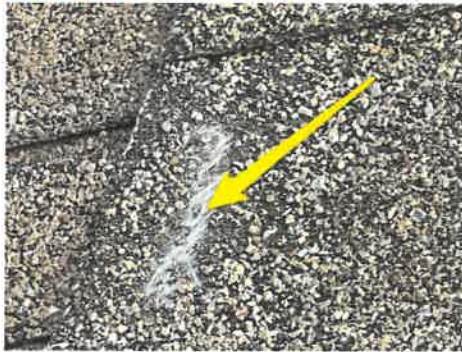
Portions of the surface granulation are deteriorated and there are minor surface cracks developing.

Minor granular deterioration

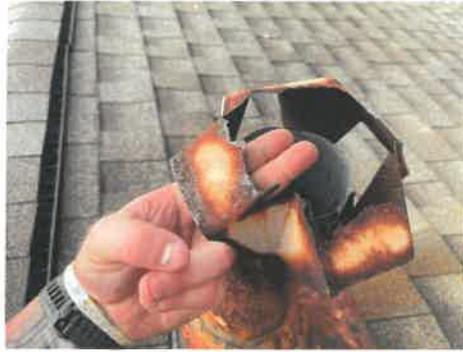
Some of the flashings, roof jacks and/or vents are damaged and/or corroded. We recommend they be repaired or replaced to prevent leakage.

Rusted/damaged rain cap on exhaust flue

*repaired*

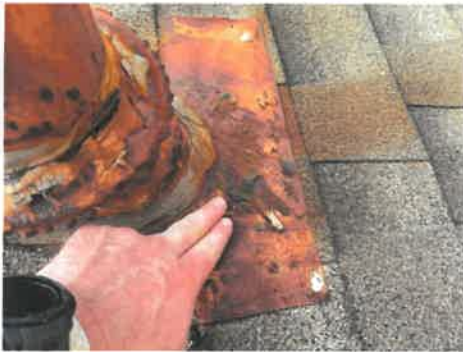
Rusted flashing

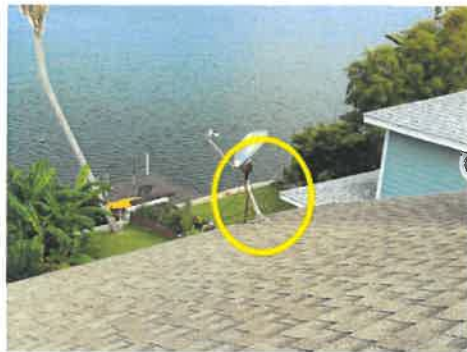
The satellite dish mount is on top of the roofing surface. While not necessarily improper, it is a poor location. Monitor the mounting bolt sealant and replace sealant as needed to maintain watertightness. If the satellite dish is not going to be used in the future, **DO NOT REMOVE THE MOUNT PLATE**. Seal around it and monitor the sealant. The roof is much more prone to leak if the existing plate is removed.

Satellite dish on roof

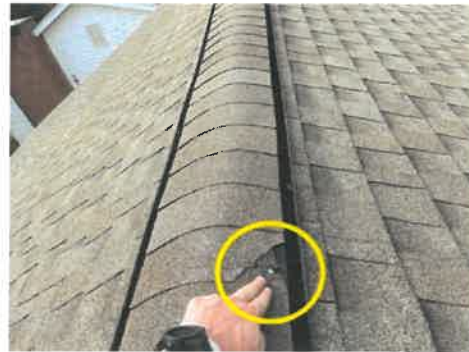
Exposed nailhead

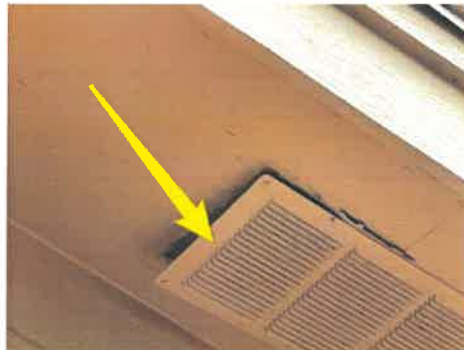
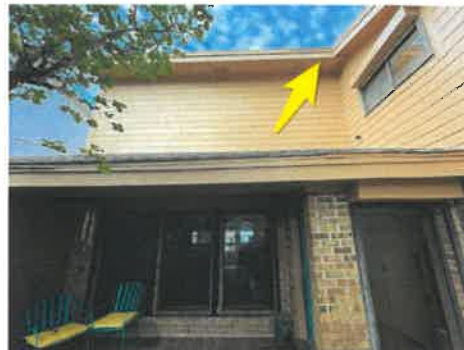
Openings were observed along the soffit areas of the structure. This can allow for water intrusion as well as unwanted pests such as bees and spiders to make entry inside of the structure. Recommend properly sealing all openings found in the soffit areas.

Opening in soffit/ secure soffit vent in place

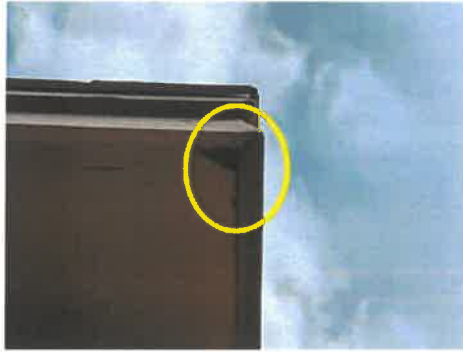
Damaged soffit material was observed on the left side of the structure. Recommend replacing all soft, rotten, and/or damaged wood.

Left front: damaged soffit

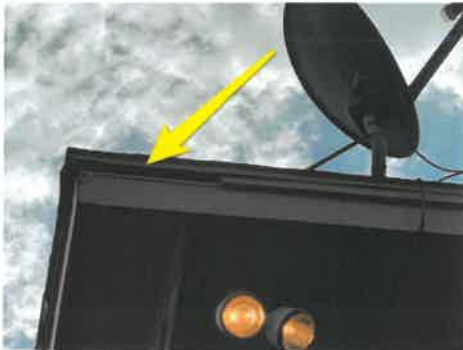
Damaged fascia: a fascia board/trim board on the rear side of the structure was observed to be missing. Recommend replacing all soft, rotten, and/or damaged or missing wood.

Right rear: missing trim board/fascia

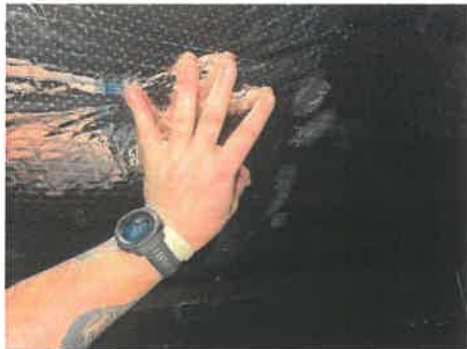
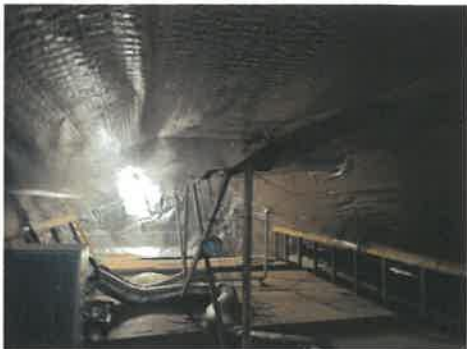
Insulation/barrier in place: there was a barrier in place at the time of inspection. This hinders the visual inspection of the inspector to be able to inspect the roof sheathing and interior wall structures within the attic. Some deficiencies may be present that could not be observed due to the barrier in place at the time of inspection.

Barrier in place blocks visual inspection of roof sheathing

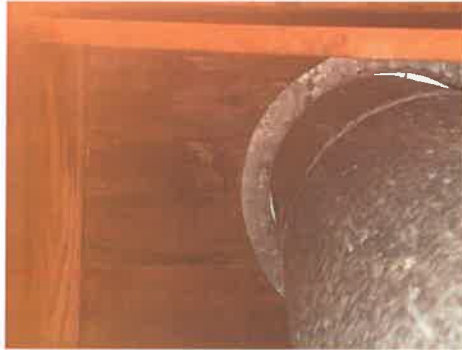
There is evidence of past leaks. We cannot determine if active leaks still exist. We recommend monitoring this condition and/or inquiries of the owner.

Moisture stain around chimney

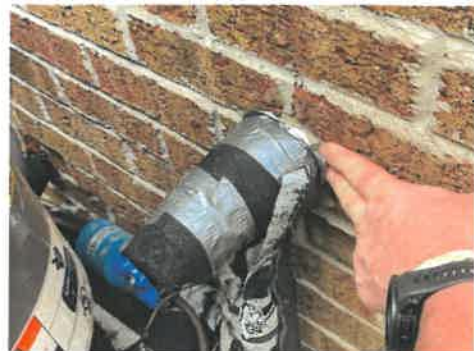
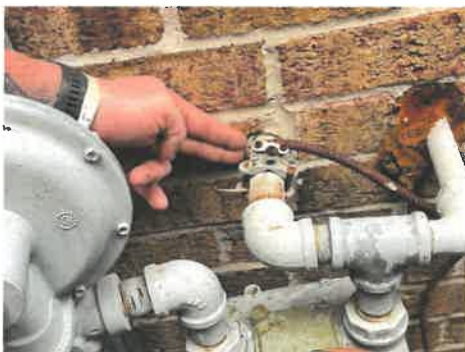
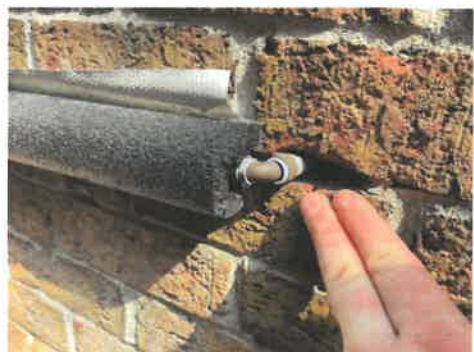
Caulk/seal all exterior wall protrusions

*repaired*

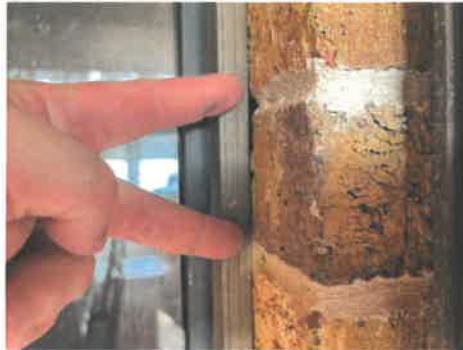
Caulking improvements are needed around the window frames on the exterior side of the structure to help alleviate water intrusion.

Caulking improvements needed around window frames on exterior side of the structure.

*caulking added*

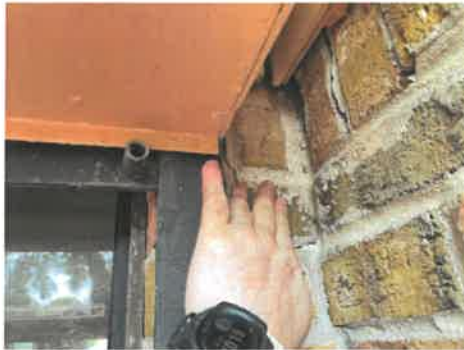
the veneer has pulled away from the building and/or has become unbonded from the wood frame in areas. We recommend removal and/or repair of the masonry because of the potential for damage or injury should the veneer completely collapse.

Front: loose brick veneer needs repaired

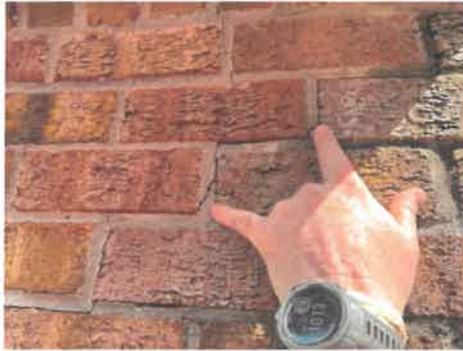
Crack; repair and monitor: some cracking was observed on the left and right side of the structure. This suggest that typical movement has occurred. This does not suggest a serious structural concern, but should be repaired and monitored for ongoing movement. If ongoing movement is observed, recommend having it further evaluated and repaired by a licensed contractor.

Crack in grout: typical movement, repair and monitor

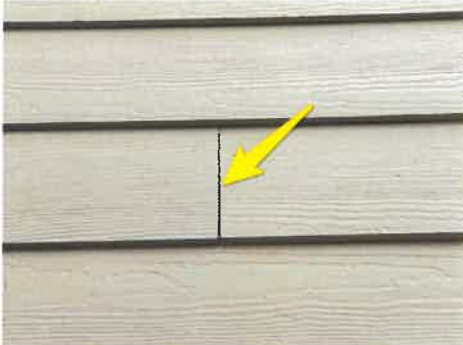
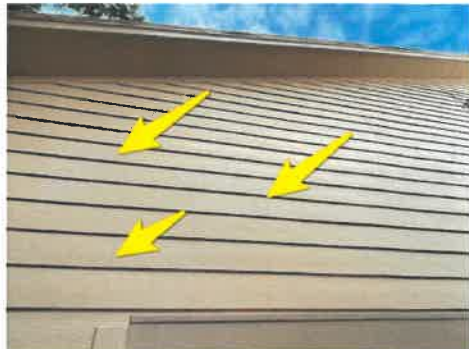
There are unsealed joints in the hardboard siding. We recommend the joints be caulked or sealed. This is a part of routine homeowner maintenance. Monitor yearly.

Seal all siding joints

*caulking added*

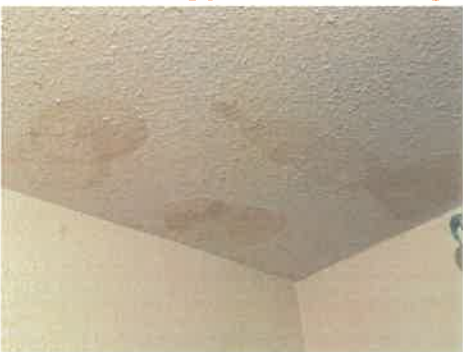
Moisture staining present in the ceiling.

Right rear corner bedroom closet: moisture stain

*repaired*

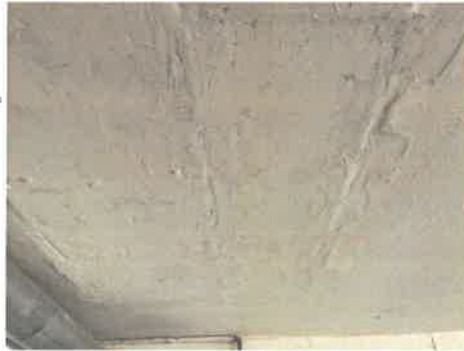
Patching observed: some patching was observed in locations throughout the structure which is indicative of previous issues. This does not mean that the problem is ongoing, but it is suggested that frequent monitoring of the area should be taken.

Garage: patching observed

*repaired*

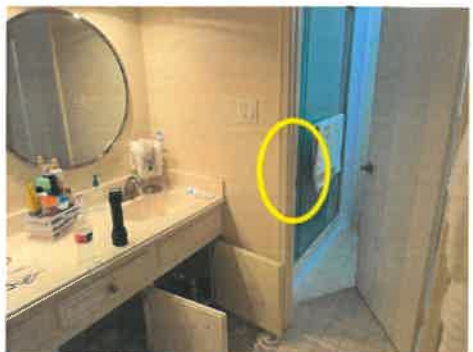
Several doors throughout the structure would not properly latch. Recommend adjusting the strike plate so that the doors latch as intended.

Master bathroom: won't latch

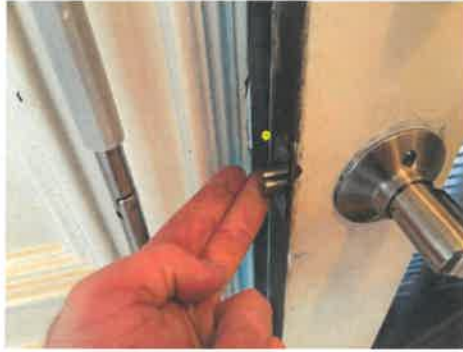
Back exterior door: won't latch

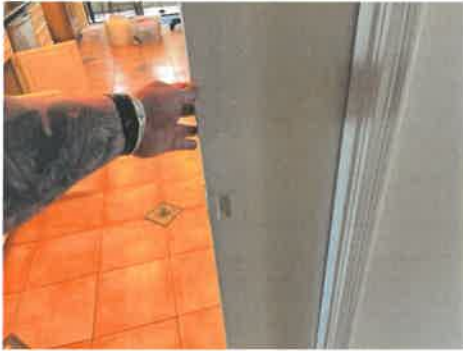
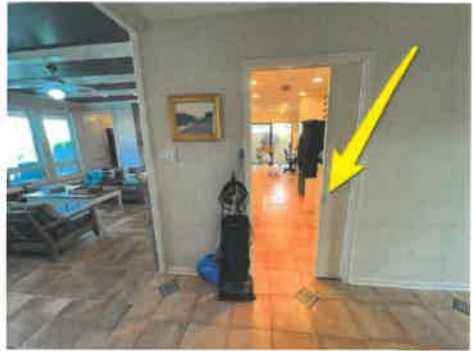
Sliding door won't open/close: the sliding door that leads from the kitchen to front entry would not close fully at the time of inspection. Recommend repairs by a licensed contractor so that the door opens and closes as intended.

Kitchen: door doesn't close all the way

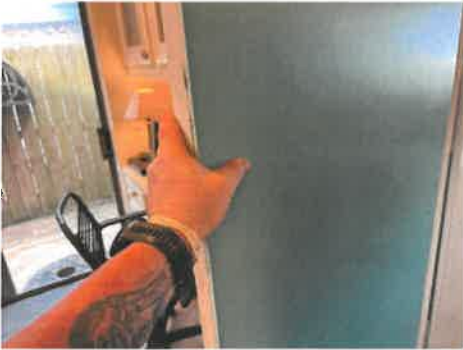
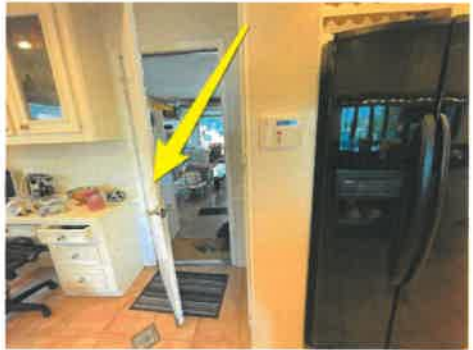
Garage man door: Not a proper fire rated door.

Garage door: not fire rated

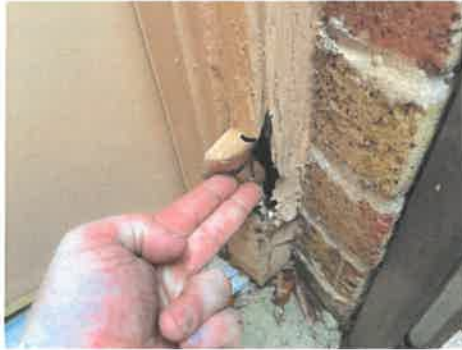
Wood decay at door jam: Wood decay was observed to the door jam on the right side of the structure. Recommend replacing all soft, rotten and or damaged wood.

Right: wood decay

*repaired*

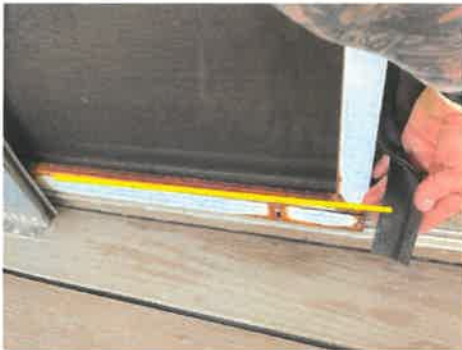
Screen door: damage/corrosion : the screen doors to the upstairs bedrooms that lead out to the rear balcony were observed to have minor damage and corrosion to the frame of the door screen. Although the doors operated as intended, Recommend repair/replacement.

Upstairs bedrooms: screen door corrosion/damage

*repaired*

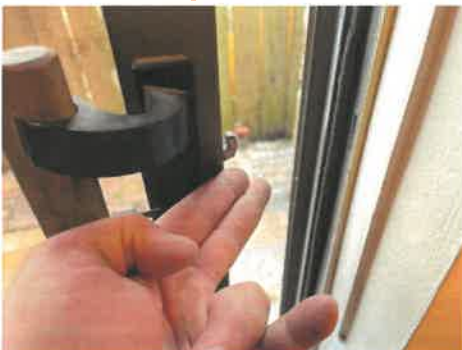
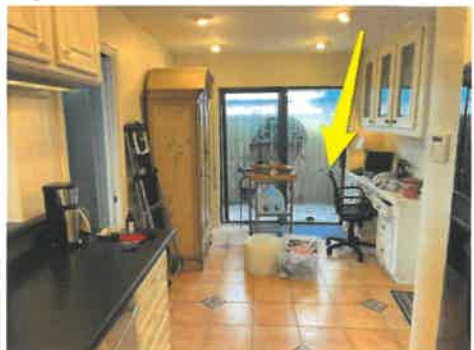
Sliding door won't lock: the sliding door that leads to the right side, exterior would not latch at the time of inspection. Recommend repair/replacement.

Right: sliding glass door won't lock

*repaired*

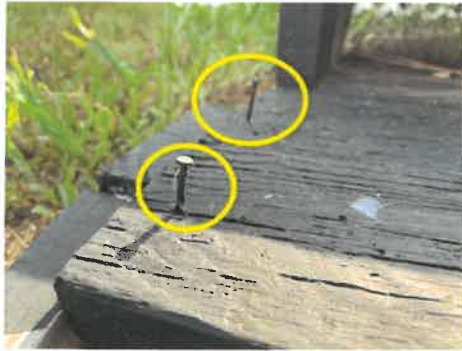
The stairs at the pictured areas are damaged.

Damaged steps/raised nails

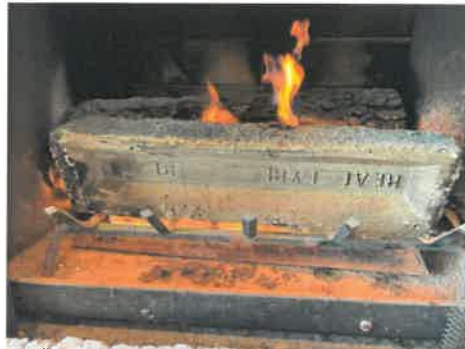
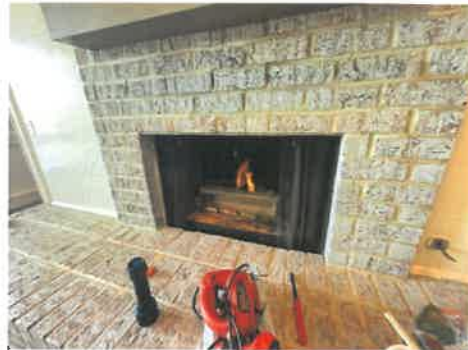
GENERAL: The fireplace appeared properly installed and undamaged at the time of inspection.

Damper lacks a mechanical stop to keep it from completely shutting. This allows any gas that might leak into the fireplace to be vented to the exterior. This is required now because of the gas log starter.

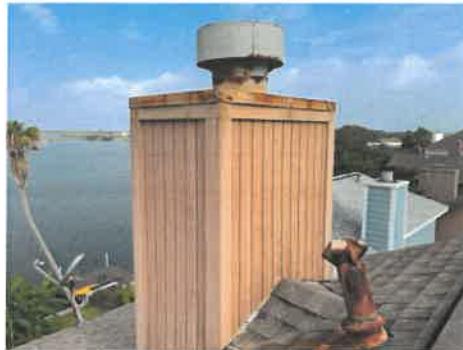
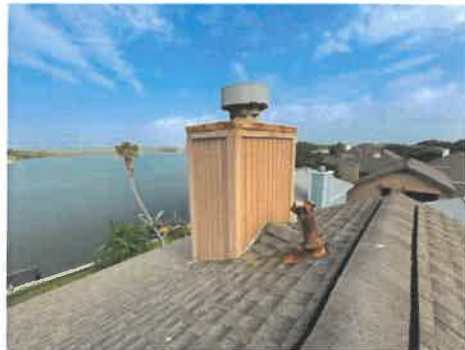
The chimney appears to be in good condition. No major problems were observed that would affect the satisfactory operation of the fireplace.

Chimney OK

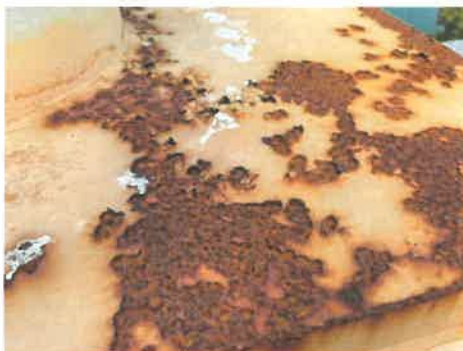
Chimney cap flashing rusted. The chimney cap had excessive corrosion at the time of inspection. Recommend corrosion control or replacement to alleviate the potential for water intrusion.

Chimney cap is rusted

*replaced*

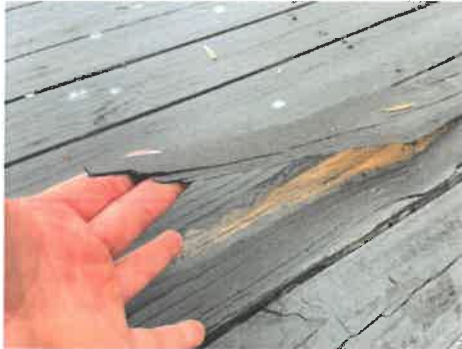
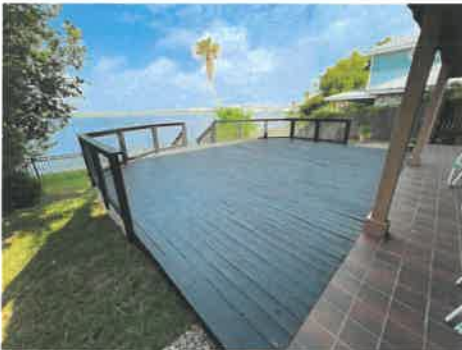
There are deteriorated deck boards at the pictured area(s). We recommend replacement of all damaged material.

Deck has some deterioration: recommend replacement

*all repaired*

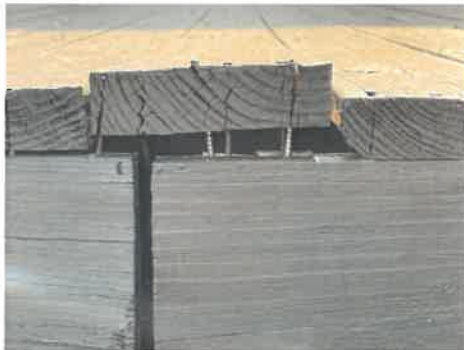
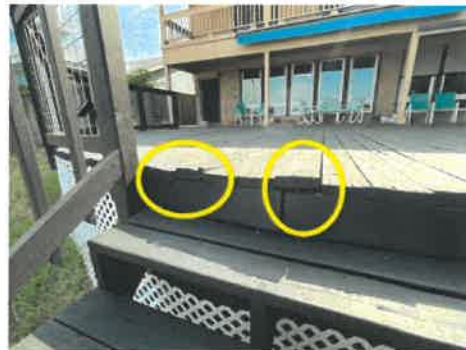
Some of the decking board nails have backed out and are protruding. We recommend the nails be reset.

Raised decking needs secured in place

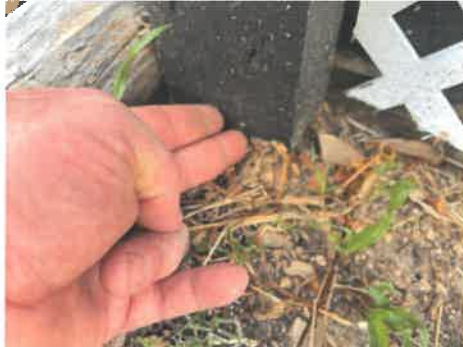
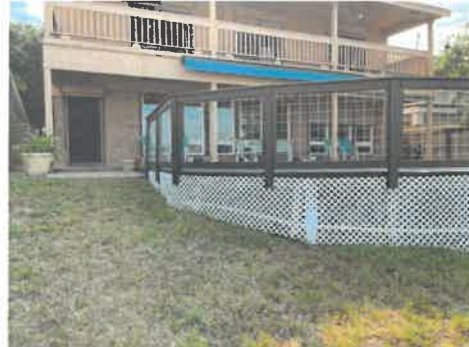
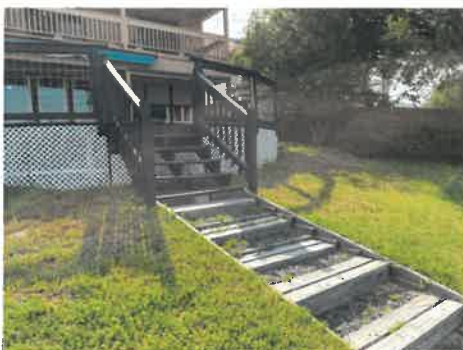
Wood to ground contact/obstructs view: wood to ground contact was observed on the rear deck where it joints to the main structure. Wood to ground contact is a conducive condition for wood destroying insects and should be eliminated. Recommend removing the conducive condition or getting a treatment performed by a licensed pest company for wood destroying insects for preventative measures. Note that the rear deck obstructs most of the foundation slab face on the rear side of the structure, which hinders the view of the inspector. Deficiencies may have been present that could not be viewed because of this obstruction.

Wood to ground contact/ deck obstructs view of foundation face

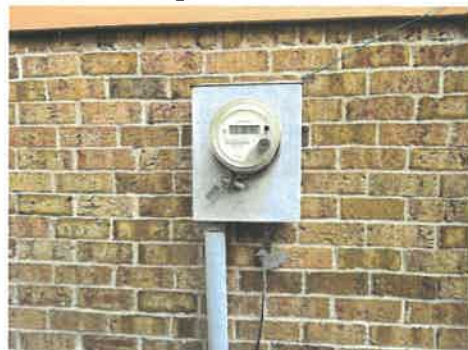
Right: service meter

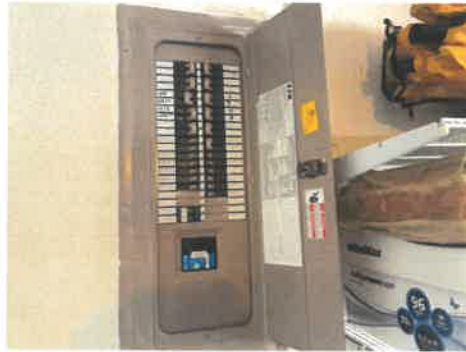
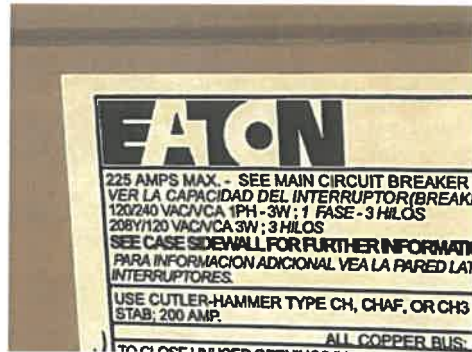
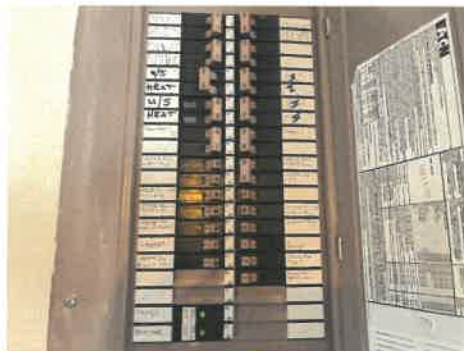
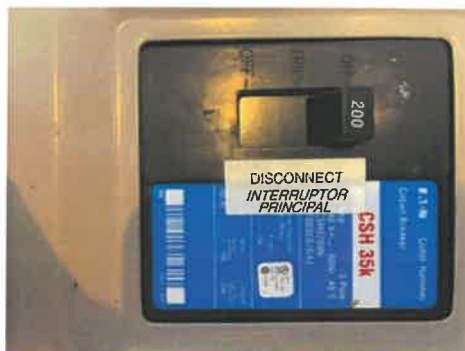
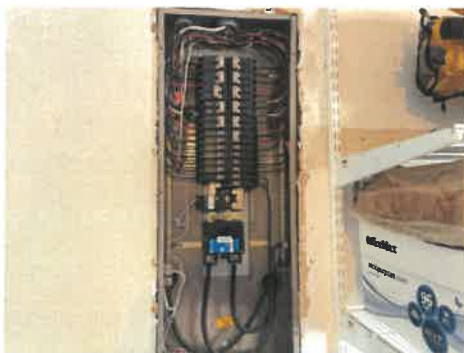
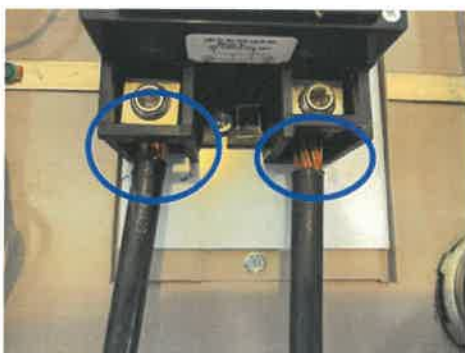
Garage: service panel

Garage: service panel Eaton manufacturer 225 amp rating

Garage: service panel appears properly labeled

Garage: service panel with 200 amp disconnect

Garage: service panel with dead front off

Garage: service panel with 2/0 copper service entrance wires

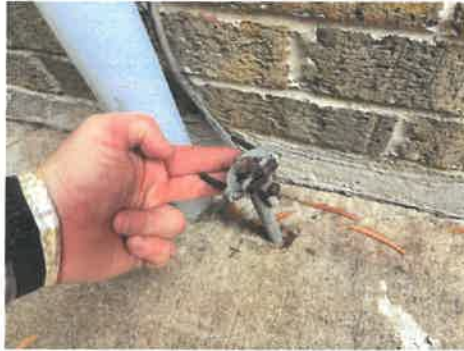
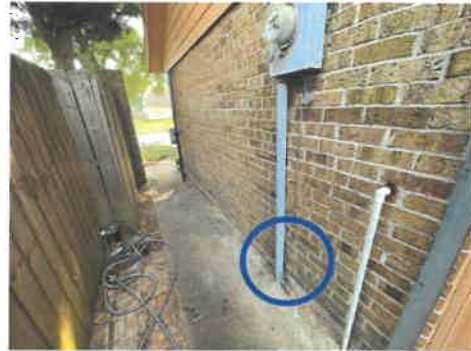
Ground wire/rod OK

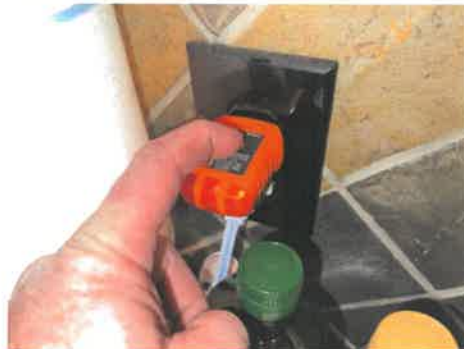
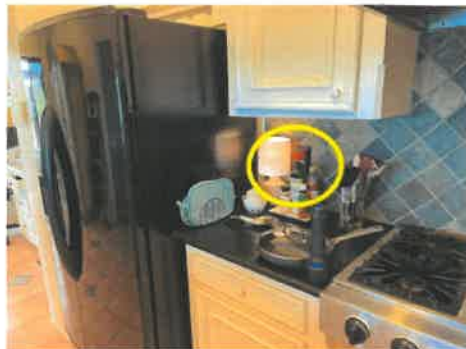
Kitchen receptacles are not all GFCI protected. All countertop receptacles should be protected.

Kitchen: not all GFCI protected

*replaced & repaired*

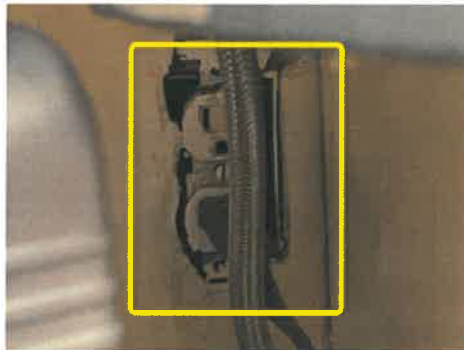
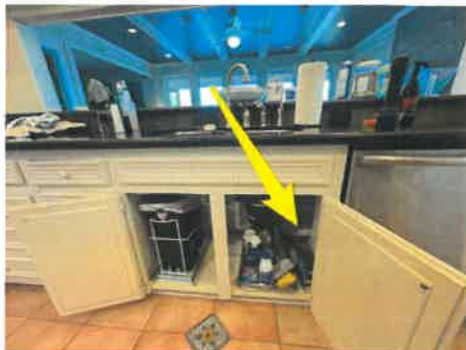
Some cover plates missing in the interior. Recommend cover plates to be installed over all electrical receptacles to help alleviate accidental shock.

Kitchen: missing cover plate

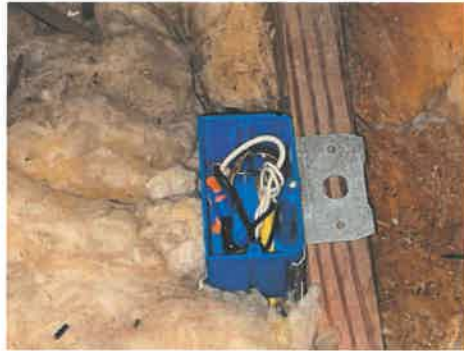
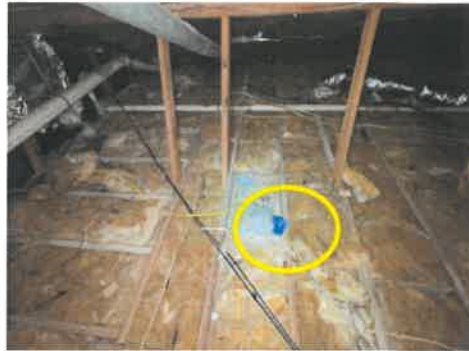
Junction boxes within the attic space need to cover plates installed for safety purposes.

Attic: open junction box

Repaired

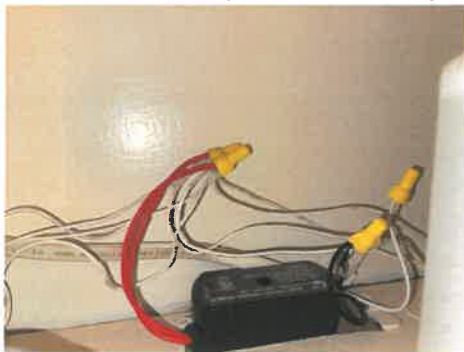
Master bathroom: splice should be in junction box with a cover plate

Master bathroom: open splice

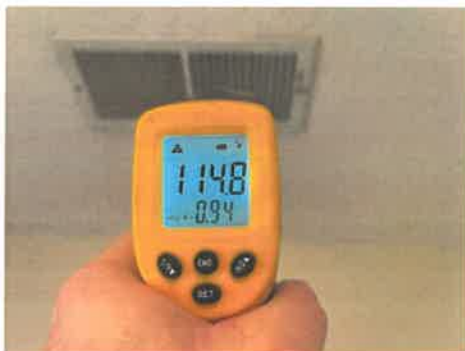
2nd floor: hot air temperature

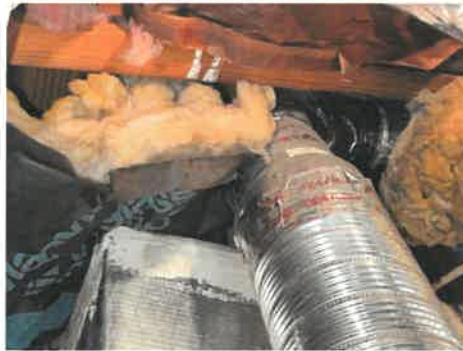
Fire stop missing: no fire stopping was observed where the HVAC duct protrudes through the attic area. The fire stop is recommended so that in case of fire, it will not penetrate through the attic to the rest of the house. Recommend installation by qualified professional.

Fire stop missing

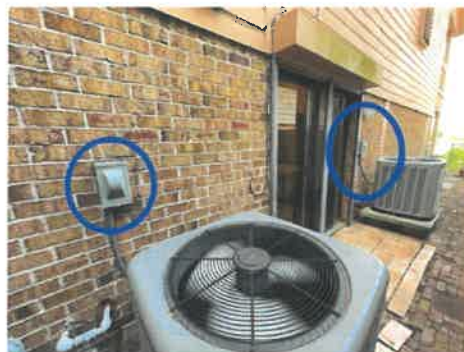
Service disconnects OK

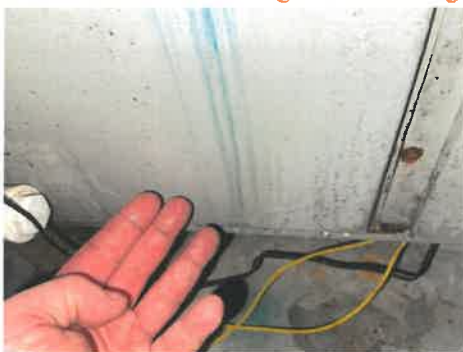
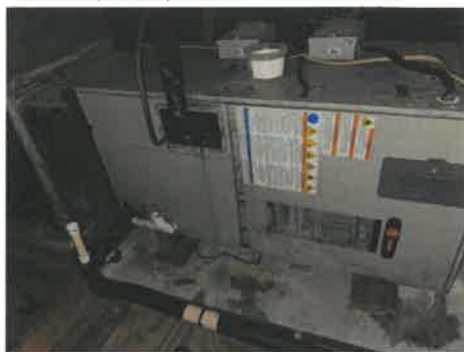
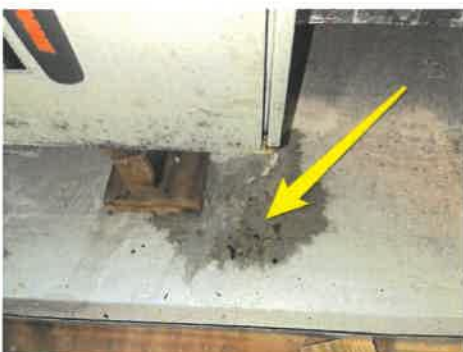
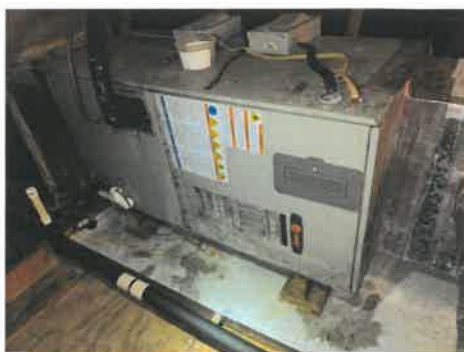
The indoor air containing unit is leaking condensate (water) from the unit when the ac is run.

Condensation buildup on outside of unit

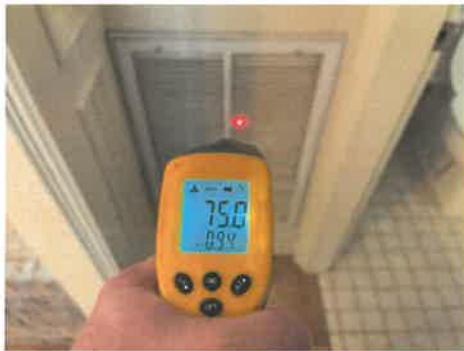
1st floor return air temperature 75 degrees

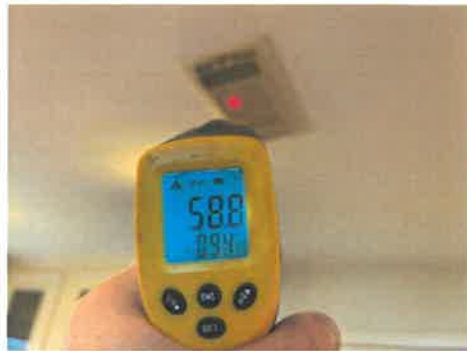
1st floor supply cool-air temperature 58 degrees

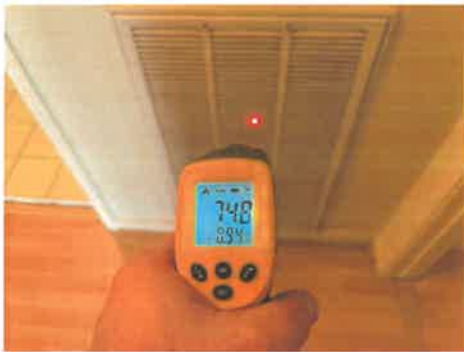
2nd floor return air temperature 74 degrees

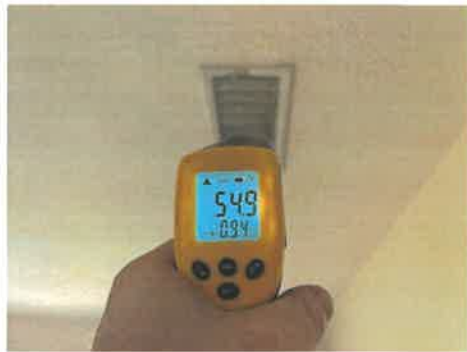
2nd floor supply cool-air temperature 54 degrees

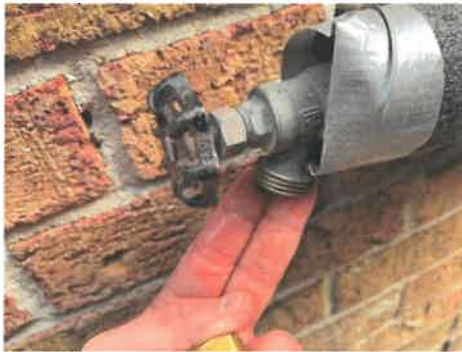
A backflow preventer is recommended

A back flow preventer is recommended to help alleviate the potential for siphoning of dirty water into the clean potable water.

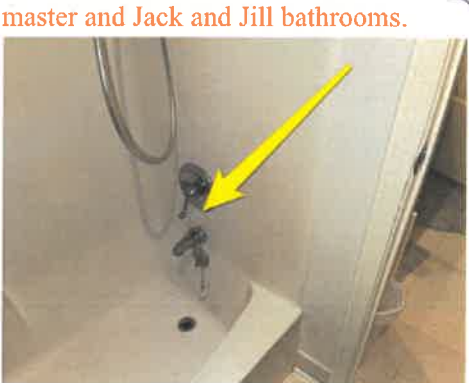
Shower and tub wall protrusions should be caulked and sealed to alleviate water intrusion in between the walls. This was observed in the master and Jack and Jill bathrooms.

Caulk/seal all shower and tub wall protrusions

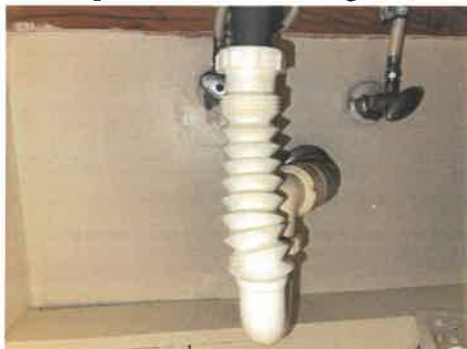
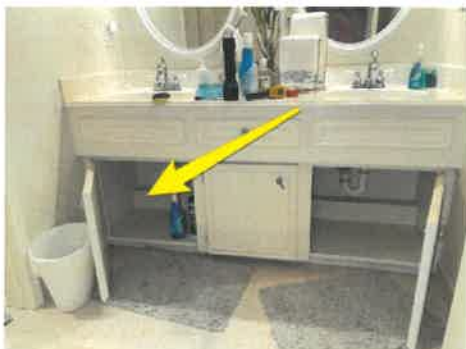
Improper piping was installed in one or more bathroom(s). The accordion sides can trap water and are prone to leaks and clogs.

Corrugated drain line present

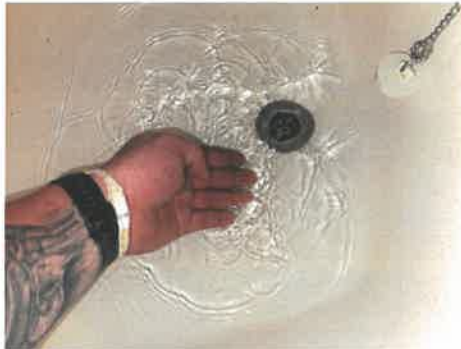
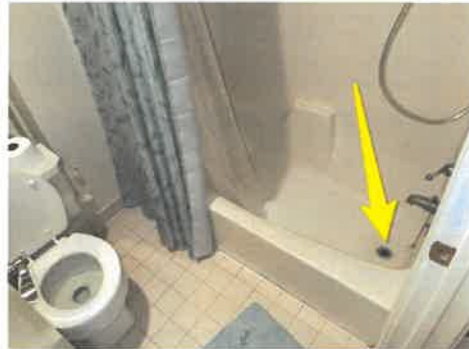
Slow drain 2nd floor: a slow drain was observed in the hall bathroom. This is probably due to a normal clog within the drain but may need to be evaluated and repaired by a licensed plumber.

2nd floor hall bathroom: slow drain

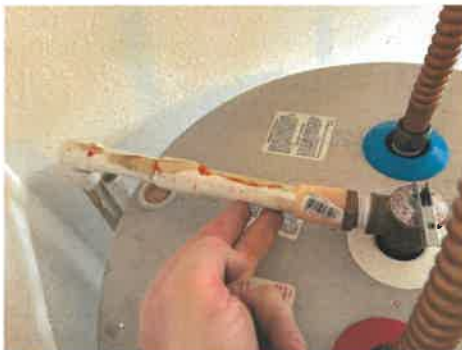
DISCHARGE PIPING: The discharge pipe is smaller than the discharge fitting on the temperature and pressure relief valve. This is potentially hazardous. We recommend it be replaced with an approved and properly sized pipe as well as having the discharge pipe terminated to outside of the structure.

TPR discharge not proper

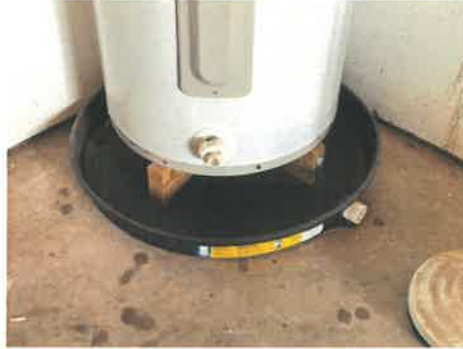
Present standards require that the water heater be elevated to provide a minimum of eighteen inches of clearance between any point of ignition and the garage floor. This configuration helps prevent ignition of fumes from spilled flammable liquids.

Improper elevation

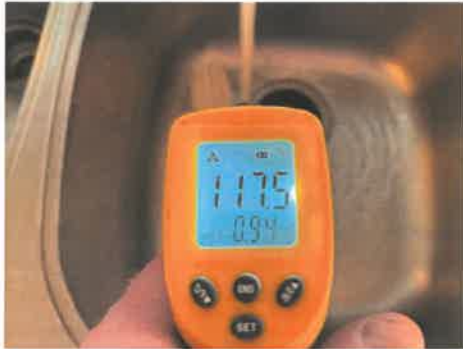
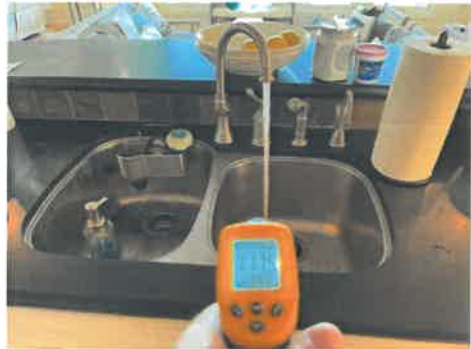
Hot water temperature

Water temperature at kitchen sink. Please note if the temperature is above 120 degrees Fahrenheit: Excessive temperature can be dangerous and inefficient. We recommend the temperature setting be set at 120\* or lower to provide safer, more efficient operation.

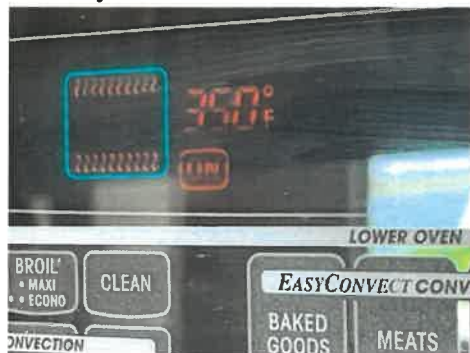
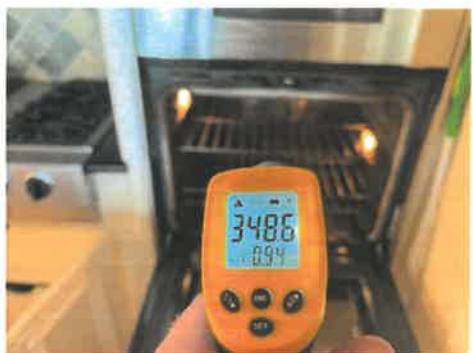
The oven was turned on with the normal operating controls and found to be in working condition. The standard test is to set the oven on 350°F and read the temperature inside. If it varies by more than 25° then it is considered deficient.

Oven when set to 350 degrees

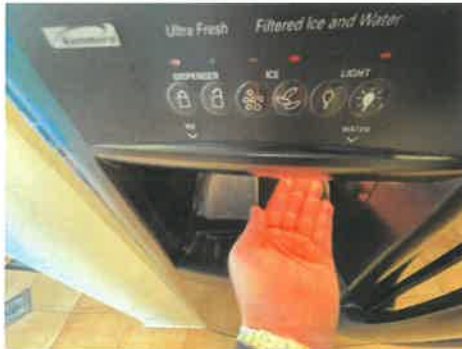
Ice maker/water dispenser NOT working

← disclosed

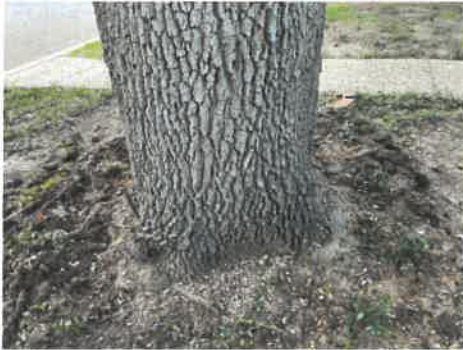
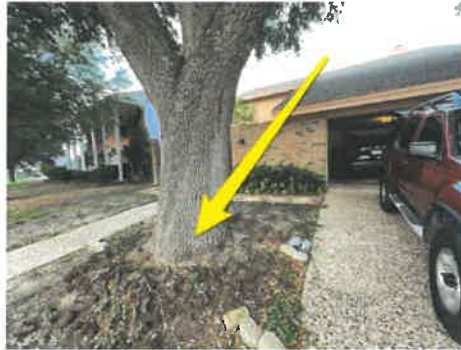
**1:** There are trees in close proximity to the foundation. This can pose risks to the foundation, walls and roof. If any foundation issues are suspected, consult a qualified foundation expert.

Tree in close proximity of structure

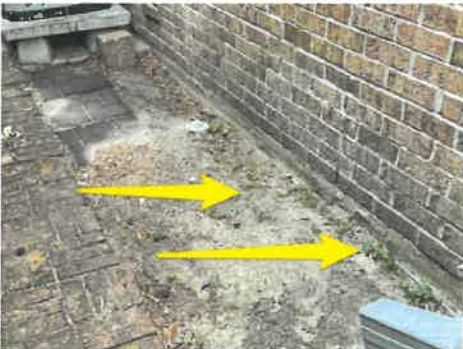
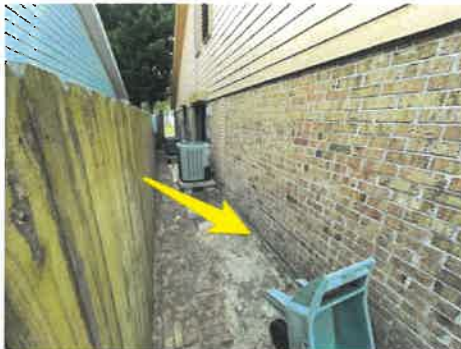
**WARN 2:** Grading is sloped toward the structure in some areas. Low spots and negative grading promote water accumulation near the slab or in the crawl space (if present).

Right: negative grade

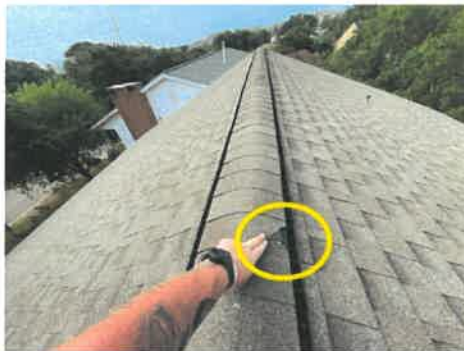
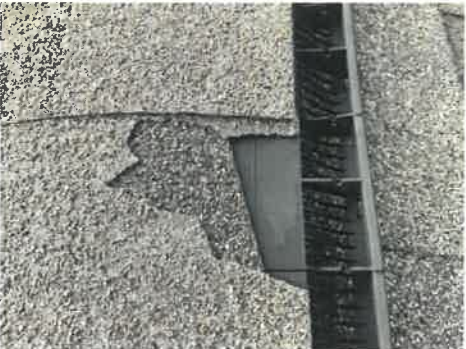
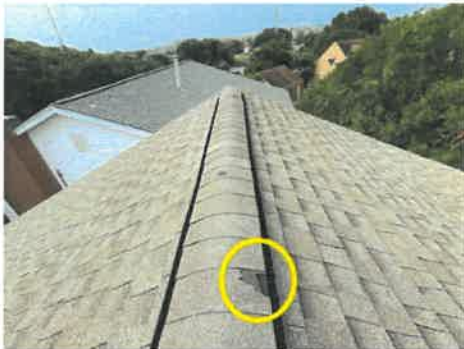
4: Some of the shingles are damaged and/or deteriorated.

Damaged ridge cap shingle

*repaired*

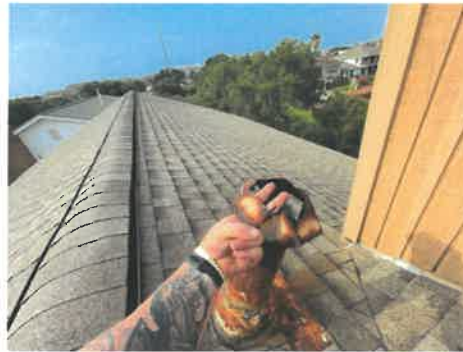
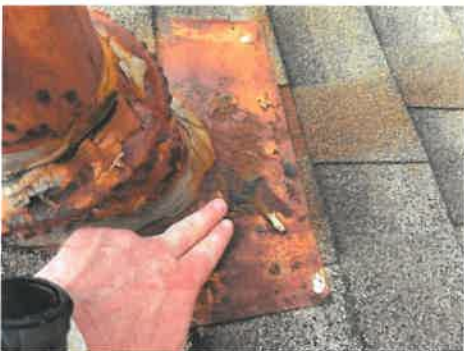
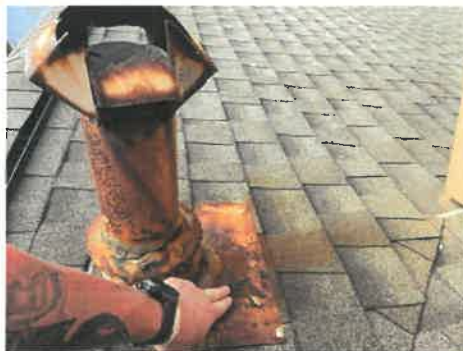
**5:** Some of the flashings, roof jacks and/or vents are damaged and/or corroded. We recommend they be repaired or replaced to prevent leakage.

Rusted/damaged rain cap on exhaust flue

Rusted flashing

*repaired - replaced*

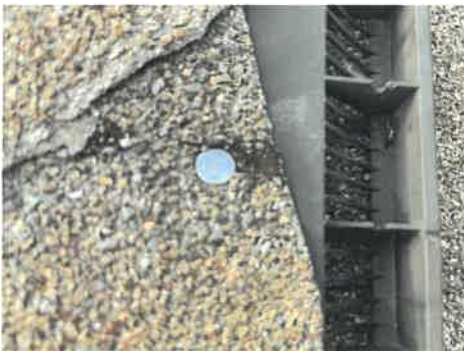
**6:** Exposed nail heads: exposed nail heads on top of the roof structure should be caulked and sealed to help alleviate water intrusion.

Exposed nailhead

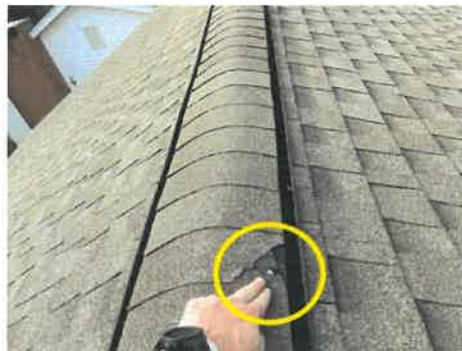
Exposed nailhead

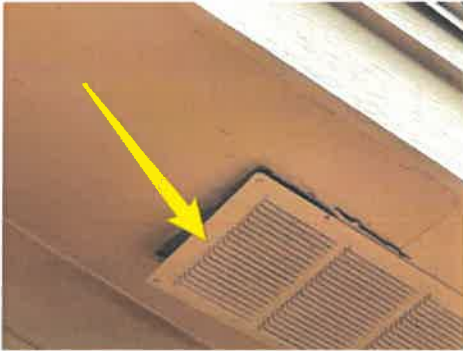
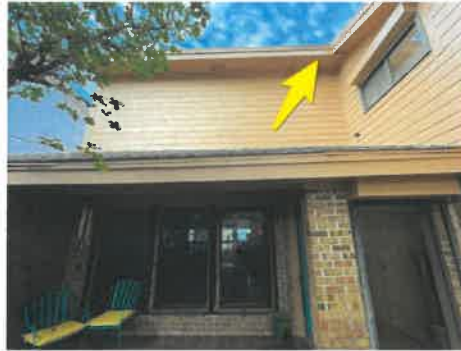
7: Openings were observed along the soffit areas of the structure. This can allow for water intrusion as well as unwanted pests such as bees and spiders to make entry inside of the structure. Recommend properly sealing all openings found in the soffit areas.

Opening in soffit/ secure soffit vent in place

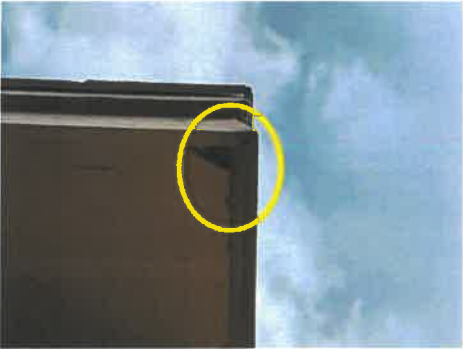
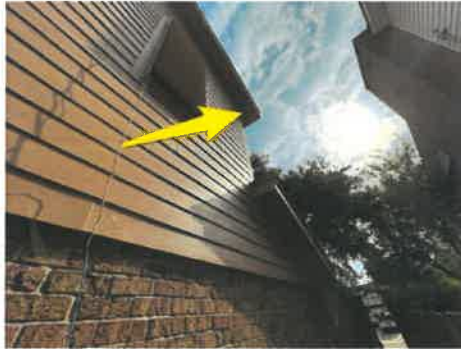
8: Damaged soffit material was observed on the left side of the structure. Recommend replacing all soft, rotten, and/or damaged wood.

Left front: damaged soffit

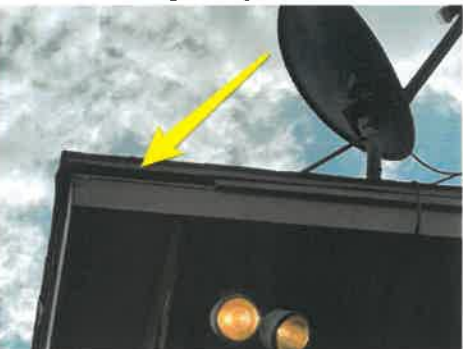
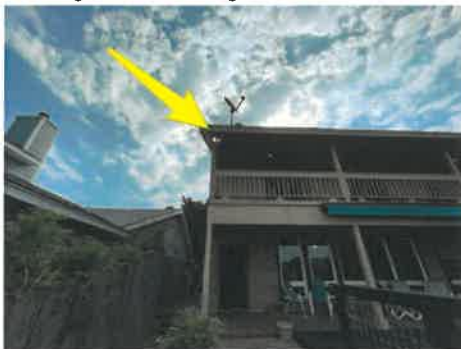
9: Damaged fascia: a fascia board/trim board on the rear side of the structure was observed to be missing. Recommend replacing all soft, rotten, and/or damaged or missing wood.

Right rear: missing trim board/fascia

*Repaired*

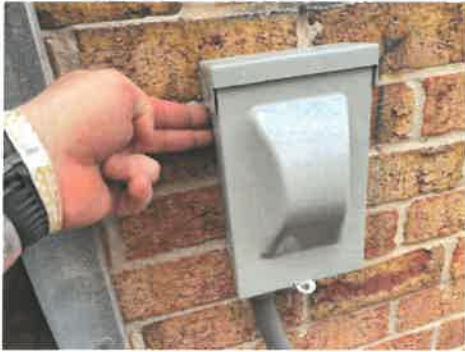
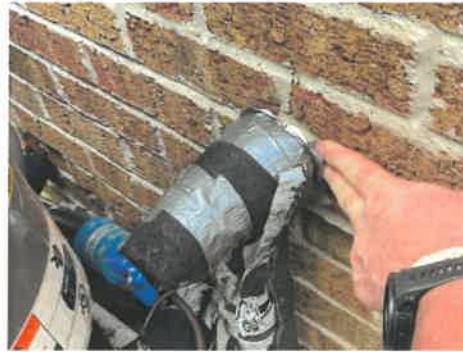
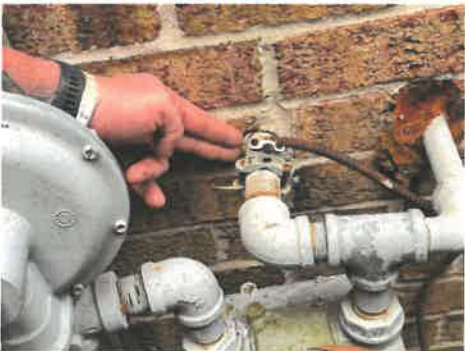
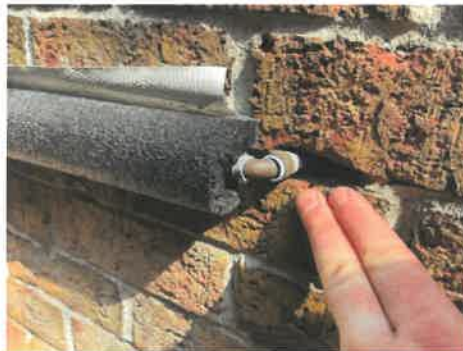
10: Any and all openings in the exterior wall should be caulked and sealed to alleviate water and unwanted pest intrusion into the structure.

Caulk/seal all exterior wall protrusions

*caulking repaired*

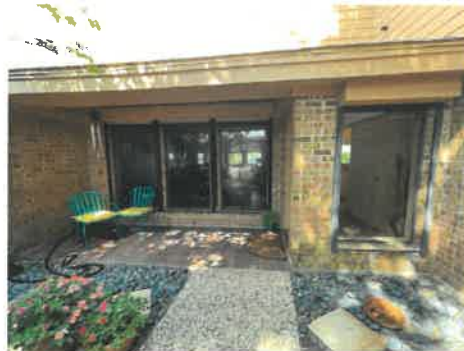
Caulking improvements needed around window frames on exterior side of the structure.

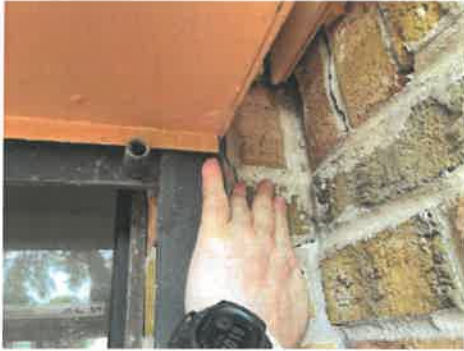
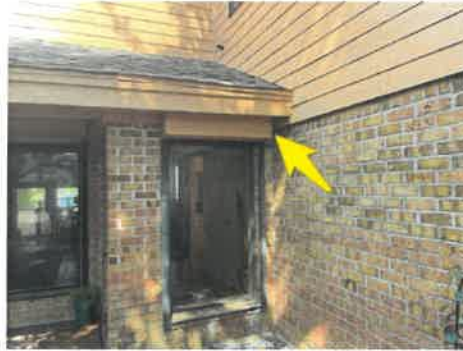
12: the veneer has pulled away from the building and/or has become unbonded from the wood frame in areas. We recommend removal and/or repair of the masonry because of the potential for damage or injury should the veneer completely collapse.

Front: loose brick veneer needs repaired

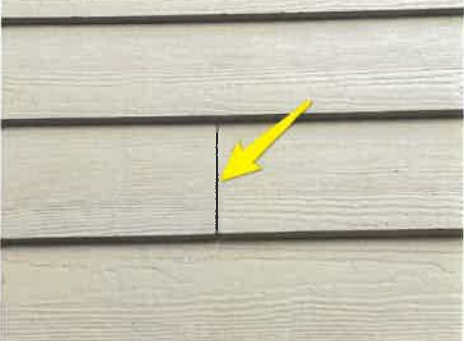
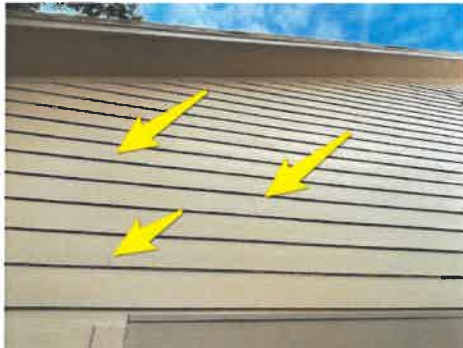
13: There are unsealed joints in the hardboard siding. We recommend the joints be caulked or sealed. This is a part of routine homeowner maintenance. Monitor yearly.

Seal all siding joints

*repaired*
