# Property Inspection Report

LOCATED AT:  
12 Quintana Dr  
Galveston, Texas 77554

INSPECTED ON:  
Tuesday, June 20, 2023

Inspector, Terry May TREC#23696  
May Home Inspection

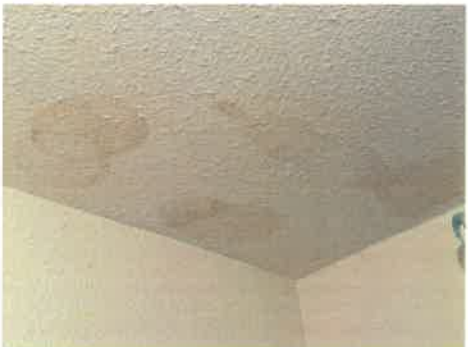
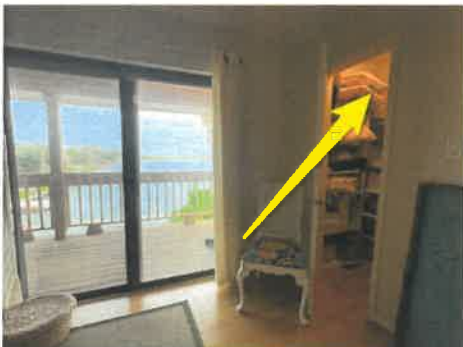
14: Moisture staining present in the ceiling.

Right rear corner bedroom closet: moisture stain

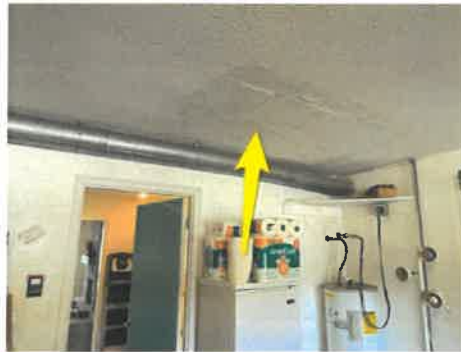
**15: Patching observed:** some patching was observed in locations throughout the structure which is indicative of previous issues. This does not mean that the problem is ongoing, but it is suggested that frequent monitoring of the area should be taken.

Garage: patching observed

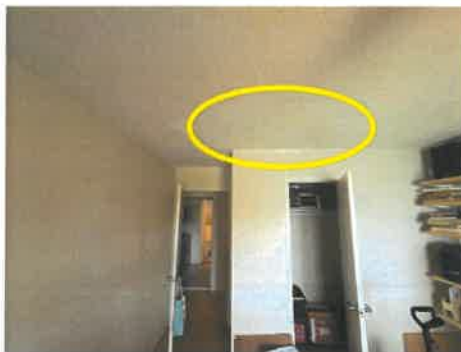
2nd floor rear middle bedroom: patching observed

*repaired*

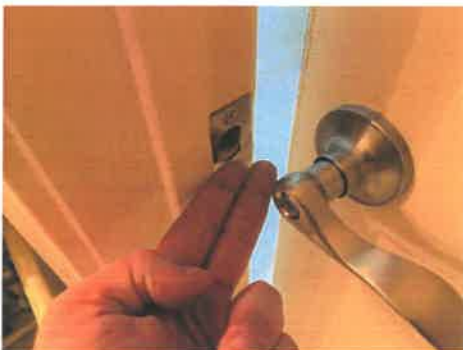
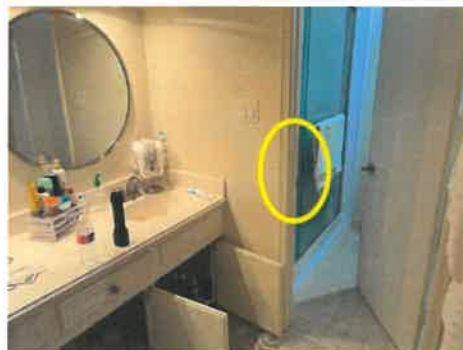
**16:** Several doors throughout the structure would not properly latch. Recommend adjusting the strike plate so that the doors latch as intended.

Master bathroom: won't latch

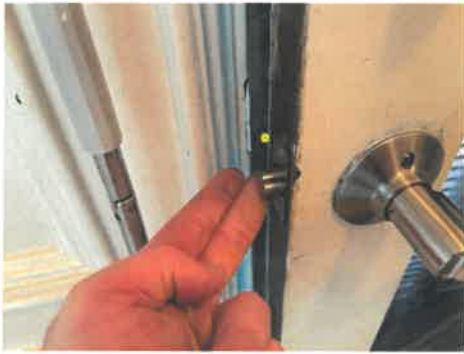
Back exterior door: won't latch

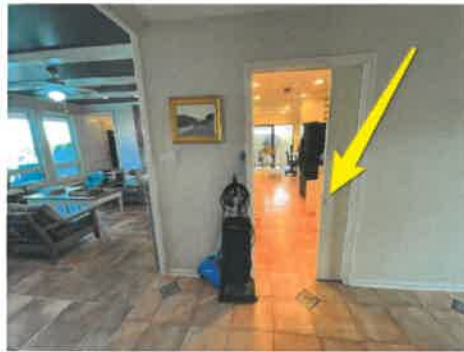
**17: Sliding door won't open/close:** the sliding door that leads from the kitchen to front entry would not close fully at the time of inspection. Recommend repairs by a licensed contractor so that the door opens and closes as intended.

Kitchen: door doesn't close all the way

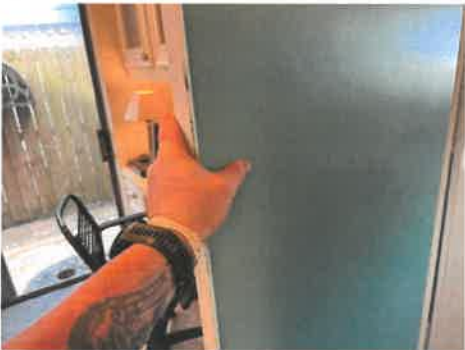
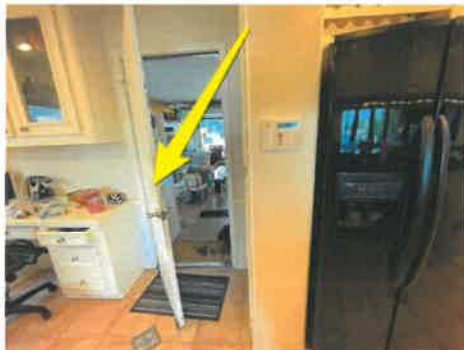
**18: Garage man door:** Not a proper fire rated door.

Garage door: not fire rated

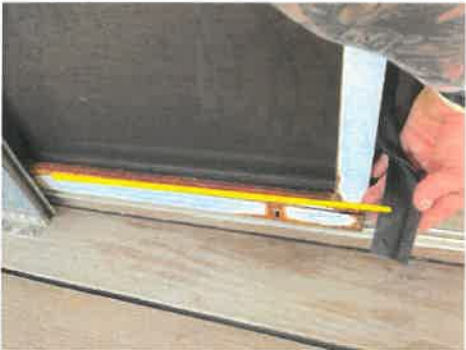
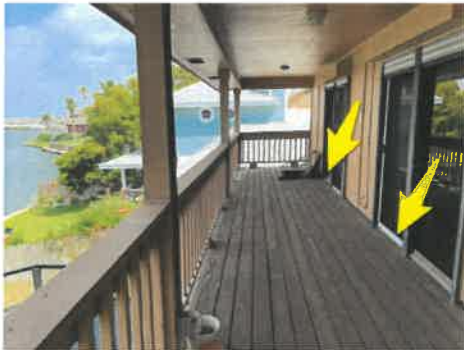
**20: Screen door: damage/corrosion :** the screen doors to the upstairs bedrooms that lead out to the rear balcony were observed to have minor damage and corrosion to the frame of the door screen. Although the doors operated as intended, Recommend repair/replacement.

Upstairs bedrooms: screen door corrosion/damage

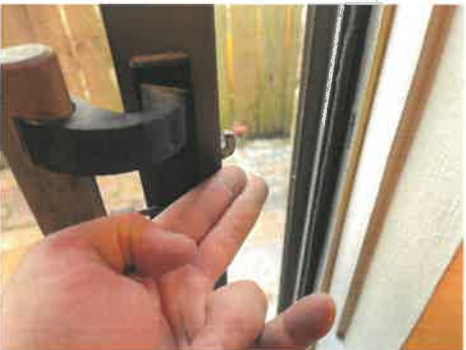
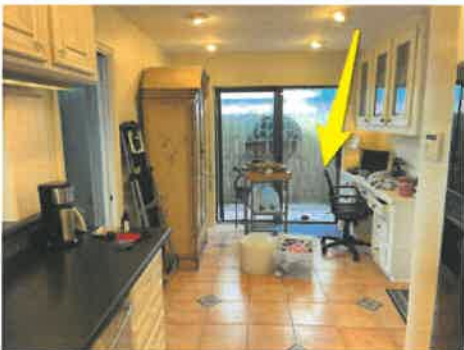
**21: Sliding door won't lock:** the sliding door that leads to the right side, exterior would not latch at the time of inspection. Recommend repair/replacement.

Right: sliding glass door won't lock

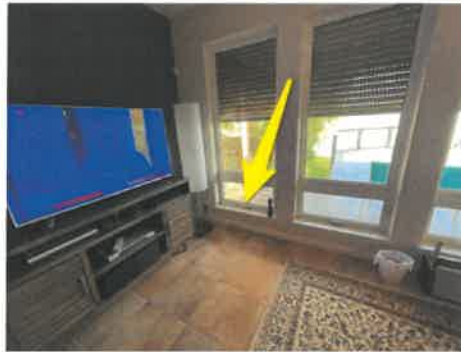
22: Some damaged or poor fitting window screens.

Living room: Window screen damage

*repaired*

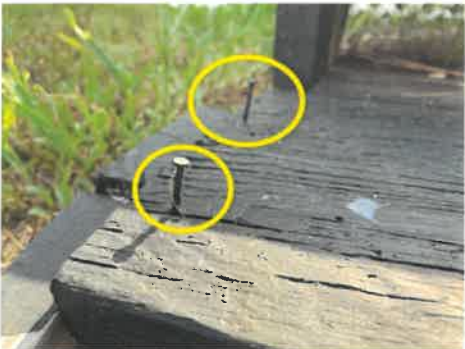
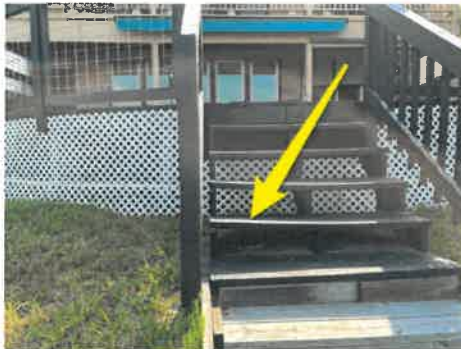
23: The stairs at the pictured areas are damaged.

Damaged steps/raised nails

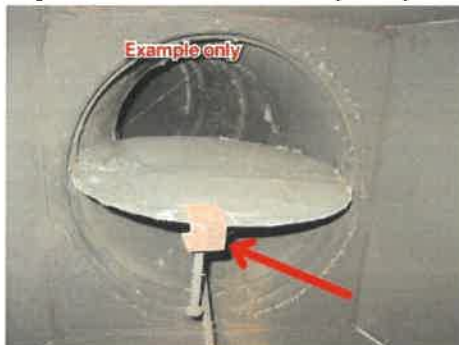
25: Damper lacks a mechanical stop to keep it from completely shutting. This allows any gas that might leak into the fireplace to be vented to the exterior. This is required now because of the gas log starter.

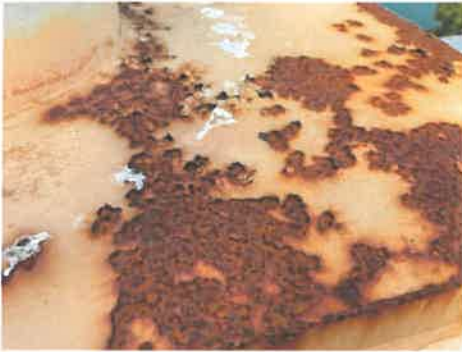
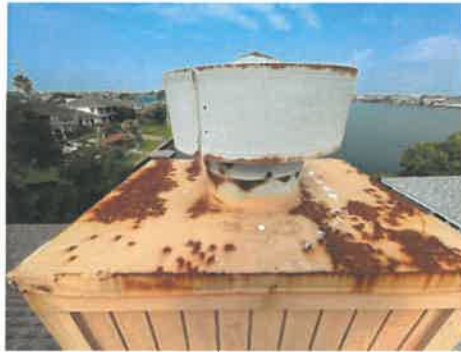
**26:** Chimney cap flashing rusted. The chimney cap had excessive corrosion at the time of inspection. Recommend corrosion control or replacement to alleviate the potential for water intrusion.

Chimney cap is rusted

*replaced*

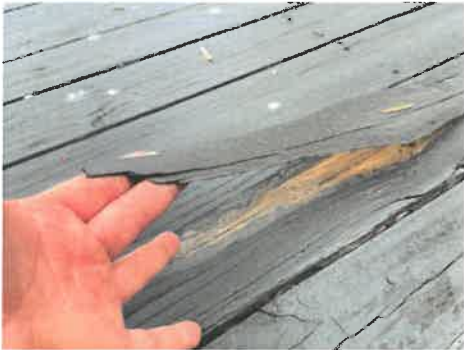
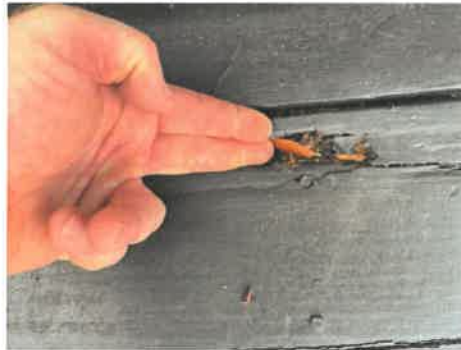
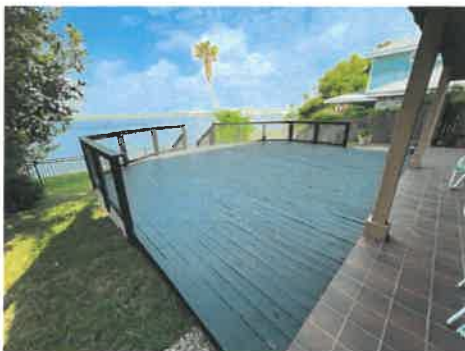
**27:** There are deteriorated deck boards at the pictured area(s). We recommend replacement of all damaged material.

Deck has some deterioration: recommend replacement

*repaired*

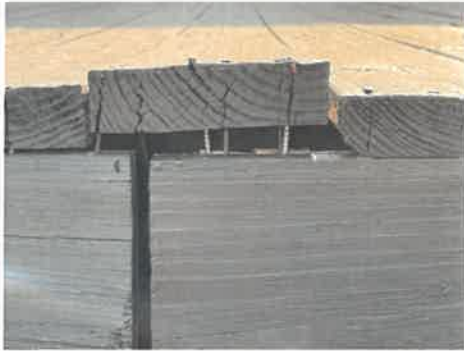
**28:** Some of the decking board nails have backed out and are protruding. We recommend the nails be reset.

Raised decking needs secured in place

*repaired*

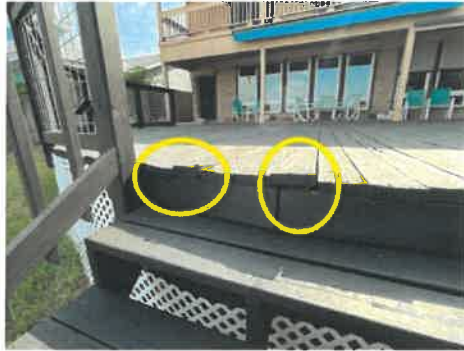
Raised decking needs secured in place

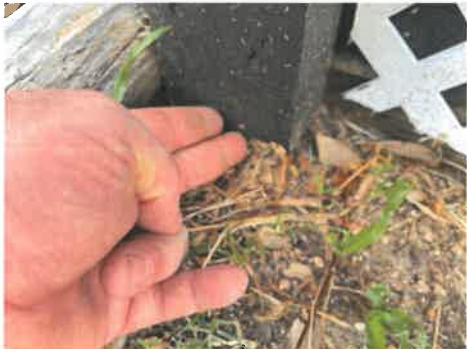
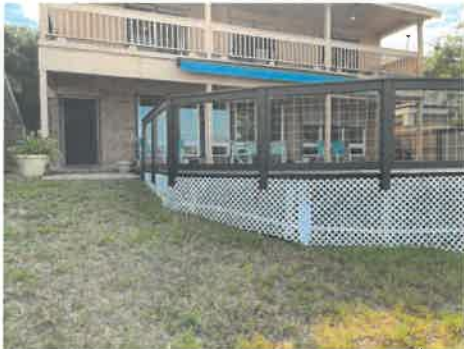
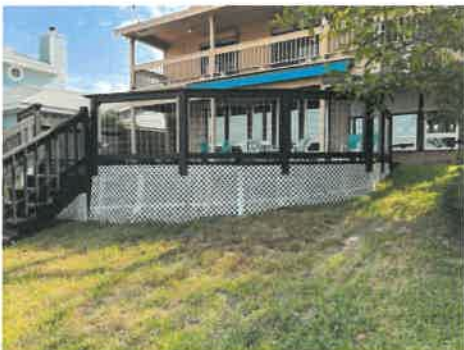
**29:** Wood to ground contact/obstructs view: wood to ground contact was observed on the rear deck where it joints to the main structure. Wood to ground contact is a conducive condition for wood destroying insects and should be eliminated. Recommend removing the conducive condition or getting a treatment performed by a licensed pest company for wood destroying insects for preventative measures. Note that the rear deck obstructs most of the foundation slab face on the rear side of the structure, which hinders the view of the inspector. Deficiencies may have been present that could not be viewed because of this obstruction.

Wood to ground contact/ deck obstructs view of foundation face

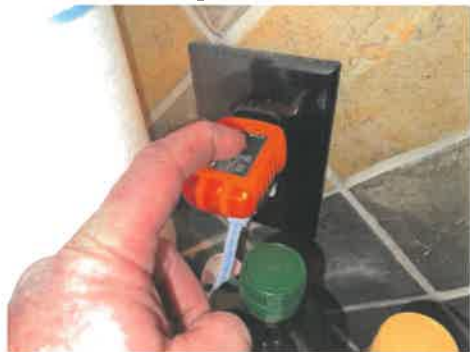
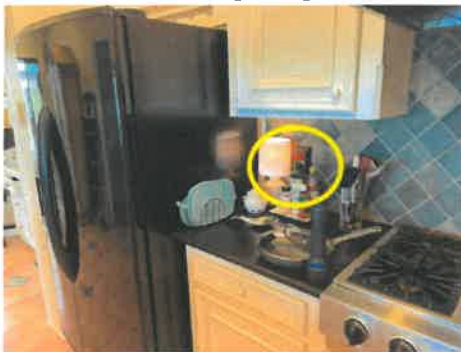
30: Kitchen receptacles are not all GFCI protected. All countertop receptacles should be protected.

Kitchen: not all GFCI protected

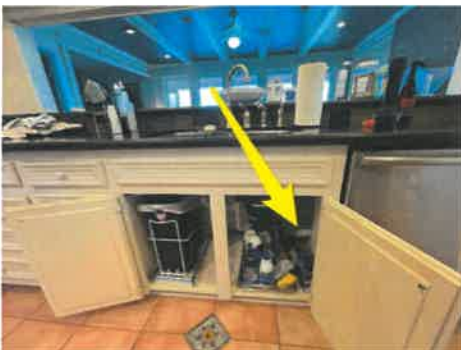
31: Some cover plates missing in the interior. Recommend cover plates to be installed over all electrical receptacles to help alleviate accidental shock.

Kitchen: missing cover plate

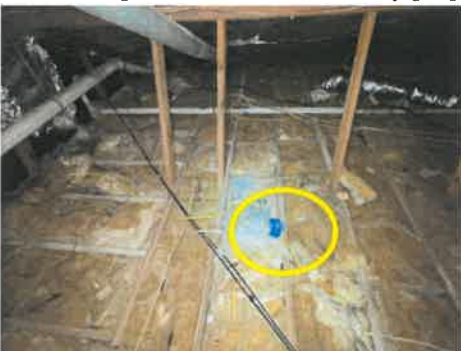
32: Junction boxes within the attic space need to cover plates installed for safety purposes.

Attic: open junction box

*repaired  
or  
replaced*

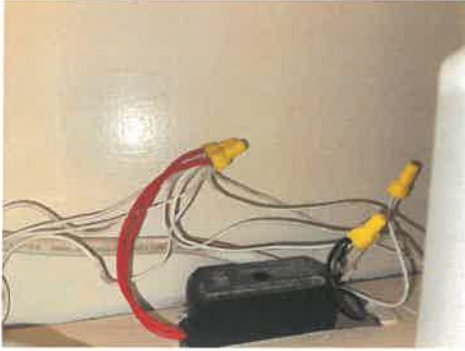
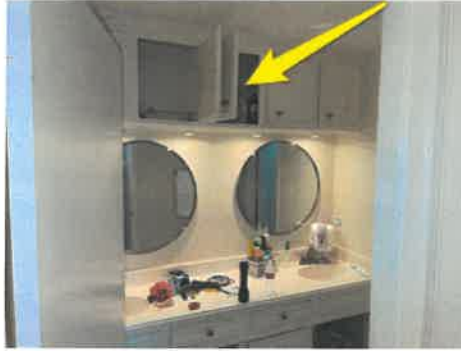
**33: Master bathroom: splice should be in junction box with a cover plate**

Master bathroom: open splice

*repaired*

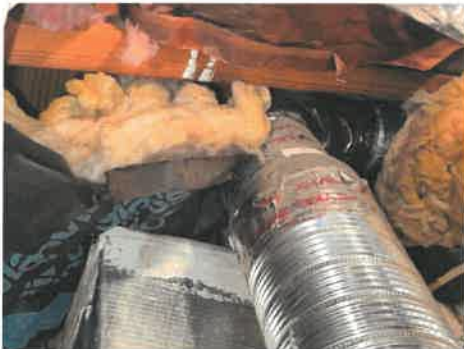
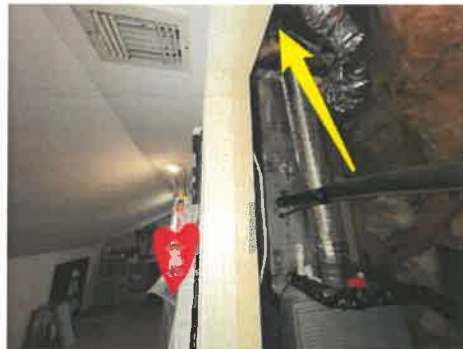
**34: Fire stop missing:** no fire stopping was observed where the HVAC duct protrudes through the attic area. The fire stop is recommended so that in case of fire, it will not penetrate through the attic to the rest of the house.

Fire stop missing

Recommend installation by qualified professional.

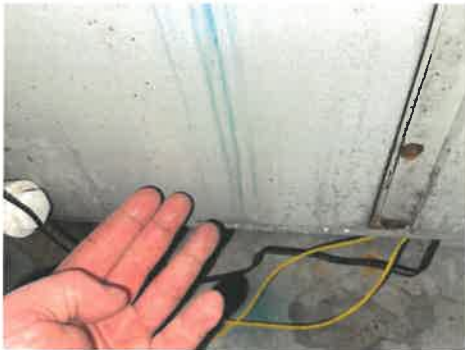
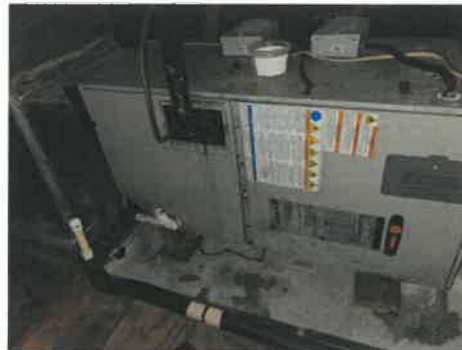
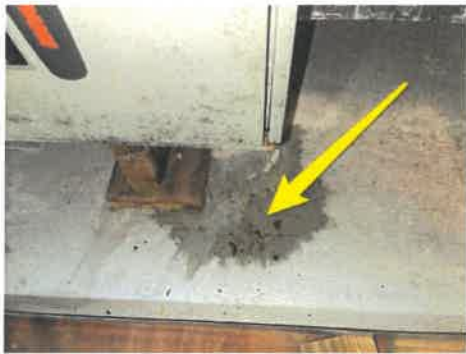
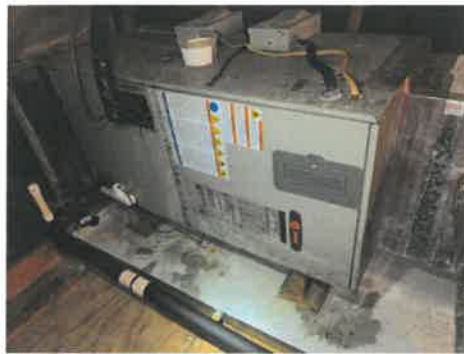
**35: The indoor air containing unit is leaking condensate (water) from the unit when the ac is run.**

Condensation buildup on outside of unit

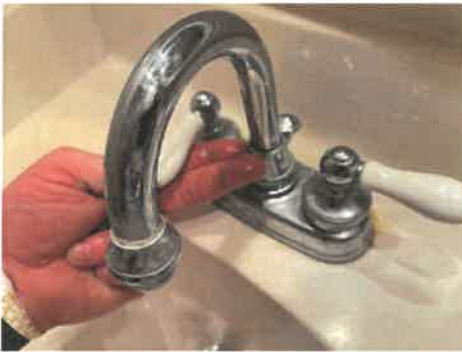
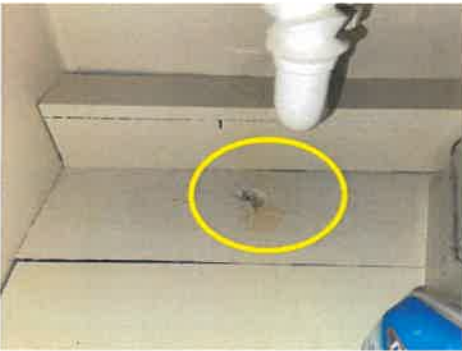
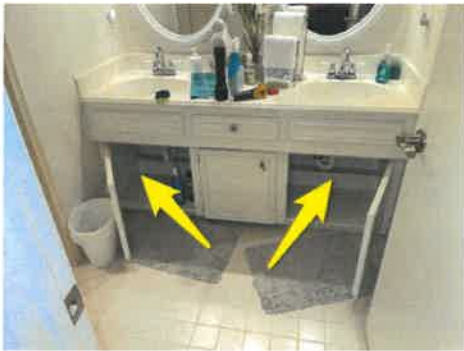
36: Hall bathroom: leaks at faucet/control handles: repairs or replacement should be carried out by a licensed plumber.

Hall bathroom: leaks at faucet on both sinks

*Faucets replaced  
leaks repaired*

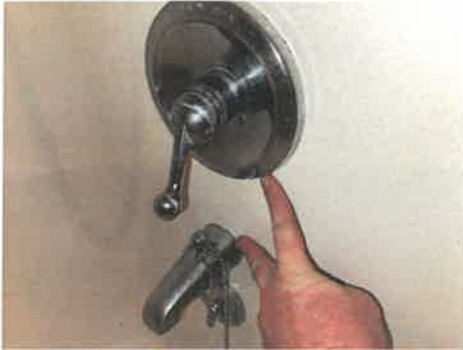
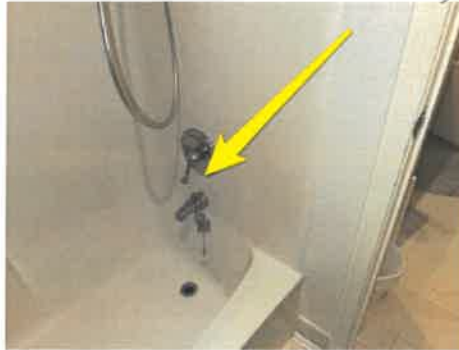
37: Shower and tub wall protrusions should be caulked and sealed to alleviate water intrusion in between the walls. This was observed in the master and Jack and Jill bathrooms.

Caulk/seal all shower and tub wall protrusions

*Caulking added*

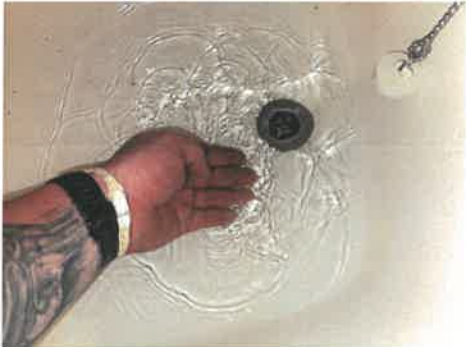
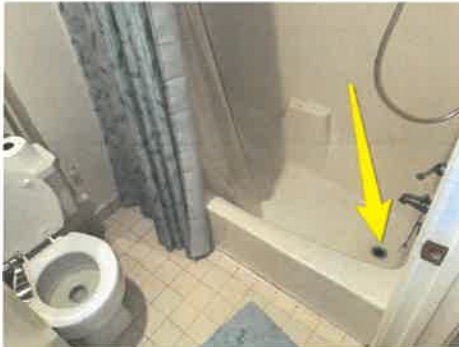
38: Slow drain 2nd floor: a slow drain was observed in the hall bathroom. This is probably due to a normal clog within the drain but may need to be evaluated and repaired by a licensed plumber.

2nd floor hall bathroom: slow drain

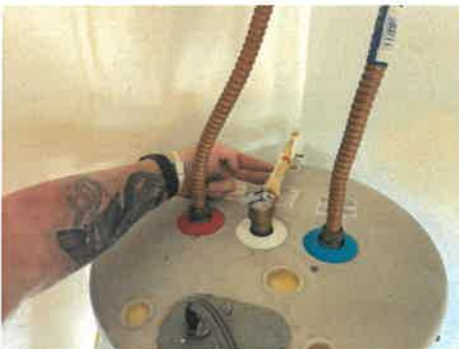
39: DISCHARGE PIPING: The discharge pipe is smaller than the discharge fitting on the temperature and pressure relief valve. This is potentially hazardous. We recommend it be replaced with an approved and properly sized pipe as well as having the discharge pipe terminated to outside of the structure.

TPR discharge not proper

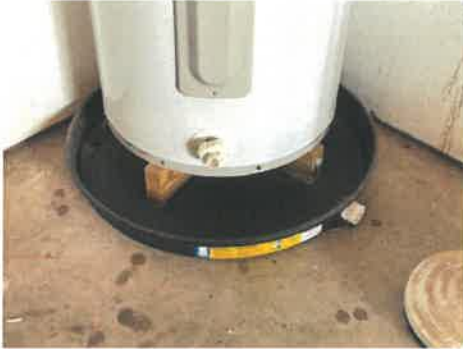
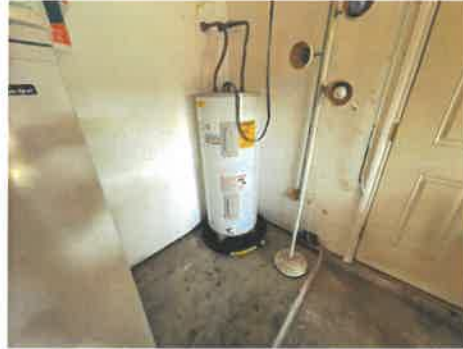
**40:** Present standards require that the water heater be elevated to provide a minimum of eighteen inches of clearance between any point of ignition and the garage floor. This configuration helps prevent ignition of fumes from spilled flammable liquids.

Improper elevation
