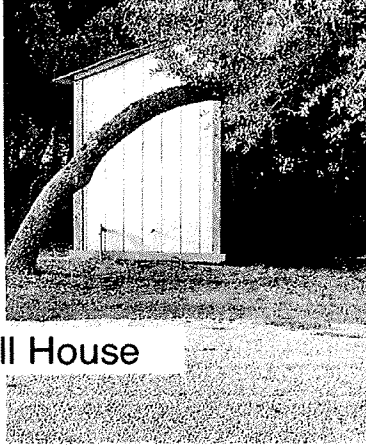
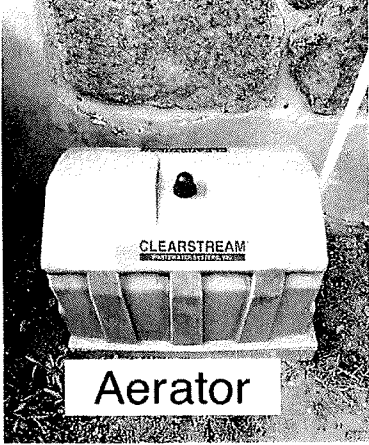
Aerator

**Alarms:** The audible & visual light were not functional. Floats or control panel will need to be checked.  
**Aerator:** Operational. *Repaired SEE INVOICE*

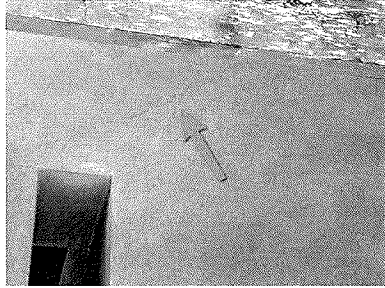
**2: Wall penetrations not sealed**

moisture penetration.

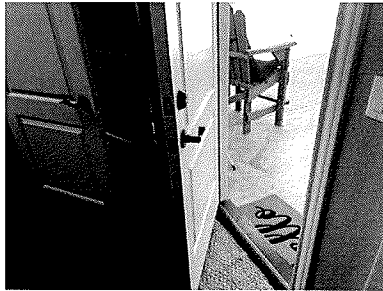
**3: Loose or missing door hardware**

Openings from a private garage directly into a room used for sleeping purposes shall not be permitted. Other openings between the garage and residence shall be equipped with solid wood doors not less than 13/8 inches (35 mm) in thickness, solid or honeycomb-core steel doors not less than 13/8 inches (35 mm) thick, or 20-minute fire-rated doors, **equipped with a self-closing device.**

Remediation is recommended.

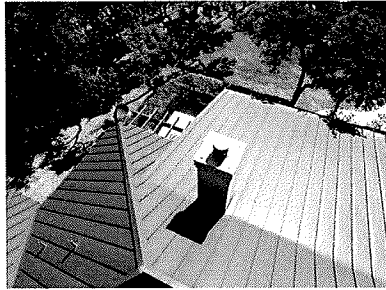
**1: Buildup of soot and creosote**

*Attic fire stop:* Not accessible  
*Chimney cap installed:* Yes  
*Combustion Air Vent:* Yes  
*Gas Valve/Logs:* Yes

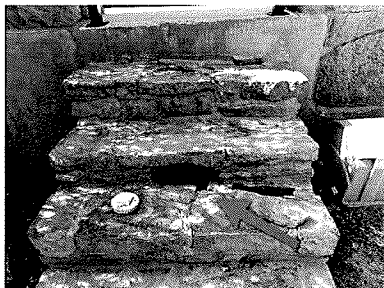
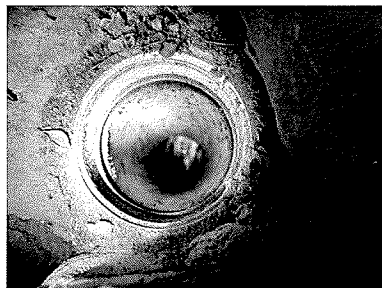
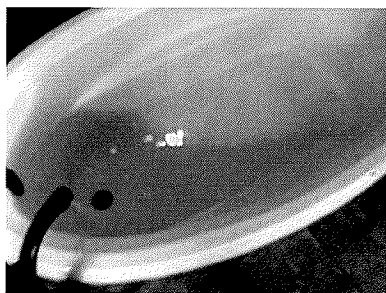
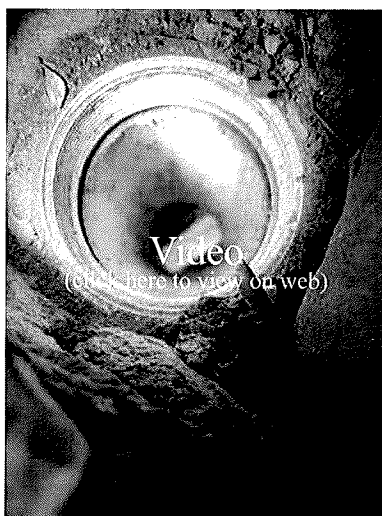
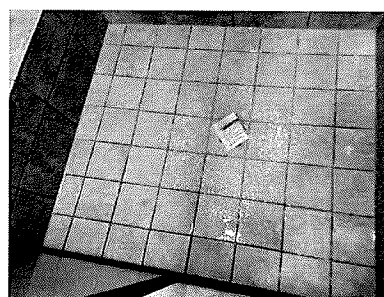
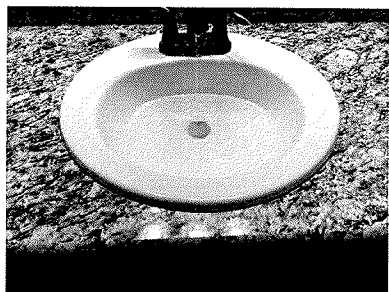
**1: Missing stopper**

The drain stopper is missing or non-functional at one or more sinks or tubs. Repair and/or replace as necessary.

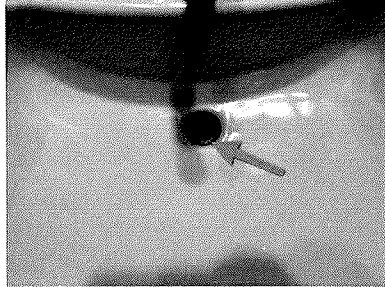
**2: Stopper did not function**

One or more drain stoppers did not function properly. Repair or adjustment as needed for proper operation of the stopper.
