**20942 Punkin Street
New Caney TX 77357**

Client(s): Ortiz
Inspection Date: 6/24/2023
Inspector: JB Atterberry , 24834 (TX)

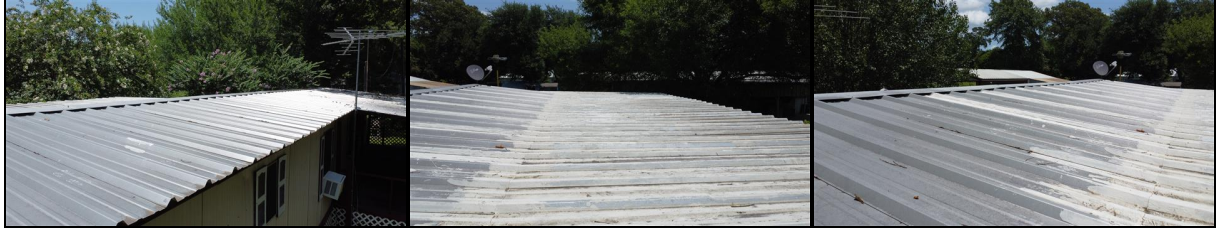
The roof covering appeared in good condition. No leaks were active at time of inspection. The covering appeared to be properly fastened.

Metal roofs have an expected maintenance period of about every 8-10 years, where the deficient grommet seals on the roof fasteners are replaced as needed and loose fasteners are reset. Penetrations are replenished of sealant and/or jackboot flashings are replaced. The roof appears to be nearing the period where maintenance is recommended. Recommend query owner for record of last maintenance period. If none in last 7 years, a qualified metal roofer should be contacted and a maintenance check be performed.

Remove all debris from roof slopes and valleys. Leaf debris may hide possible defects and damage to roofing materials. Debris may also cause water to dam up on roofing material.

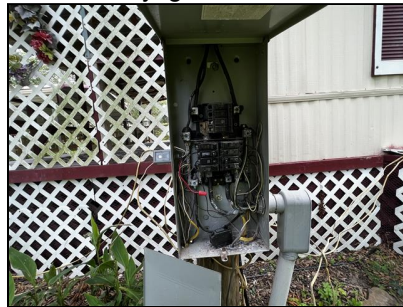
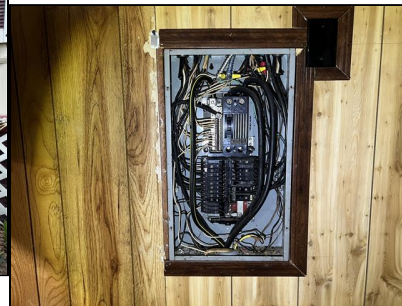
Main panel

System panels installed correctly, grounded.

The main panel box is located on the electrical pole, in the left side yard. The sub-panel is located in the hall of the home.

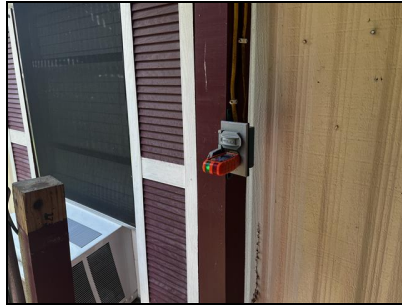
While operating switches, one without an obvious function was found in the main entry. Ask the Seller to explain the function of any such switch. If this does not solve the "mystery," consult with a qualified electrician.

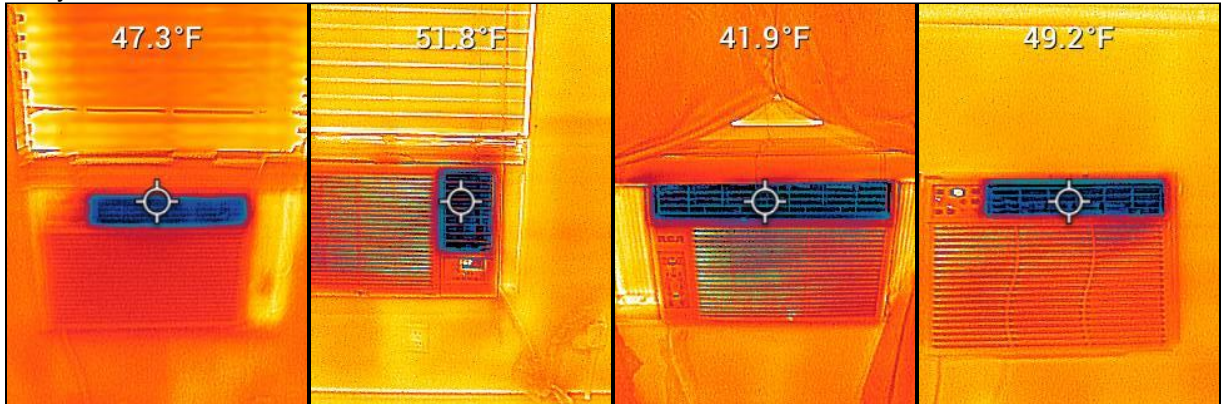
Noted the home has four window units for air conditioning. All four window units appear to be functioning correctly.

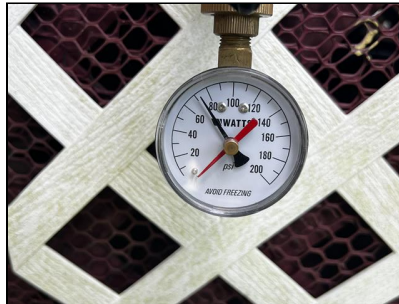
One or more exterior hose bibs (faucets) are missing back-flow check valves as called for by today's standards.

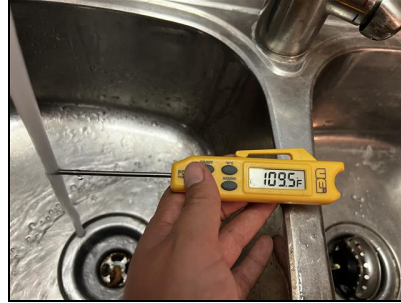
The water heater was functional at the time of the inspection. However, there were exceptions. Those deficiencies/exceptions are listed below.

Noted the water heater was not accessible at time of inspection. Water heater was closed off, and has no access door.
