TREC-7-6

24607 Emerald Pool Falls Dr
Tomball, TX 77375

PROPERTY INSPECTION REPORT FORM

Offer Pad	06/29/2023 12:00 pm
<i>Name of Client</i>	<i>Date of Inspection</i>
24607 Emerald Pool Falls Dr, Tomball, TX 77375	
<i>Address of Inspected Property</i>	
Cullen Fleetwood	TREC # 20717
<i>Name of Inspector</i>	<i>TREC License #</i>
<i>Name of Sponsor (if applicable)</i>	<i>TREC License #</i>

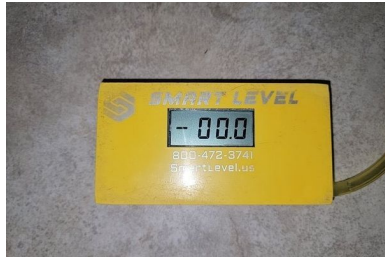
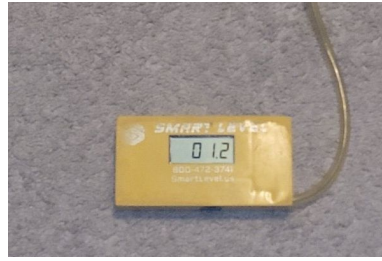
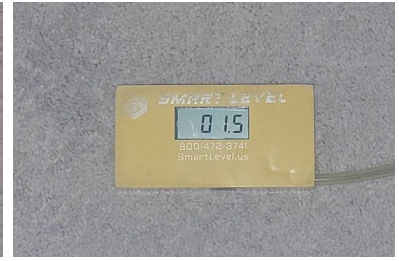
Foundation Performance: EXCESSIVE MOVEMENT ON ZIP LEVEL READING ONLY

ZIP LEVEL READING OUT OF TOLERANCE - Foundation observed appeared to be out of tolerance per the ZIP LEVEL READING ONLY. Zip level showed an elevation difference of 1.5".

There were no other visual signs of settling noted at the time of inspection. Prior to closing, the foundation should be inspected by a qualified foundation specialist, familiar with the soils and construction methods of the region, in order to determine if permanent repairs are required.

Recommendation: Contact a qualified professional.
