MECHANICAL INSPECTION

505 Jackson Hill St Unit 203 Jacksons Place
Houston, TX 77007

PROPERTY INSPECTION REPORT FORM

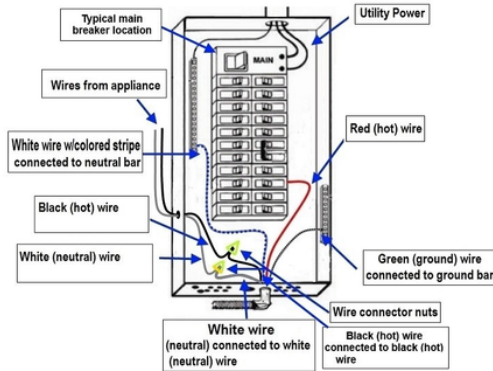
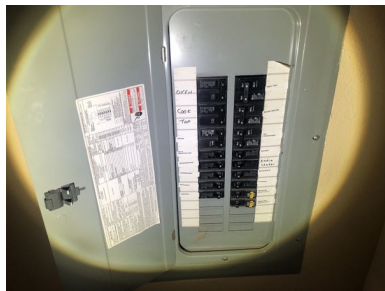
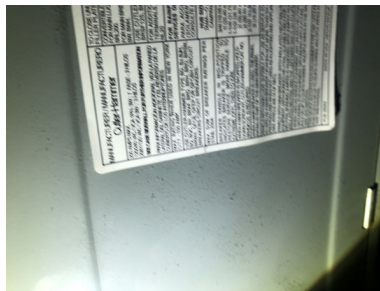
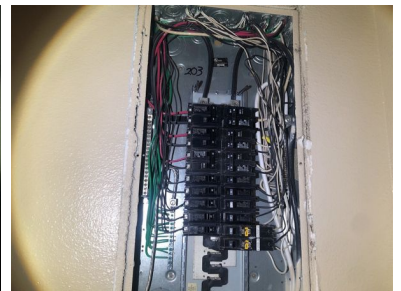
Circuit Breaker Wiring Diagram

<u>Location</u>	<u>Manufacturer</u>	<u>Rating - Amps</u>
Bedroom	Cutler Hammer	200

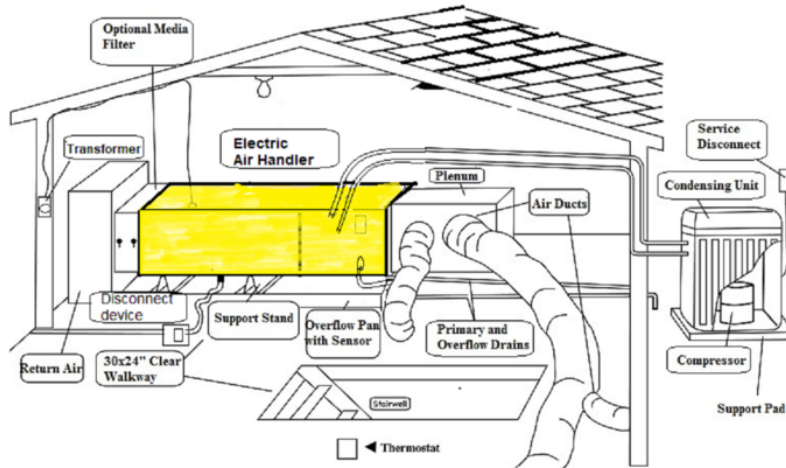
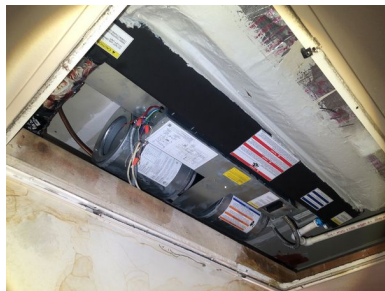
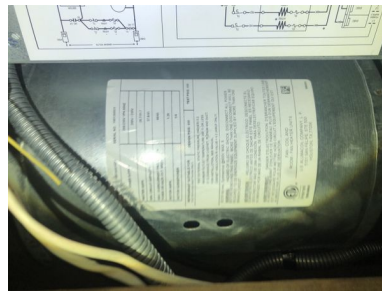
<u>ZONE</u>	<u>BRAND</u>	<u>DATE</u>	<u>LOCATION</u>
House	Alumacoil	2019	Bathroom

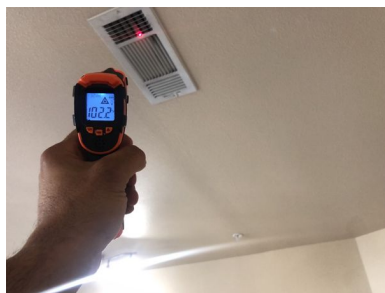
The heating equipment was observed to be operating and functional at the time of the inspection. The heating equipment responded to the thermostat(s) and the equipment appeared to be heating the air adequately.

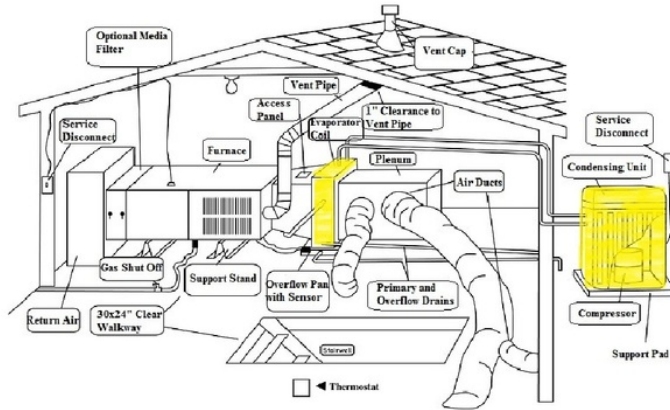
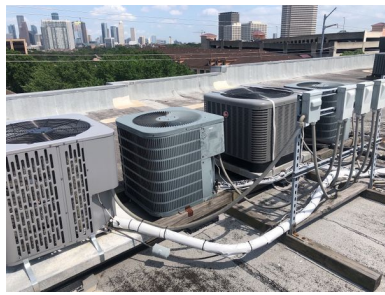
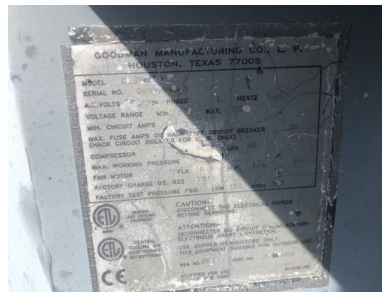
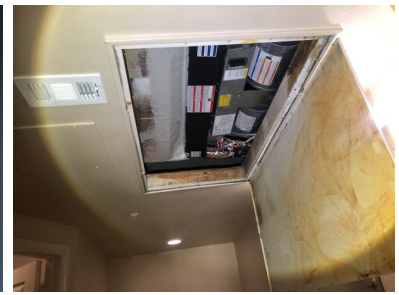
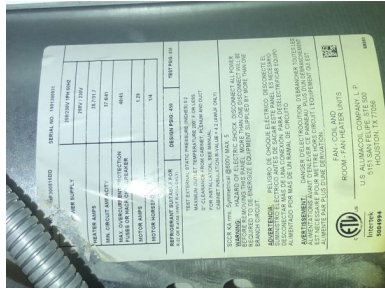
The condensing unit equipment was functional at the time of the inspection. The equipment responded to the corresponding thermostat, and the compressor components and fan motor components appeared to be operating as evidenced by the cooling performance of the system.

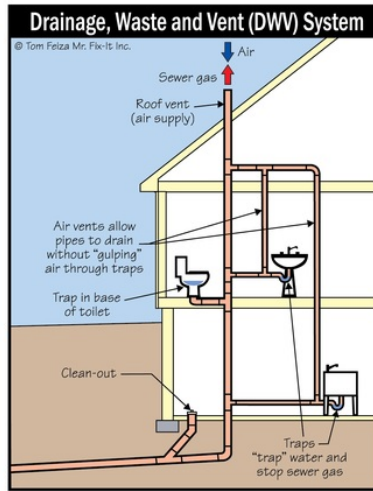
No evidences of a system wide problem were observed when the system was operationally checked by running water through each of the plumbing fixtures during the duration of the inspection. It is noted that most of the drain waste system in the walls, under the floors, and in the ceilings is not visible. If further investigation is desired, it is recommended that a plumber be contacted to perform an in depth survey with a camera or hydrostatic test.

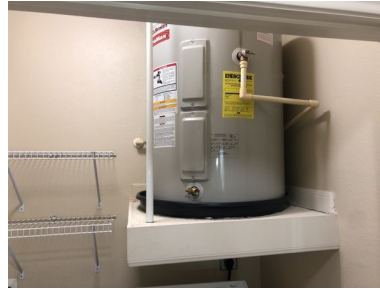
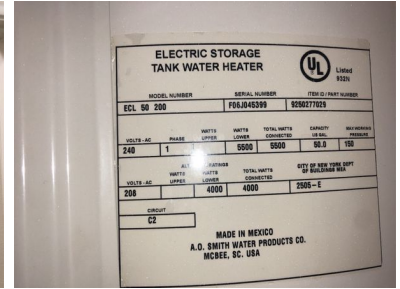
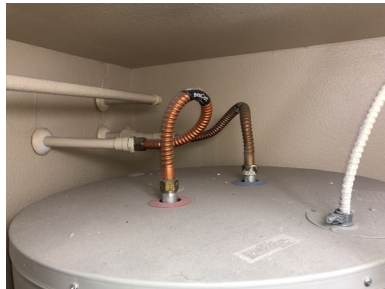
The water heater equipment was functional at the time of the inspection and providing hot water to the applicable plumbing fixtures.

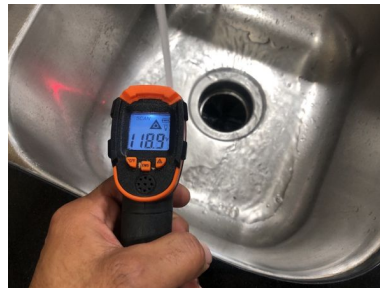
Due to the age and/or condition of the equipment, it is our opinion that the equipment has only a limited amount of life remaining. Normal life expectancy for a water heater in the Houston area is approximately 10-12 years.

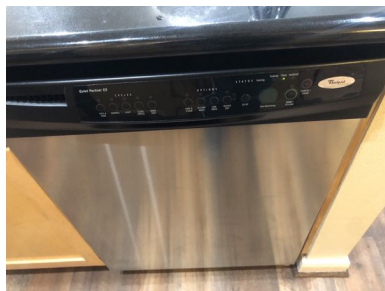
The dishwasher was functioning and responded to the controls. The unit was run through a cycle at the time of the inspection and appeared to be operating properly.

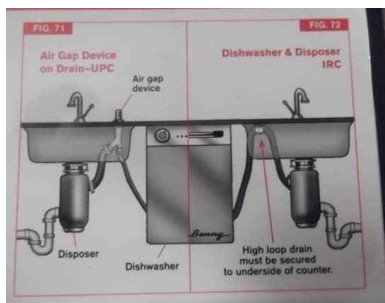
The drain line under the sink was looped up so that the top of the loop was higher than the point where the drain line connected to the disposal. This will help to prevent garbage from running down the drain line into the dishwasher.

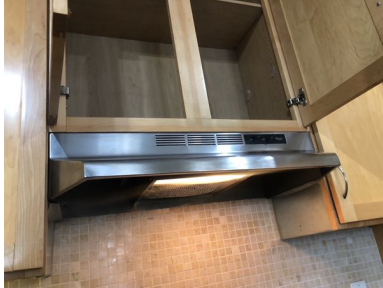
The recirculating vent fan was operating and responded to the controls at the time of the inspection. It is pointed out that the equipment does not vent to the outside, but rather filters the air through a grease filter and vents the air back into the kitchen.

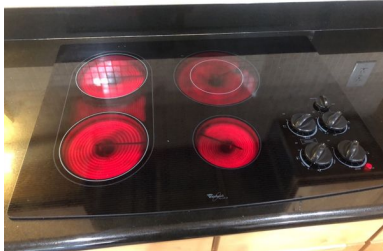
The electric cooktop was functional at the time of the inspection and responded to the controls. All of the elements and controls were operational at the time of the inspection.

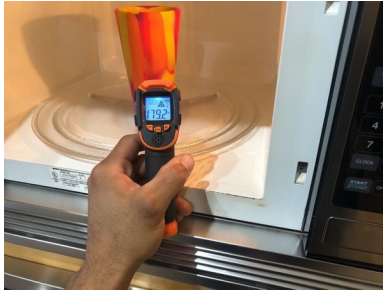
No items requiring repair were visible at the time of the inspection for the heating operation of the microwave. A cup of water was placed in the unit, and the microwave heated the water adequately. It is pointed out that the unit was not checked for microwave leakage.

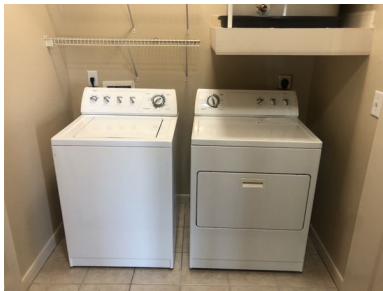
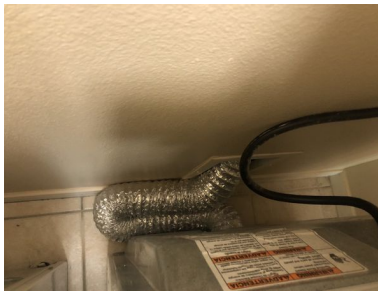
The vent was connected to the dryer but was not tested. It is recommended that the vent be checked for an excess of lint and that it be cleaned if necessary. (Information)
