Goodspeed Inspection Services, Inc.

Alison McGallion

1725 Ave N 1/2
Galveston TX 77550

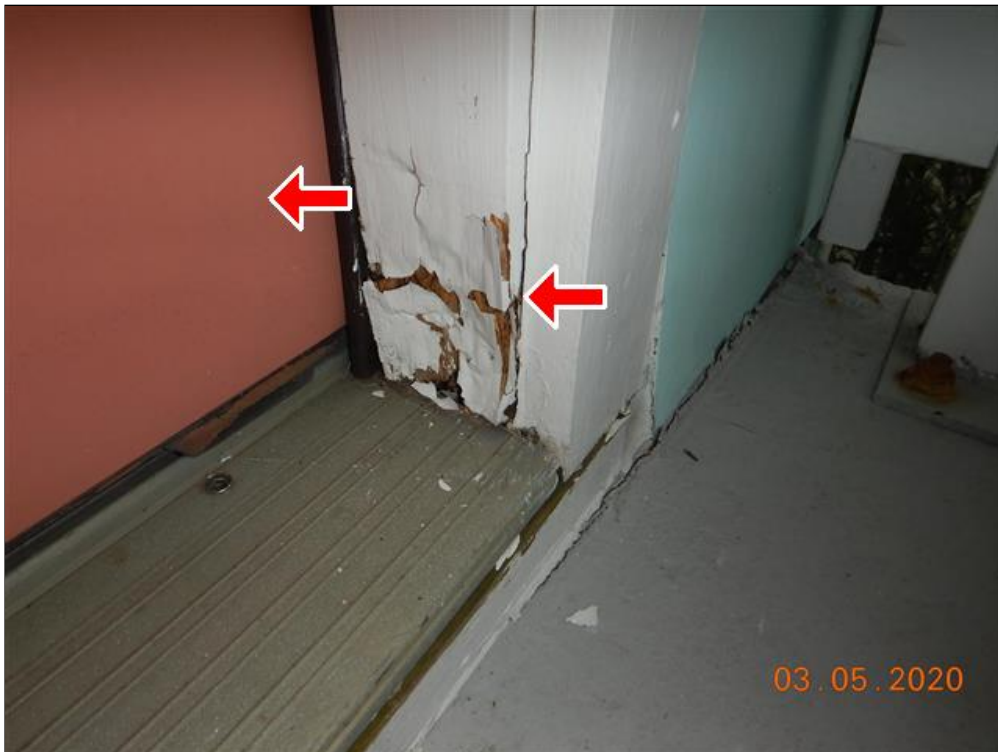
6.1 Item 1(Picture)

(2) D - Excessive wood rot to Exterior front door and Jamb(s) . Recommend full evaluation by qualified specialist to determine exact cause and repair needed - prior to the end of the Buyers Option Period.

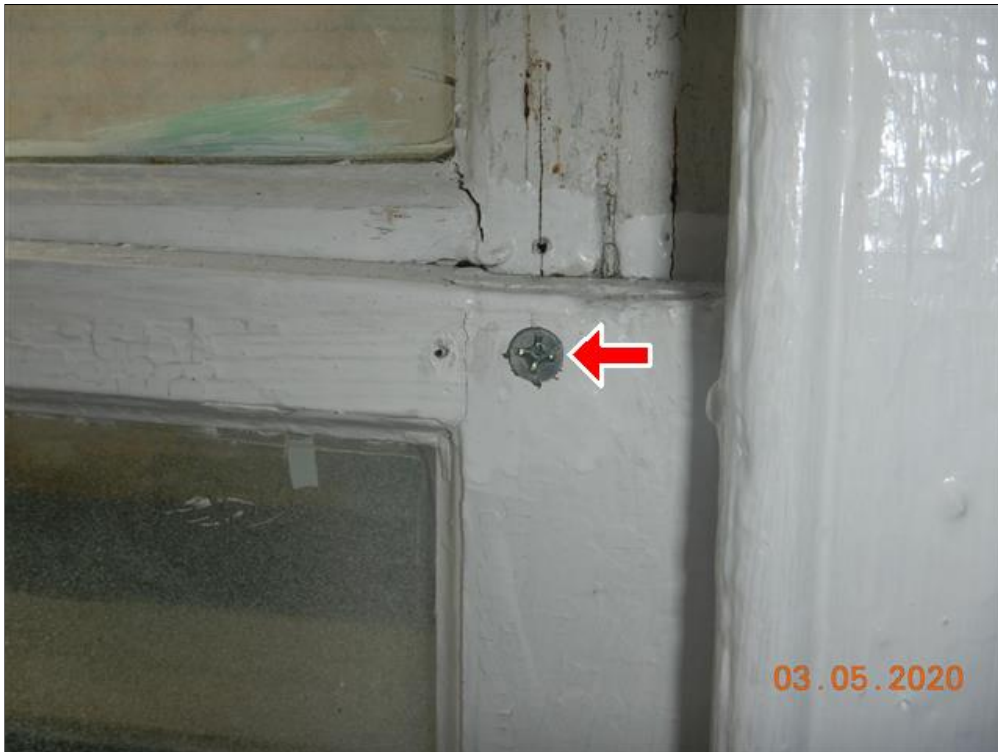
6.4 Item 1(Picture)

(2) D - Non opening windows in bedroom # 2. Egress(Exit) hazard in case of emergency. Recommend that these windows be replaced or repaired to allow emergency exit prior to occupancy of house.

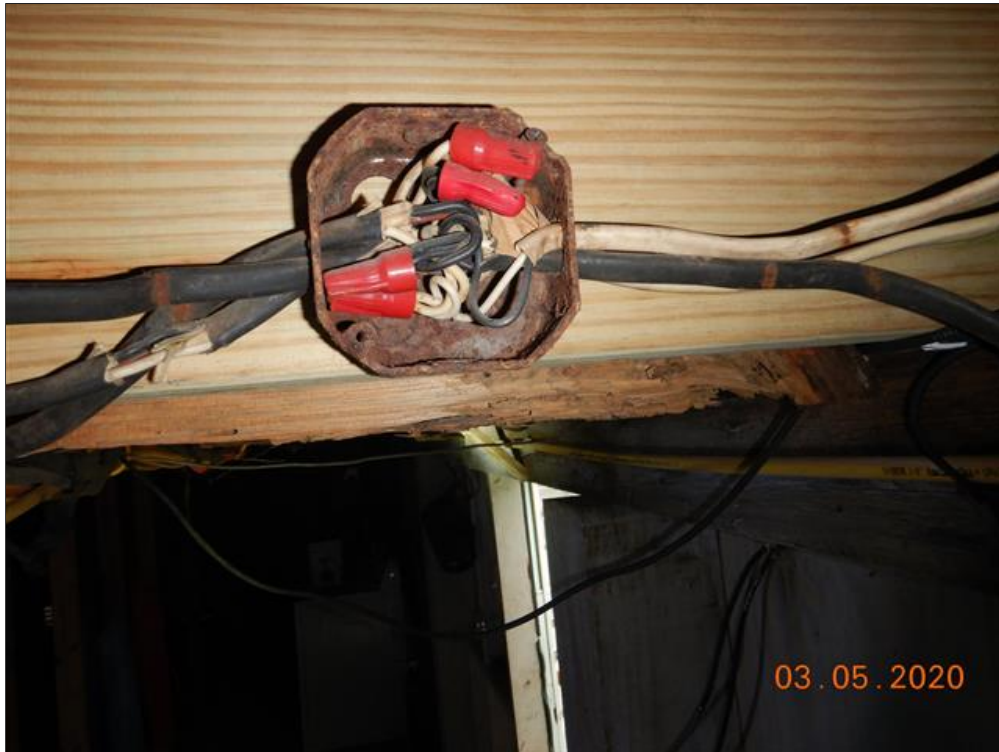
10.0 Item 1(Picture)

(1) D - Due to overall conditions it is recommended that the entire electrical system be fully evaluated by qualified electrician.

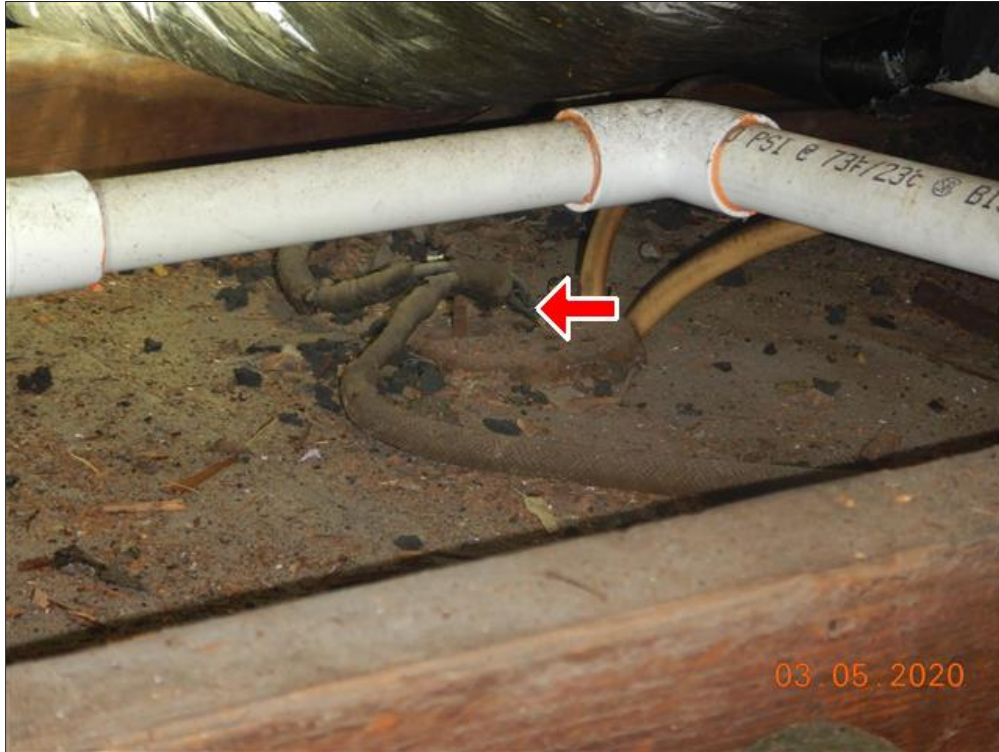
10.0 Item 5(Picture)

(5) D - Open wire splices in attic above bathroom, Electrical Fire Hazard.

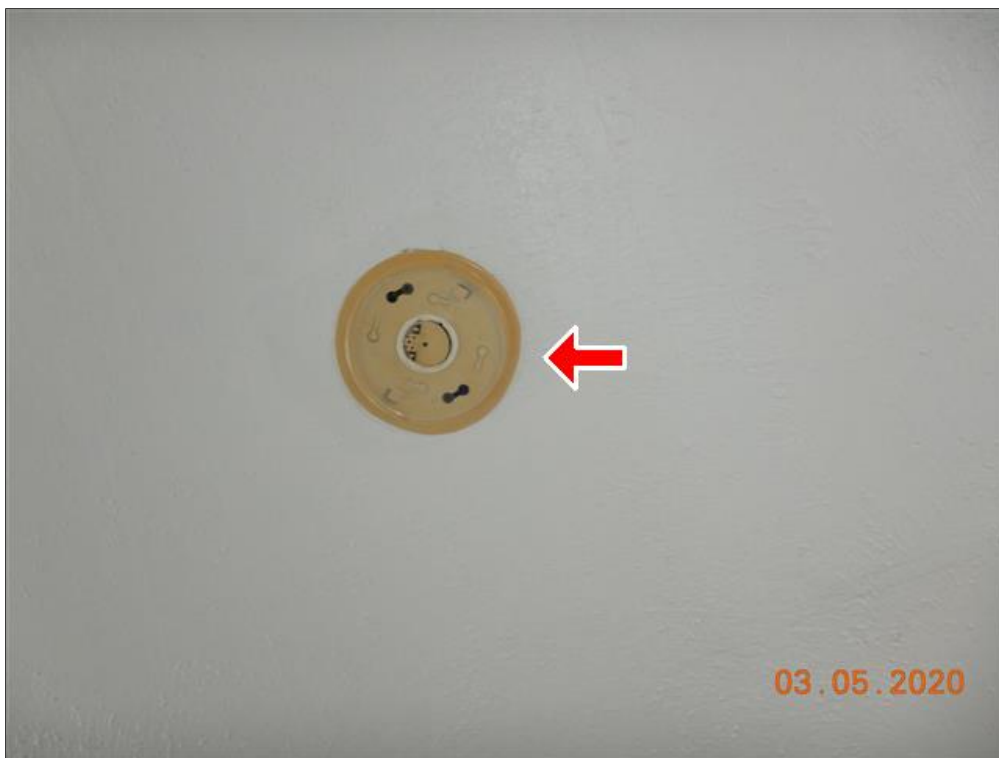
10.6 Item 2(Picture)

(2) D - Carbon Monoxide Detectors are not installed as required per current codes. Carbon Monoxide Detectors are recommended inside sleeping areas of house and a minimum of one per floor. While no evaluation was made regarding the present or potential carbon monoxide levels in the home nor was a comprehensive backdrafting test performed on the mechanical systems. Carbon monoxide and gas detectors are also recommended for houses with fuel burning appliances, fireplaces or attached garages at least one per level in sleeping areas of the house. Any installed systems should be checked/services at least monthly. See <http://www.epa.gov/iaq/pubs/coftsht.html#Carbon%20Monoxide%20Can%20Be%20Deadly>.

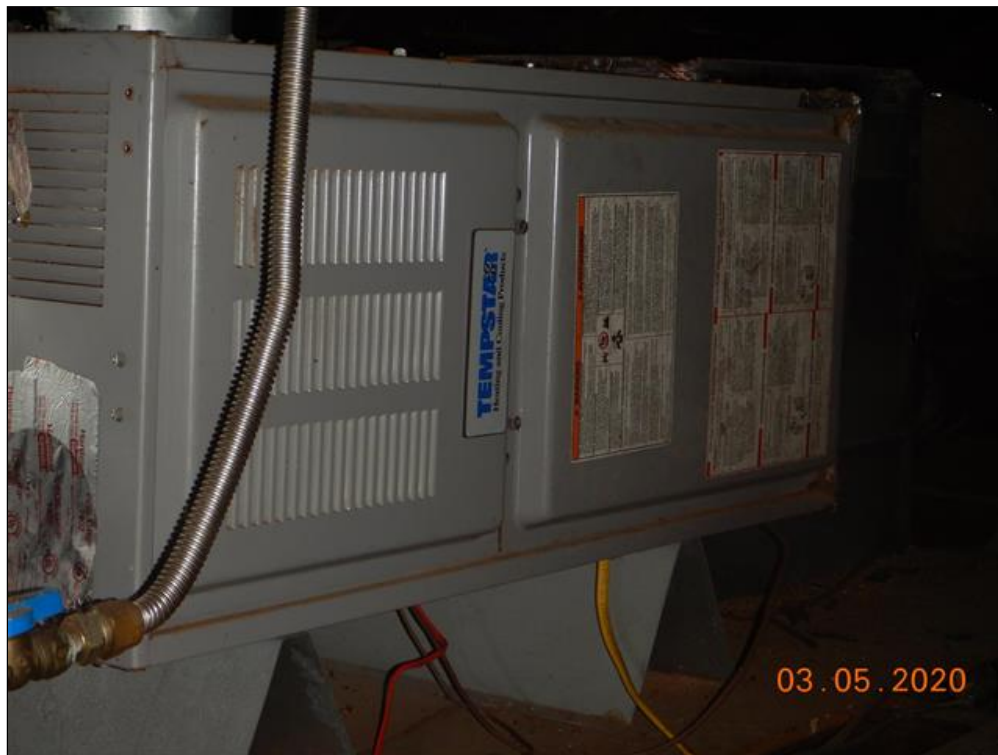
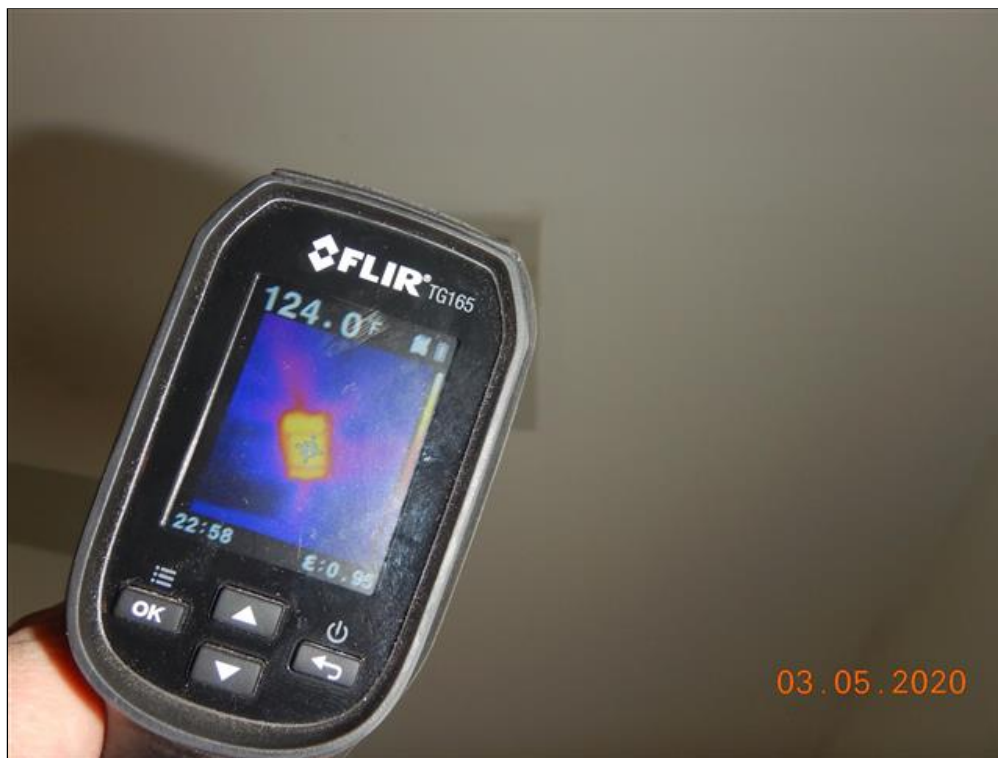
11.0 Item 1(Picture)

Heating System - Approximate age as determined by the manufactures label plate - if found. See Age Note.: 8 - 9 +- years old

C - The heat exchanger which is a metal chamber is the major component of a furnace. Most or all of this metal chamber is not readily visible to a home inspector - assessment of a furnace is limited to operational conditions. The probability of failure increases as the unit becomes older. Advise a qualified HVAC contractor do a thorough inspection for full evaluation of heat exchanger conditions - particularly if the unit is beyond 10 years plus old or any ware is exhibited.

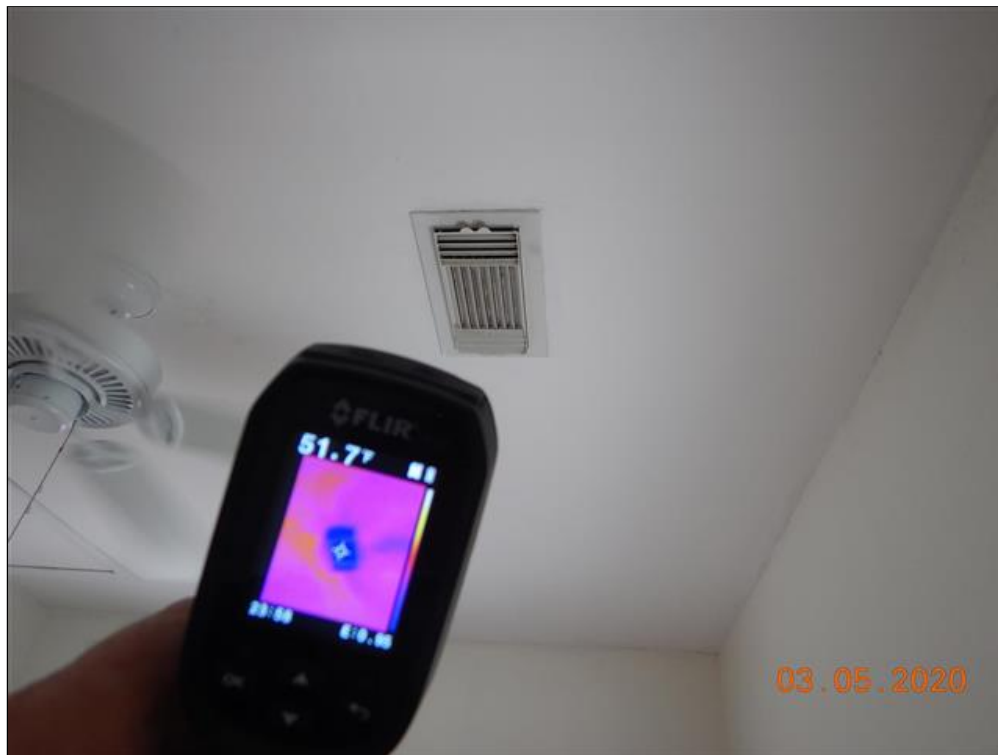
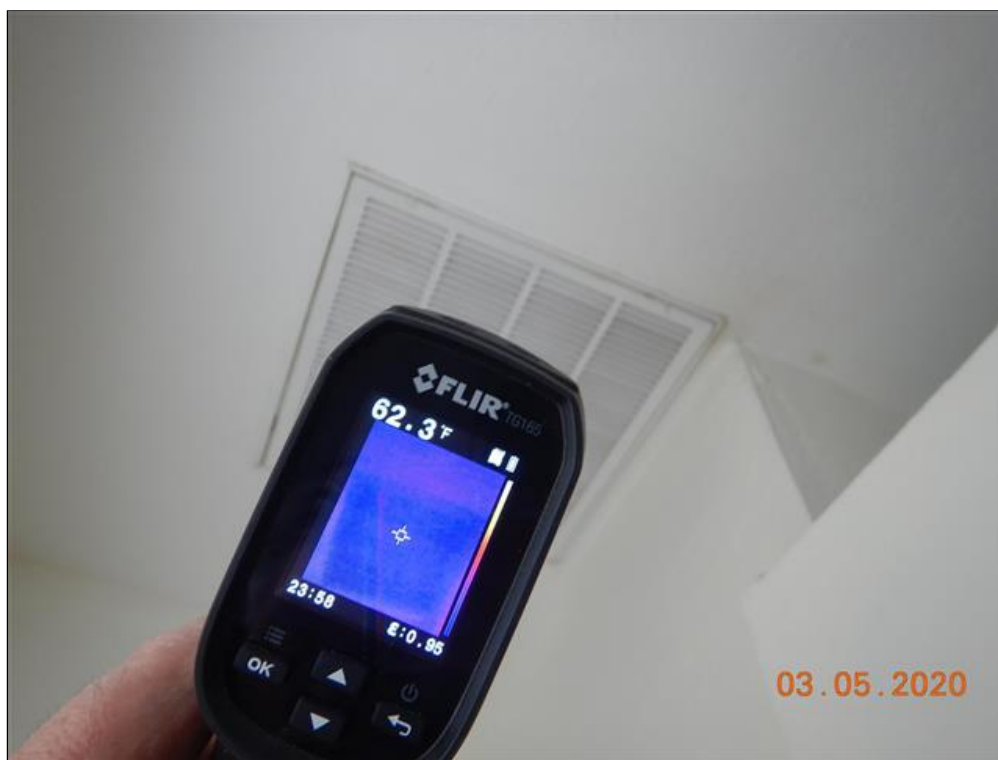
11.3 Item 1(Picture)

D - Cooling system appears to not be functioning properly, 11 deg."Delta t" - normal" Delta t" is 15 - 20 deg. Supply air temperature was 51 deg. +-, Return air temperature was 62 deg.+-. The cause of this possible defect is not determinable as part of a Limited Time & Scope Inspection Ii is recommended that the HVAC system be cleaned and serviced by a qualified HVAC contractor prior to closing to repair all possible defects. Note: Recording the temperature differential is just one of the ways suggested by T.R.E.C. to determine proper operation of a cooling system without using specialized equipment or cutting holes into the HVAC system, the ."Delta t" is in no way the only means of testing the system. If the client feels that further evaluation is needed please contact a HVAC contractor prior to end of Option Period. The temperature differential is determined normally by recording the difference in temperature in front of the evaporator coil and behind the evaporator coil in the attic, this is the temperature of the air coming from the house and the temperature of the air going back into the house after it has been cooled. The generally recognized industry standard is a temperature difference (DT) of 15 - 20 degrees +- 2 deg. , this can vary and has many controlling factors. If a high or low DT is noted it is recommended that a qualified professional HVAC contractor evaluate the system for possible needed repairs.

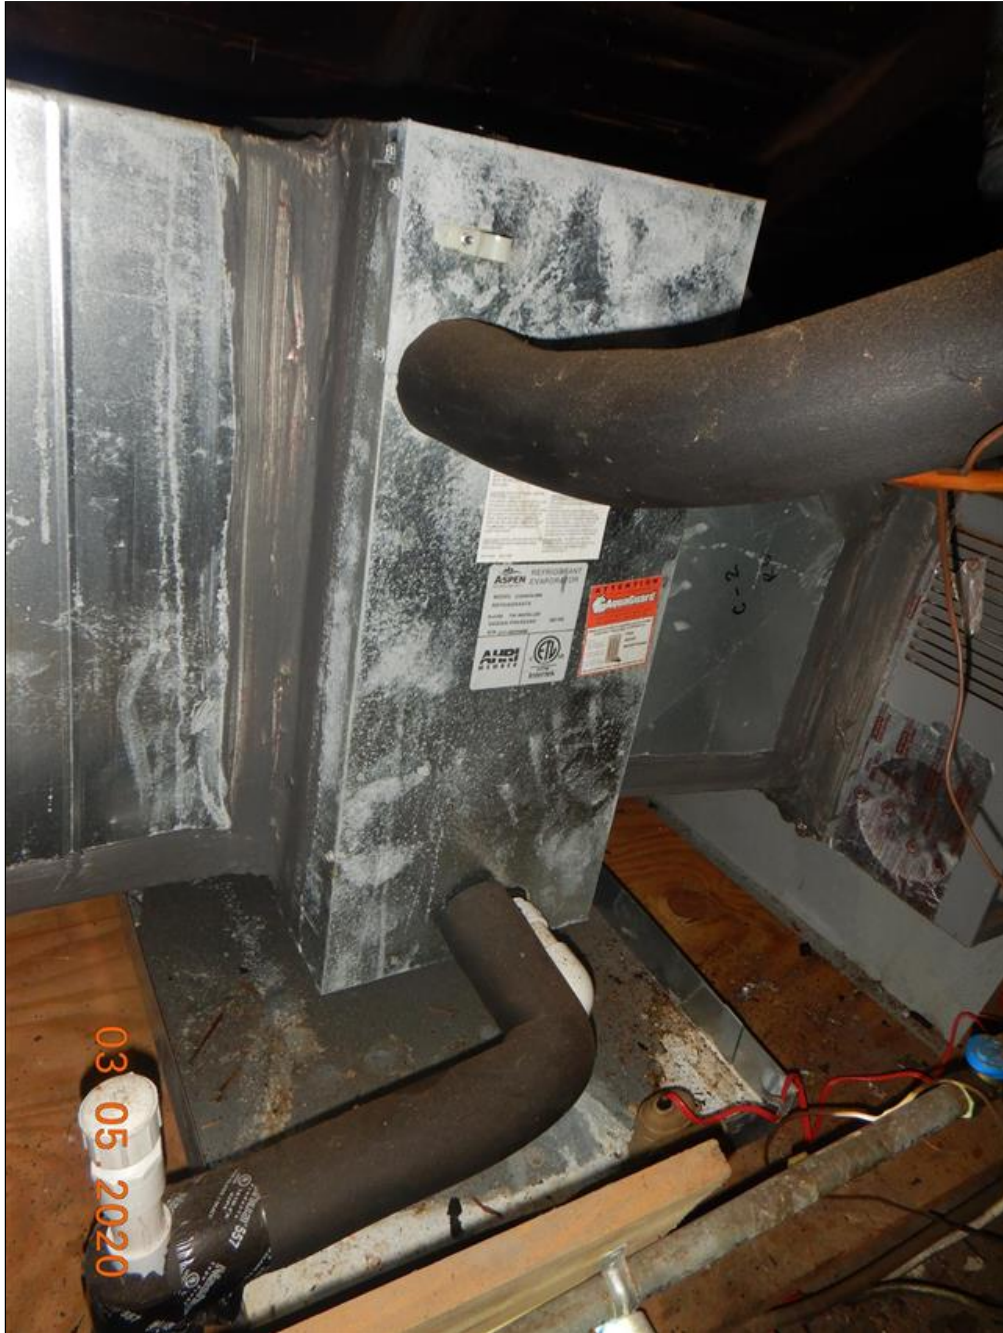
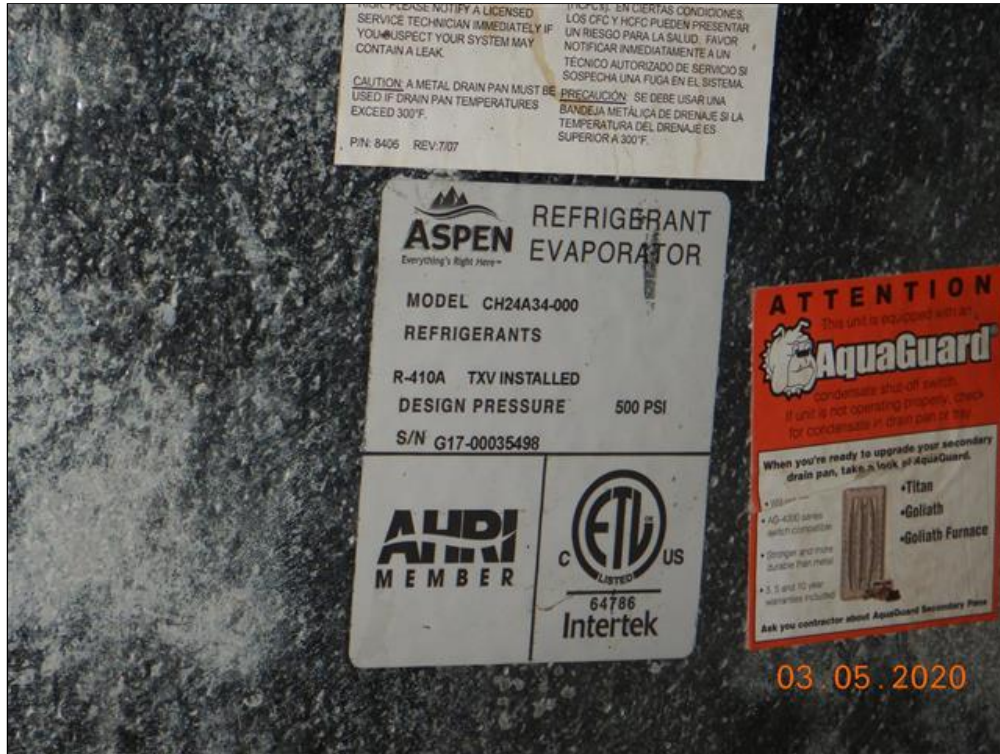
11.4 Item 1(Picture)

Location of Unit - a/c emergency overflow termination: Not above window as required by codes, Not found

C - Complimentary photo of the air conditioning emergency overflow drain pipe termination point (usually above a window or door so as to be visible). Note: It is not normal for water to ever come from any of these pipes. It is an indication of a deficiency to the air conditioning system, i.e. primary or emergency air conditioning condensate pans. Water dripping from these pipes is an indication of a malfunctioning air conditioning system that could lead to water damage into the house. If water is evident from one of these pipes it is recommended to immediately turn off the air conditioning system and call a air conditioning contractor as soon a possible.

The primary condensate drain line(s) are terminated under a vanity sink (s). This is an acceptable termination point and is only noted to alert occupants that a dripping noise may be heard at times.

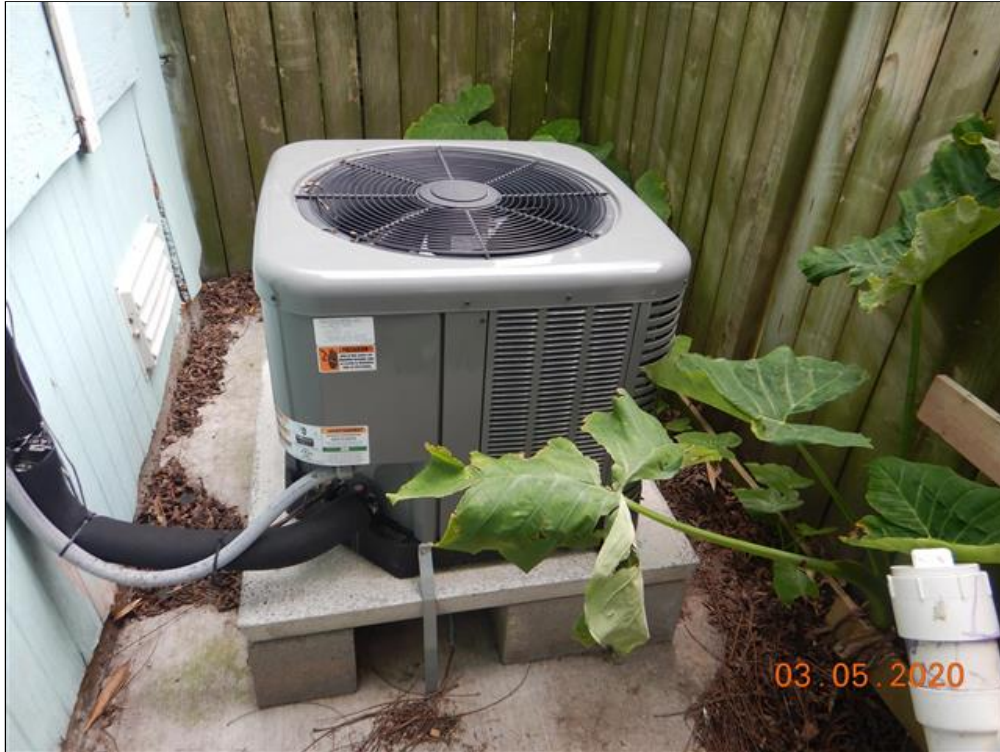
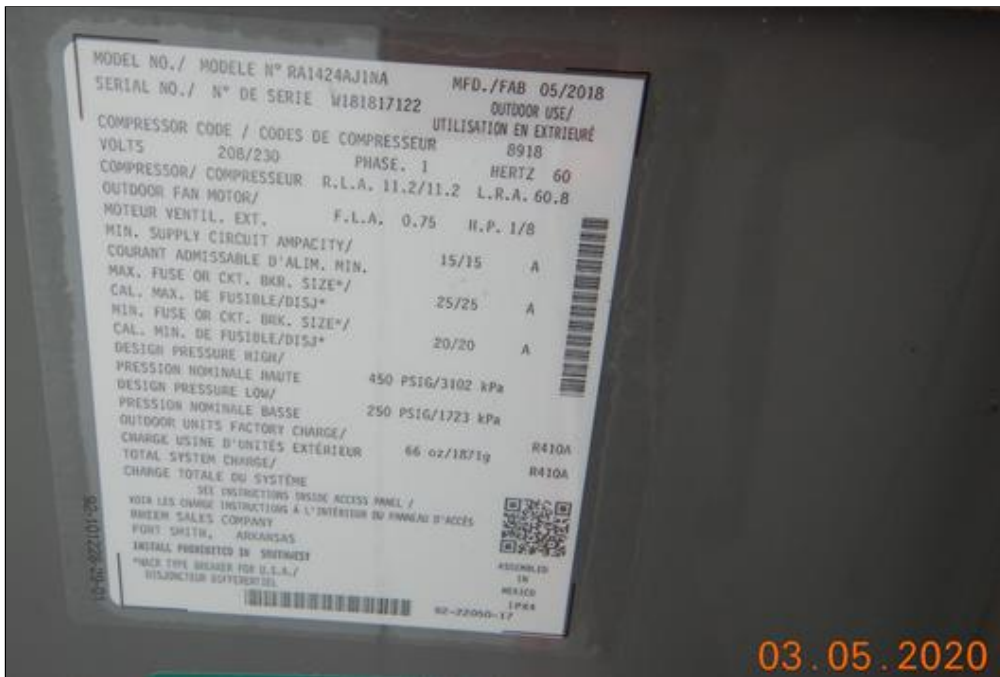
11.5 Item 1(Picture)

Condensing Unit - Approximate age as determined by the manufactures label plate - if found. See Age Note.: 2 - 4 +/- years old, 2018 +-

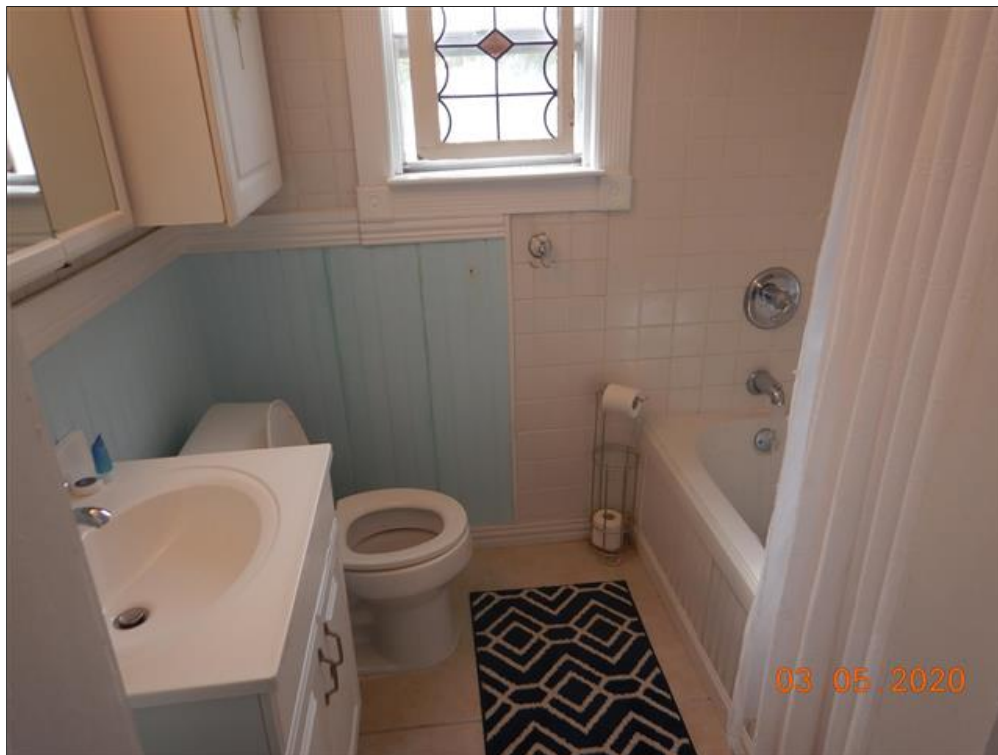
14.0 Item 1(Picture)

(2) D - Commode tank flapper valve is leaking with subsequent water leakage into bowl (Running Tank), condition will lead to excessive water usage and wasted water.

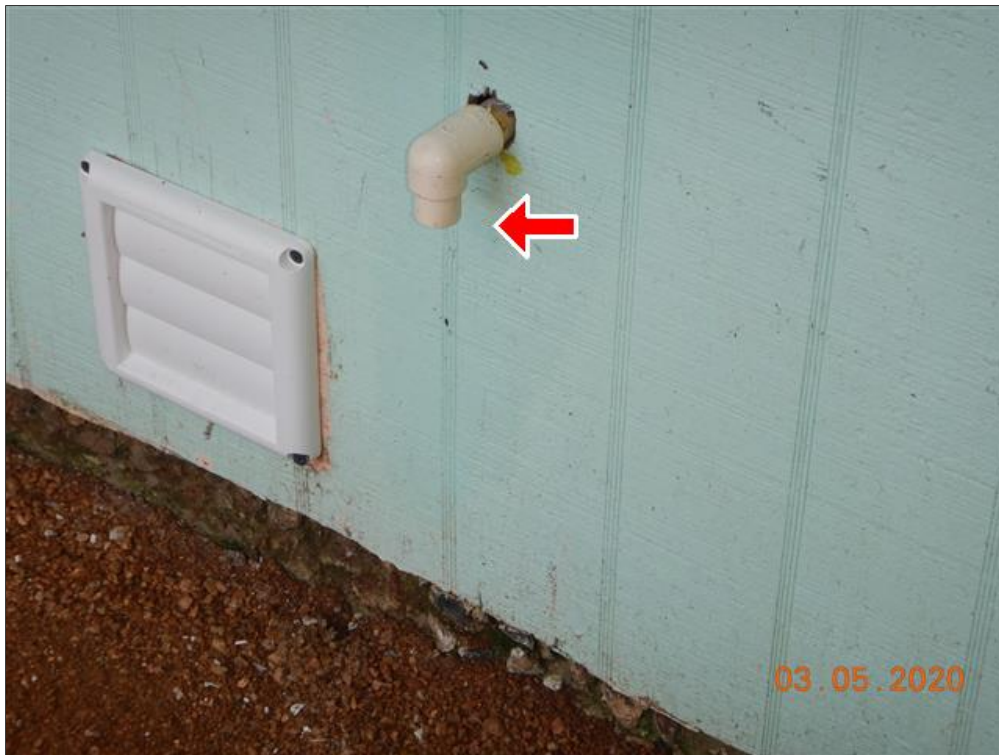
16.3 Item 1(Picture)

Note: It is not normal for water to ever come from one of these pipes. It is an indication of a deficiency to the water heater or pipes, i.e. Temperature Pressure Relief valve malfunction, tank or pipe leakage or some other defect. If water is evident from one of these pipes it is recommended to immediately turn off the water to the water hear and turn off the electric or gas to the water and call a plumber as soon a possible.

The TPRV should be tested annually, if found to be malfunctioning it should be replaced immediately by a qualified plumber.

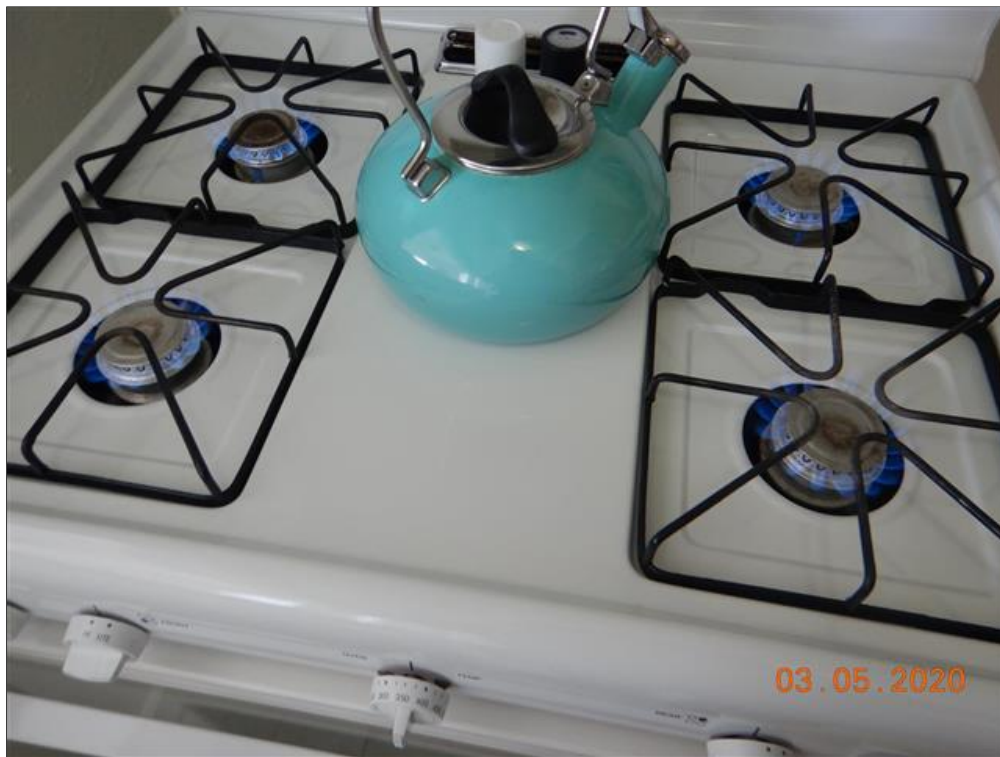
18.3 Item 1(Picture)

(2) D - No anti-tip device installed as required by most current code and Texas Real Estate Commission Standards of Practice. This device when installed properly will help prevent freestanding stove/oven from tipping forward causing a crushing accident.
