Inspection Report

Property Address:
8 Howell Ct
Beaumont TX 77706

PROPERTY INSPECTION REPORT FORM

Subash Behara	8/31/2023
<i>Name of Client</i>	<i>Date of Inspection</i>
8 Howell Ct, Beaumont, TX 77706	
<i>Address of Inspected Property</i>	
Joe Askew	TREC# 0010495
<i>Name of Inspector</i>	<i>TREC License #</i>
<i>Name of Sponsor (if applicable)</i>	<i>TREC License #</i>

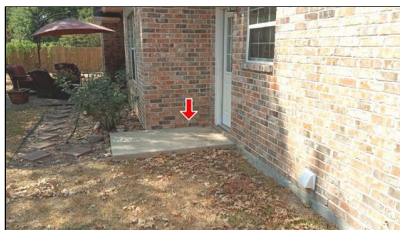
B. (Picture 3)

(4) The concrete at the left side back door was poured high in relation to the home. Current standards call for the bottom of brick veneer and/or siding to be elevated 4" to 6" above the surrounding grade.

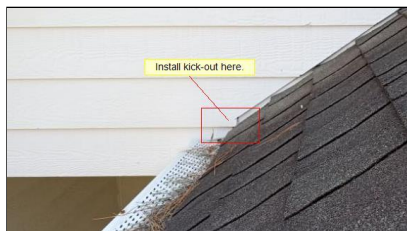
C. (Picture 10)

(5) Client may wish to install a kick-out flashing at the bottom of the roof-to-wall transition flashing above the right side of the front entry. See picture for example of kick out flashing.

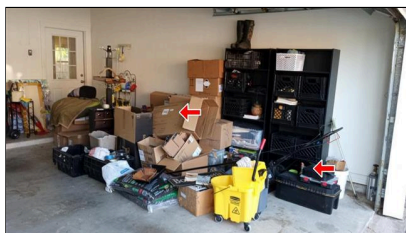
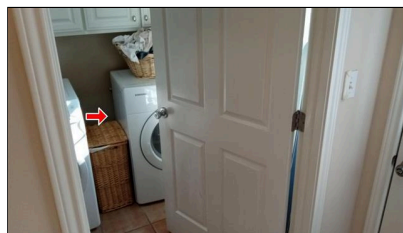
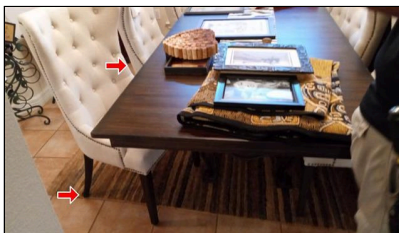
(1) The home/garage was filled with storage/belongings, blocking/preventing inspection of many areas. Items such as furniture, rugs, door mats, paintings, and wall coverings can conceal/obstruct large areas of the home. Storage areas such as cabinets and closets were also full. Client is encouraged to conduct a final walk-through once the home is empty.

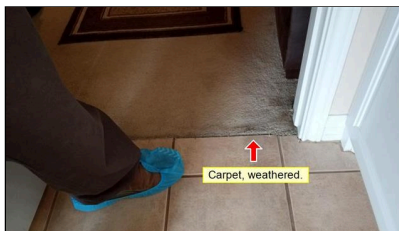
F. (Picture 2)

(2) Portions of the floor covering were weathered.

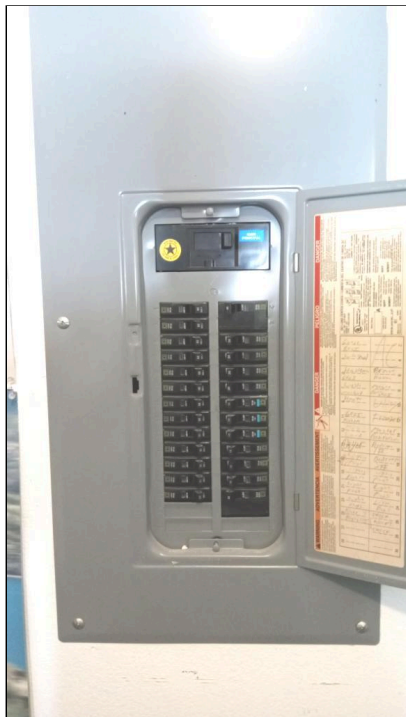
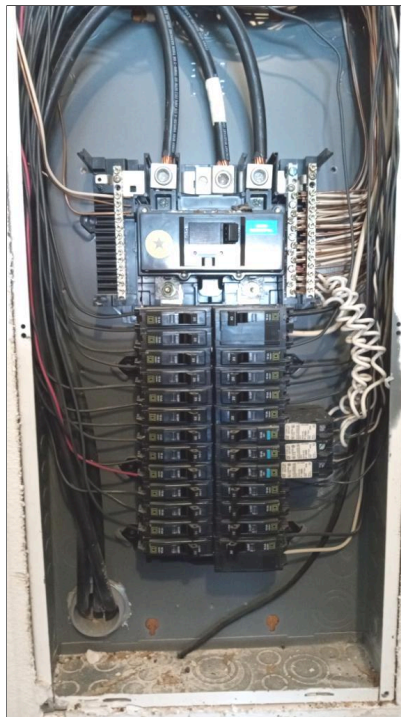
(1) A 200 amp panel box was noted in the garage.

(2) Some of the neutral wires were double-tapped at the bus bar. There should be one neutral wire per lug. Each grounded conductor shall terminate within the panel board in an individual terminal that is not also used for another conductor ref. NEC 2002 408.21, NEC 2005 408.41. Recommend correction as necessary by an electrical contractor.

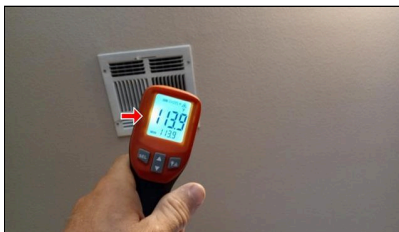
A. (Picture 1)

(1) Heating equipment operated within industry standards at time of inspection. When in heating mode the supply temperature read 113 and the return temperature read 79, indicating a difference of 34. Normal differential is between 30 to 50 degrees. NOTE: *A complete evaluation of the heat exchanger in gas fired heating appliances requires dismantling of the heater and is beyond the scope of visual inspection.*

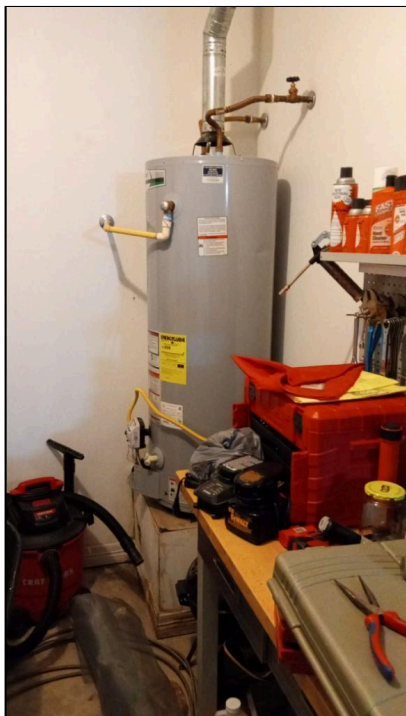
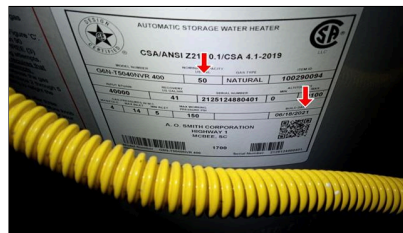
- (2) The water heater was installed without a catch pan/drain. Client may wish to add.
- (3) Part of the flue pipe for the water heater was separated. Recommend having corrected by a qualified contractor.

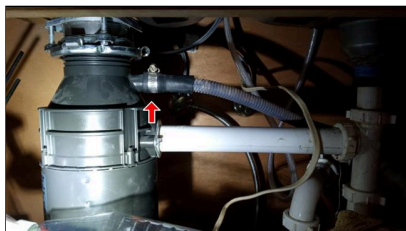
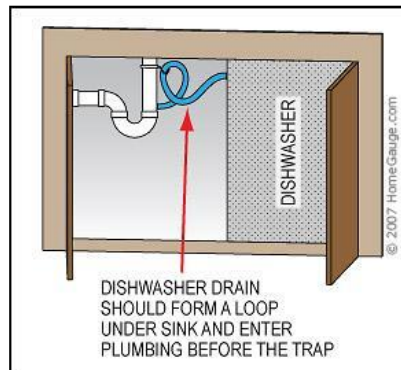
The drain line for the dishwasher should be installed with a loop or an anti-siphon device per TREC recommendations- (easy fix, see illustration).
