Invasive Stucco Inspection

Brooke Sankey
904 W 18th St Unit D
Houston, TX 77008

October 12, 2021

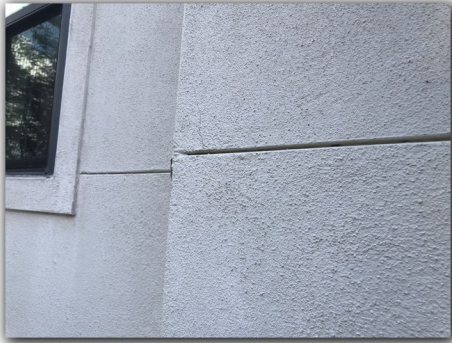
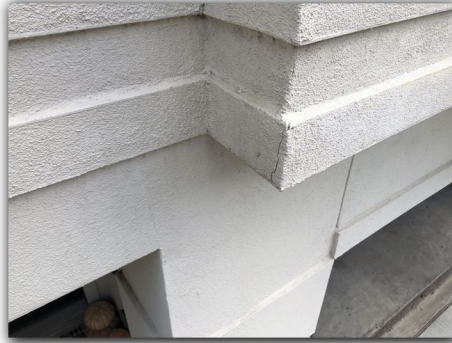
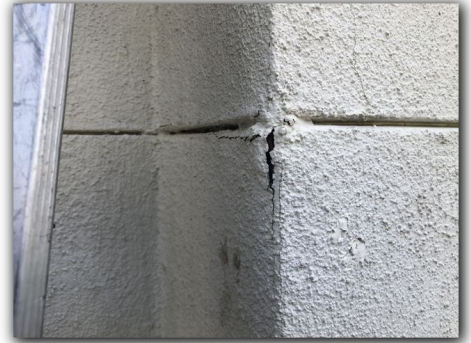
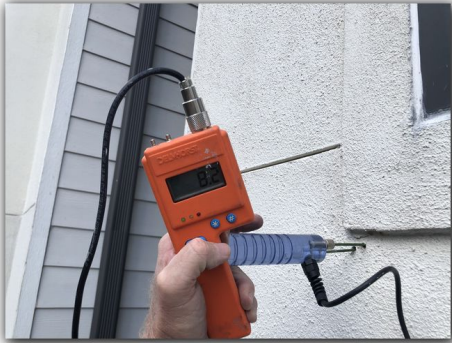
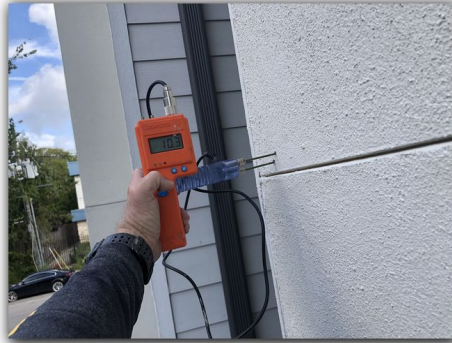
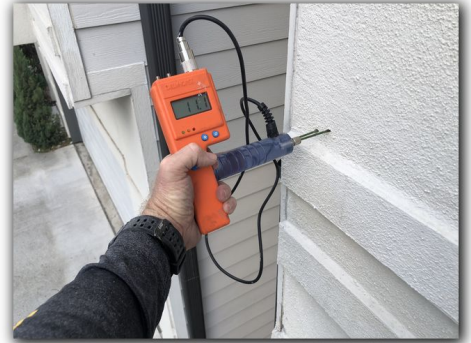
Location	Moisture Reading	Substrate Condition	Observations / Comments
1	Low	Firm	Cracks and deteriorated sealant
2	Low	Firm	
3	Low	Firm	
4-5	Low	Firm	Deteriorated/missing sealant
6-7	Mid Range	Semi Soft - Damage	Cracks and deteriorated sealant
8	High	Soft - Damage	"
9-10	Mid Range	Semi Soft - Damage	Missing weep screed/Missing diverter/end dam flashing/Deteriorated/missing sealant
11	High	Soft - Damage	"

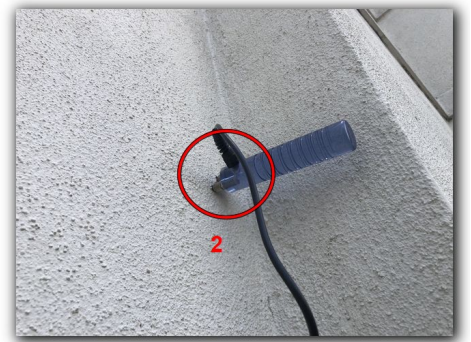
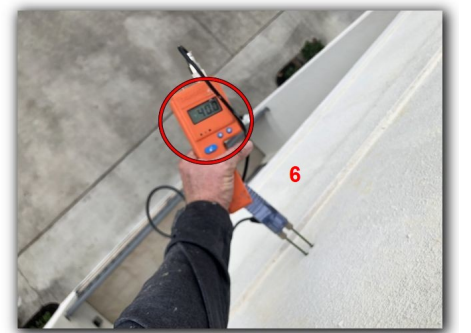
Front Elevation 2

Location	Moisture Reading	Substrate Condition	Observations / Comments
1	Low	Firm	
2	High	Soft - Damage	Cracks and deteriorated sealant
3	Mid Range	Semi Soft - Damage	Cracks and sealant missing
4-5	Mid Range	Semi Soft - Damage	Missing weep screed/Cracks and deteriorated sealant
6	High	Soft - Damage	"
7	Mid Range	Semi Soft - Damage	"
8	Mid Range	Semi Soft - Damage	"
9	High	Soft - Damage	"

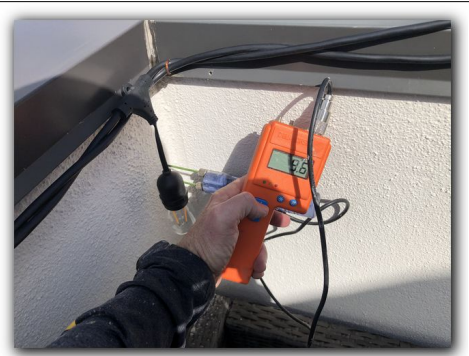
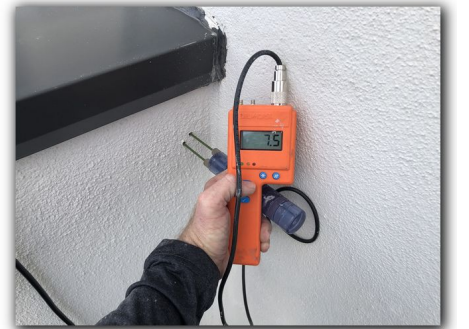
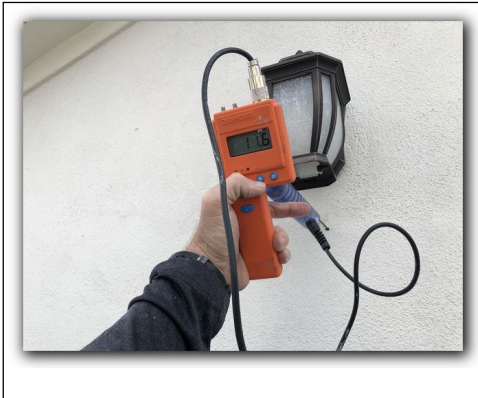
Roof Top 1

Location	Moisture Reading	Substrate Condition	Observations / Comments
1	Low	Firm	Deteriorated/missing sealant
2	Low	Firm	Deteriorated/missing sealant
3	Low	Firm
