**Seller's Disclosure Packet**  
**115 Colonel Drive**

CONCERNING THE PROPERTY AT 115 Colonel Drive, Richmond, TX 77469  
(Street Address and City)

Report Identification: 115 Colonel Dr, Richmond, TX 77469 - May 26, 2022

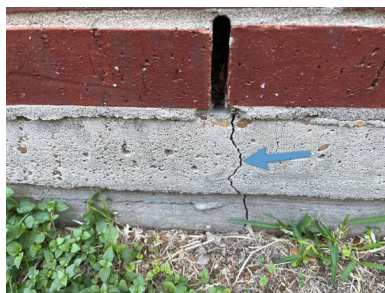
**2: Common Foundation Wall Cracks**

Cracks were observed in the foundation wall at one or more locations. This is a common occurrence as the home settles. Recommend monitoring for further shifting/displacement.

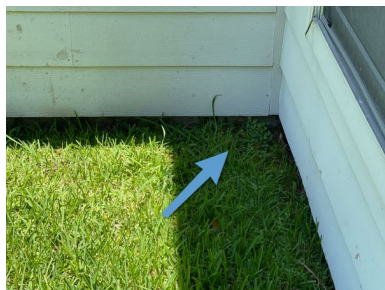
**5: Areas of pooling or possible pooling water**

There are areas of pooling or possible pooling water near the foundation at one or more locations. The grading may need to be improved to ensure proper moisture runoff in those areas.

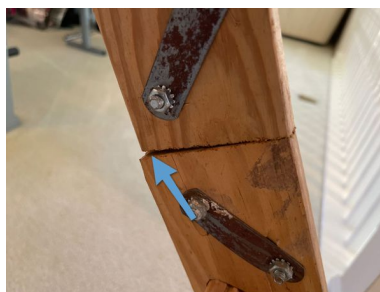
**1: Attic ladder improperly cut**

The attic ladder is improperly installed. It appears the ladder is not cut to the proper length causing it buckle at the lower hinge. This can reduce the load bearing capacity of the ladder.

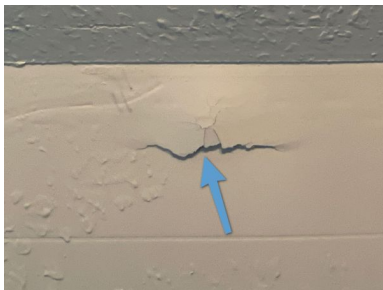
There are cracks on the ceilings. This can be caused by expansion and contraction of construction materials and/or structural movement. Repair as necessary.

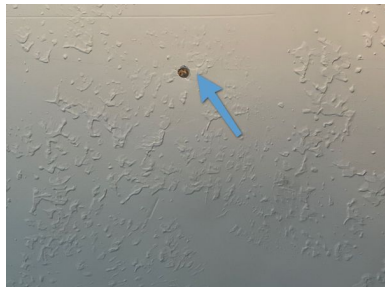
**2: Ceiling Nail Pops**

There are nails backing out of the ceilings at one or more locations. This is a common occurrence usually related to expansion and contraction of the roof rafters and/or seasonal structural movement.

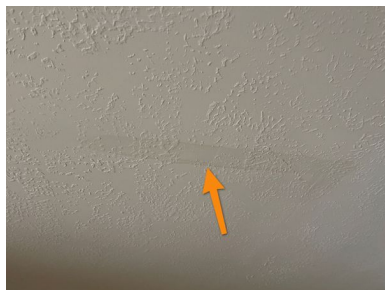
### 3: Ceiling Water Stains

Water stains were observed on the ceiling at one or more locations. This may indicate previous moisture penetration in that area. The extent of damage, if any, is beyond the scope of this inspection. Further information from the home owner and further evaluation of the water stain is recommended.

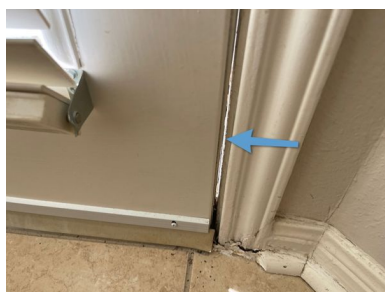
**3: Weatherstripping Insufficient**

Door is missing standard weather stripping. This can result in significant energy loss and moisture intrusion. Recommend installation of standard weatherstripping.

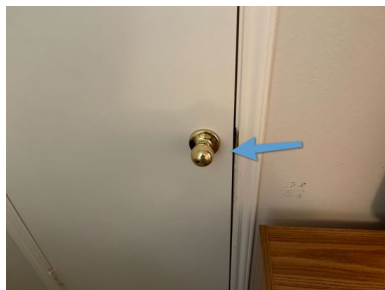
One or more doors do not latch when closed. This appears to be due normal movement and minor adjustment is needed.

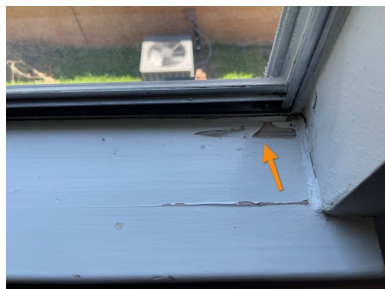
There is evidence of moisture condensation pooling on the window stools in one or more locations. This may be caused by temperature differences at the window frames, typically during the winter when it is warm inside and cold outside. Repair as desired.

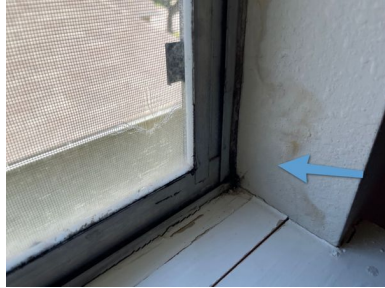
**2: Water stains window returns**

The window stool caps are delaminated at one or more locations. This commonly occurs as a result of moisture penetration and/or as a result of condensation forming on the window frames and wicking into the stool cap. In some cases this may indicate a hidden leak. Repair or replace as necessary.

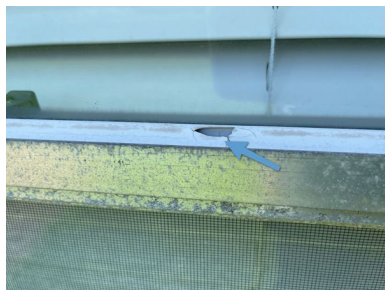
The window glazing bead is loose and/or damaged at one or more locations. The Snap-In Vinyl Glazing Bead is a cosmetic feature used on aluminum windows between the glass and outer channel. When a glazing bead is "snapped-in", all that remains visible is a "bead" that leaves the window with a neat, clean sight line. Glazing beads can be replaced if necessary.

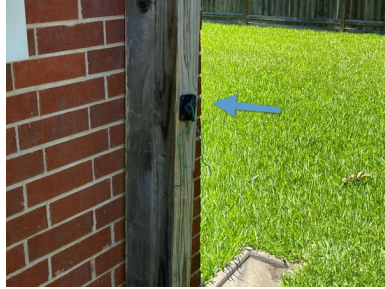
The fence gate is difficult to shut/latch. Minor adjustments are needed to allow for proper operation.

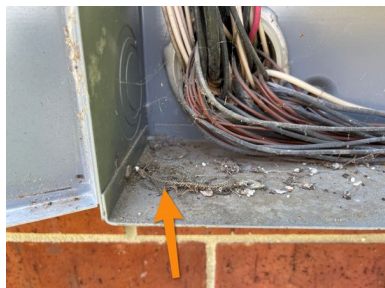
**4: No arc-fault protection installed**

There are no arc-fault protection devices installed at the electrical panel. These may not be required in every jurisdiction but are recommended to prevent shock and fire hazards. The installation of arc-fault breakers is reflected in the 2015 International Residential Code: E3902.16 Arc-fault circuit-interrupter protection. Branch circuits that supply 120-volt, single-phase, 15- and 20-ampere outlets installed in kitchens, family rooms, dining rooms, living rooms, parlors, libraries, dens, bedrooms, sun-rooms, recreations rooms, closets, hallways, laundry areas and similar rooms or areas shall be protected.

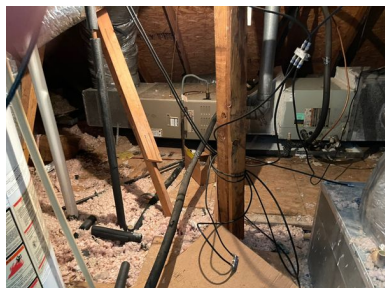
**Cabinet sealed shut:**

The air handling cabinet in the attic was sealed shut at the time of the inspection. Cutting any permanent sealant is beyond the scope of this inspection. Therefore the air handler could not be uncovered. The cover should be removed and the internal parts of the air handler should be evaluated before closing.

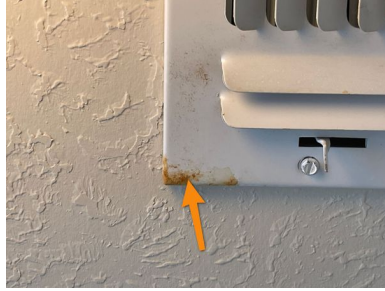
**1: Grime/rust on registers**

There is a buildup of grime on the air diffusers, registers, and inside the ducts. This commonly occurs when the cooling equipment is under performing or oversized and not dehumidifying the air as intended. This allows moisture to condense on duct equipment. Moisture mixes with dust and dirt creating a build up of grime. This can also result in fungal growth. The ducts and registers should be inspected and cleaned as

necessary by a professional duct cleaning contractor.

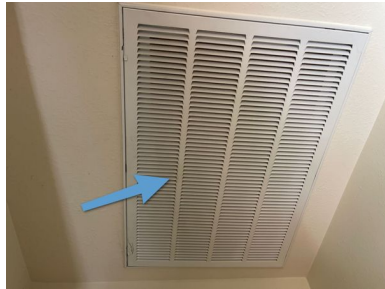
**2: Dirty air filter**

The air filter is dirty. Replacement is recommended.

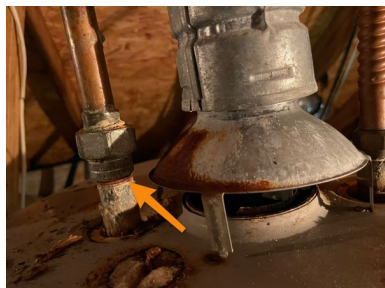
**3: Observable Rust**

One or more observable rust spots were present at the water heater housing. This is typical of units that are nearing the end of their life expectancy. Further evaluation and/or repair by a licensed plumber is advised.

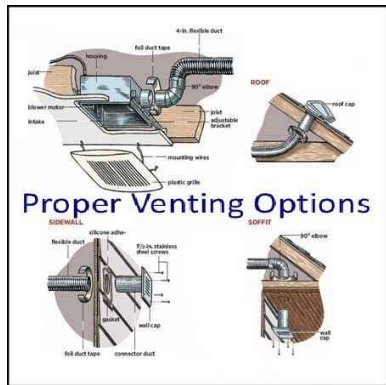
The mechanical exhaust fans vent into the soffit. The fans should vent outside to prevent moist air buildup in the attic. Venting to the soffit was common practice when this house was built. Standards changed to require the vents to terminate outside the building envelope. Later standards were further clarified to require the vents to be directly vented to the exterior. Vents terminating into the soffit can result in back drafting and

possible moisture damage to the soffit boards. This standard is reflected in the 2015 International Residential Code as follows: M1501.1 Outdoor discharge. The air removed by every mechanical exhaust system shall be discharged to the outdoors in accordance with Section M1506.3. Air shall not be exhausted into an attic, soffit, ridge vent or crawl space.

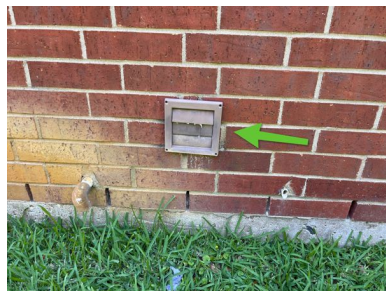
*Photo - Vent Termination:*

**1: Dryer vent lint accumulation**  
**▲Code/Safety Concerns**

Lint accumulation was observed in the dryer vent cover. This may indicate the vent and/or cover need to be cleaned. Lint accumulations can obstruct air flow and reduce dryer performance. Additionally, dryer vent obstructions are a fire hazard. It is recommend the vent be cleaned to ensure proper performance.

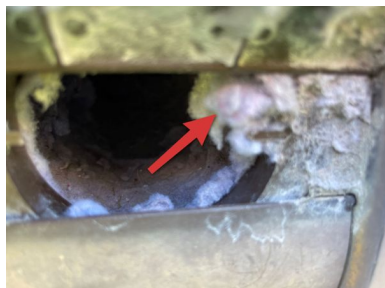
**2: Vent is not sealed to the wall**

The dryer vent is not sealed to the exterior wall covering. The cover should be sealed to the wall covering to help prevent moisture and/or pest intrusion.
