FIG Services LLC d/b/a FOX INSPECTION GROUP

Property Inspection Report #10/21/20231815 Auburn Trail
8616 Daffodil St. Houston, TX 77063

PROPERTY INSPECTION REPORT FORM

1815 Auburn Trail, Sugar Land, TX 77479

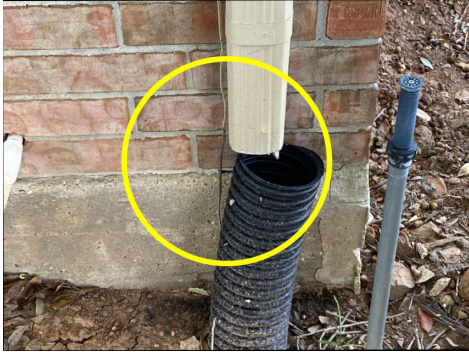
Downspout needs to be better connected to the drain system at north exterior wall.

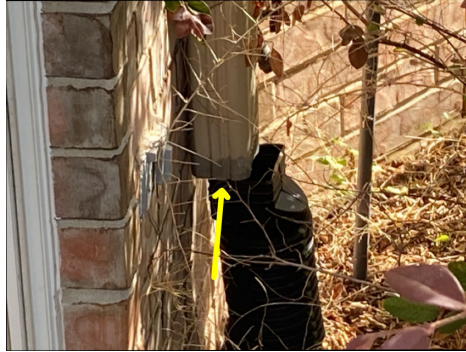
Downspout needs to be better connected to the drain system at one or more locations.

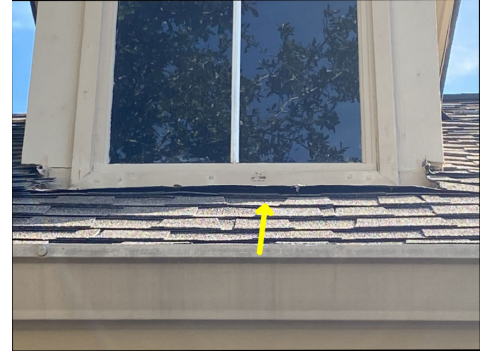
Lower edge of flashing not sealed.

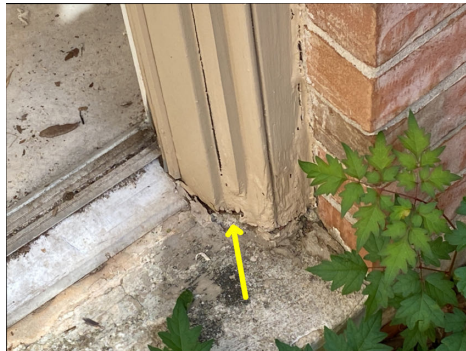
Wood rot of lower door and/or jamb; garage east door

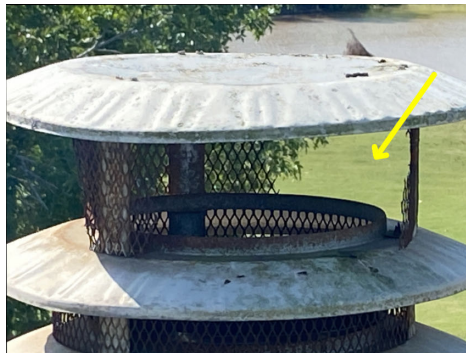
Storm collar needs caulking on the chimney.

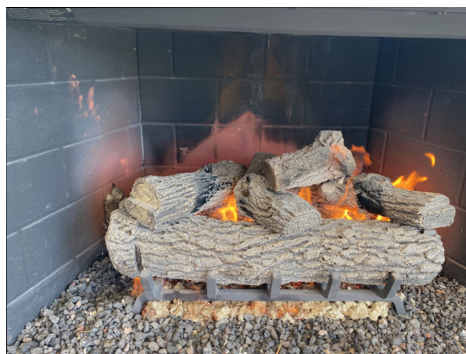
Inadequate sized non-combustible hearth extension at sides of the fireplace.

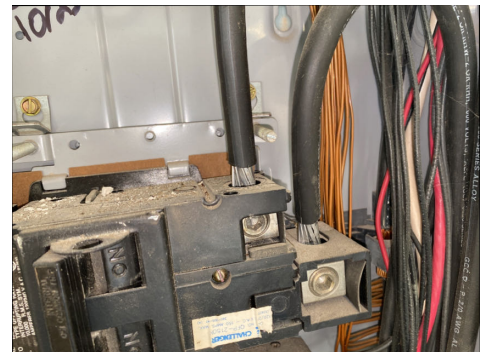
Aluminum feeder wires at main panel in garage

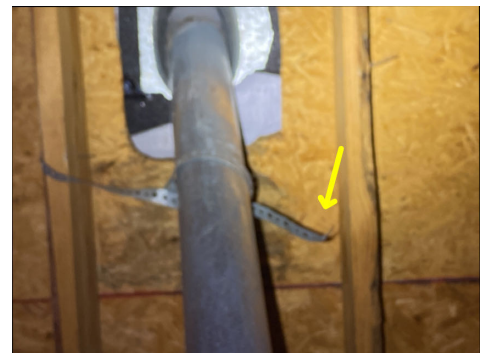
Vent pipe(s) not properly secured (strapped) in place.

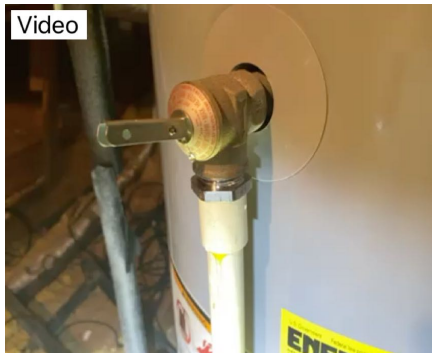
TPR valve leaks water when tested service/repair/replace as necessary.

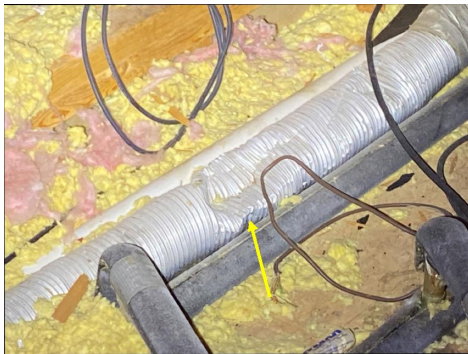
The exhaust duct is crimped/crushed in the attic.

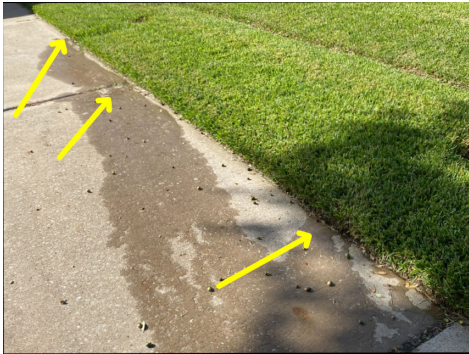
Zone 1 spray heads are clogged and / or grass has grown over head, blocking / preventing proper operation.
