**BPG Inspection, LLC**

**4601 Woodway Avenue  
Rosenberg TX 77471**

Client(s): Serrano  
Inspection Date: 9/27/2023  
Inspector: Silviu Stanescu , TREC #24311 (TX)

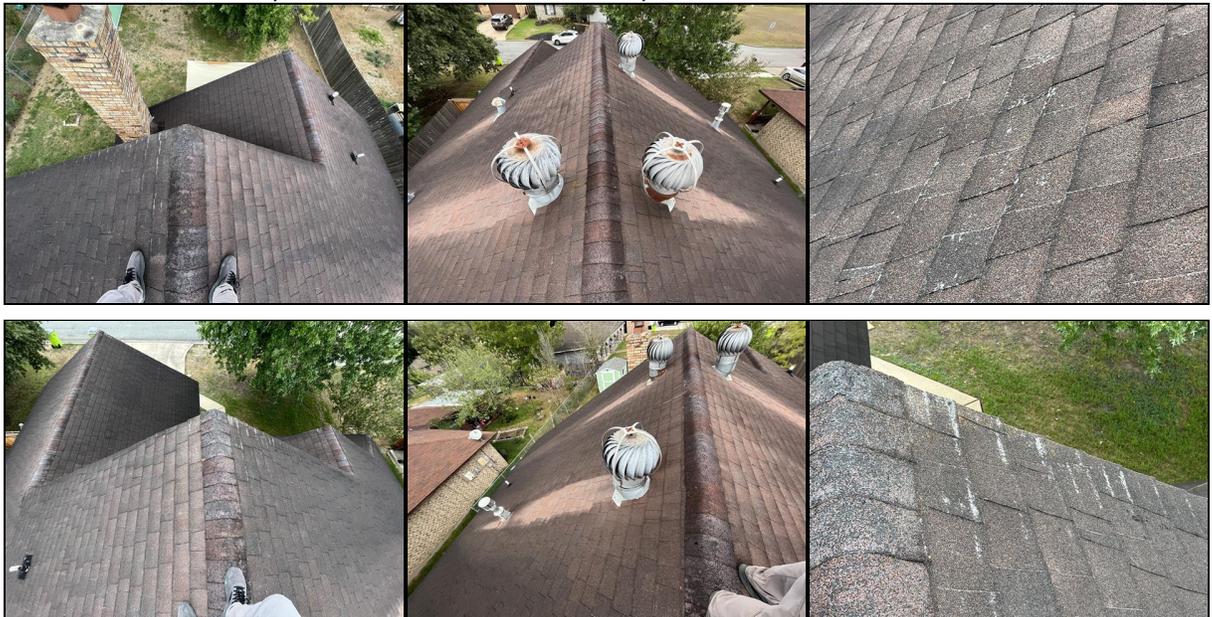
There were vent, counter or step flashings observed to be raised, improperly sealed and/or damaged. A qualified roofer should reseal and seal these roofing components as needed to prevent any future water penetration.

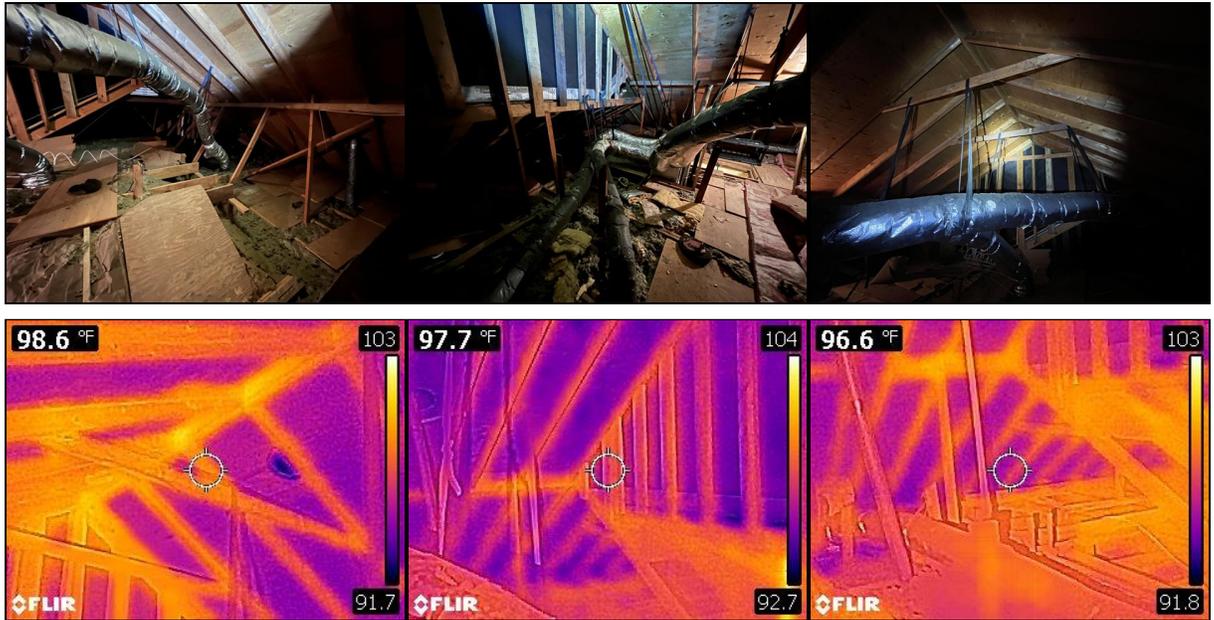
There was evidence of leaks in areas of the attic (flue pipe penetrations). It could not be determined if any areas of the deck require repair. Replacement of flashing, jackboots or parts of covering at these areas may be necessary to ensure it is leak free. Roofer should evaluate roof covering, deck and exterior flashings and jackboots for need of repair or replacement.

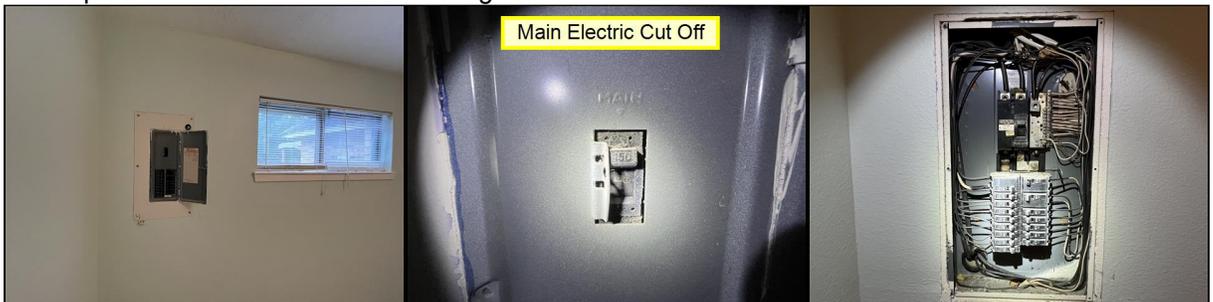
The main panel box is located in one of the guest bedrooms.

There are no Arc Fault Circuit Interrupt (AFCI) breakers present as called for by recent TREC reporting standards. AFCI breakers are used to protect living area branch circuits that are not GFCI (Ground Fault Circuit Interrupt) protected. These were not part of the building standards at the time of construction.

The aluminium service wires should be coated with anti-oxidation grease where they are stripped back to be connected to the mains, main or branch circuit breakers.

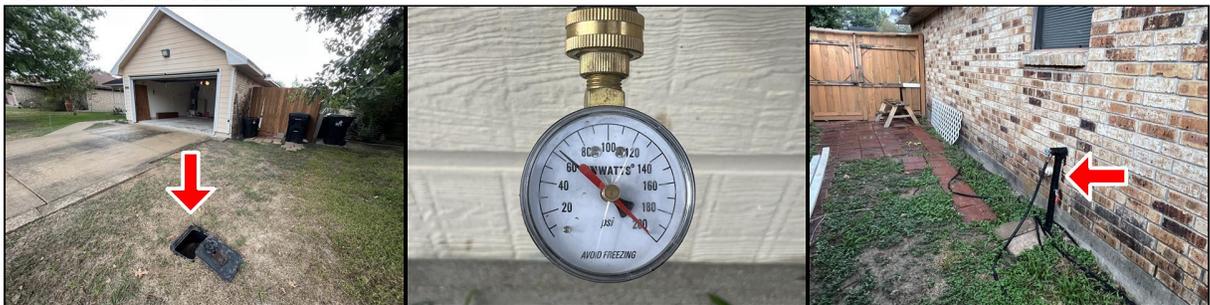
Water Meter Location

Fixtures functional. Flow/Volume acceptable. The toilets flushed properly. Water pressure into home from city 62 PSI. Recommended maximum satisfactory pressure: 80 PSI. Meter visually inspected with no leaks or bypass concerns noted.

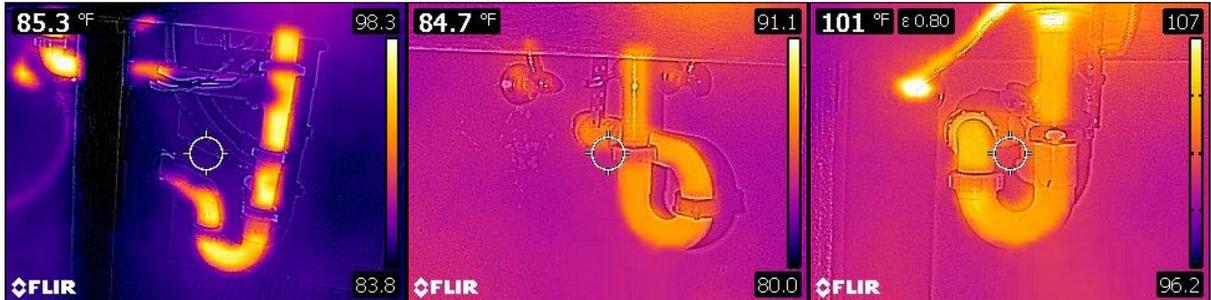
The drain was slow, and may be clogged in the guest bath sink and master bath tub. I recommend repair by a plumber.
