**Advantage** *Home Inspections*

PROPERTY INSPECTION REPORT FORM

DANZIG HAMPTON <i>Name of Client</i>	01/20/2024 <i>Date of Inspection</i>
100 SOUTH BROCKMAN, CLUTE, TX 77531 <i>Address of Inspected Property</i>	
Eddie Rape <i>Name of Inspector</i>	TREC # 5013 <i>TREC License #</i>
<i>Name of Sponsor (if applicable)</i>	<i>TREC License #</i>

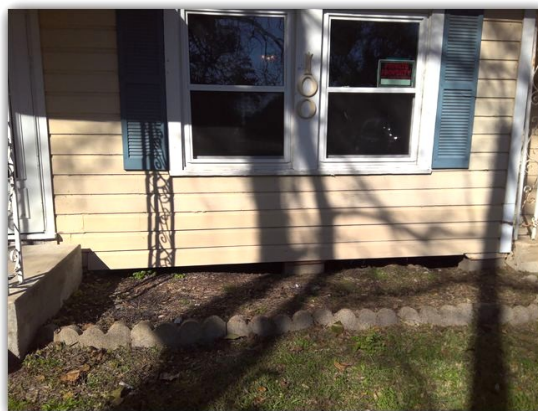
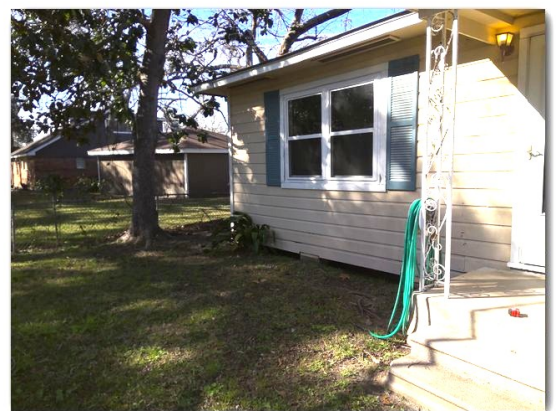
4.SOIL IS TOO HIGH AT N/E SIDE OF RESIDENCE. SOIL/FLOWERBEDS NEED TO BE KEPT AT LEAST 6 INCHES BELOW SIDING.

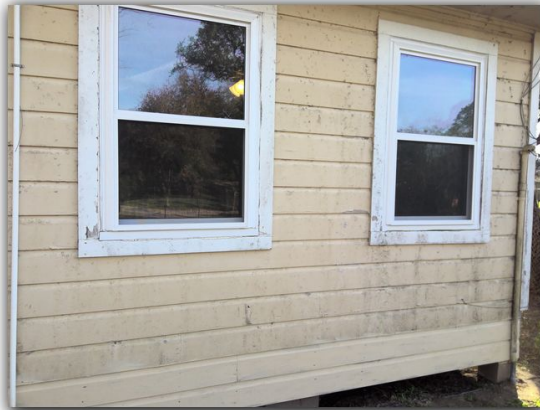
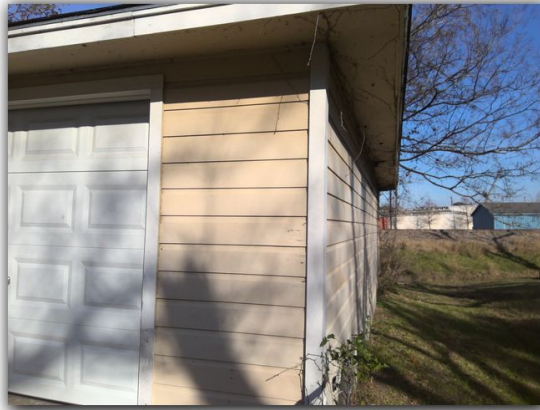
1.SIDING, FACIA BOARDS, SOFFIT BOARDS AND/OR TRIM ARE LOOSE, CHIPPED, NEEDS MORE CAULKING, NEEDS MORE PAINT AND/OR WEATHER DAMAGED AND/OR ROTTEN AT VARIOUS AREAS AT ALL SIDES OF RESIDENCE AND DETACHED GARAGE.

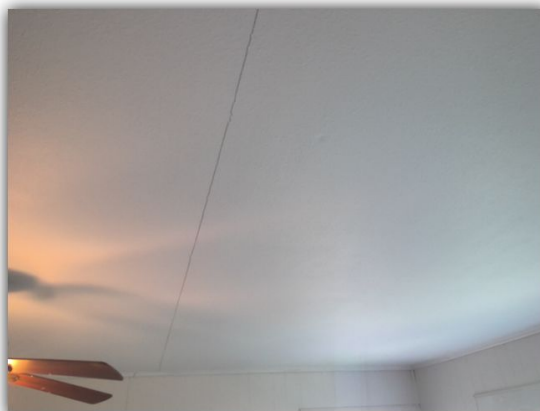
1.EXCESSIVE SETTLEMENT CRACKS WERE OBSERVED AT DEN.

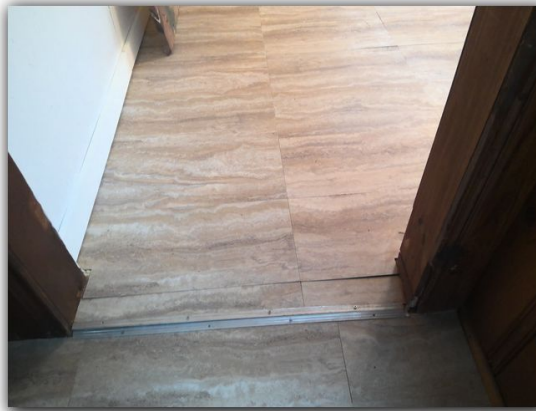
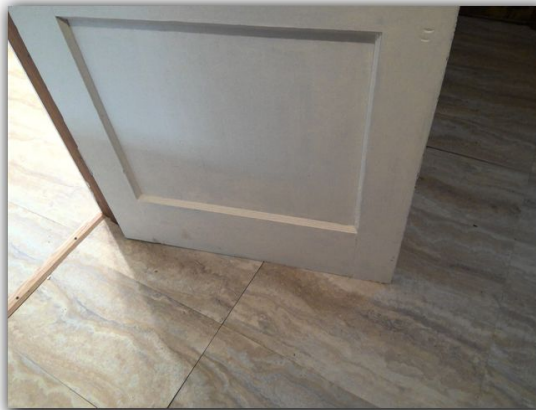
1.LOOSE, CHIPPED AND/OR DAMAGED FLOORING WAS OBSERVED AT VARIOUS AREAS THROUGHOUT RESIDENCE. THIS COULD BE A TRIP HAZARD.

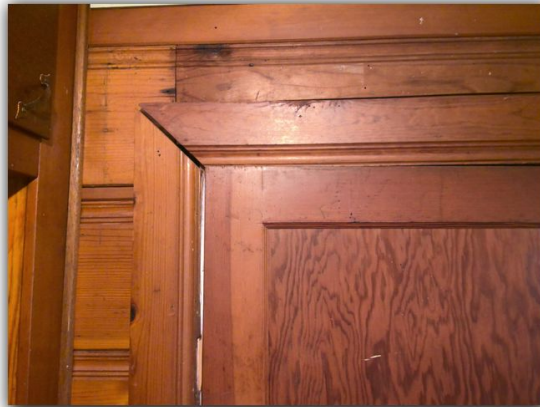
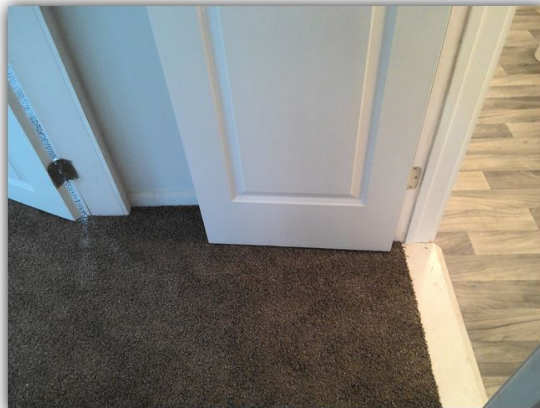
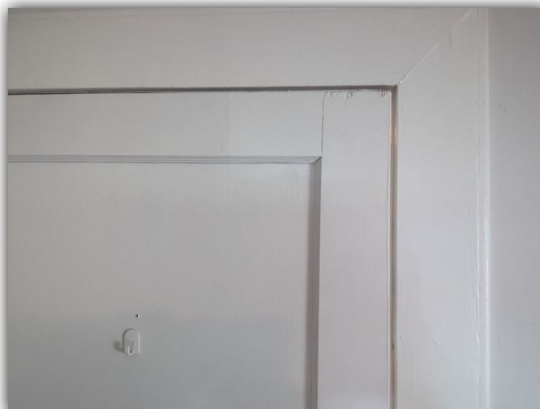
1.DOORS STICK AND/OR DO NOT PROPERLY FIT INTO THE DOOR FRAMES AT SEVERAL DOORS THROUGHOUT RESIDENCE. THIS IS A COMMON CHARACTERISTIC OF EXCESSIVE FOUNDATION MOVEMENT.

3.CLOSET DOOR IS MISSING AT EAST SIDE BEDROOM.

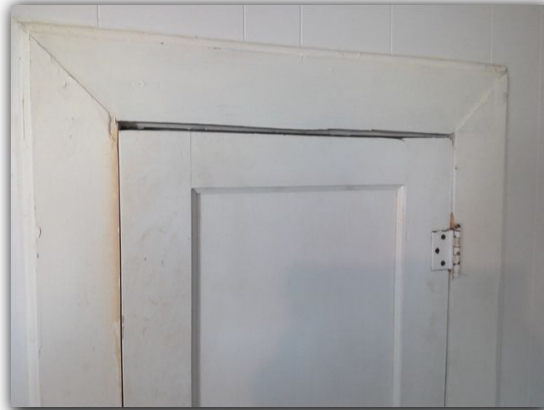
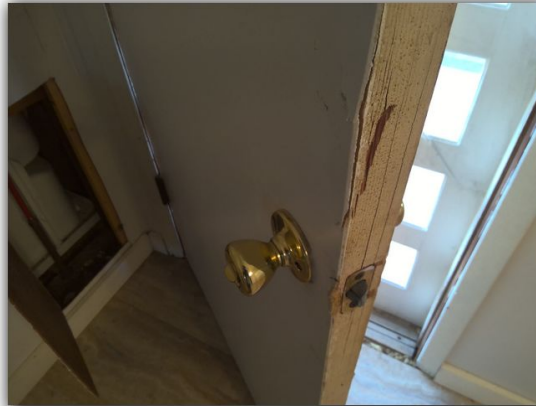
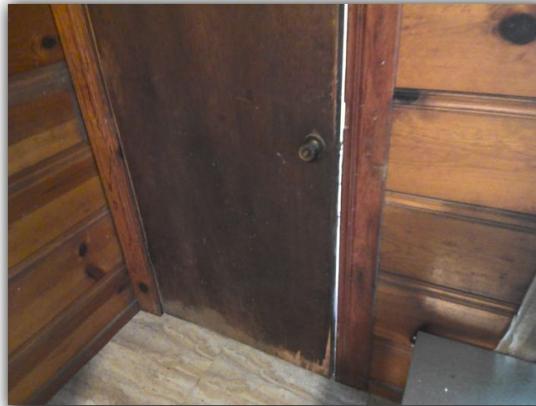
- 1.DOORS ARE WEATHER DAMAGED AND ARE IN POOR CONDITION AT BACK DOOR AND UTILITY ROOM DOOR.
- 2.DAMAGED PAINT WAS OBSERVED AT EAST SIDE, FRONT DOOR. THE DOOR NEEDS TO BE PROPERLY PREPPED, SANDED AND PAINTED TO PREVENT FURTHER DAMAGE.
- 3.LOOSE, TORN AND/OR MISSING WEATHER STRIPPING WAS OBSERVED AT ALL EXTERIOR DOORS.
- 4.WOOD AT LOWER PORTION OF DOOR FRAME IS WEATHER DAMAGED AND/OR ROTTEN AT OVERHEAD GARAGE DOOR.
- 5.SAFETY GLASS LABELS WERE NOT OBSERVED AT EAST SIDE FRONT DOOR. CURRENT RULES REQUIRE ALL PATIO DOOR GLASS TO BE SAFETY GLASS.
- 6.SCREEN DOOR IS DAMAGED AT BACK DOOR.

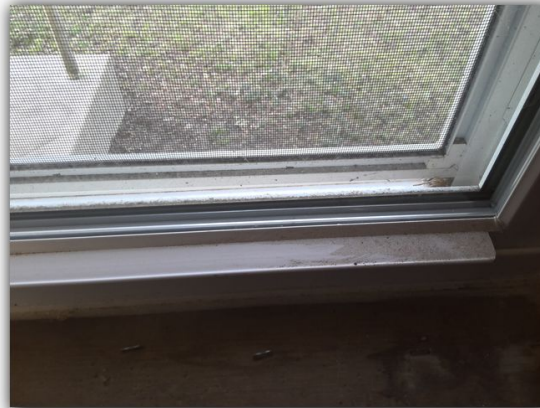
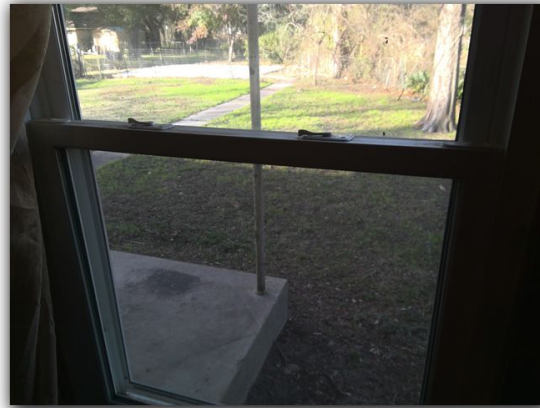
1.IMPROPERLY SIZED WINDOW SCREENS AT UTILITY ROOM.

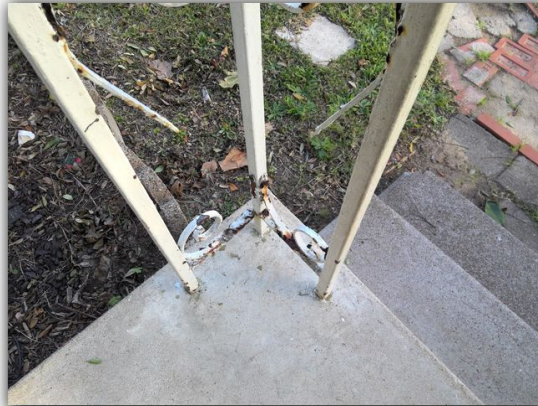
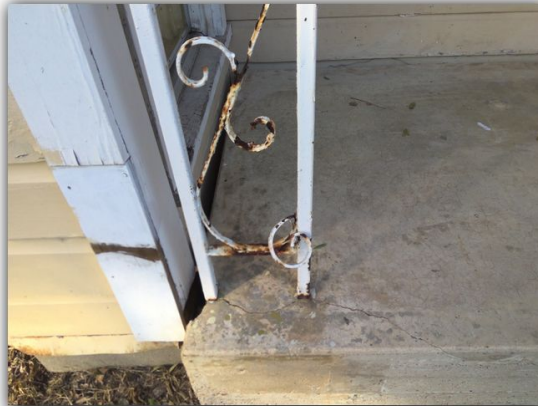
Comments:
1.LOWER PORTION OF PORCH PILLARS ARE WEATHER DAMAGED/CORRODED AT FRONT PORCHES.
2.4 X 4 DIMENSIONAL COLUMN APPEARS TO BE UNDERSIZED AT EAST SIDE, FRONT PORCH. I RECOMMEND CONSULTING WITH A REPUTABLE CONTRACTOR FOR FURTHER EVALUATION.

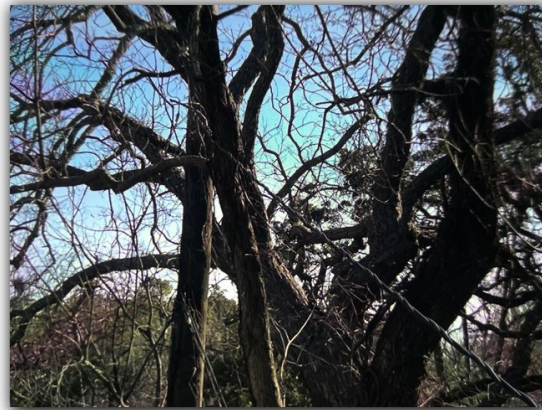
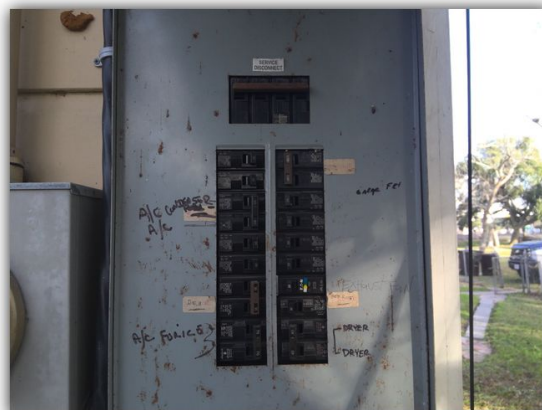
I-T-E BRAND, 200 AMP BREAKER PANEL: LOCATED AT WEST SIDE, EXTERIOR WALL OF RESIDENCE.

- 1.GROUND WIRES ARE SHARING THE SAME GROUND LUG/SCREW. CURRENT CODES DO NOT ALLOW MORE THAN ONE ELECTRICAL WIRE PER LUG/SCREW.
- 2.EXPOSED WIRE ENDS WERE OBSERVED INSIDE THE BREAKER PANEL THAT WERE TAPED, BUT IT NOT APPEAR TO HAVE WIRE NUTS. THE EXPOSED WIRE ENDS SHOULD BE PROPERLY CAPPED WITH WIRE NUTS.
- 3.WIRE NUTS SHOULD BE WRAPPED/SECURED WITH ELECTRICAL TAPE.
- 4.ALL CIRCUIT BREAKERS NEED TO BE PROPERLY IDENTIFIED AND LABELED.
- 5.ALTHOUGH NOT REQUIRED WHEN HOME WAS BUILT, NO ARC FAULT CIRCUIT INTERRUPTER BREAKERS WERE OBSERVED TO REQUIRED POWER OUTLETS. THESE ARE SAFETY DEVICES DESIGNED TO TRIP OFF WHEN ARCING IS DETECTED IN POWER OUTLETS AND/OR WIRING. NEW RULES REQUIRE ALL 15 AND 20 AMP BREAKERS TO BE ARC FAULT CIRCUIT PROTECTED.
- 6.CURRENT RULES REQUIRE A WHOLE HOUSE SURGE PROTECTOR TO BE INSTALLED.

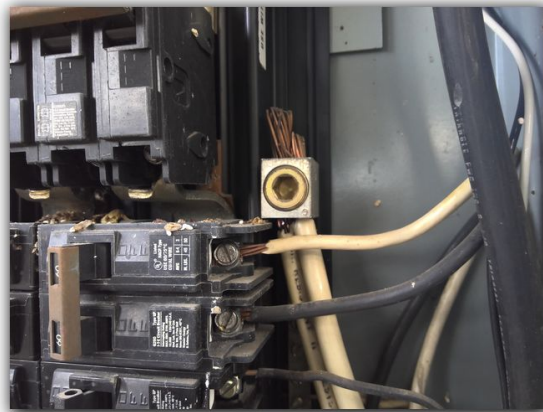
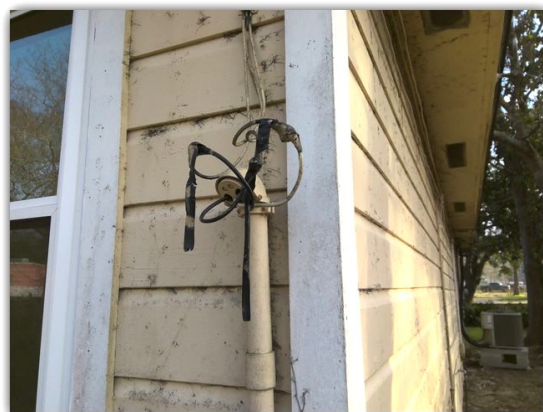
WEATHER HEAD AT N/W SIDE OF RESIDENCE:

1.WEATHER HEAD AND/OR ELECTRICAL WIRES ARE TOO LOW AND TOO CLOSE TO THE RESIDENCE, TO MEET CURRENT RULES. WIRES WERE ENERGIZED AT TIME OF INSPECTION. I RECOMMEND CONSULTING WITH A LICENSED ELECTRICIAN FOR FURTHER EVALUATION.

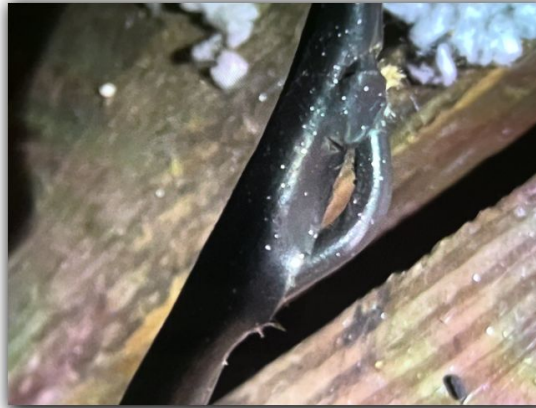
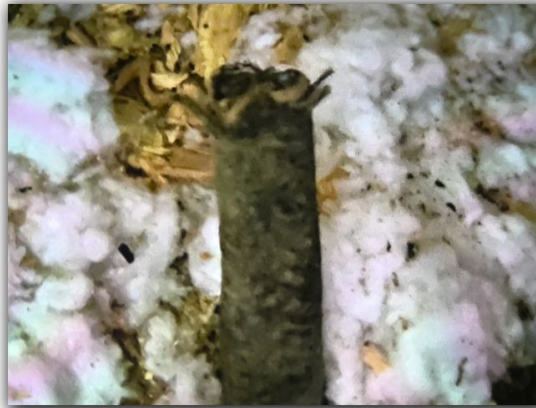
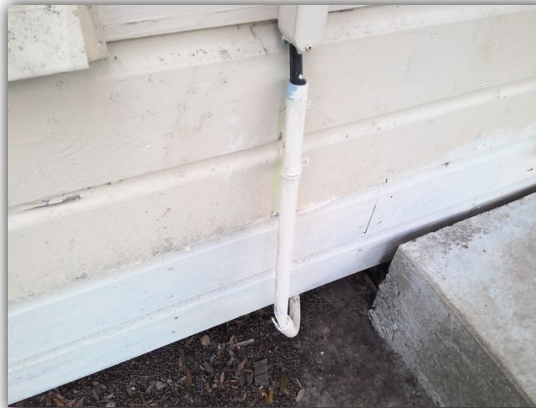
- 3.NO POWER TO POWER OUTLETS AT UTILITY ROOM AND EAST SIDE LIVING ROOM. I TAGGED/LABELED THE POWER OUTLETS FOR EASY IDENTIFICATION.
- 4.POWER OUTLETS ARE LOOSE IN THE WALL AND/OR HAVE LOOSE/WORN POWER OUTLET CONNECTIONS AT EAST SIDE LIVING ROOM AND UTILITY ROOM. ORANGE STICKERS WERE PLACED ON OUTLETS FOR EASY IDENTIFICATION.

- 8.TAMPER RESISTANT POWER OUTLETS ARE NOT INSTALLED AT ALL REQUIRED LOCATIONS AT RESIDENCE. THE TEXAS REAL ESTATE COMMISSION STANDARD OF PRACTICE RULES REQUIRE INSPECTORS TO LIST NON-TAMPER RESISTANT POWER OUTLETS, LESS THAN 5 1/2 ABOVE THE FLOOR AS DEFICIENT.

- 9.EXPOSED WIRE ENDS AT SOUTH SIDE ATTIC SHOULD BE ENCLOSED IN A JUNCTION BOX.
- 10.DAMAGED SHEATHING WAS OBSERVED ON A ELECTRICAL WIRE AT SOUTH SIDE ATTIC.

- 11.ELECTRICAL WIRES ARE IMPROPERLY INSTALLED BELOW ATTIC DECKING. THIS CAN CAUSE DAMAGE TO THE WIRES AND IS A FIRE HAZARD.
- 12.LOOSE, UNSECURED, IMPROPERLY INSTALLED ELECTRICAL WIRES WERE OBSERVED LAYING TOO CLOSE TO THE ATTIC ENTRANCE.

- 15.DAMAGED CONDUIT WAS OBSERVED AT BACK SIDE OF RESIDENCE.

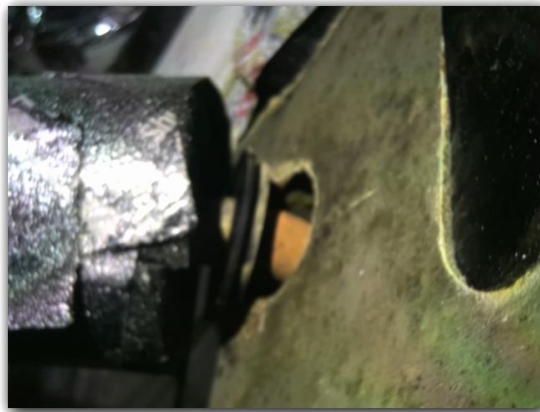
CARRIER BRAND EVAPORATOR HOUSING. MANUFACTURE DATE 11/2017.

1. RUBBER INSULATION IS DAMAGED AND/OR MISSING ON THE SUCTION/DISCHARGE LINE, AT/OR NEAR THE EVAPORATOR HOUSING.

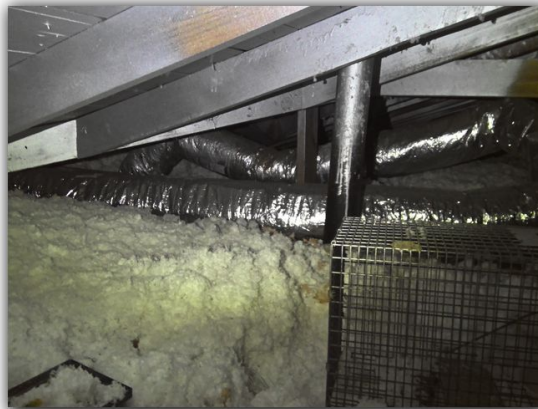
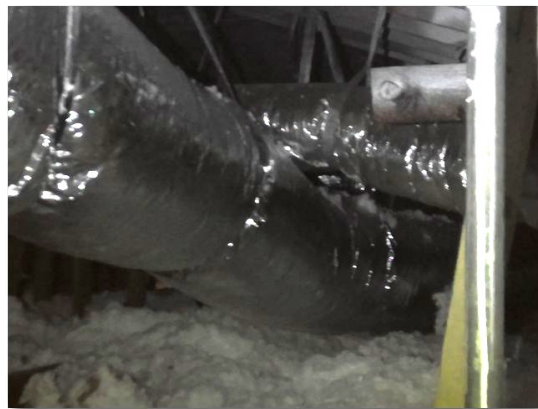
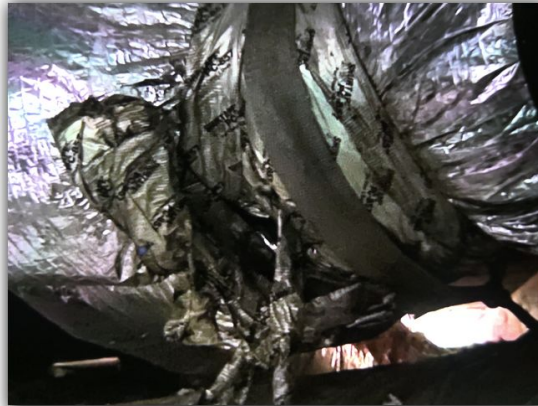
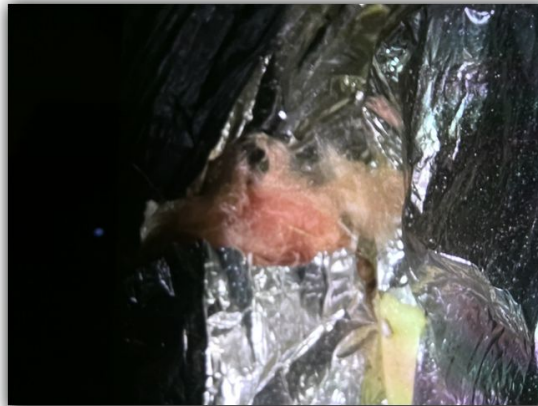
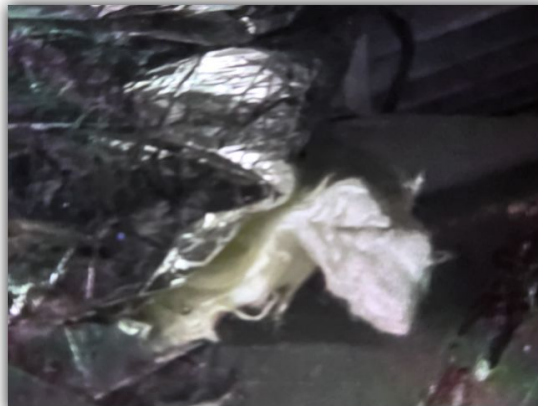
- 1.THE INSULATION IS LOOSE AND/OR TORN ON SEVERAL DUCTS THROUGHOUT ATTIC.
- 2.THE RETURN AIR FILTER IS DIRTY. THIS CAN CAUSE DAMAGE TO THE EVAPORATOR COILS WHICH ARE NOT ACCESSIBLE. I RECOMMEND HIRING A LICENSED H.V.A.C. TECHNICIAN FOR FURTHER EVALUATION.
- 3.DUCTS SHOULD BE KEPT FROM TOUCHING OTHER DUCTS, TO PREVENT CONDENSATION. BLANKET INSULATION IS A GOOD WAY TO SEPARATE THE DUCTS.
- 4.DUCTS SHOULD BE RAISED OFF OF THE ATTIC FLOOR TO PREVENT CONDENSATION.

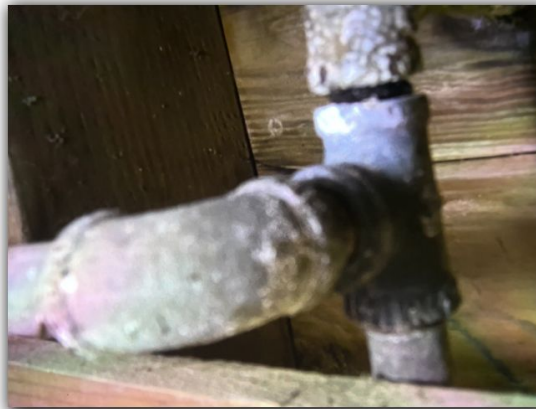
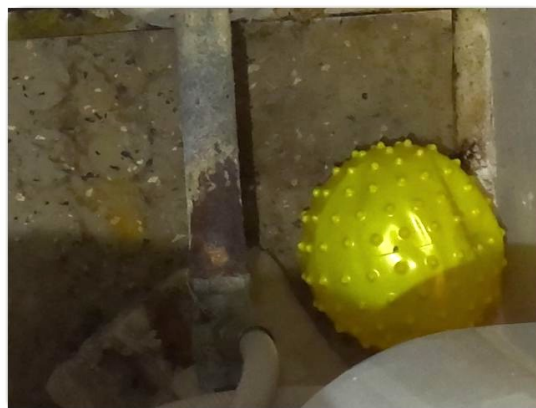
1.DROP IN WATER PRESSURE WAS OBSERVED WHEN OPERATING MORE THAN ONE WATER FIXTURE. GALVANIZED WATER PIPES ARE SUBJECT TO CORROSION. AS CORROSION BUILDS UP INSIDE THE PIPES, THE PIPES BECOME CONSTRICTED, RESULTING IN LOSS OF WATER PRESSURE AND/OR LEAKS. RUST WARTS AND/OR CORROSION WAS OBSERVED ON SEVERAL WATER LINES BELOW RESIDENCE. I RECOMMEND CONSULTING WITH A LICENSED PLUMBER FOR FURTHER EVALUATION.

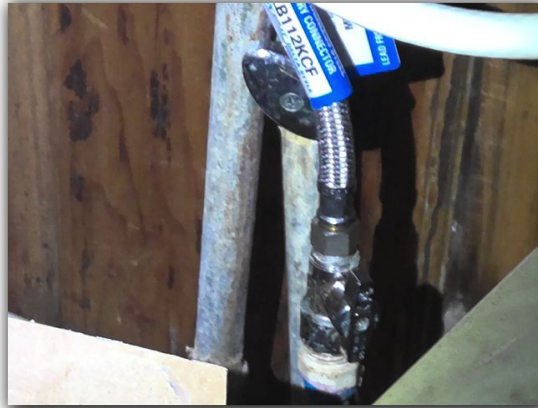
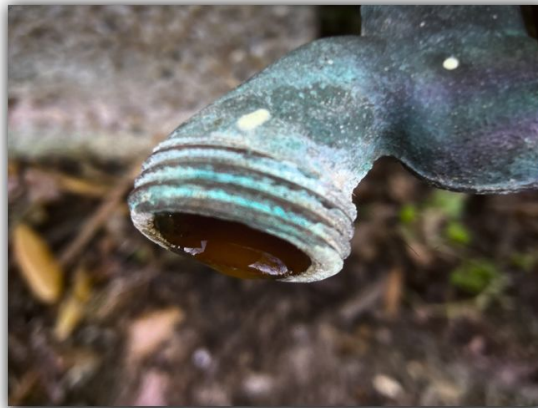
EXTERIOR:

- 1.CURRENT CODES REQUIRE BACKFLOW PREVENTERS (ATMOSPHERIC VACUUM BREAKERS) AT ALL EXTERIOR HOSE BIBS. THESE ARE INEXPENSIVE SCREW ON ADAPTERS THAT PREVENT CONTAMINATED WATER FROM BEING SIPHONED BACK INTO POTABLE WATER LINES.
- 2.WATER IS LEAKING AT PIPE JOINT AT BACK SIDE OF RESIDENCE.

- 1.CURRENT REGULATIONS DO NOT PERMIT THE USE OF P.V.C. WATER LINES, EXCEPT AT EXTERIOR AREAS OF RESIDENCE. P.V.C. WATER LINES WERE OBSERVED AT SOME INTERIOR AREAS OF RESIDENCE.

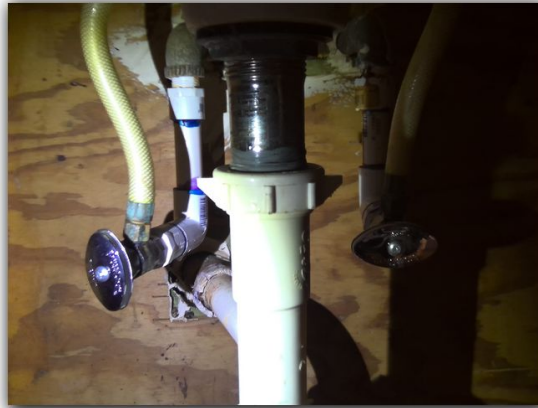
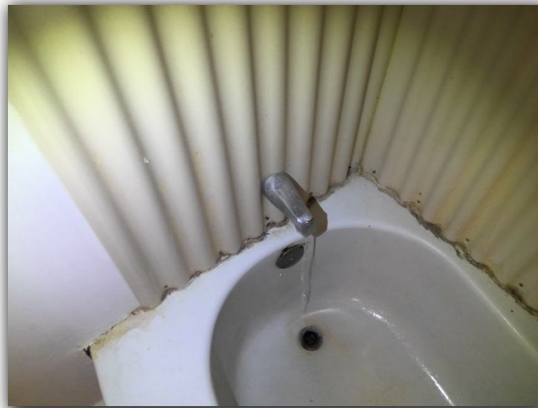
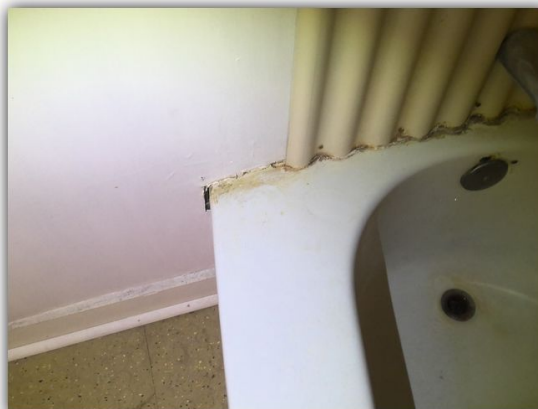
SOUTH SIDE HALL BATHROOM:

1. IMPROPER/EXCESSIVE AMOUNTS OF CAULK WAS OBSERVED AT SHOWER SURROUND PANELS. WATER CAN TRAVEL BELOW THE BUILT UP/EXCESSIVE CAULK.
2. SHOWER PANELS NEED MORE CAULKING. THE SHOWER PANELS ARE ALSO LOOSE AND TYPE OF MATERIAL IS NOT RECOMMENDED FOR USE AS A SHOWER SURROUND.
3. TOILET IS LOOSE AT THE FLOOR.

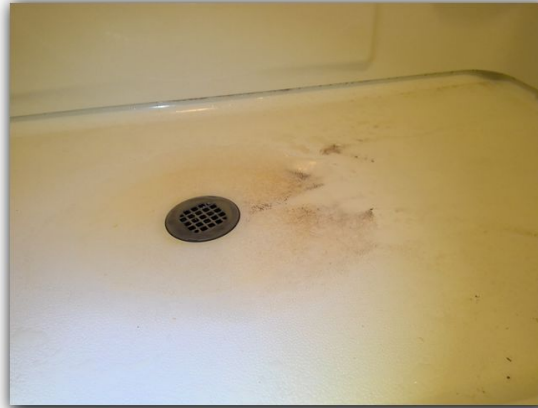
NORTH SIDE BATHROOM:

1. TOILET IS LOOSE AT THE FLOOR.
2. VERY LITTLE WATER PRESSURE AT SINK AND SHOWER FIXTURE.
3. SHOWER PAN DOES NOT PROPERLY SLOPE TOWARDS THE DRAIN. STANDING WATER WAS OBSERVED AT SHOWER PAN.
4. SHOWER SURROUND PANELS NEED TO BE ADDED AROUND THE BATHTUB/SHOWER TO PREVENT WATER DAMAGE AT WINDOW FRAME. SHOWER SURROUND PANELS AND/OR TRIM SHOULD BE AT LEAST SIX FEET ABOVE THE FLOOR.

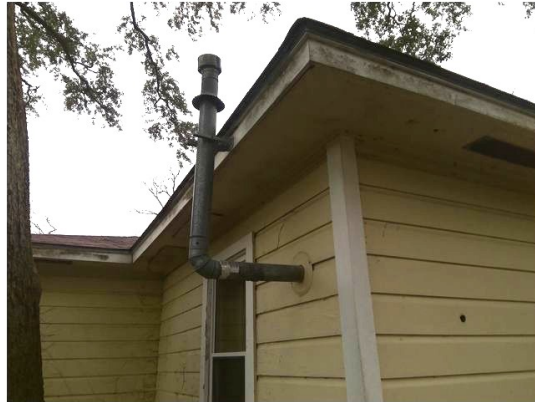
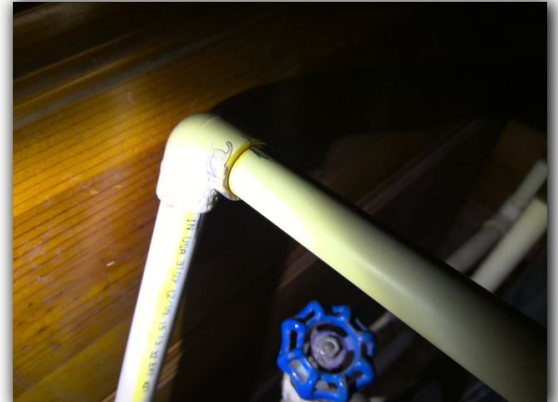
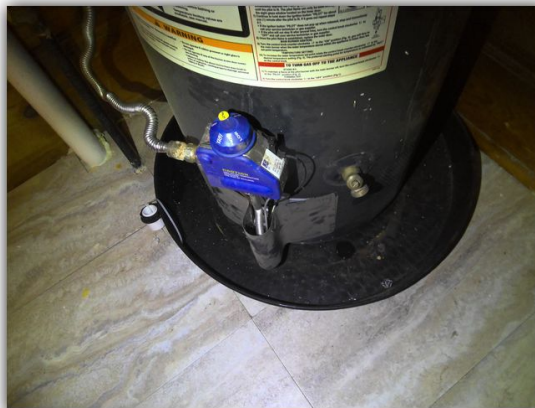
1. VENT PIPE IS IMPROPERLY INSTALLED. CURRENT CODES REQUIRE THE VENT PIPE TO EXTEND AT LEAST TWO FEET ABOVE THE ROOF LINE AND 8 FEET FROM A VERTICAL WALL.

2. WATER WAS LEAKING AT PIPE JOINT AT THE EMERGENCY DRAIN LINE.
3. AN EMERGENCY DRAIN LINE SHOULD BE INSTALLED AT THE EMERGENCY DRAIN PAN TO PREVENT WATER DAMAGE, IN THE EVENT THE WATER HEATER TANK LEAKS.
4. CURRENT RULES REQUIRE A SEDIMENT TRAP (DRIP LEG) TO BE INSTALLED ON THE GAS LINE NEAR THE WATER HEATER.

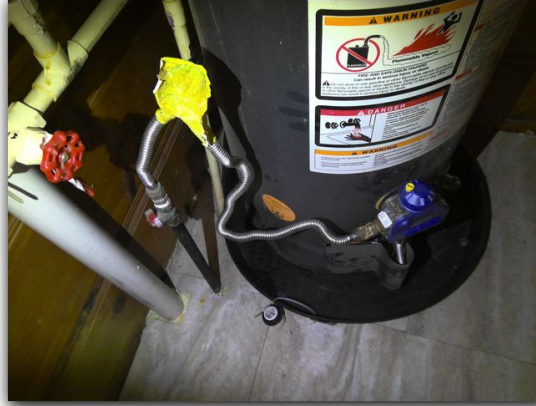
THE TIME HOME WAS BUILT. T.R.E.C. GUIDELINES REQUIRE ME TO LIST THIS AS DEFICIENT.
