TREC REI 7-6
3403 Ramsgate Dr
Spring, TX 77388

Inspector
Donald Sellstrom
TREC License #24991
(281) 816 7007
info@htxhomeinspections.com

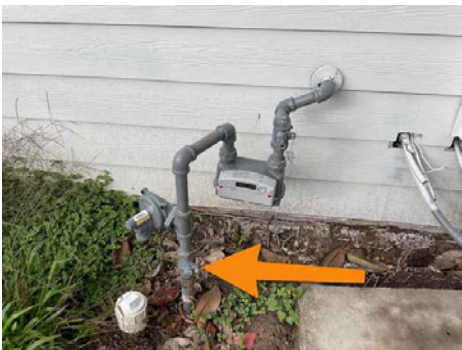
Gas service off

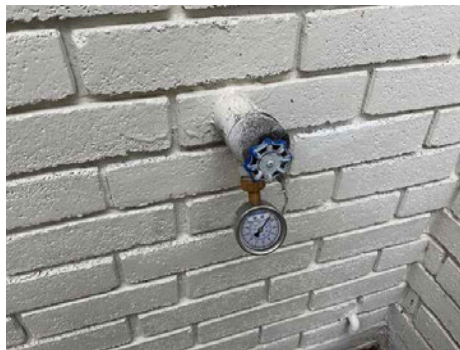
No water service

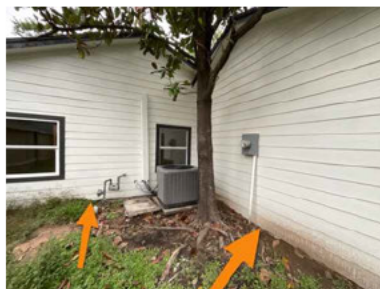
Foundation could not be completely inspected due to low siding, high soil or vegetation, inaccessibility, concrete patio, equipment, and/or a wrap around deck With siding installed on exterior walls it is recommended that 3-4” of the foundation wall be visible; with brick at least 1-2”.

Rear high soil

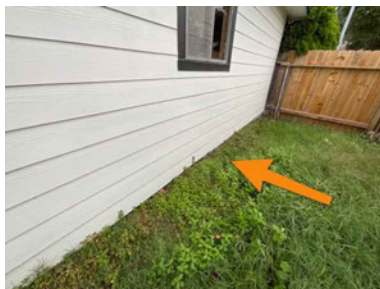
Garage

Observed the grade level at or above the foundation in one or more area(s). Landscaping, grass, decks and soil height within 4" of the siding, stucco or brick veneer may allow moisture and pest intrusion within the wall cavity. Recommend allowing at least a 2" clearance between brick veneer, siding or stucco and the grade around the home.

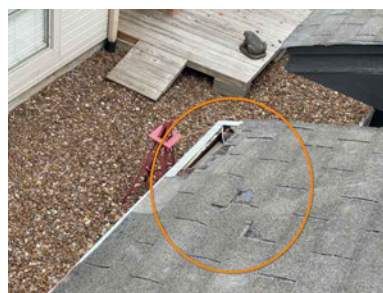
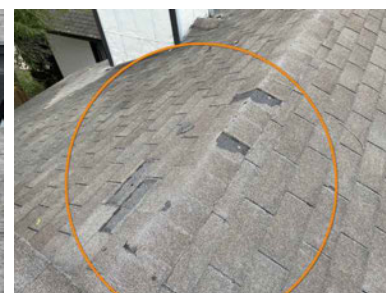
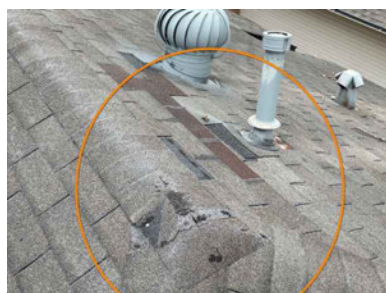
Left side

Ridge

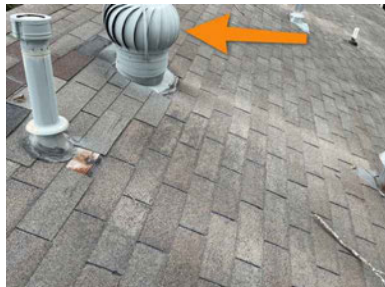
Roof surfaces have multiple types of vents to allow for proper ventilation of attic space and mechanical equipment. Depending on severity of damage, proper functionality of the venting system may be impeded. Rust, corrosion, improper penetration, and damage on metal vents can be the source of water intrusion if not properly maintained. Deterioration in rubber boot around air vents or base flashing that are lifted or improperly installed can allow moisture intrusion within attic space and possibly into ceiling in home. Air and exhaust vents, dryer vents, turbine vents, ridge vents, static vents and powered vents are all sources of ventilation for different systems within the home.

Turbines not turning

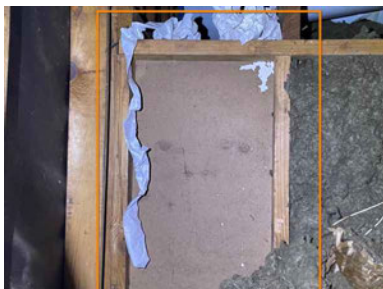
Observed attic space(s) that showed signs of displaced or missing insulation at time of inspection. Blown in attic insulation should be between 10-14" in depth and is a major component in increasing or maintaining the energy efficiency of a home. We recommend that the appropriate amount of insulation be installed or replaced to meet the minimal of R-30 rating for energy efficiency.

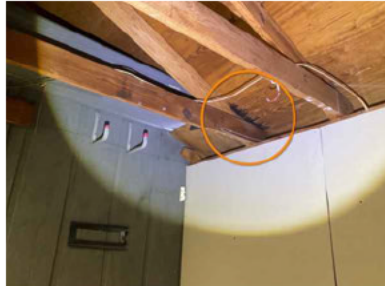
Garage

Observed moisture stains in attic space at time of inspection. At time of inspection moisture was not detected and dried or observed but unable to verify or locate source.

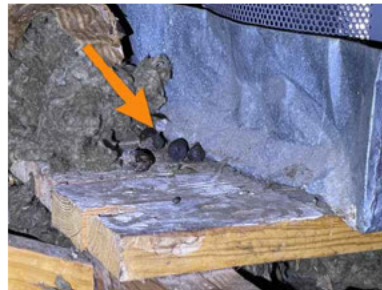
Droppings in Attic

Observed signs of pest intrusion or pest control at time of inspection. Pest identifiers such as gnawing on fiberglass insulation or foam pipe coverings, rodent droppings, rodent traps, mud tubes on exterior foundation walls, actual sightings of pest during inspection and nest are an indication that there has been previous pest control attempts or current pest activity. Pest such as ants and wood destroying insects build nest utilizing the soil and can go undetected if soil level or grass is not kept at a proper height around foundation wall. Pest intrusion that has caused damage to structure could be an indication that wood destroying insects or termites have been present or are currently present.

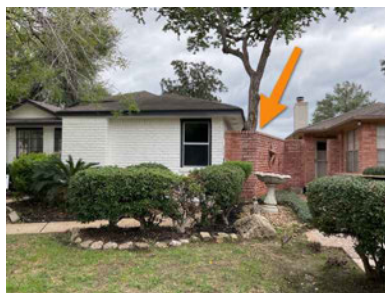
Right exterior wall inaccessible :

Right wall located within private property.

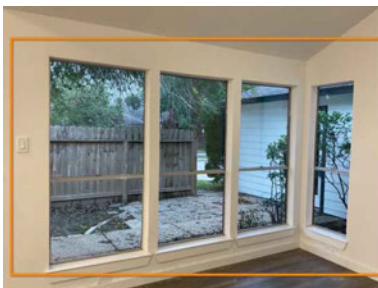
Living Room windows stuck shut

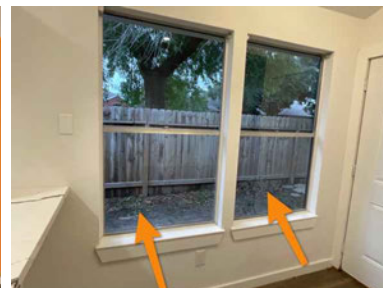
Breakfast area windows stuck shut

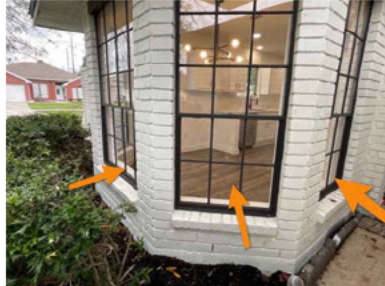
Observed one or more windows with damaged, missing or not properly fitted window screens at time of inspection. The primary advantage is that a window screen keep your home protected. Window screens are mandatory if you like to let fresh air into the home without the risk of pest entering the space. Screens serves as the primary barrier between the exterior and interior of your home and provide an added layer of security.

Front windows missing screens

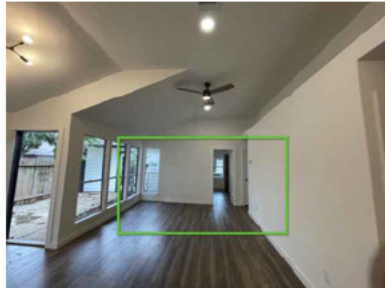
No fire place

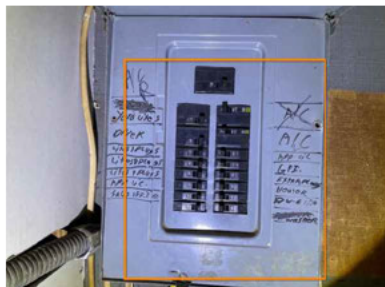
Observed missing/uninstalled surge protection device in breaker panel at time of inspection. In new construction homes this is a requirement, this was not required on homes built prior to 2020 and not required by TREC inspectors to report on until late 2021. If changes are being made to update the breaker panel this has to be changed to meet today's standards.

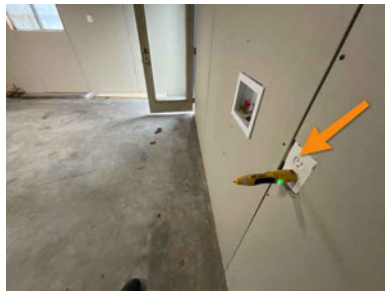
Garage

Observed locations where GFCI protection is required, but either not present or functioning properly at time of inspection. Any area within six feet of a sink, water source, kitchen countertop or exterior of home is required to have GFCI protected outlets.

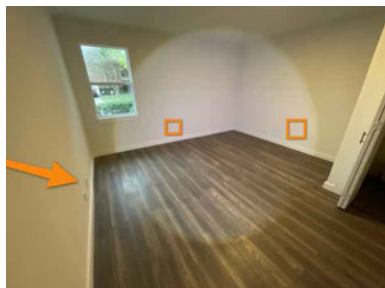
Primary Bedroom

Observed an inadequate amount of receptacle outlet(s) at time of inspection. Receptacles shall be installed such that no point measured horizontally along the floor line of any wall space is more than 6ft from a receptacle outlet. We recommend contacting a licensed electrical contractor for further evaluation.

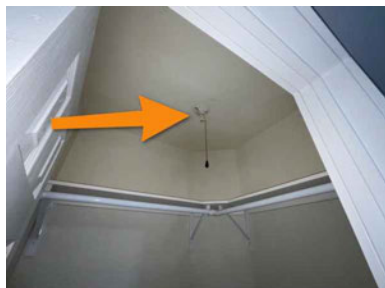
Bedroom 1 Closet

Observed one or more lights are not operating properly at time of inspection. New light bulb possibly needed or a potential wiring problem exists.

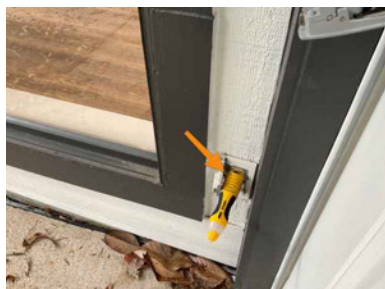
At Rear door

Observed an inoperable outlet when testing at time of inspection. Receptacle didn't produce any signs of power when tested. Outlets in bathroom and kitchen areas that are within 6' of a water supply should be GFCI protected. It is unknown to the inspector if an inoperable outlet in aforementioned locations meet this requirement.

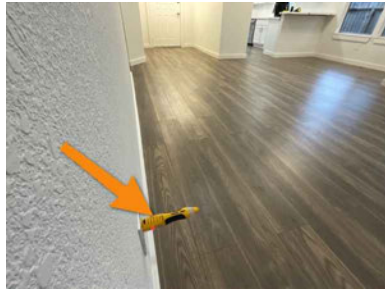
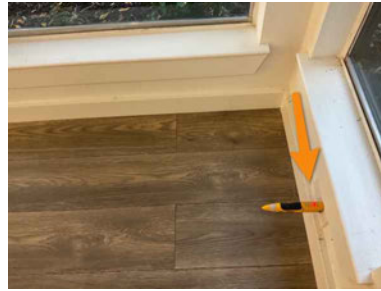
Living Room

Observed open ground on one or more outlets. Outlets installed in homes built in the early 60's - 70's were wired with two wires and didn't require a grounding wire. Recommend consulting an electrical contractor for further evaluation.

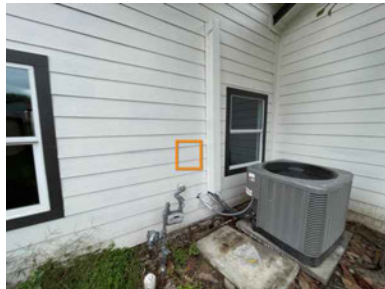
Observed missing outlet in location that requires a service outlet. Because a receptacle is often necessary for servicing HVAC equipment, the National Electrical Code (NEC 210.63) specifies that a 125-volt, single-phase, 15- or 20-amp receptacle outlet must be installed in an accessible location within 25 feet of the equipment and on the same level.

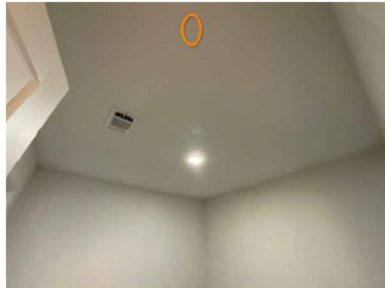
Bedroom 1

At time of inspection observed that smoke detectors were not installed in all appropriate areas of the home. Smoke detectors should be on every floor outside sleeping areas and inside bedrooms.

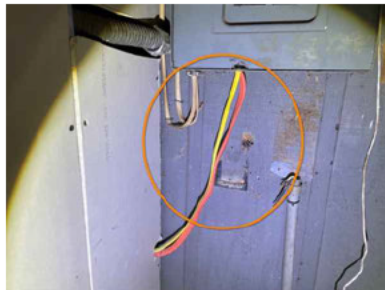
At panel

Observed what appears to be a unprotected romex wire at time of inspection. Due to proximity of impact it is recommended that a conduit covering be installed for protection from impact.

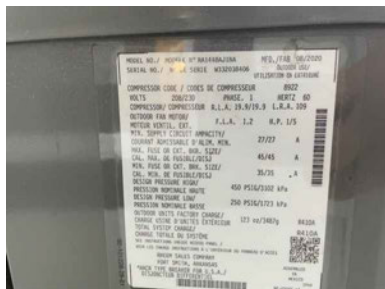
Condenser Manufactred:08/2020

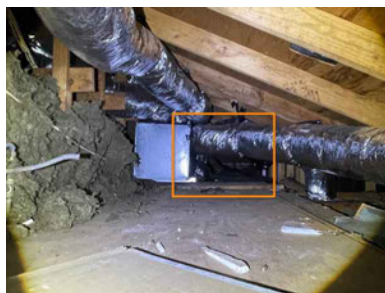
Exterior or interior components of the HVAC system were inaccessible and not fully inspected due to location and impeding factors. Insufficient space on platforms, height and location of such platforms, units behind panels that are screwed shut and safety concerns will impede a thorough inspection of the condenser units. If possible, the inspector will use drone technology to view the condenser(s) visually and make determinations based on them. For a more in depth inspection of a condenser(s) that we deem inaccessible we recommend a licensed HVAC contractor for further evaluation.

Inadequate head room

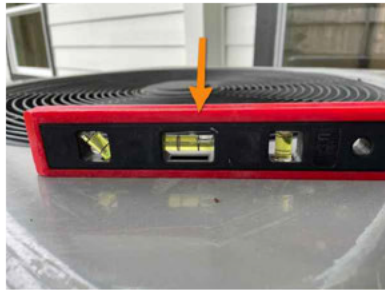
Condenser and concrete pad supporting the unit is not level, this will negatively impact the functionality and life span of the unit. The motor inside a compressor requires oil, if the condensing unit isn't level proper lubrication of the entire motor won't be achieved. Also, there are times when the oil in a compressor travels in the lines with refrigerant, and unlevel unit will cause this oil to separate from the refrigerant and pool in the lines and coils whereas a level unit will allow for the oil to return to the compressor and gets redeposited where needed.

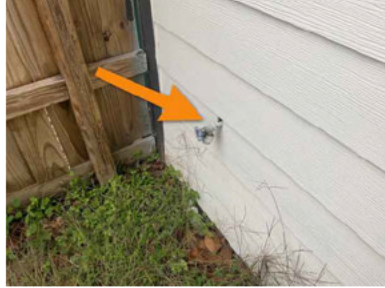
Rear hose bib

Observed missing insulation on hose bibb. Hose bibb insulation help protect plumbing pipes from freezing and eventually bursting during a extreme cold weather event.

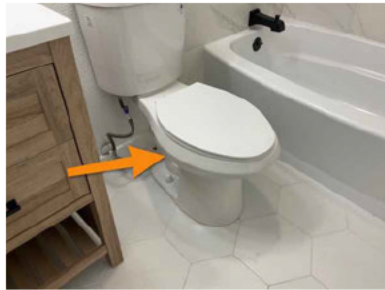
Primary Bathroom 1

Observed toilet not properly fastened or secured to floor. The toilet should be secured to the floor to prevent tip over, potential leak at sewer line, flood bathroom floor or lead to rotted wood and possibly mildew.

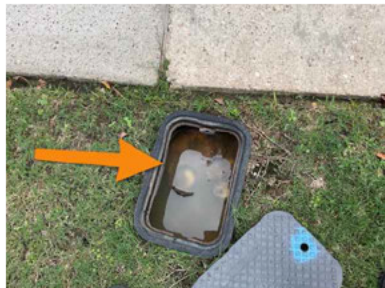
The water meter box was full of water, debris or mud at time of inspection. If the result is due to heavy rain or over watering this may correct itself. If the water in the box does not dissipate under dry conditions, this may indicate a leak.

Full of water

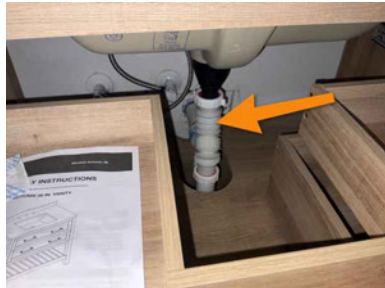
Primary Bathroom

Observed flexible drain pipe installed at time of inspection. Flexible drain pipe or accordion-style pipe that are not made of a rigid material or installed incorrectly may allow for sewer gases to seep into home and not drain as intended from collecting debris. We recommend contacting a professional plumbing contractor to further evaluate the validity and functionality of this installation.

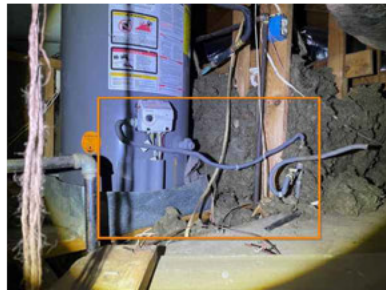
Gas line connection to water heater does not have a sediment trap installed. A sediment trap, also known as a drip leg, is a device installed on a natural gas or propane water heater (or other gas appliances) to capture and collect any sediment, debris, or moisture that might be present in the gas supply line. Its primary purpose is to help prevent these contaminants from reaching the sensitive components of the appliance, ensuring its proper and safe operation.

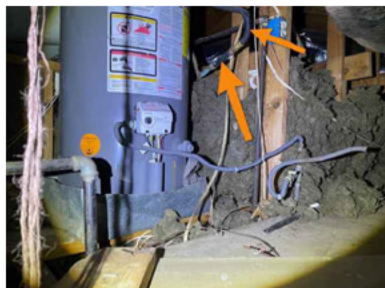
Observed TPR drain pipe material that appears to not meet specific heat resistance requirements. Materials such as copper, CPVC, stainless or galvanized steel, polyethylene and polypropylene are acceptable to use for TPR drain pipes; PVC is not.

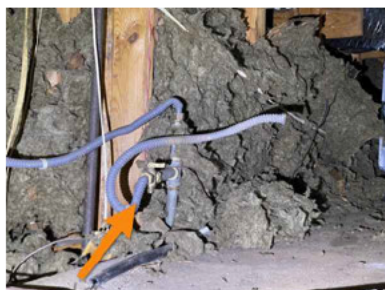
Attic

Observed a gas supply line that was uncapped or abandoned during inspection. Unused gas lines should be capped to prevent gas from accidentally leaking into home. Flex lines that are connected to a gas supply line should be physically connected to the appliance it is intended to serve.

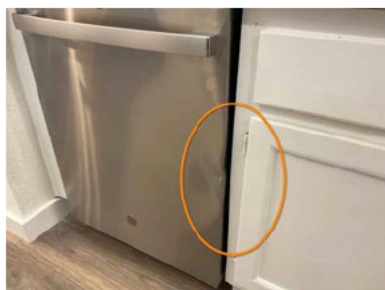
Observed dishwasher door damaged or not properly securing/latching/opening at time of operation. Door not securely fastening will cause dishwasher to leak.

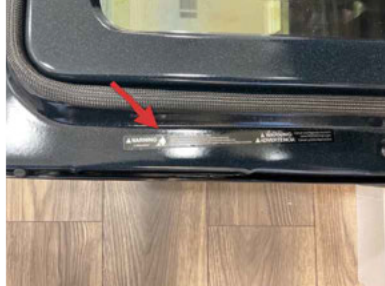
Observed range was not fastened to the floor at time of inspection. This poses a safety hazard to children due to the possibility of the cooktop tipping over if a child stands on the oven door when open.
