HOUSTON INSPECTIONS

PROPERTY INSPECTION REPORT FORM

03/08/2022

4615 Pin Oak Ln, Bellaire, TX 77401

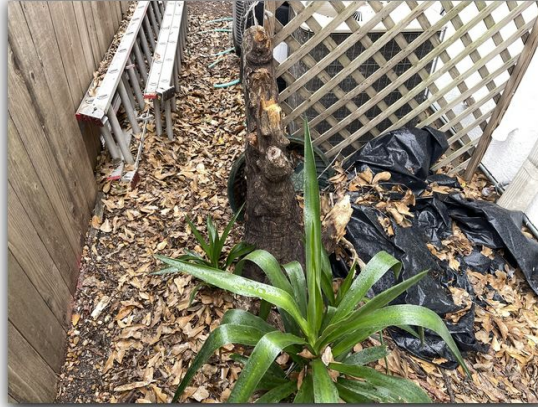
A decaying tree stump was noted at the Left Side of Property of the foundation. As this stump continues to decay, the soils may collapse / sink leaving voids in the soil which help support the foundation grade beams in this area. A qualified tradesman should be consulted to determine what corrective action, if any, are recommended to prevent future problems.

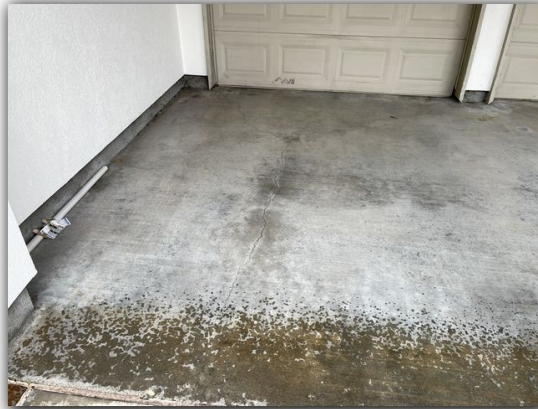
Shrinkage cracks were observed at various visible locations on the foundation / concrete floors. Cracking is a normal property of concrete as it dries and shrinks during the curing process. Additional shrinkage cracks may be present under the floor coverings in the structure.

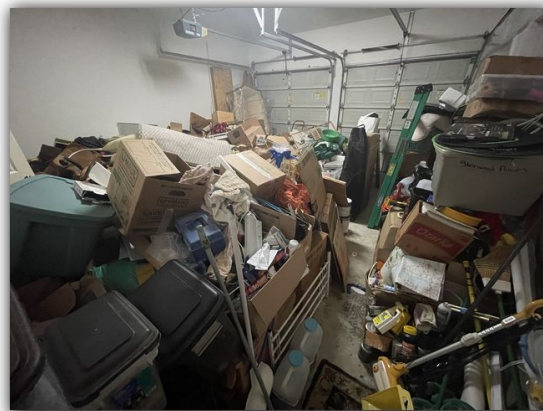
The inspection of the garage foundation was limited at this time due to the amount of storage on the interior. Further investigation of the garage foundation may be needed when storage is removed from the garage.

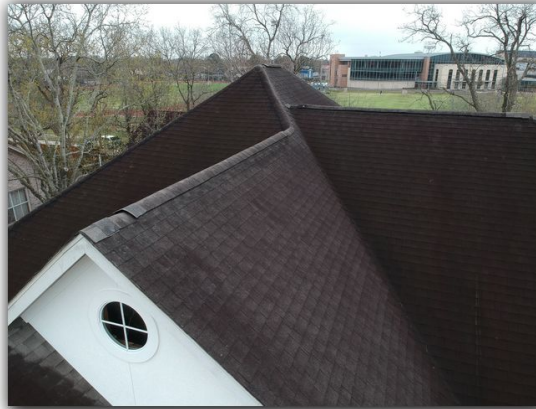
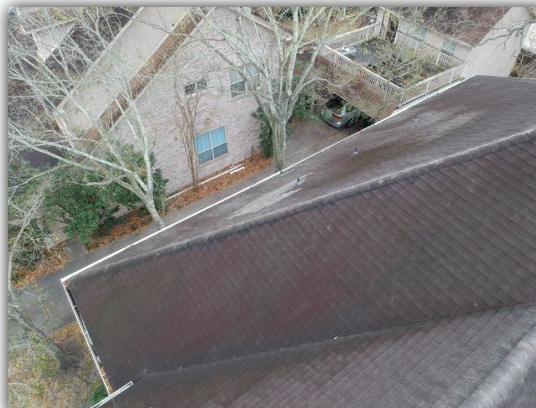
The hip and ridge shingles appear to have reached the end of their serviceable life's as evident by excessive loss of aggregate and damage at many locations. This commonly occurs when these shingles are a different quality than the main body. Recommend contacting a qualified tradesman to evaluate the roof and make the necessary repairs.

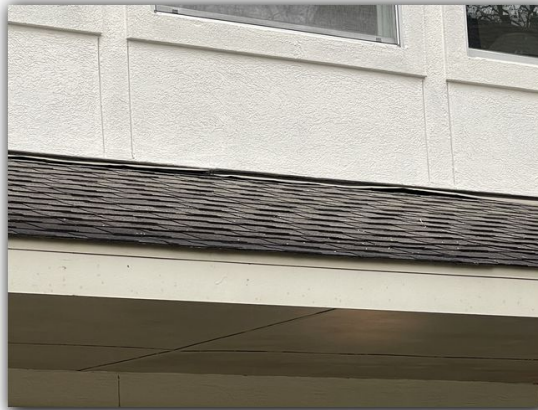
Sections of the roof flashing are raised which could lead to water penetrations. Recommend repairs.

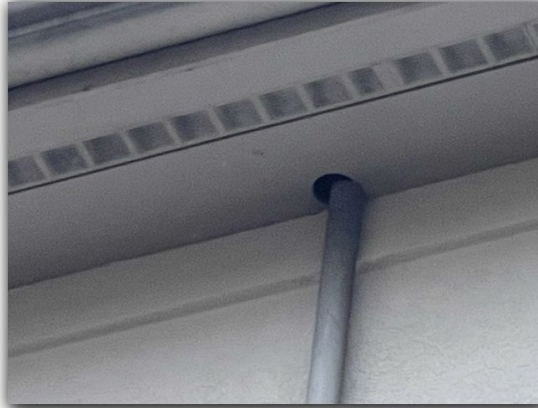
Voids were found at the left soffit. These voids should be sealed.

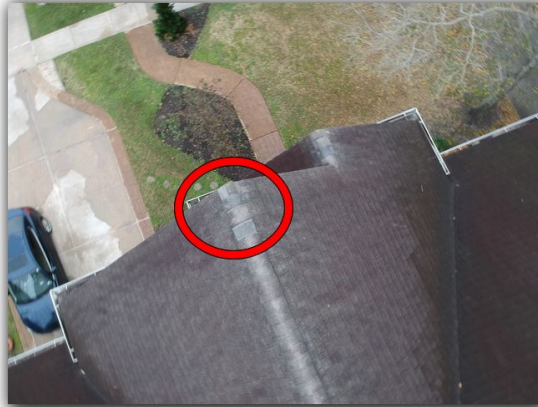
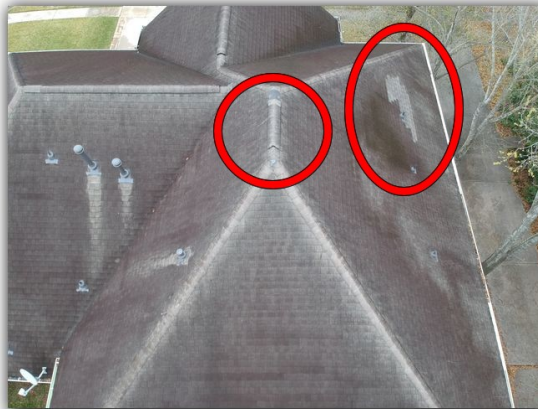
Evidence of roof patching was noted during the inspection as evident by different color and age shingles.

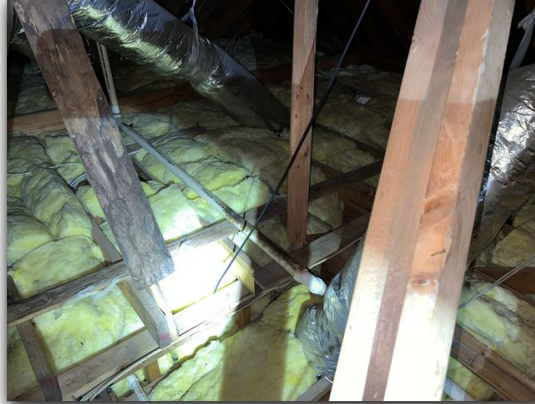
Evidence of rodent activity was noted in the attic as evident by nesting materials, holes, etc.

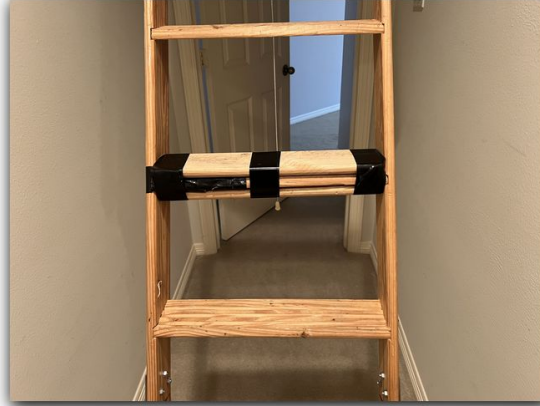
One of the attic ladder steps appears to have been damaged and repaired in the past. It is recommended that this step be replaced or professionally repaired.

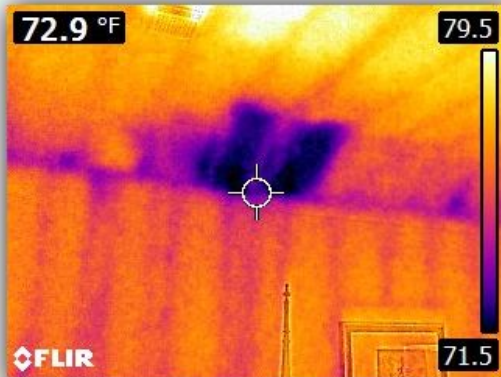
Missing insulation was found at sections of the ceiling / attic in the left side master bedroom while using a infrared camera.

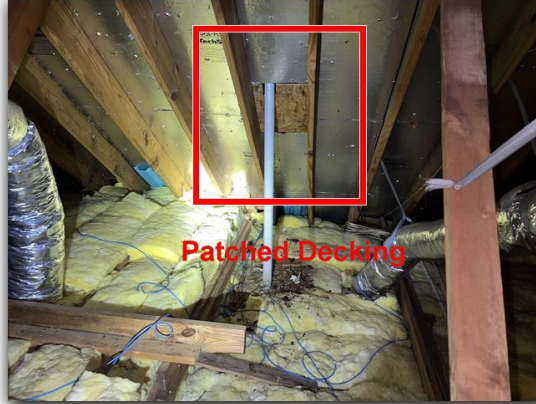
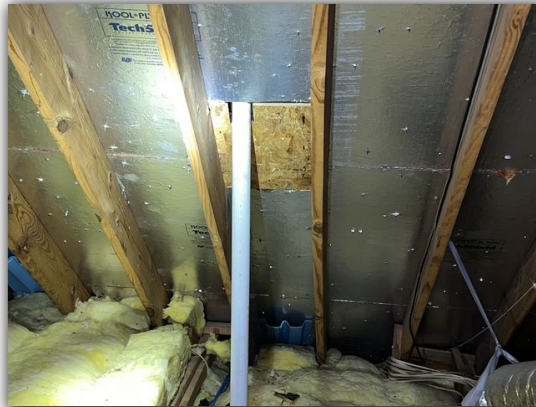
Evidence of previous structural repairs were found in the attic as evident by new lumber at several locations.

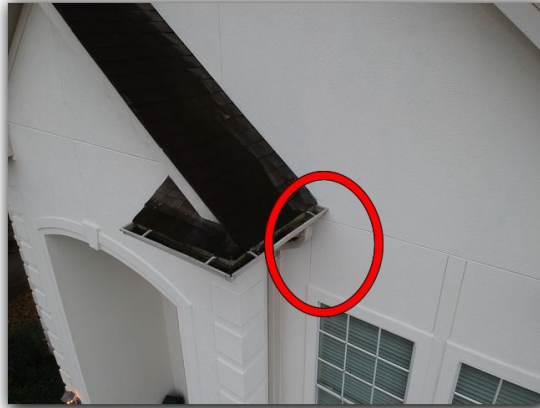
Kickout / diverter flashing is not installed at the wall & roof Intersections. This creates a opening that could allow moisture to enter the wall cavity and create damage.

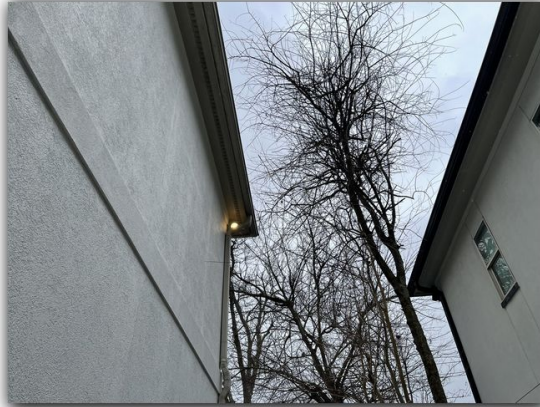
Tree limbs were noted in contact with the exterior walls. The tree limbs should be trimmed away from the walls to prevent future damage.

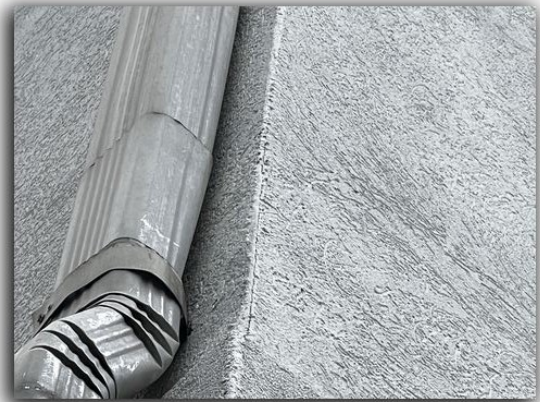
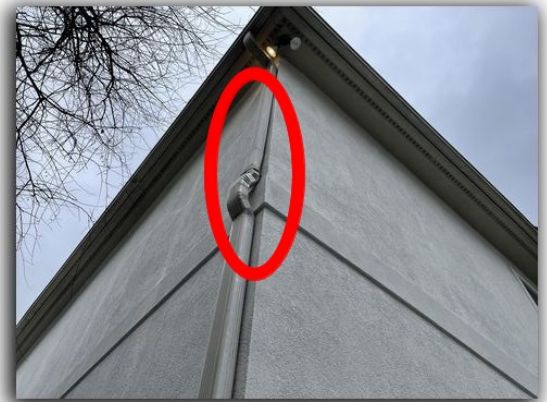
Cracks were found at the stucco walls. Recommend repairs.

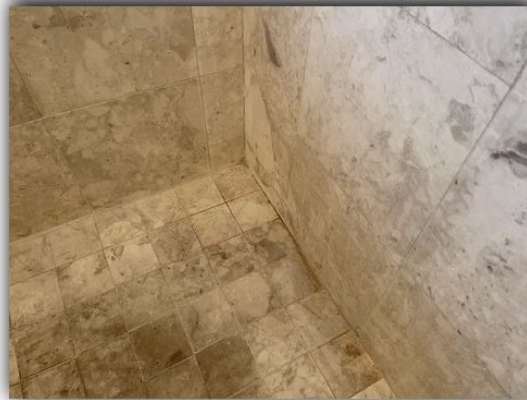
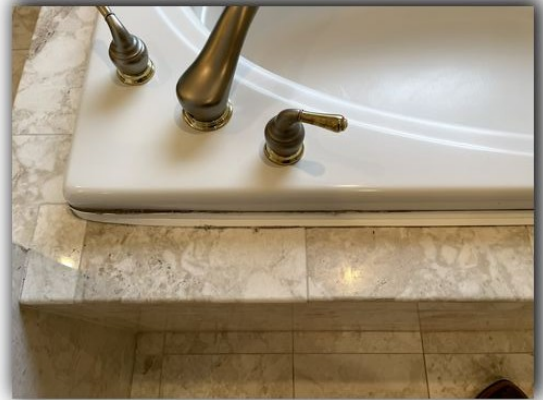
The grout / caulking in the master bathroom shower and tub enclosure is discolored.

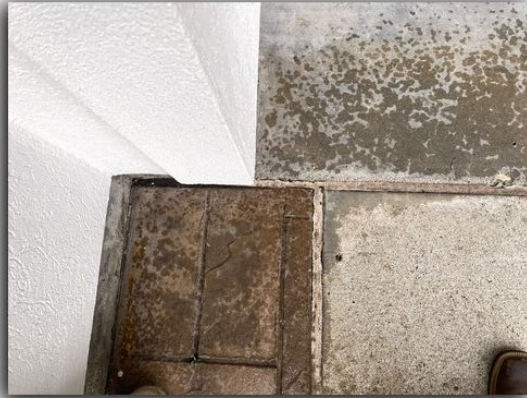
Evidence was found that this property (portions or all) has been treated for wood destroying insects in the past. Final determination of structurally significant damage to wood members (if any) cannot be determined without removal of wall coverings. Recommend client obtain additional information from seller regarding extent and location of previous infestation, chemical and company used, warranty if applicable, etc.. Houston Inspections specifically excludes hidden / latent damage if present (we cannot see thru walls).

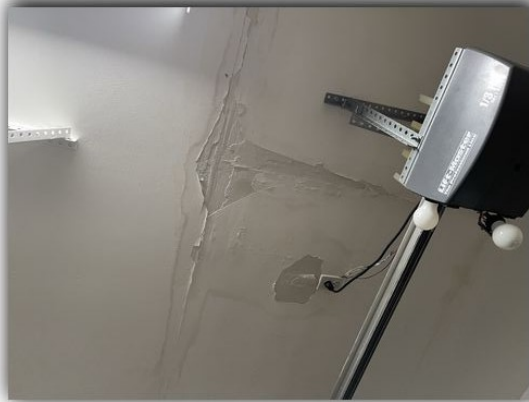
Damaged / discolored drywall was found in the garage, Kitchen Pantry and front left guest bedroom during the inspection. No abnormalities were found at this area with the infrared camera and no elevated moisture readings were observed when inspected with a pinless (non invasive) moisture meter. Recommend further evaluation to determine the needed repairs.

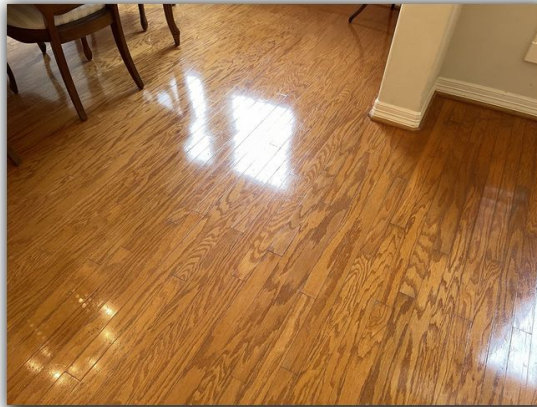
The wood floors are showing signs of wear and tear (ding's, scratches, etc.).

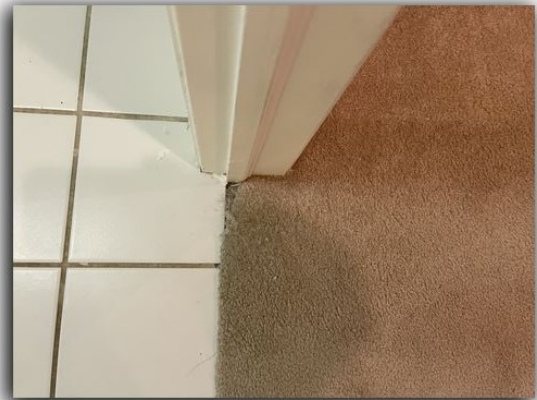
Stained and / or damaged carpet was found on the interior of the building.

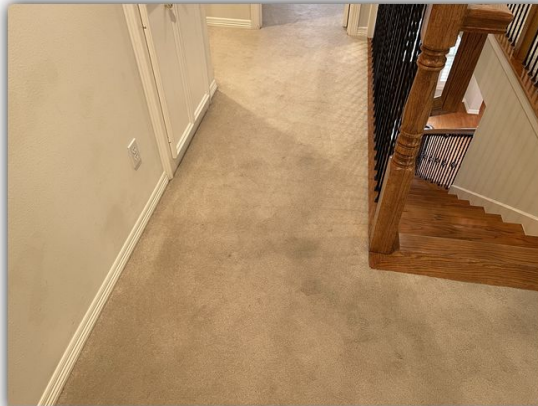
Loose flooring was noted on the second floor as evident by noise when walking. Recommend securing / re-nailing all loose flooring.

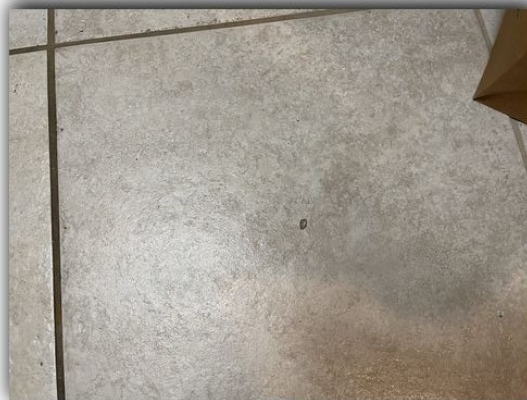
Chipped floor tiles were found in the Kitchen Pantry.

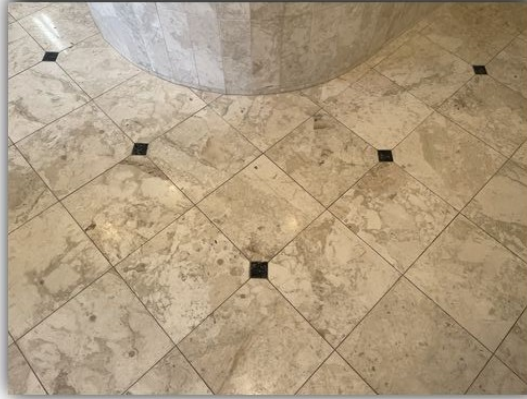
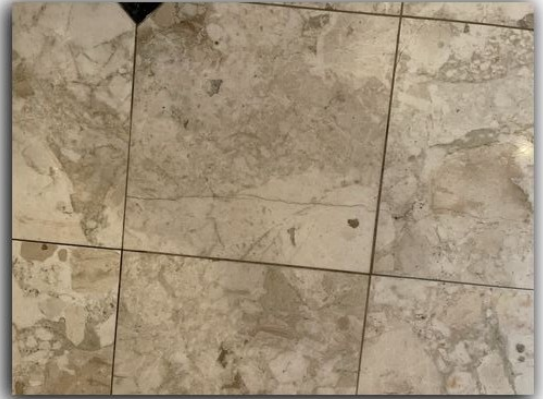
Cracked floor tiles were found in the master bathroom.

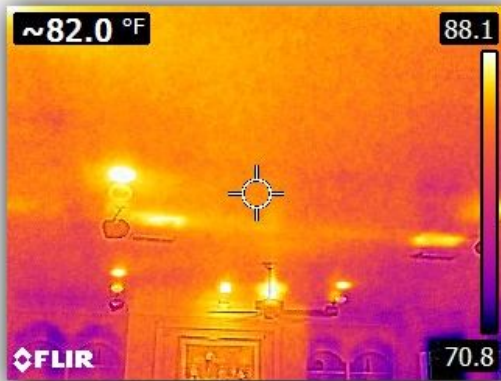
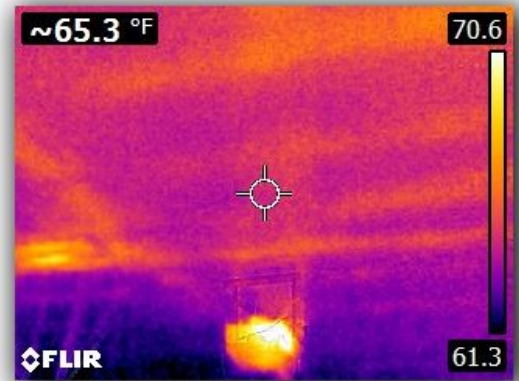
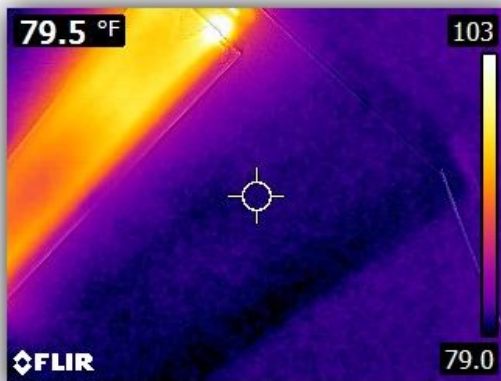
During the inspection of the ceilings on the interior of the structure with a infrared camera abnormalities were not noted. The picture(s) below are a sampling of some image(s) taken during the inspection.

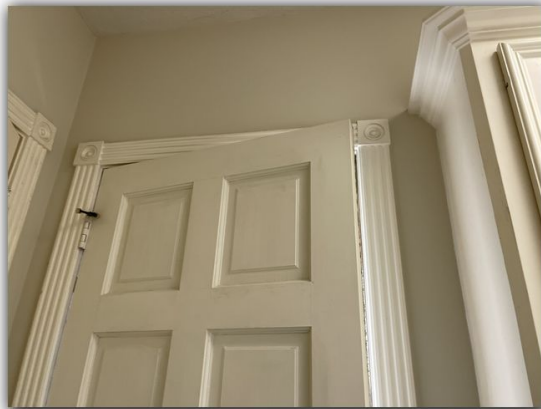
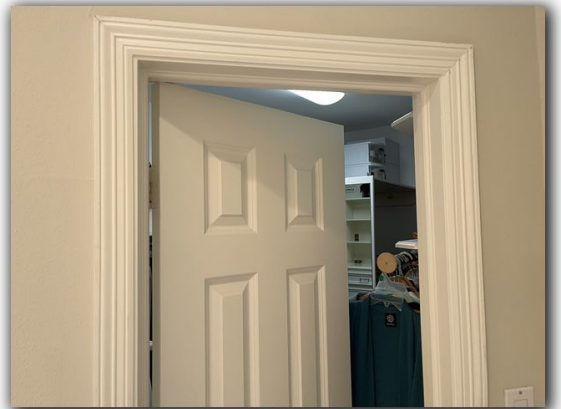
Door(s) were found in the following locations that are in need of adjustments (do not latch, stick when closed, etc).:

1. Right exterior
2. Rear master closet

All doors at the property should be adjusted to operate properly.

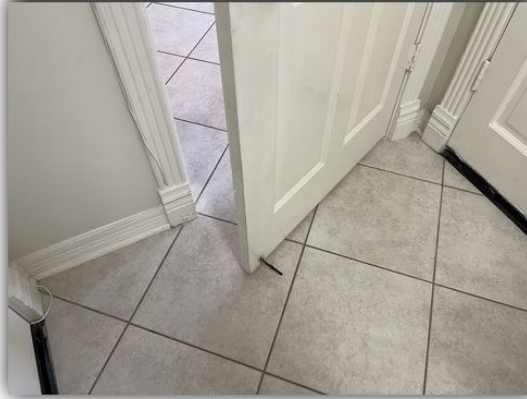
Damaged door stops were found.

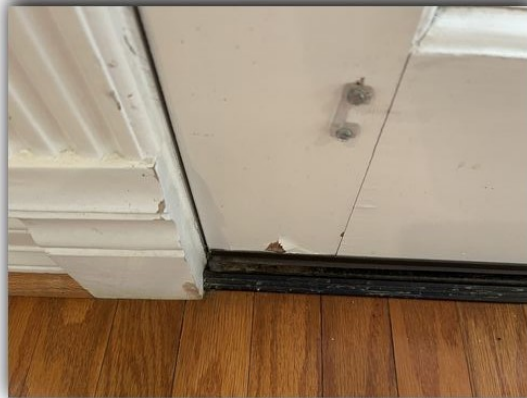
Damage was found at the rear exterior door.

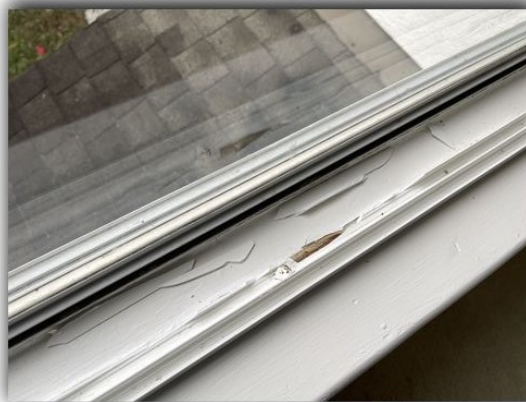
The window frame is damaged at the right front master bedroom storm window.

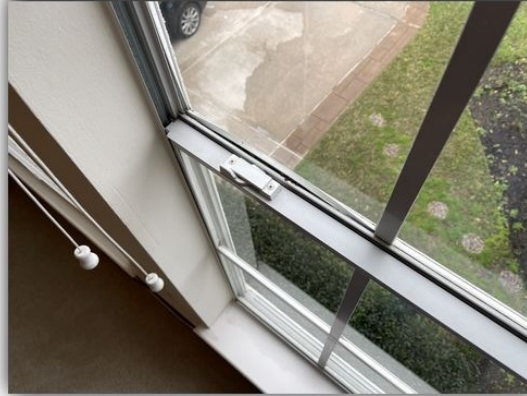
Damaged and / or missing weather stripping was noted at portions of the exterior windows. All weather stripping should be in good condition and installed at all windows.

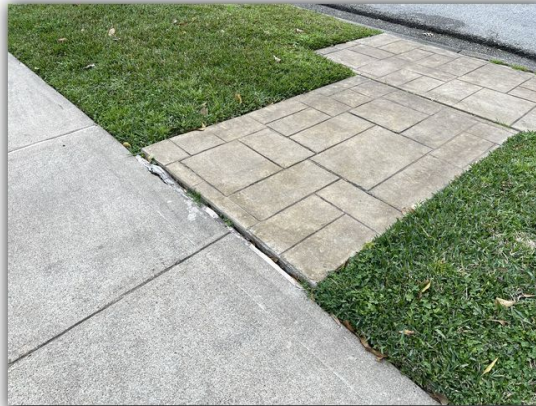
Uneven materials were observed at the flatwork. Flatwork should have a uniform surface (to prevent tripping) and slope away from the dwelling (i.e. patios, driveways, sidewalks, etc.).

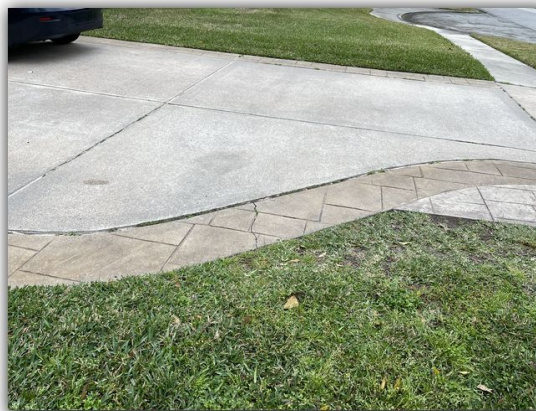
Cracking was found at sections of the driveway.

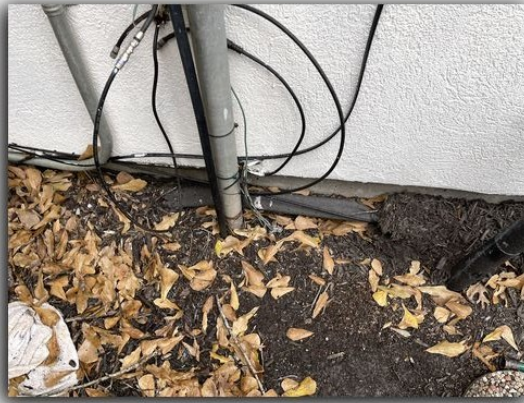
Type of Visible Grounding / Bonding: Ground Rod Connection/Water Pipe Connection

- Grounding clamp improper style for rod Installations
- Bonding not present / visible at gas lines
- Arc fault protection not installed at all required locations. Current codes require AFCI protection to be installed in kitchens, family rooms, dining rooms, parlors, libraries, dens, bedrooms, sunroom's, rec rooms, closets, hallways, and laundry rooms.
- Panel located in un-approved location (Clothes Closet, Damp Location, Etc.)
- Surge Protection not Installed Main Panel - Currently Required by Code

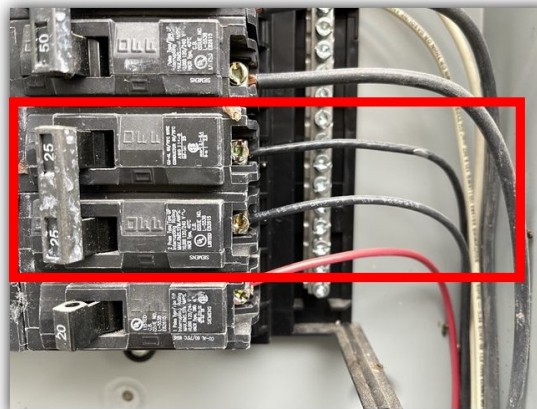
Oversized breakers were found within the exterior sub electrical panel. 25 amp breaker on 12 gauge wire. Each breaker is rated for a specific size conductor. Ideally, these breakers should be re-sized by a licensed electrician.

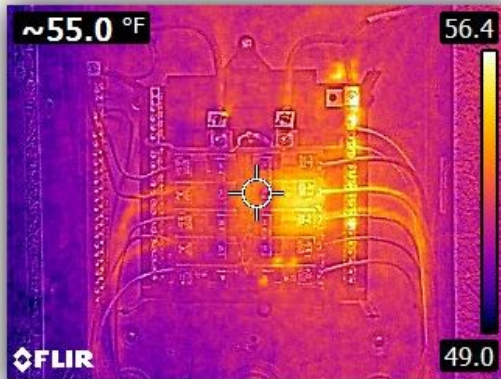
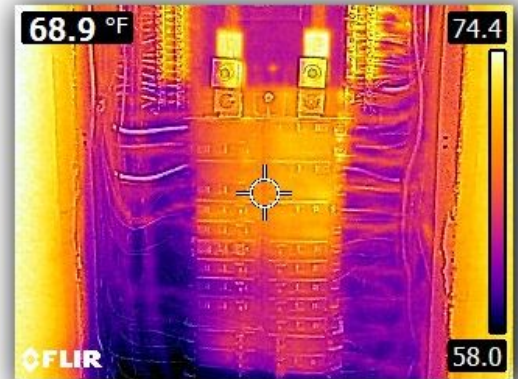
During the inspection of the electrical panel with a infrared camera significant abnormalities were not noted. The picture(s) below are a sampling of some image(s) taken during the inspection.

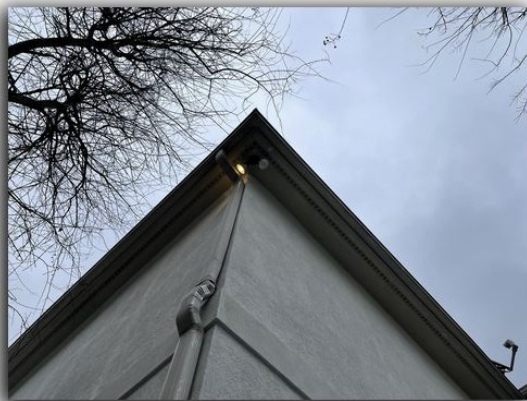
1. Exterior

If the bulbs are not blown, the circuit should be investigated.

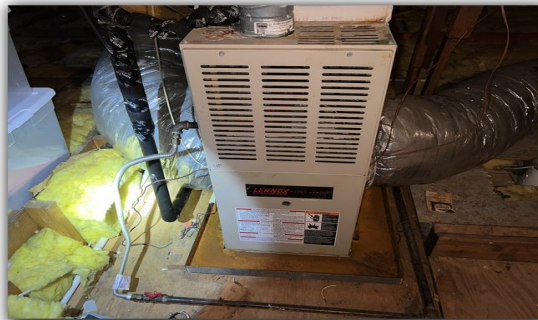
Unit #2 (second floor) heater at this property appears to be older. The client should understand that our inspections are limited to the visible and accessible components. Mechanical systems can fail at any point and the likelihood of this occurring with older equipment is higher than normal. Safety and health issues could be present and not detectable by our limited capabilities.

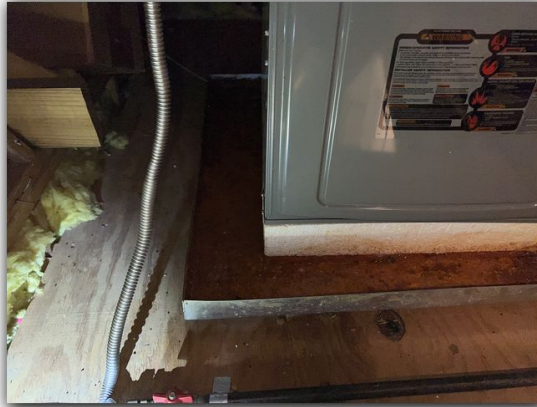
Standing water and a large amount of rust was found in the drain pan below the evaporator coil for unit #1 in the attic. This appears to be caused by condensation dripping from the housing.

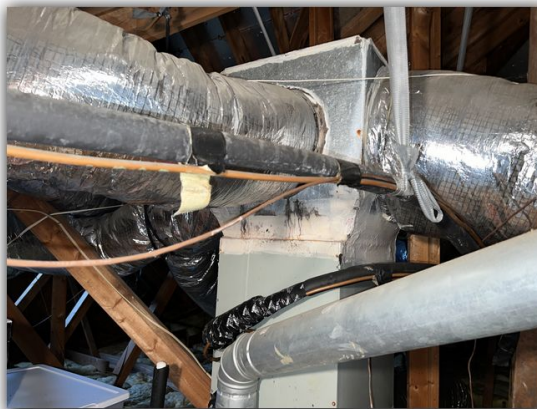
Evidence of condensation / moisture forming on the exterior of the a/c housing and components for unit #2 was found in the attic. Recommend further investigation by a licensed HVAC contractor to determine if corrective actions are needed.

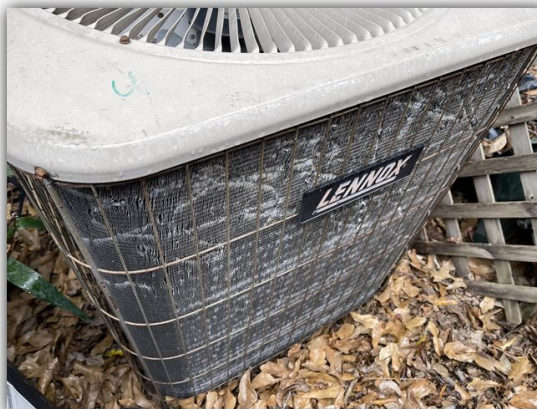
The fins at the outdoor portion of the air conditioning system(s) are damaged. This condition can reduce the efficiency of the system.

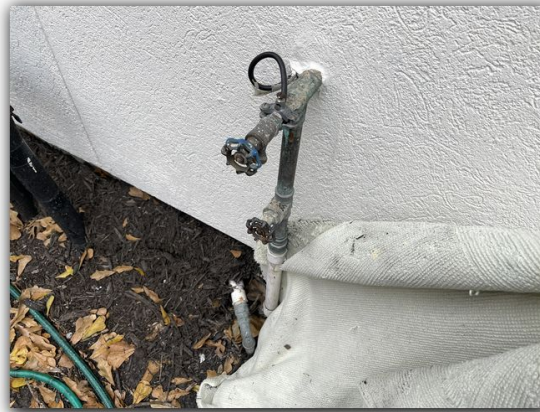
Exterior

The supply piping on the exterior of the building / structure should be insulated to protect from freezing.

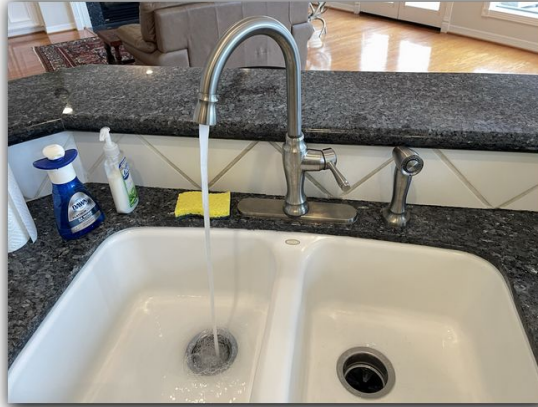
Kitchen

The sink downspout is loose at the surface the fixture is mounted on.

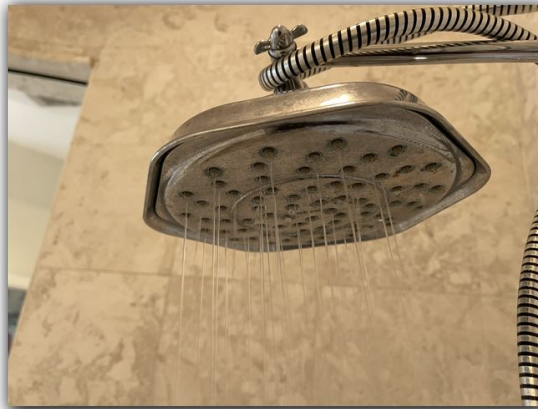
Master Bathroom

The shower aerator is in need of cleaning.

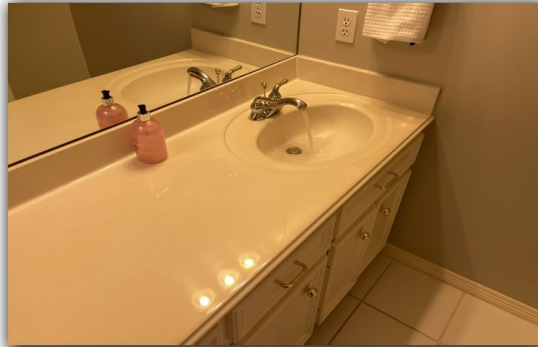
Right Guest Bathroom

The right sink downspout is loose at the surface the fixture is mounted on.

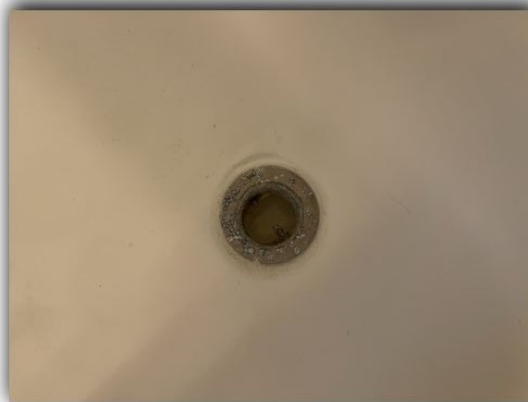
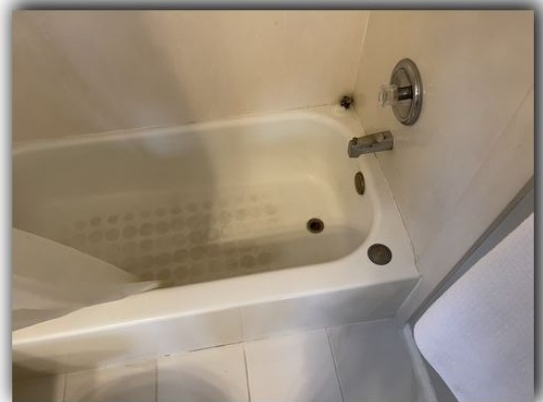
Items Damaged, Non-Functional, or Operating Improperly
Left Guest Bathroom

The tub stopper and drain components that hold the stopper is damaged.

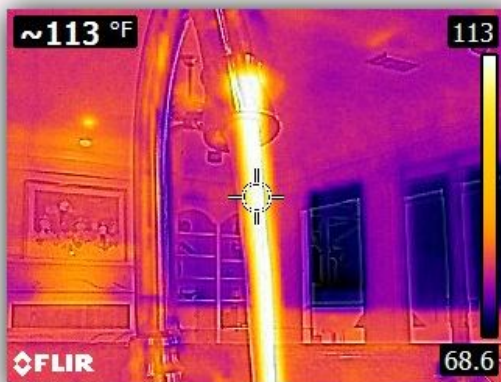
The hot water heater was functional at the time of inspection. The unit should be drained and flushed periodically to eliminate chemical deposit buildup. Adjust temperature to a maximum of 120 degrees to prevent scalding.

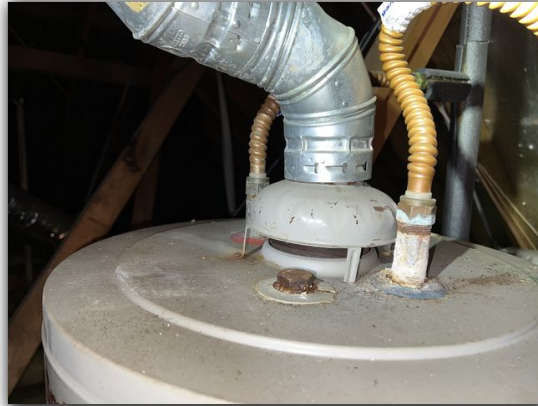
The supply piping shows evidence of corrosion where it meets the water heater. This usually occurs due to the use of dissimilar materials (copper/galvanized). The connections and corrosion should be corrected as leaks can develop. During repairs, dielectric connections should be used in an attempt to prevent future corrosion.

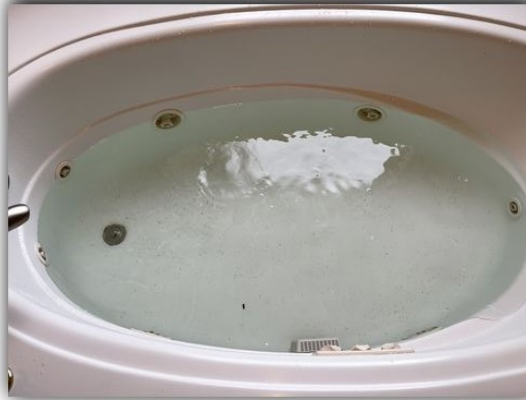
Residue was observed emanating from the jets during operation.

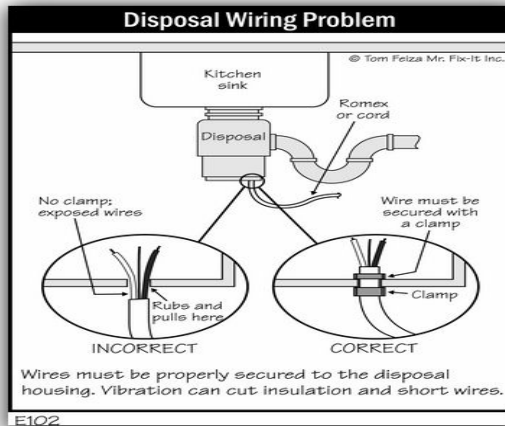
The clamp at the disposal housing and electrical conductor is loose. Recommend securing.

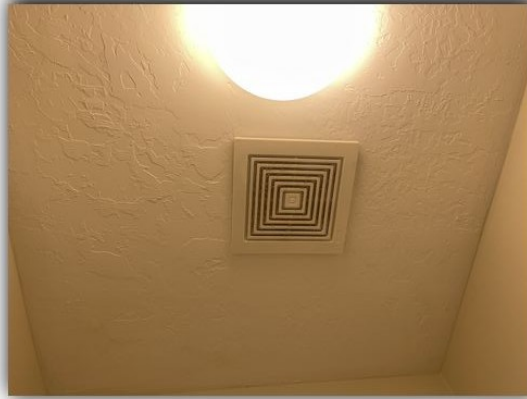
The bathroom fan covers are dirty and should be cleaned.

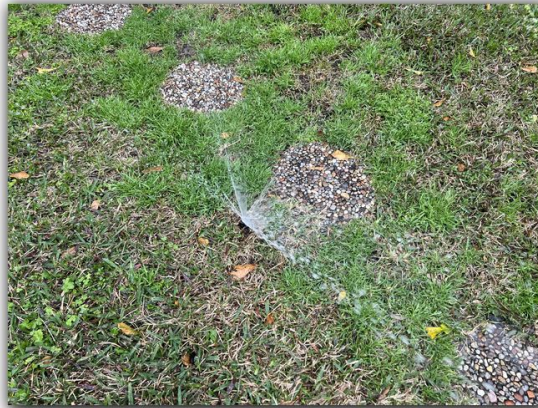
Broken sprinkler heads were found in zone #1. A qualified tradesman should be consulted to perform all necessary repairs.

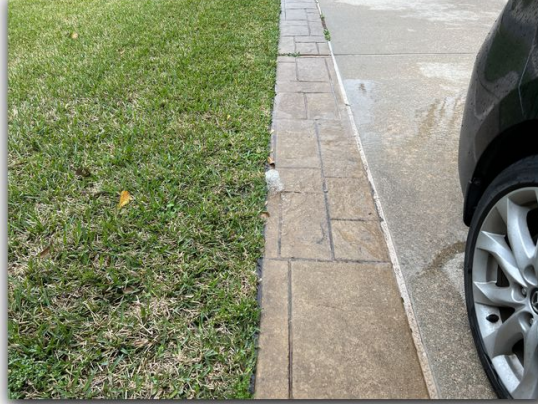
Evidence of underground leaks were found during the operation of zone #4 & #5 as evident by water surfacing from the ground. A qualified tradesman should be consulted to perform all necessary repairs.

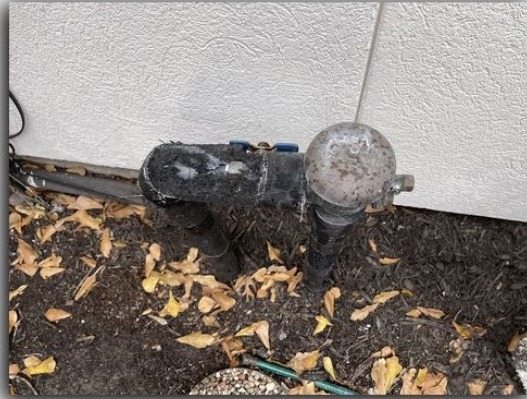
Damaged and missing insulation was found on the piping at the backflow prevention valve. The insulation should be replaced where needed.

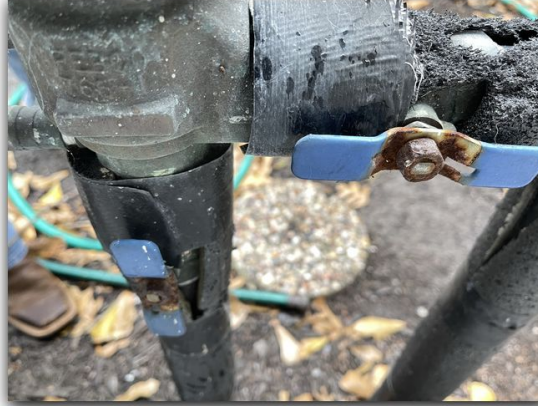
Rust and corrosion were found at the valve handles installed at the backflow prevention device. The valve handles should be repaired as the rust will eventually cause the handles to become inoperative.

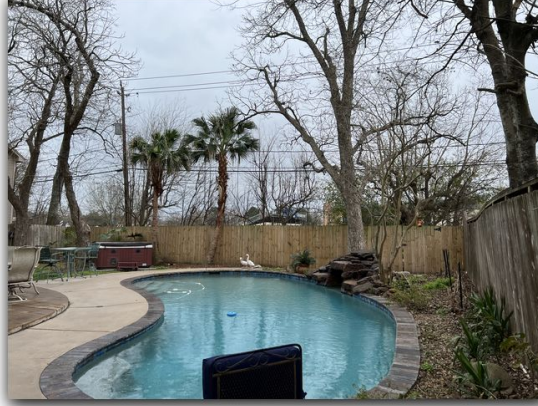
Overhead electrical service present, Do not use metal tools
Due to the electrical service for this property coming in above ground the use of metal tools around the pool is not recommended. This is a serious safety issue.

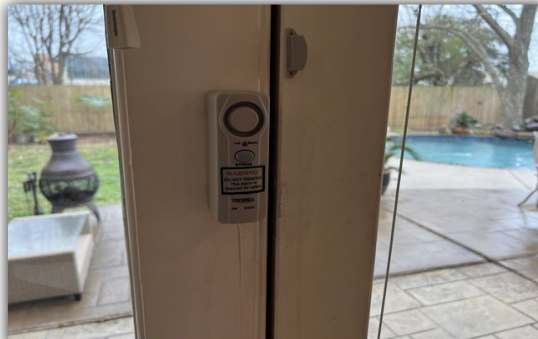
The alarm for the door leading to the pool area has been disabled.

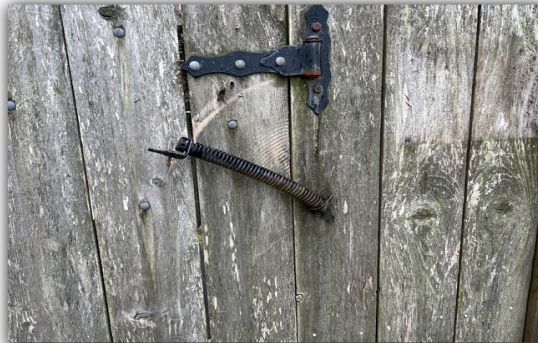
The self closing mechanism at the gates should be adjusted to fully close and latch.

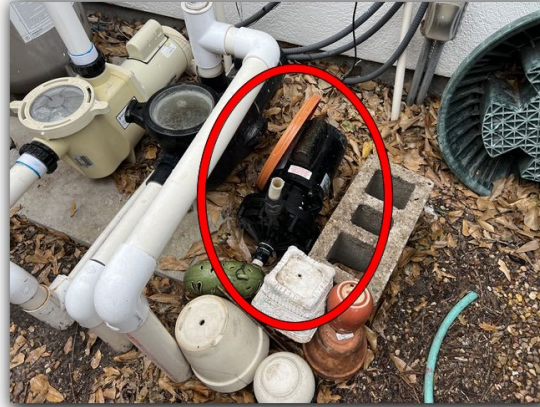
An abandoned pump was found at the pool equipment.

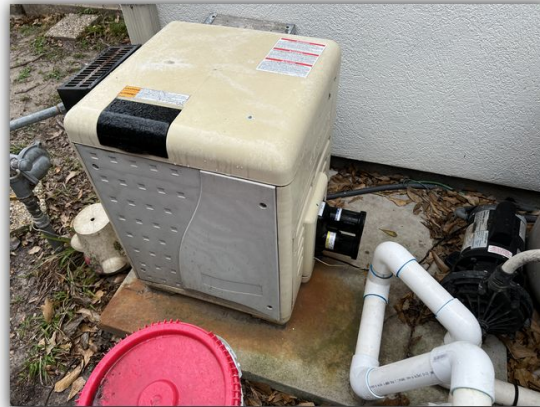
The pool heater has been disconnected and is not in use.

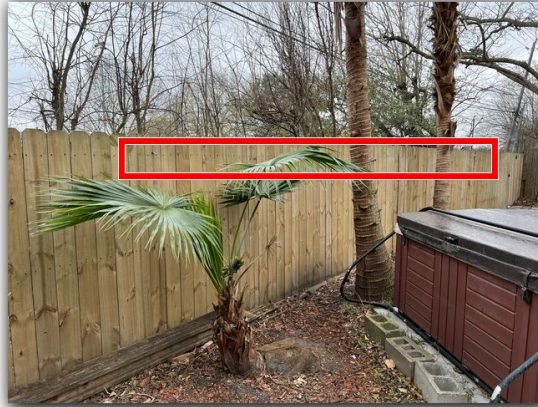
Nozzles not functioning were found at the sides and back fence during testing of the system.

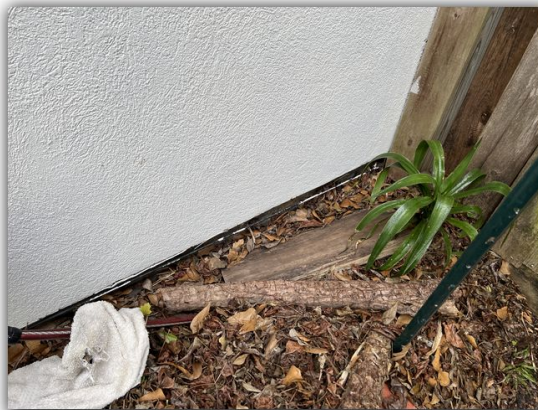
Loose tubing was found at portions of the fencing and exterior walls.
