September 30, 2023

PROPERTY INSPECTION REPORT FORM

15007 Ridingwood Dr., Missouri City, TX 77489

Will Worthen

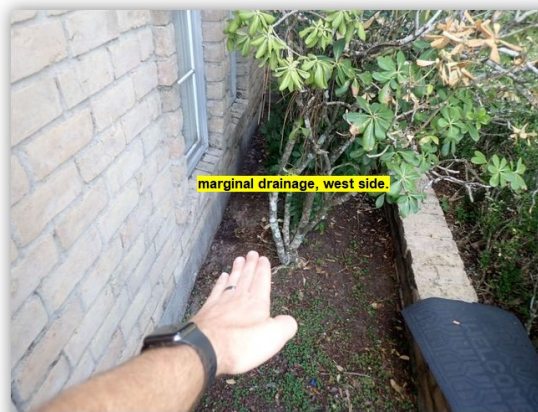
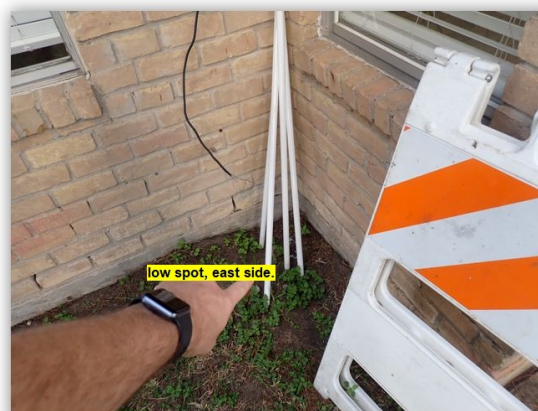
Grading & Drainage

- Ground erosion was observed on the east side, west side of the structure. Fill dirt is needed against the foundation perimeter wall where the soil line is too low to help support the foundation footer properly.
- Fill dirt is needed on the east side, west side of the structure. The low spots in the finished grade (ground) adjacent to the foundation perimeter wall should be filled in to help prevent water from standing and/or ponding next to the foundation area.
- The soil line is too high on the south side, east side of the garage structure. Under current building standards there should be at least 4-inches of foundation visible below masonry veneer and 6-inches of foundation visible below wood type veneer.

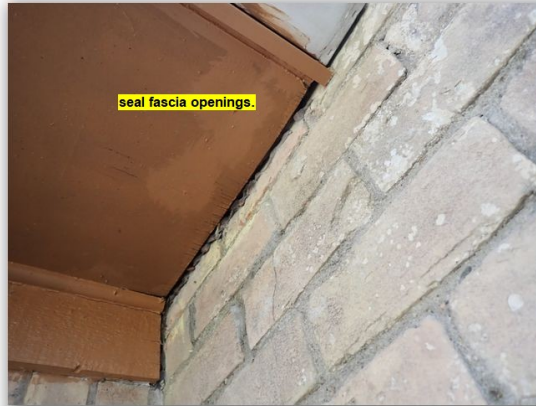
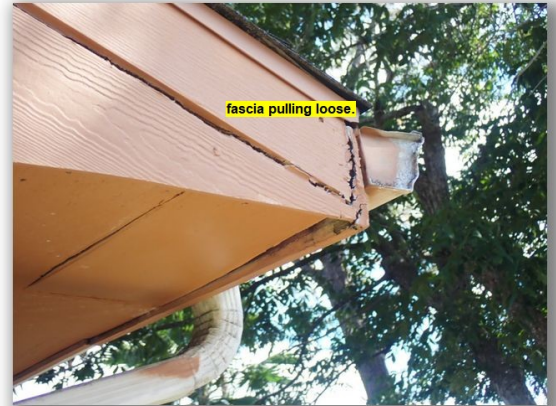
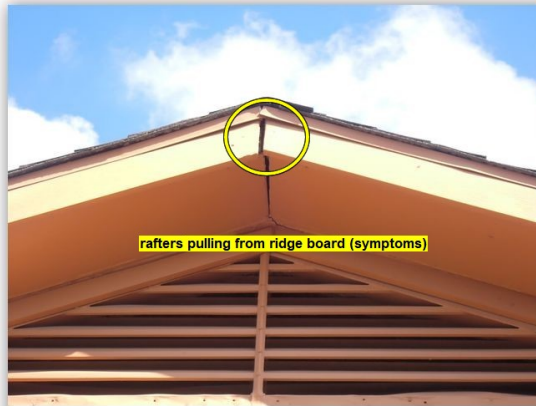
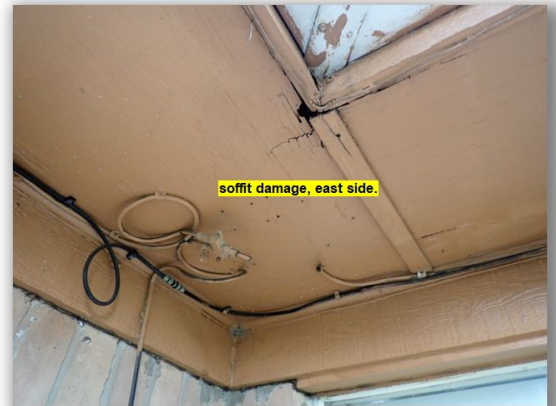
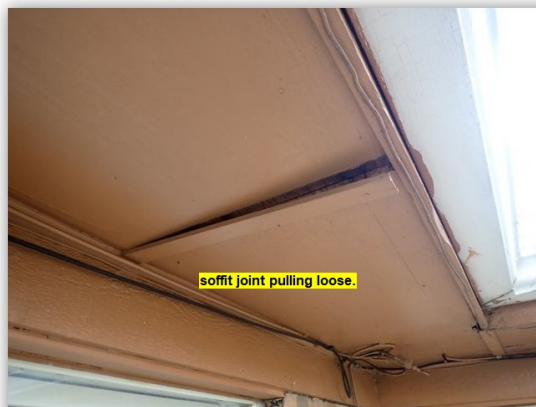
Roof Structure

- It is recommended to seal all openings between the soffit and roof covering to prevent pest/rodent intrusion at this point.
- Frieze board separations were observed.
- The soffit material has some deterioration and/or damage on the east side of the roof structure.
- One or more of the roof structure rafters were observed to be pulling away from the top ridge board.
- The soffit material is sagging and/or pulling loose on the east side of the roof structure.

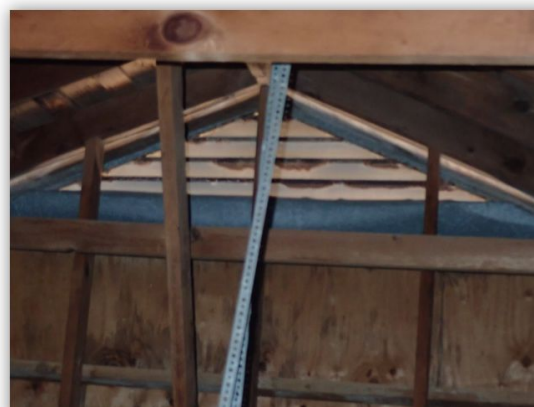
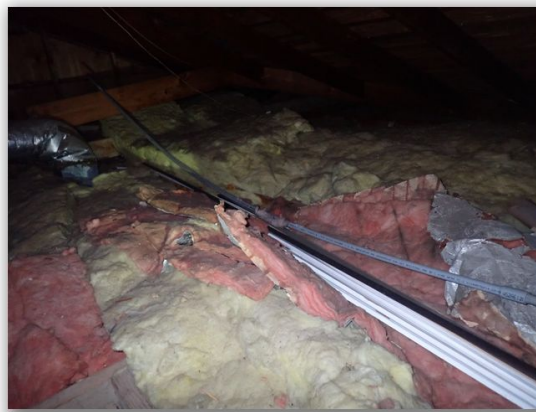
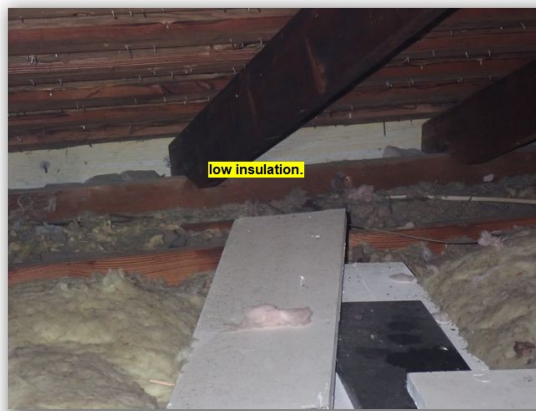
Attic Insulation

- The attic insulation is lower than typical and it is recommended to add additional insulation to achieve at least a R-30 rating.
- The attic floor insulation should be redistributed in one or more locations.

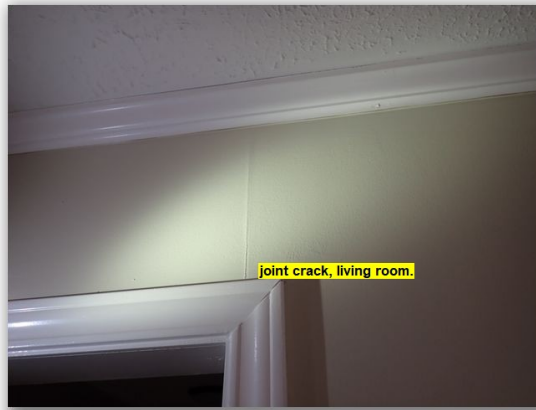
joint crack, living room.

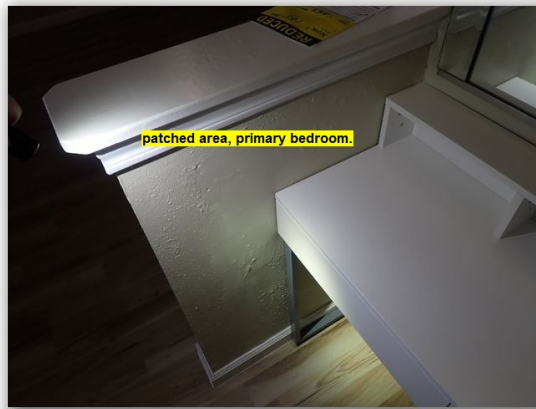
patched area, primary bedroom.

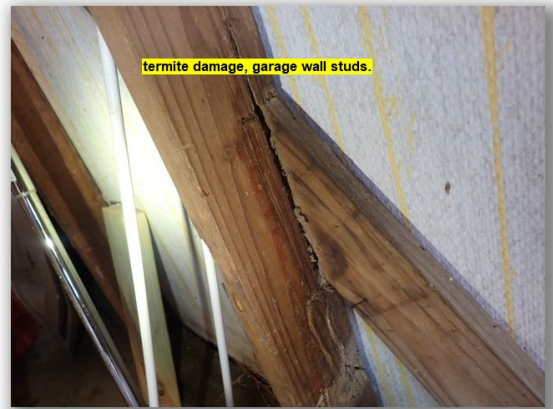
termite damage, garage wall studs.

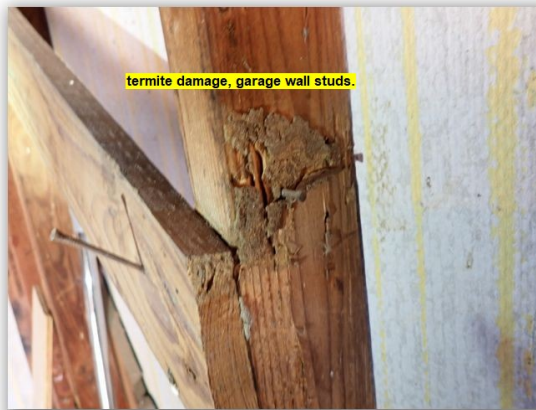
termite damage, garage wall studs.

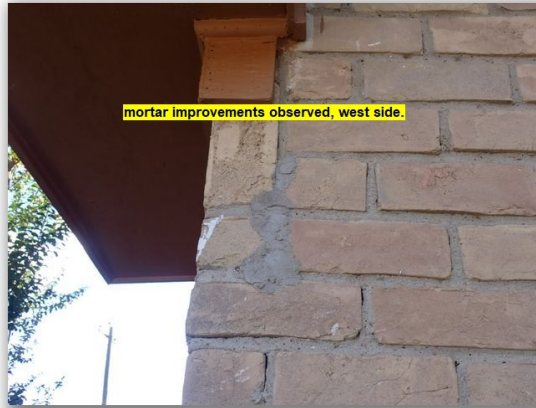
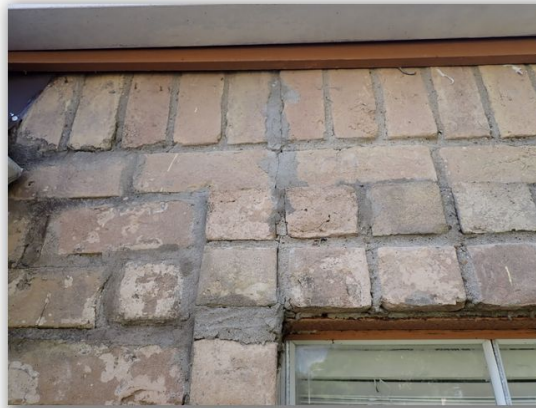
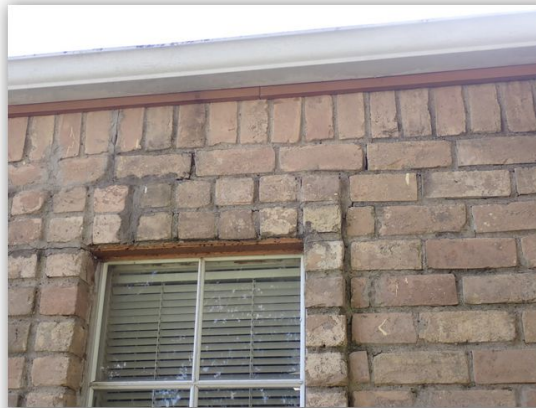
- Deflection cracks were observed in the exterior veneer on the south side of the structure.
- Mortar improvements are recommended for the exterior masonry veneer on the north, east, west and south sides of the structure.

- One or more of the exterior bricks were observed to be damaged on the west side of the structure.
- There were no weepholes observed in the lower course of the exterior masonry veneer over the window and door steel lintels. This condition does not meet current building standards and should be corrected as necessary.

- The exterior veneer / cladding has some deterioration and/or damage on the south side, east side of the garage structure.
- The exterior veneer / cladding was observed to be pulling loose and should be better secured on the south side of the garage structure.

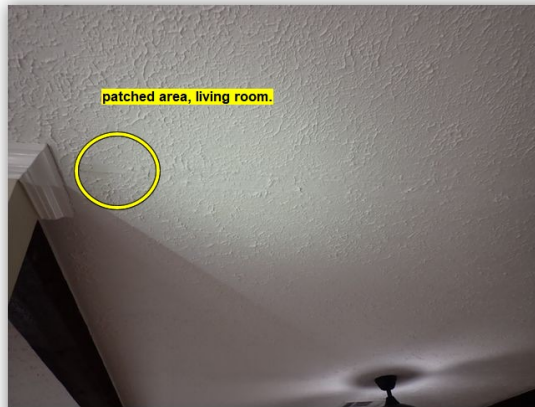
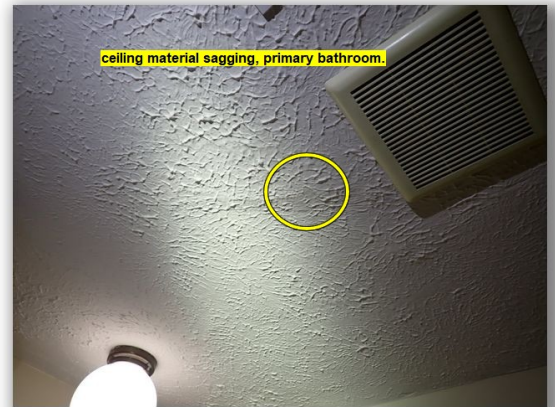
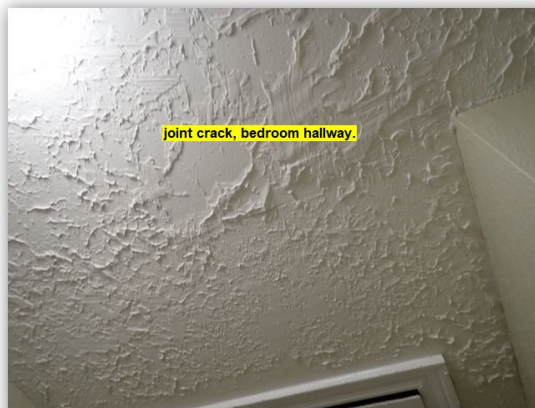
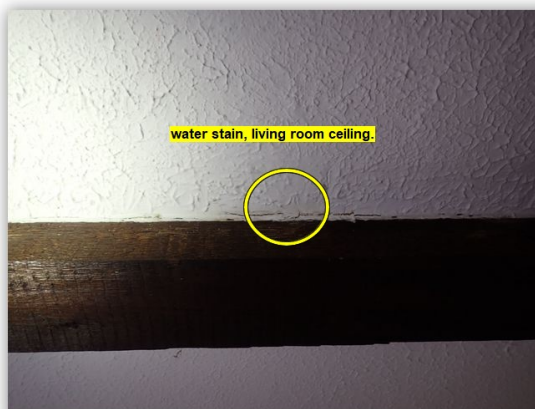
- Some of the ceiling finishing material was observed to be sagging in the primary bathroom.
- Ceiling joint cracks were observed in the bedroom hallway.

- Water stains were observed on the ceiling finish in the living room. The cause and remedy should be further evaluated and corrected as necessary.

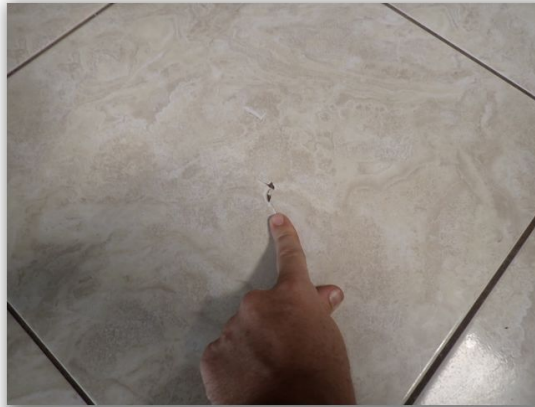
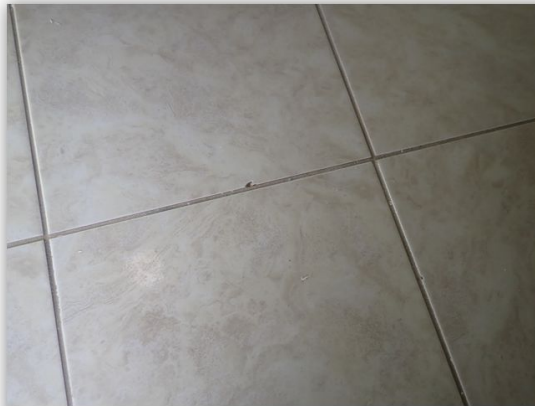
- The floor tile(s) were observed to be cracked and/or damaged in the kitchen, primary bathroom, hall bathroom.
- The floors were observed to be out-of-level in some areas of the house.

Note: Some cracking of the garage concrete floor finish was observed.

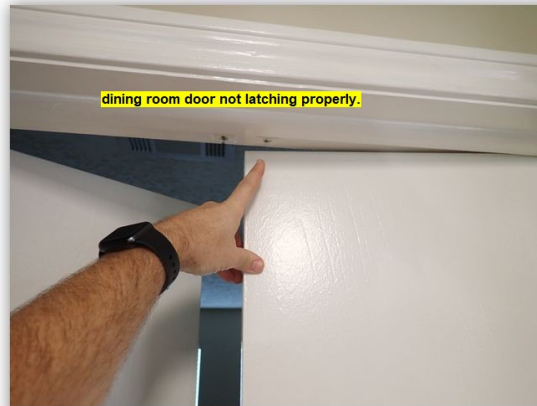
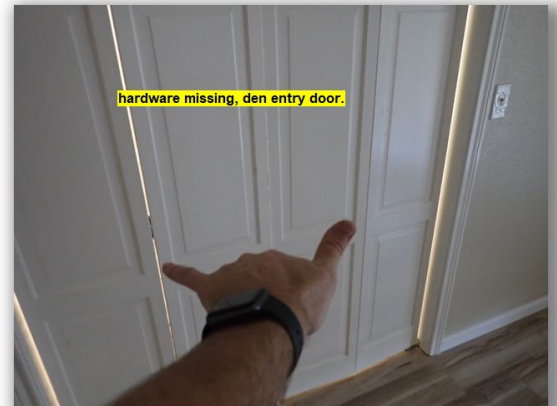
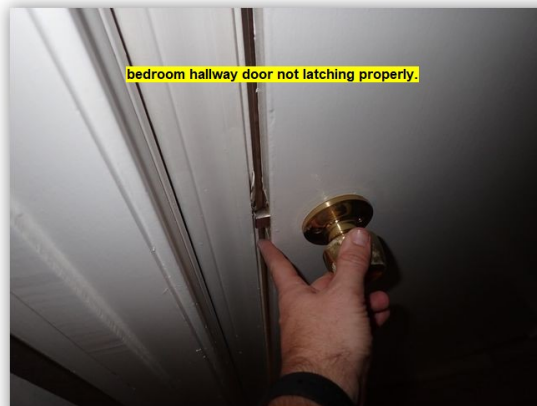
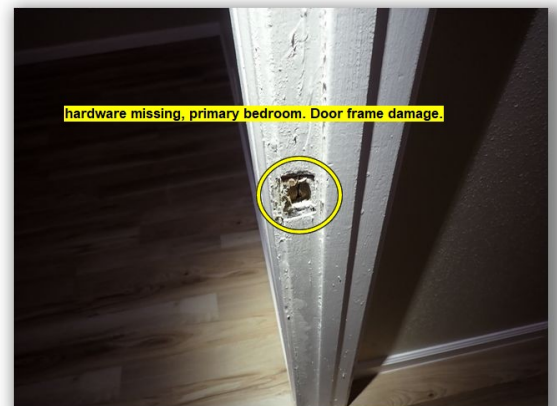
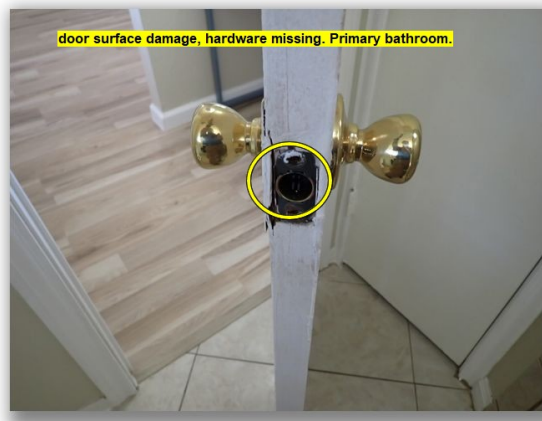
- The door hardware is missing to the den area, primary bedroom, primary bathroom.
- The door is not latching properly to the dining room, bedroom hallway.
- The door frame is damaged to the primary bedroom.
- Surface damage was observed to the door in the primary bedroom.

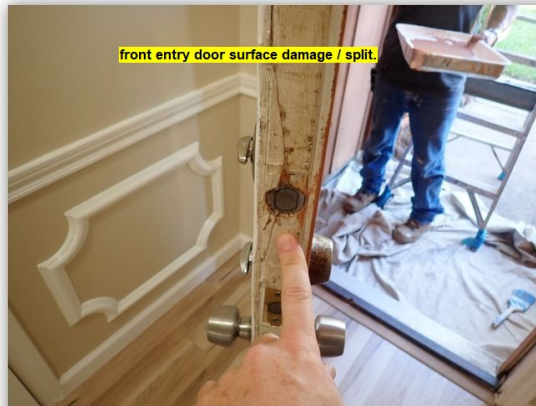
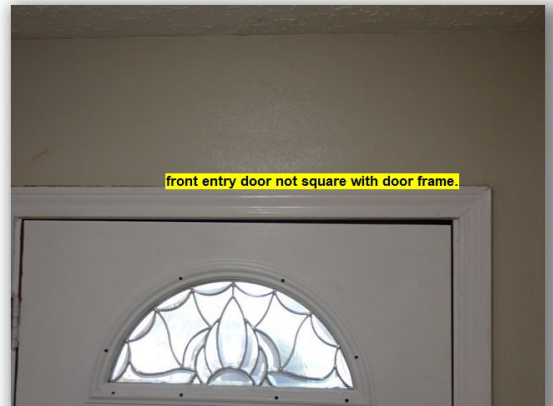
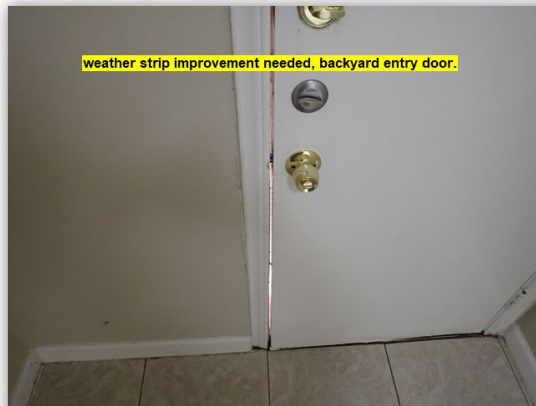
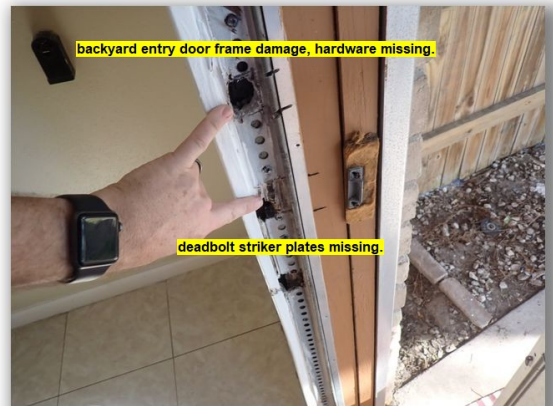
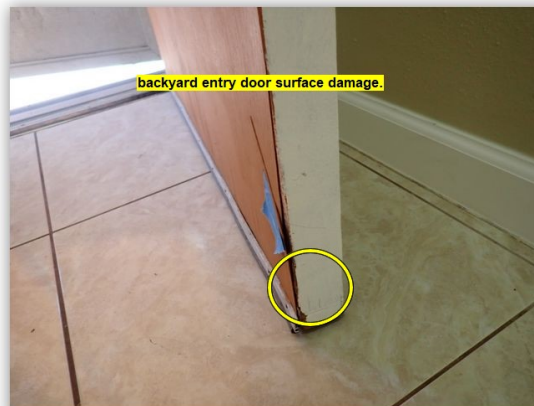
- Surface damage was observed to the door in the front entry door, backyard entry door.
- The front entry door was observed to be out of square.
- Weather-stripping improvements are recommended for the backyard entry, front entry exterior door(s).

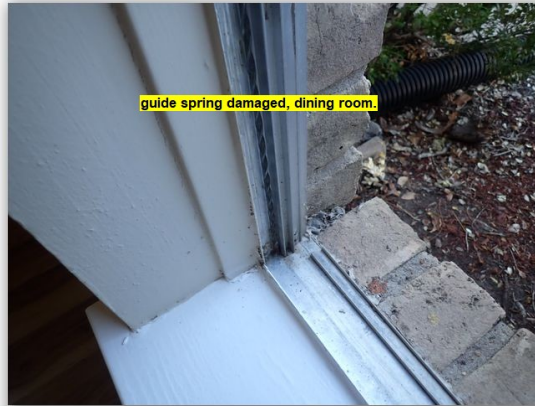
- One or more of the window screens were observed to be damaged.
- One or more of the window screens were observed to be missing.

- The window sash guide is damaged in the dining room.

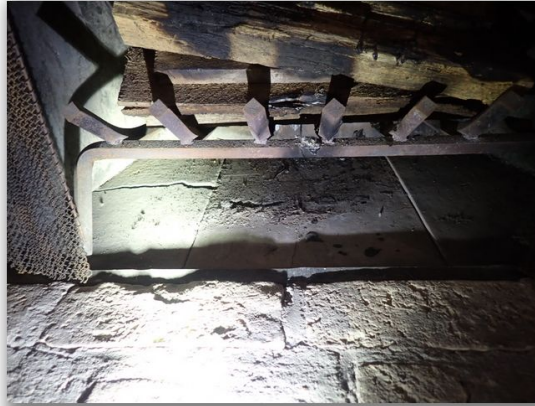
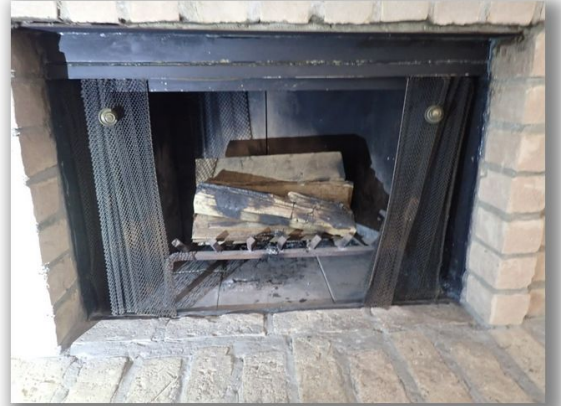
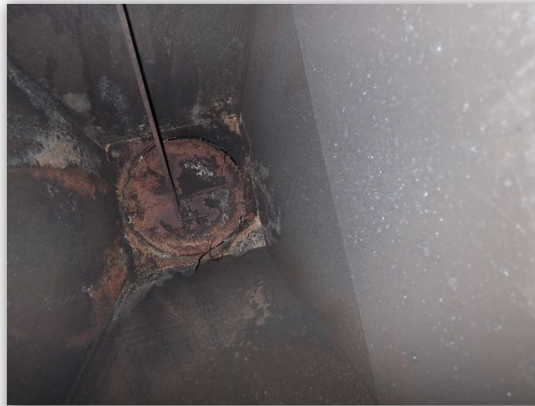
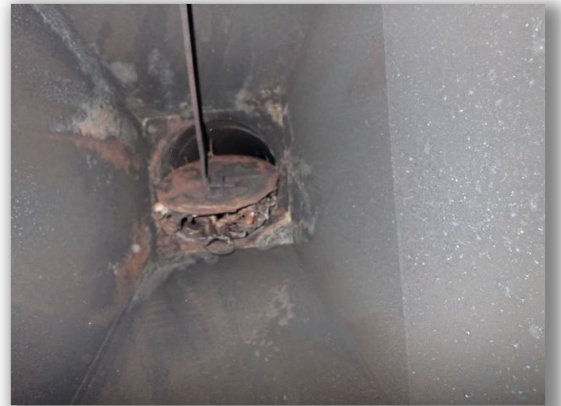
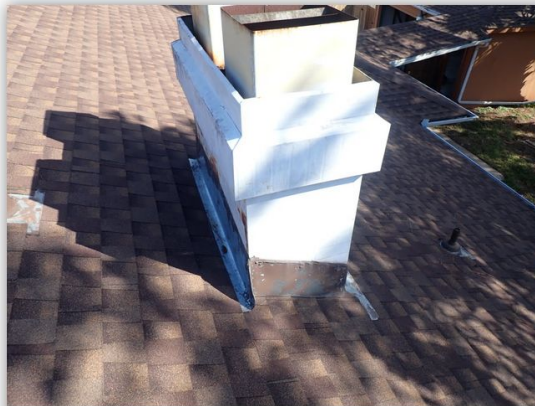
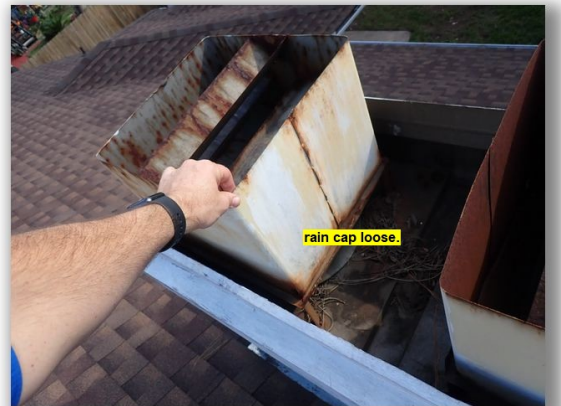
- The chimney flue should be cleaned by a Qualified Chimney Sweep. A creosote / soot build-up was observed in the visible flue area.
- The firebox base was observed to be cracked and/or damaged. This condition should be further evaluated and corrected as necessary.
- One of the rain caps was observed to be loose on the rooftop chimney.

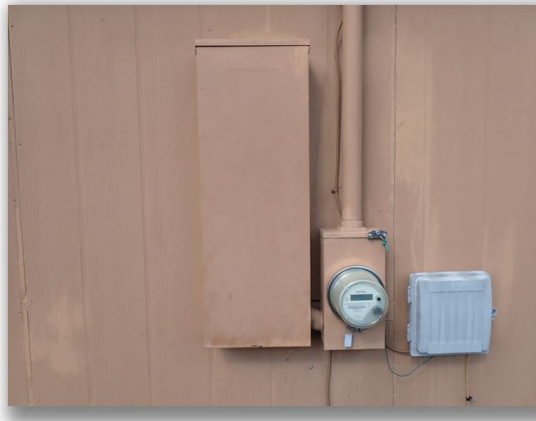
- There is no ground fault circuit interrupter type breaker for the dryer outlet, electric oven installed at the panel box. This does not meet current building standards.
- The breakers (overcurrent devices) in the electrical panel are not properly labeled.
- There is no surge protection device installed at the panel box. Under the current National Electrical Code, all electrical systems should have surge protection. This is an "as built" condition. It is recommended to add a surge protection device to the panel box.
- All openings (missing knockouts) in the electrical cabinet cover plate (dead front) and /or cabinet should have fillers.
- The electrical cabinet cover plate (dead front) should be installed with blunt tip screws and not sharp wood type screws for reasons of safety.

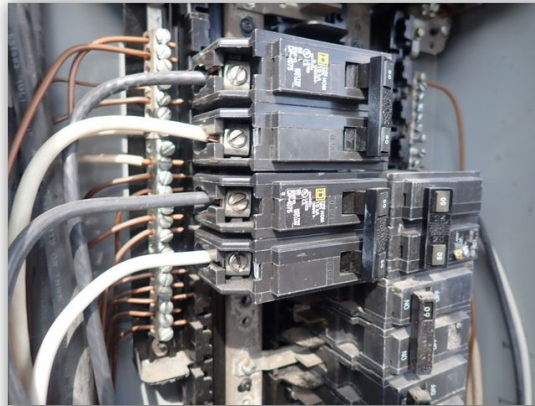
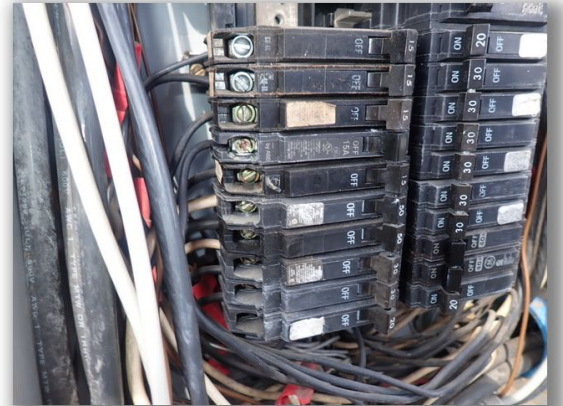
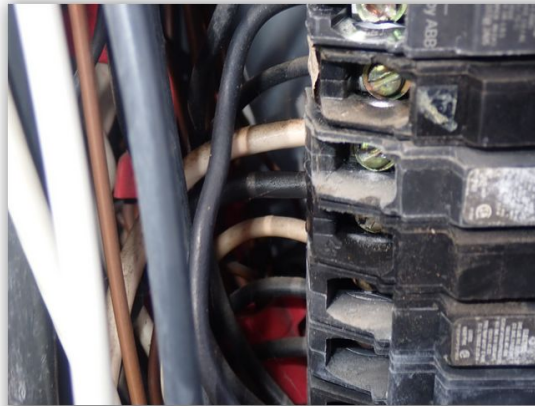
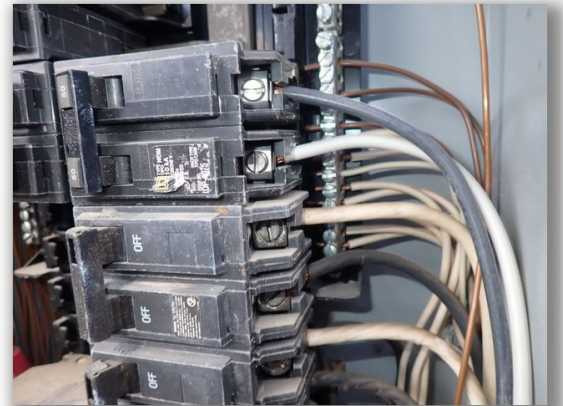
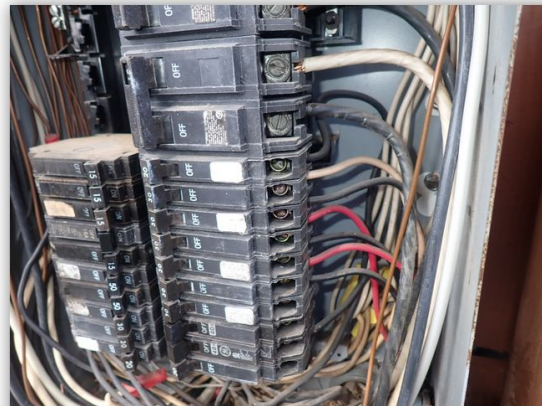
Arc-Fault Circuit Interrupter Protection (AFCI)

- None of the required dwelling unit devices, receptacle and lighting outlets (switches, receptacles and fixtures) are connected to an arc-fault circuit-interrupter (AFCI) circuit device. AFCI devices were first required under the 1999 National Electrical Code and under the 2014 NEC, all living space, kitchen and laundry room devices, receptacle and lighting outlets (switches, receptacles and fixtures) should be connected to an arc-fault circuit interrupter (AFCI) device.

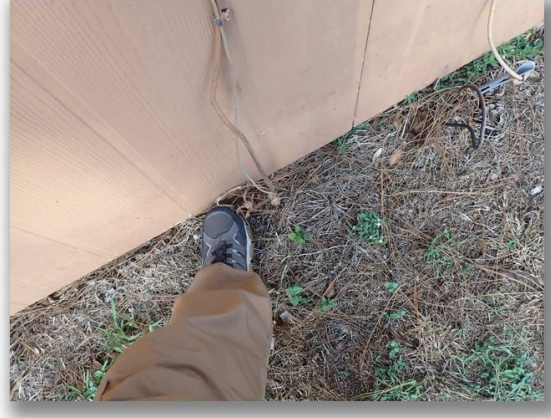
- Open electrical junction box(es) were observed in the kitchen, garage. All open junction box(es) should be properly enclosed for reasons of safety.
- Spliced electrical wires were observed in the attic area, garage. Spliced wires should be properly enclosed in junction box(es) for reasons of safety.
- Open end wires were observed in the east exterior wall. Open end wires should be properly enclosed in a junction box for reasons of safety.

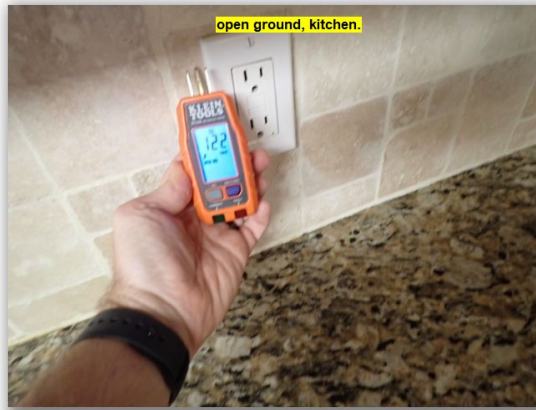
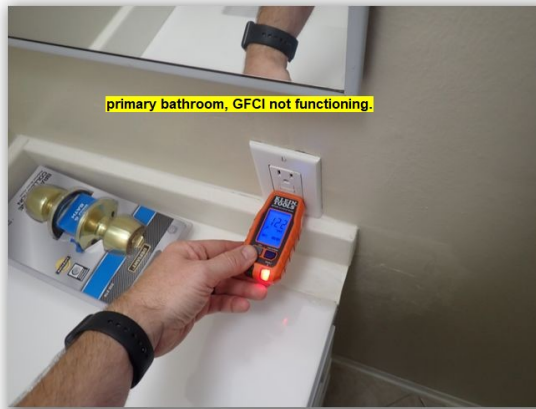
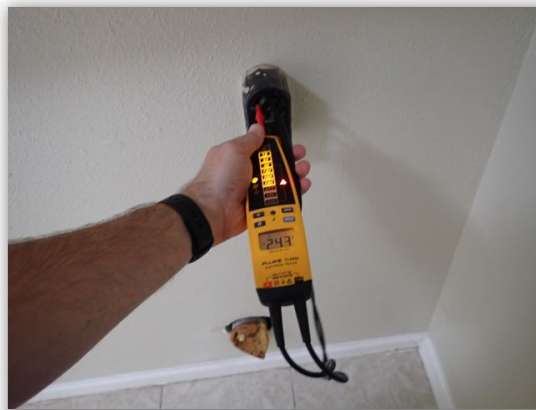
- One or more of the receptacles were observed to have an open ground connection in the kitchen, living room.
- One or more of the receptacles were observed to be damaged in the several locations throughout the house.

- All exterior receptacles should have weather tight covers. The receptacle weather cover plate is damaged and/or missing on the west exterior wall, east exterior wall.

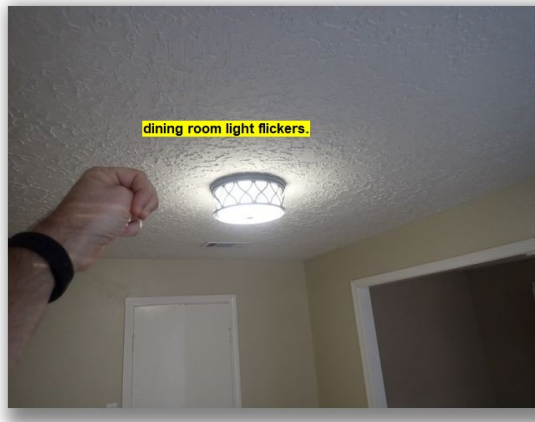
Fixtures

- One or more of the light fixtures are not functioning properly in the dining room.
- The ceiling fan is not balanced properly and wobbles when operated in the living room, front middle bedroom, front corner bedroom.
- One or more of the exterior light fixtures were observed to be damaged on the garage west soffit.

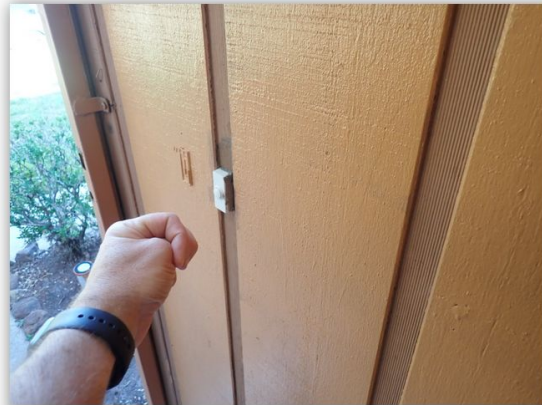
Doorbell / Chime

- The doorbell and/or associated components are inoperative.

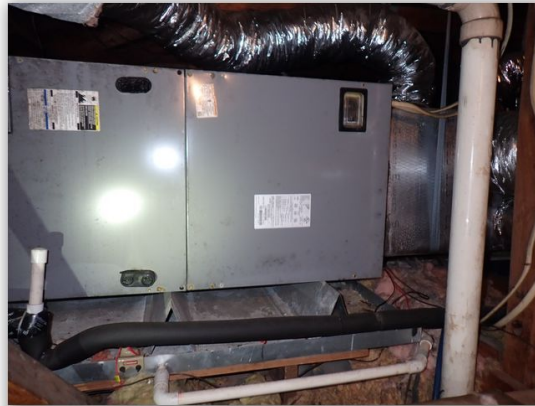
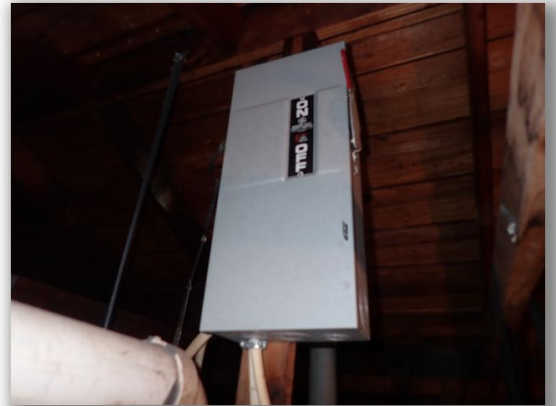
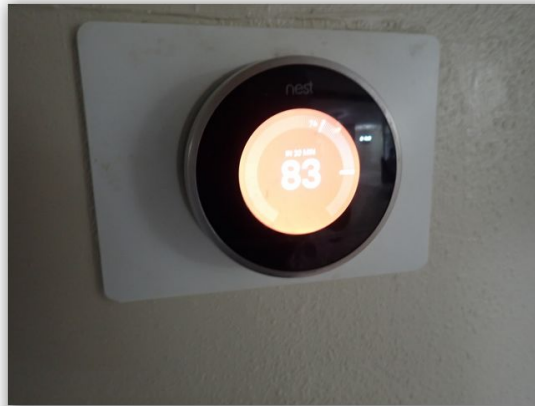
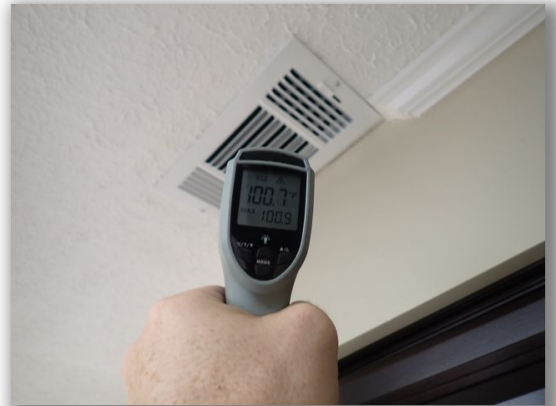
- The dirty air filter should be replaced.

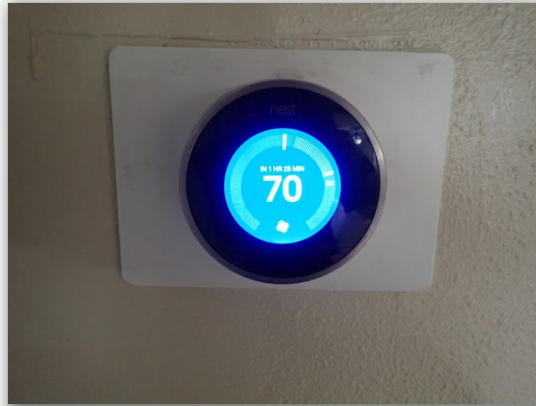
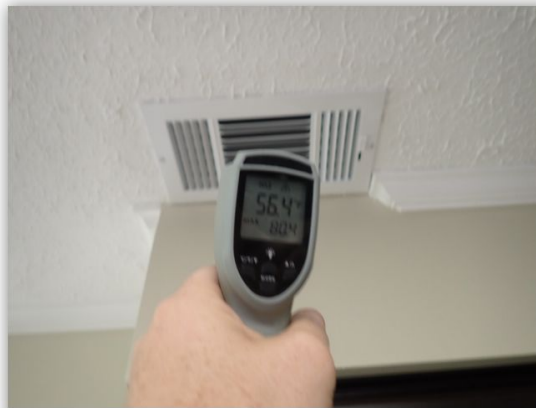
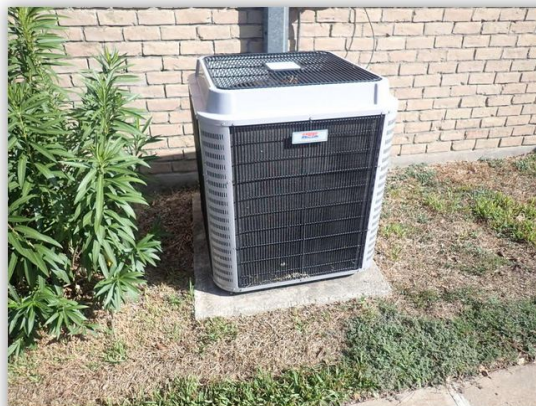
- The AC tonnage size may not be correct for the amount of air conditioned space of the property. It is recommended to have a licensed HVAC technician perform a load/size calculation to verify the correct AC tonnage size for the property.
- The dirty air filter should be replaced.

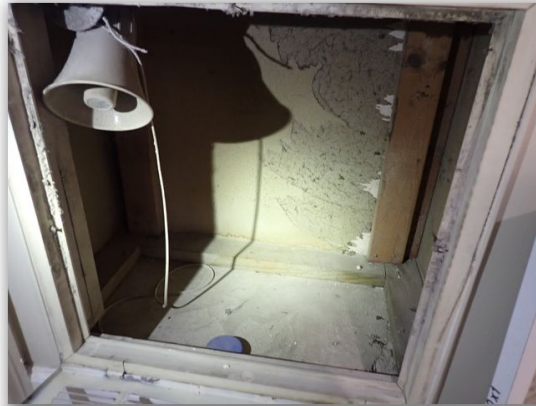
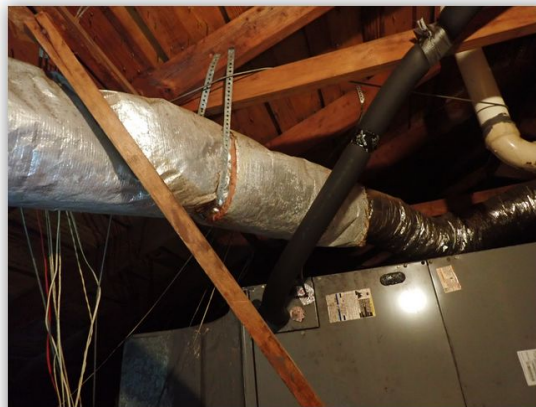
- The duct work in the attic area is not properly separated to help prevent condensation from developing. It is recommended to separate the duct work with a minimum intervals of 1.5-inches.
- The air-return chase for the HVAC system is dirty and should be cleaned to help maintain good air quality.

Additional Notice from the Inspector: The ductwork was observed to be older and in poor condition. It is recommended to replace the ductwork for improved air quality and efficiency.

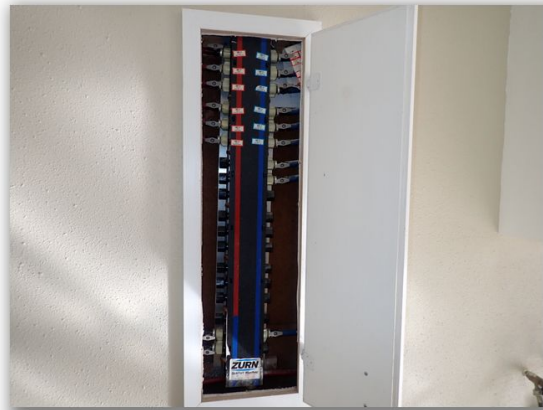
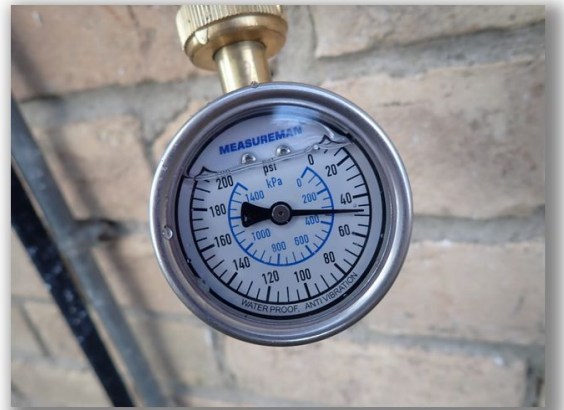
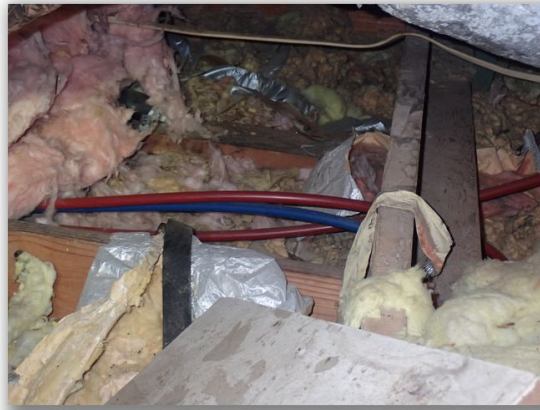
Exterior Faucets/Fixtures

- One or more of the exterior water hose bibs (faucet) do not have a back-flow or anti-siphon device (Vacuum Breakers) in place.

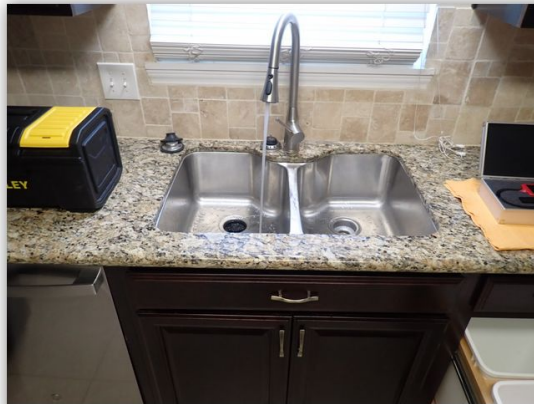
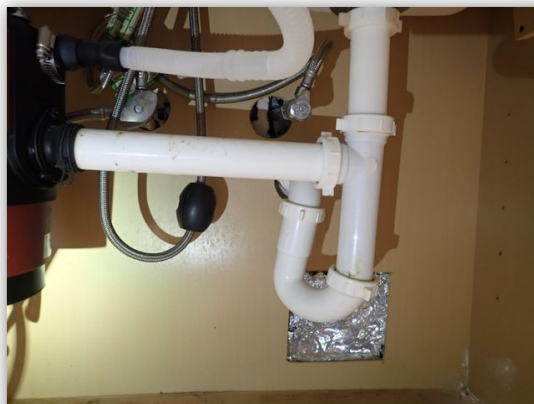
Kitchen Sink

- The drain leaks water into the cabinet.
- The faucet hot/cold water orientation is reversed.

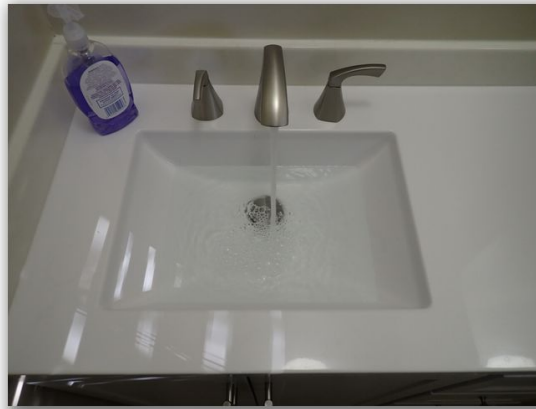
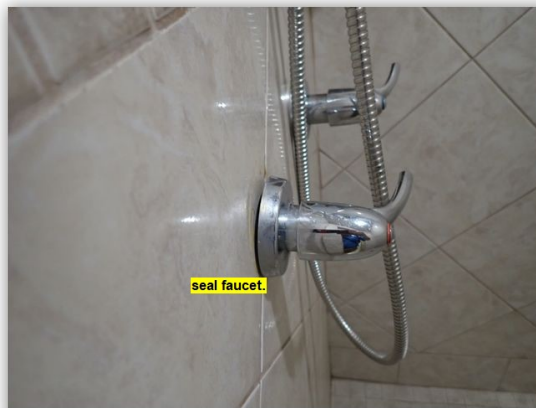
Shower

- The faucet assembly is not properly sealed at the wall. This condition has the potential to allow water to leak back into the wall cavity.
- The shower enclosure door does not function properly.
- Cracked, deteriorated and/or missing grout and/or caulking should be repaired or replaced as necessary.

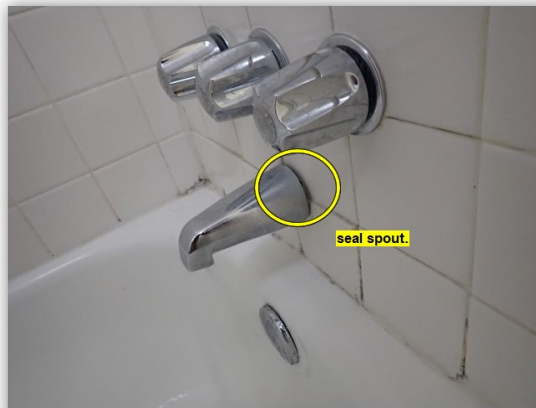
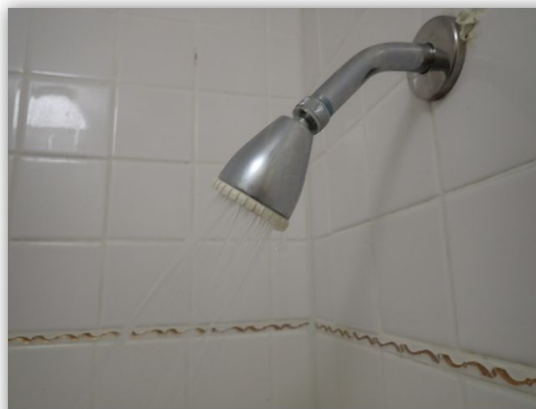
Bathtub

- Some of the enclosure tiles were observed to be cracked.
- The tub spout is not properly sealed at the wall. This condition has the potential to allow water to leak back into the wall cavity.

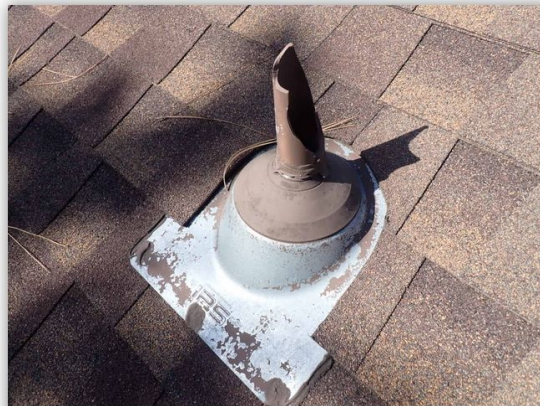
- One or more of the plumbing vent stacks was damaged.

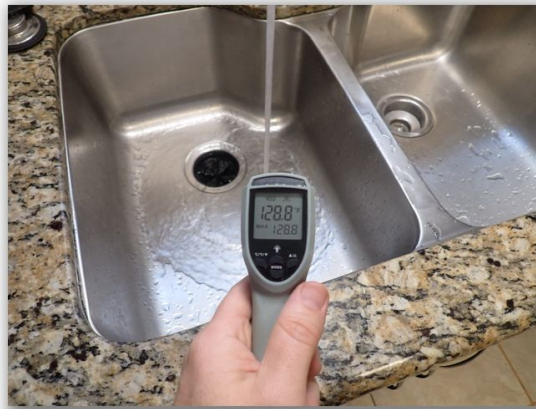
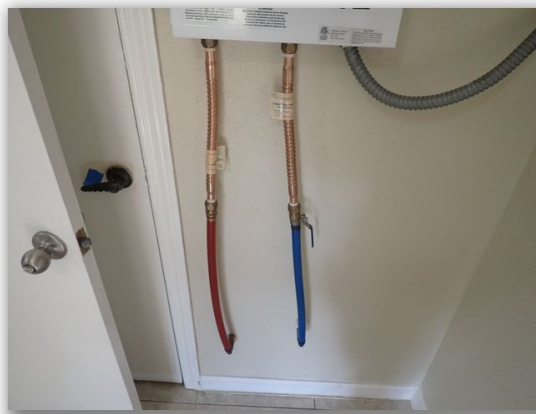
- I was unable to locate or observe a service disconnect at or around the water heater.
- There is no visible pressure relief valve in place for the water heater. This condition should be corrected to help prevent damage to the structure.

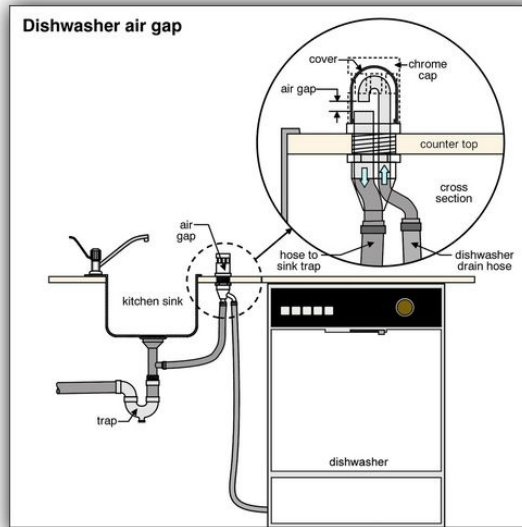
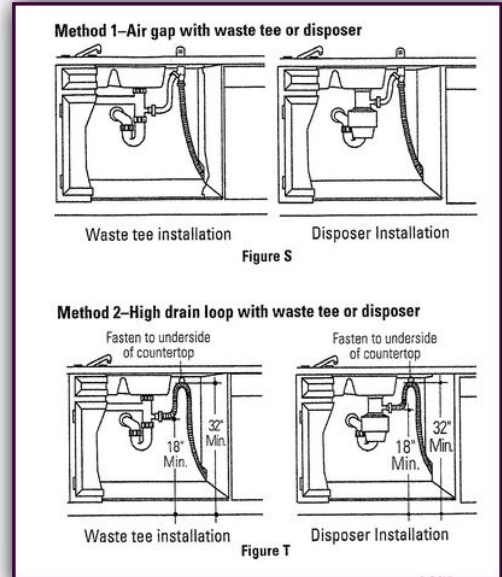
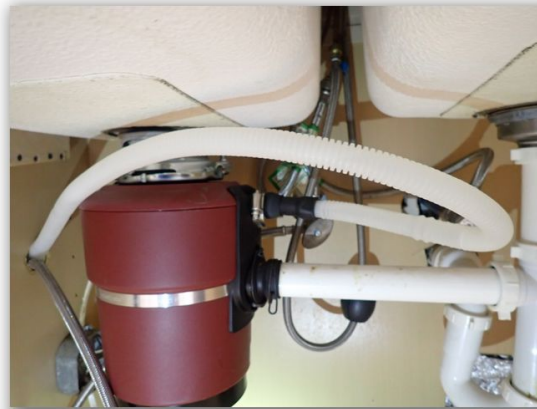
- The dishwasher drain hose is not properly installed to prevent back flow or anti-siphoning. It is recommended that an air gap device or high drain loop be installed in the drain line.

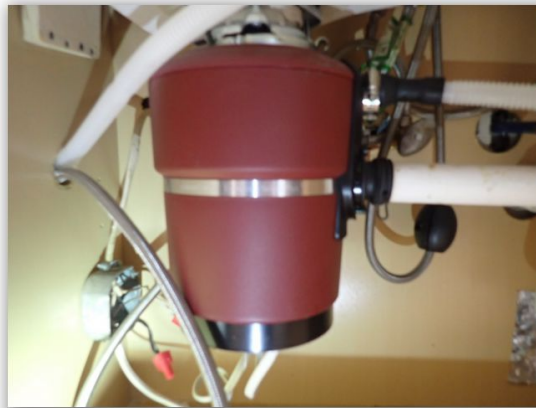
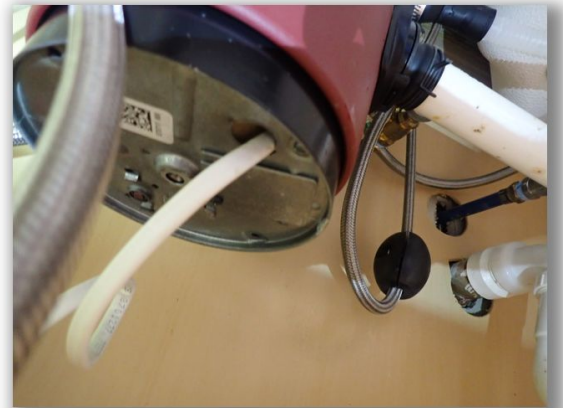
- The spliced wires at the disposal should be properly enclosed.

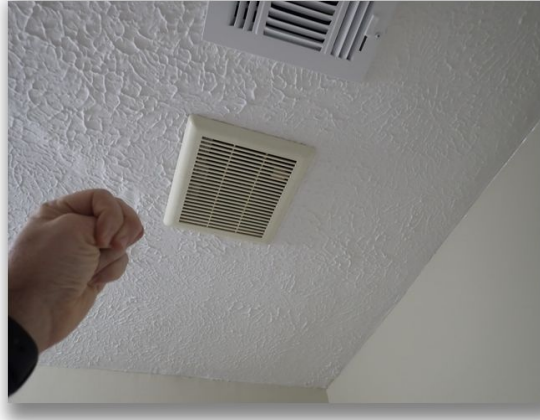
- The mechanical exhaust vent fan was noisy in the primary bathroom.

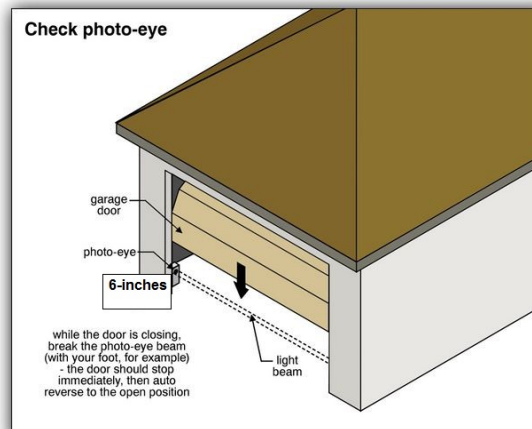
G. Garage Door Operators

- The garage door reverse sensors are not properly installed. The garage door reverse sensors should be installed within 6-inches of the garage floor.

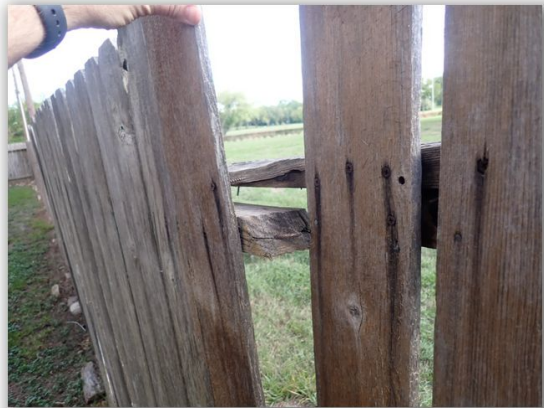
B. Fences

- One or more of the fence panel railings are damaged / deteriorated and repairs are recommended.

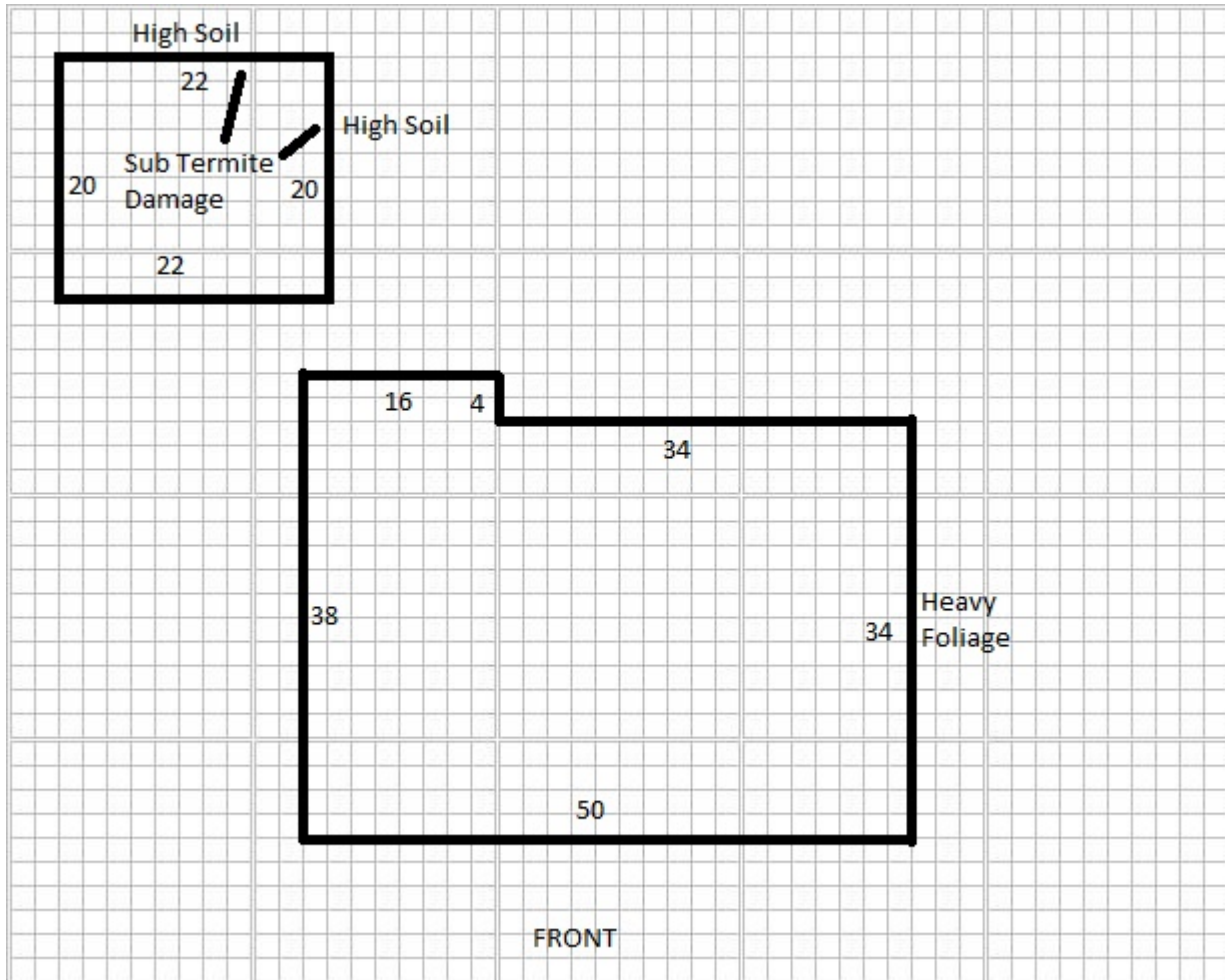
Diagram of Structure(s) Inspected

observed in the following areas: garage

Additional Comments There is visible evidence of a previous WDI infestation at the time of this inspection without signs of
