November 20, 2023

PROPERTY INSPECTION REPORT FORM

Bridget Matthews <i>Name of Client</i>	11/20/2023 <i>Date of Inspection</i>
16015 Sunbeam River Dr., Houston, TX 77084 <i>Address of Inspected Property</i>	
Joshua Donaho <i>Name of Inspector</i>	23369 <i>TREC License #</i>
<i>Name of Sponsor (if applicable)</i>	<i>TREC License #</i>

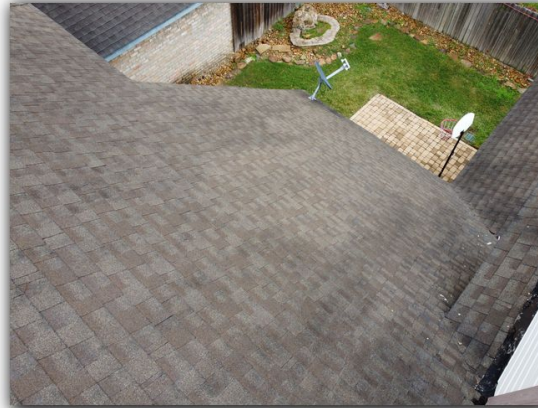
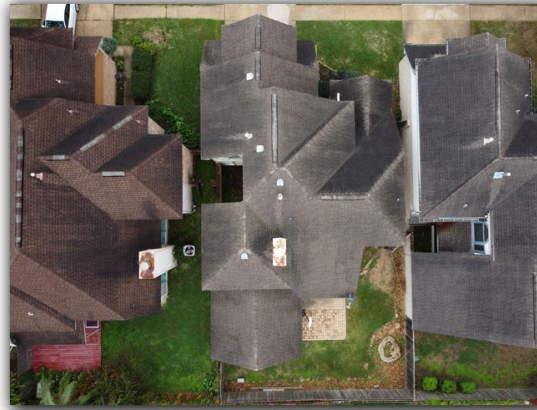
Flashing Details

- Some of the metal flashing details were observed to be rusted.
- It is recommended to paint the flashing details to prevent rust and/or UV damage.
- There was no kickout flashing details observed at the lower bottom edge of the roof line interface and the sidewall that continues past the edge of the roof. The lack of this kickout flashing could allow water to penetrate at these points.

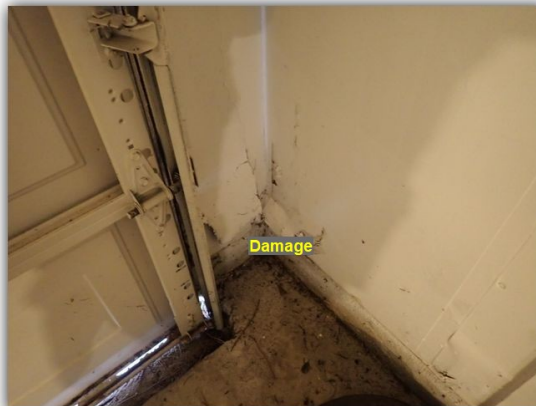
Note: There is evidence of painting and patching to the interior finish and prior interior finish repairs. This condition could limit the Inspectors visual observations and ability to render accurate opinions as to the performance of the structure.

Note: Nail heads were observed to be pushing through the interior finish in one or more locations.

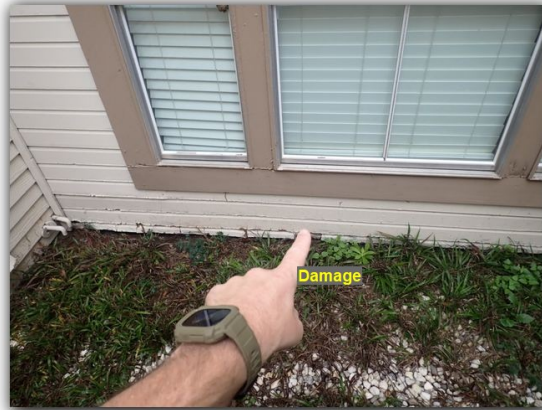
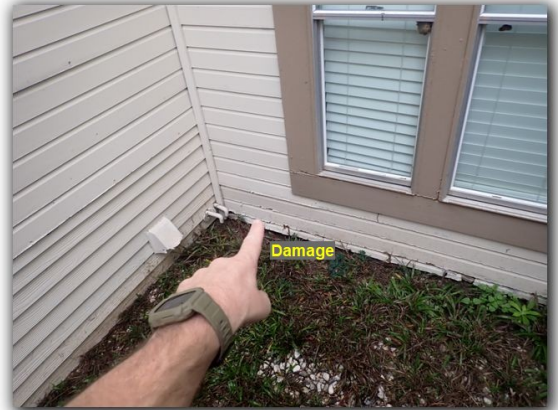
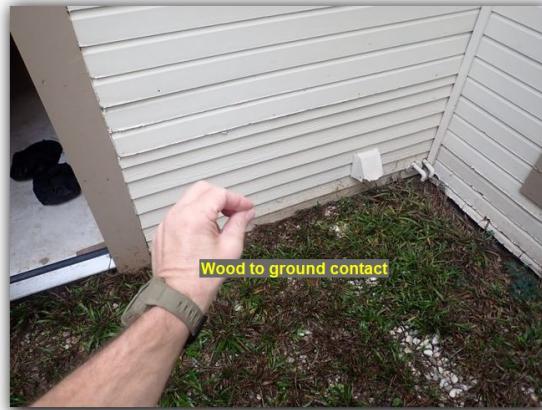
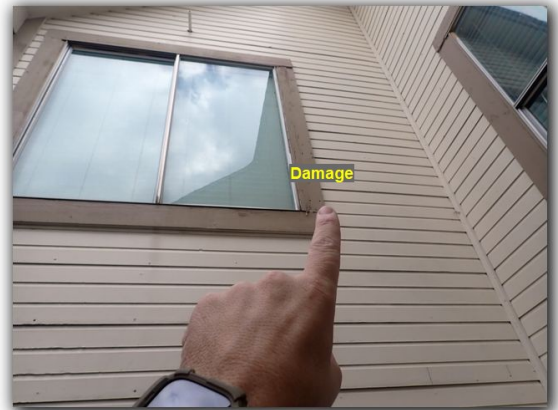
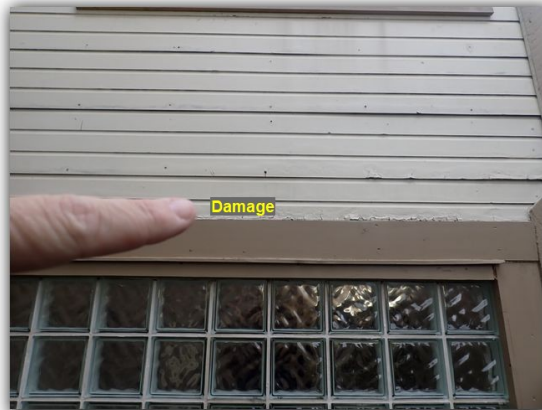
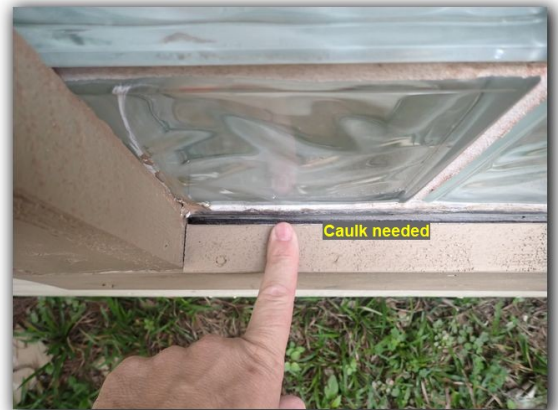
Notice: There is Masonite siding in place at the time of this inspection. This is an older siding system that is prone to failure and moisture intrusion into the property. Full evaluation of all of the siding components and the siding integrity is recommended. It is recommended to budget for replacement of all the older siding to prevent further damage to the structure.

- The exterior veneer / cladding has some deterioration and/or damage on the north, east, west and south sides of the structure.
- The wood veneer trim has some deterioration or damage on the north, east, west and south sides of the structure.

- All wood to ground contact at the base of the siding should be eliminated. Rotted or damaged siding that is uncovered should be repaired. The siding was observed to be in contact with the finish grade (ground) on the north, east, west and south sides of the structure.

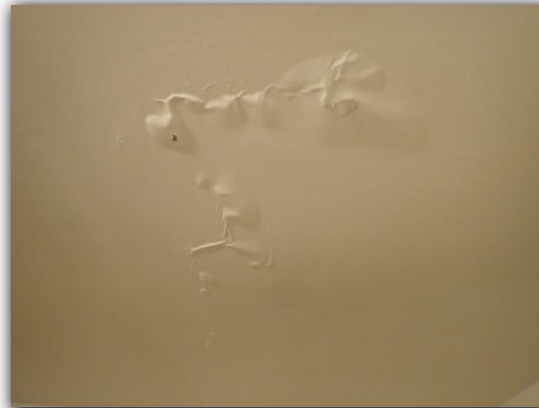
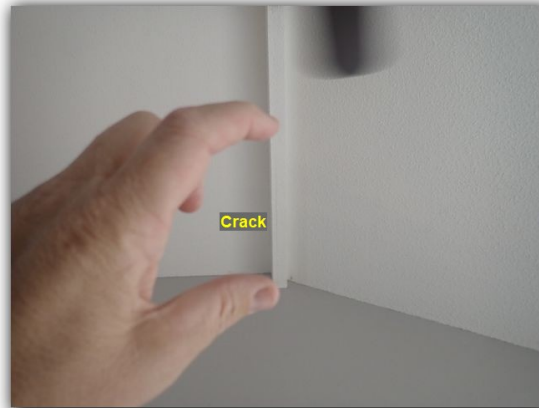
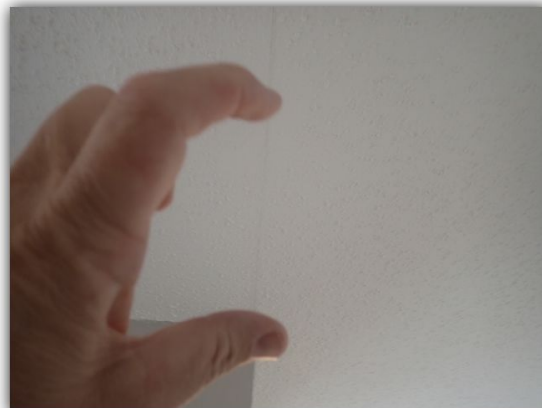
- Elevated moisture levels were detected in the ceiling finished surfaces in the garage, laundry room. The cause and remedy should be further evaluated and corrected as necessary. **Additional Note:** Due to the elevated moisture, other adverse conditions such as mold-like substance growth, wood rot/deterioration and wood destroying insects are possible.
- Water stains and water damage was observed on the ceiling finishes in the garage. The cause and remedy should be further evaluated and corrected as necessary.
- Ceiling joint cracks were observed in the several locations throughout the house.

Note: There is evidence of painting and patching to the interior finish and prior interior finish repairs. This condition could limit the Inspectors visual observations and ability to render accurate opinions as to the performance of the structure.

Note: Nail heads were observed to be pushing through the interior finish in one or more locations.

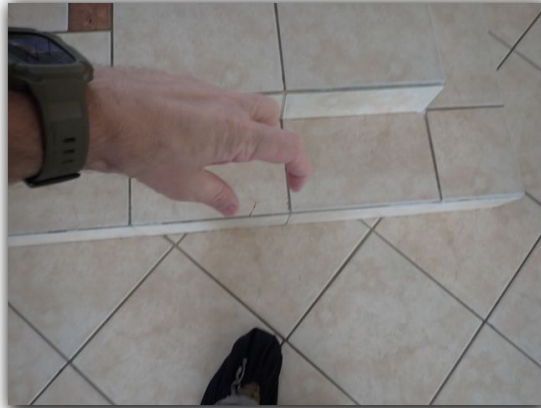
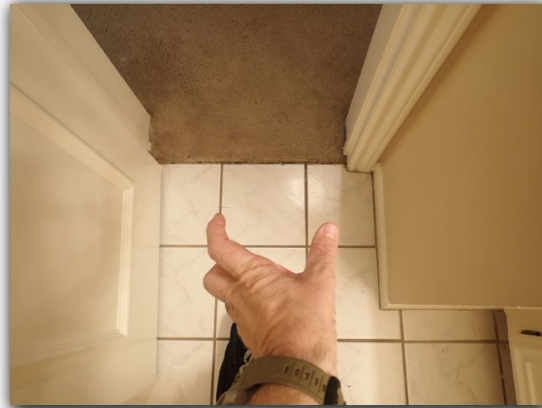
- The floor tile(s) were observed to be cracked and/or damaged in the living room.
- The floor covering is stained in one or more locations of the home.

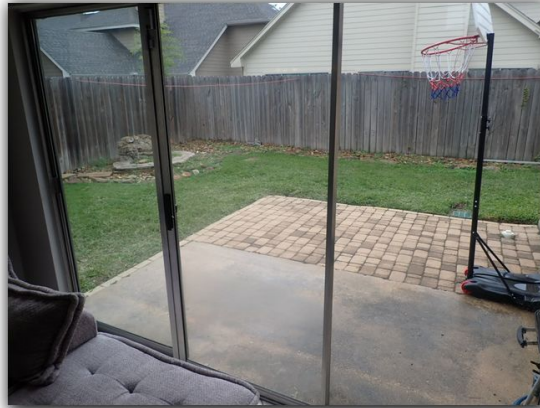
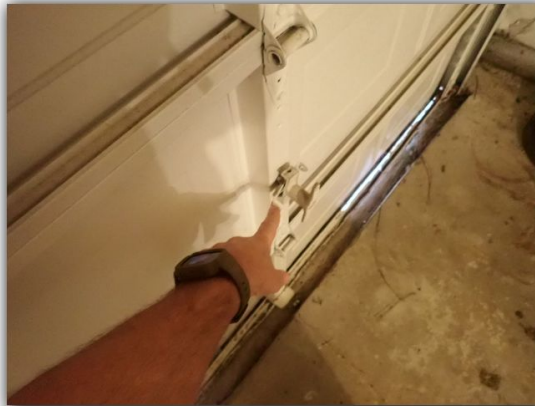
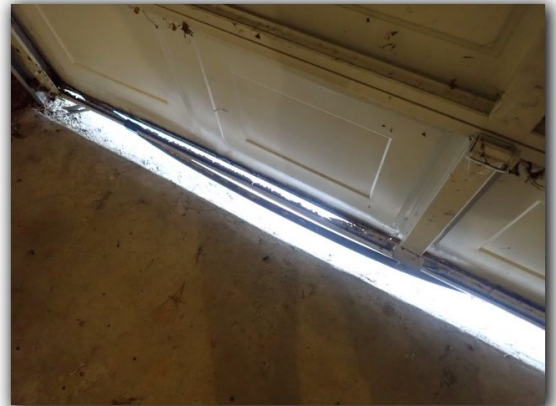
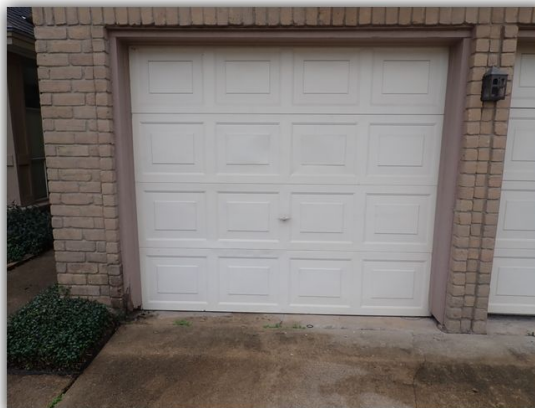
Overhead Garage Door

- Some damage to the overhead garage door was observed.
- The locks were observed to not be functioning properly.

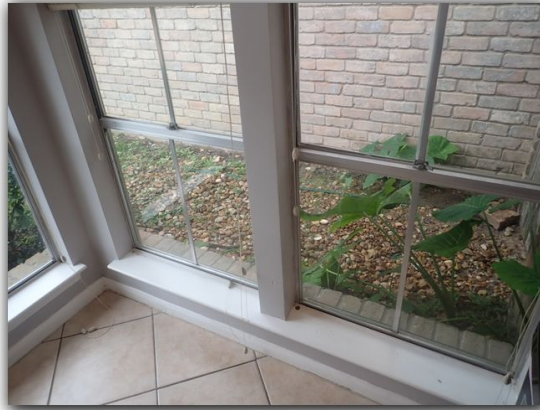
Window Screens

- One or more of the window screens were observed to be missing.

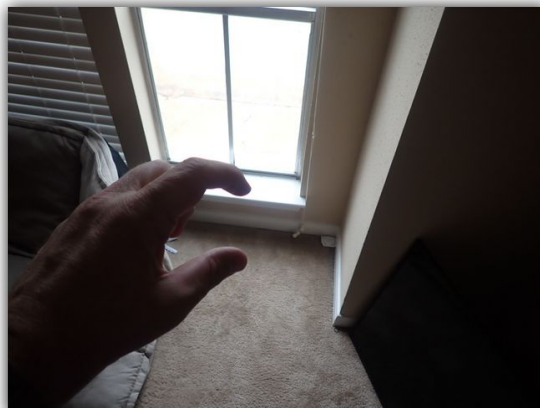
Windows

- The window(s) on the 2nd floor are installed less than 24 inches from the floor, with no visible safety/fall protection. This is a safety hazard especially for small children. A window guard is recommended to prevent the window(s) from opening more than 4 inches.

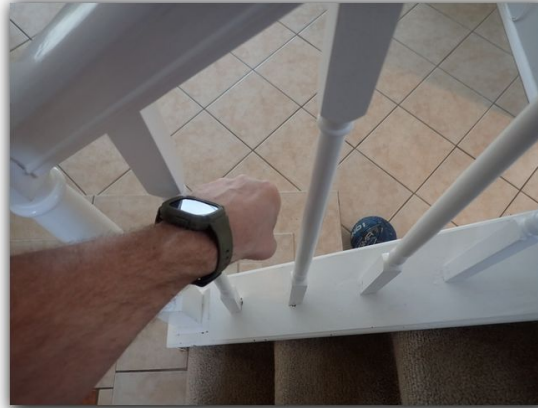
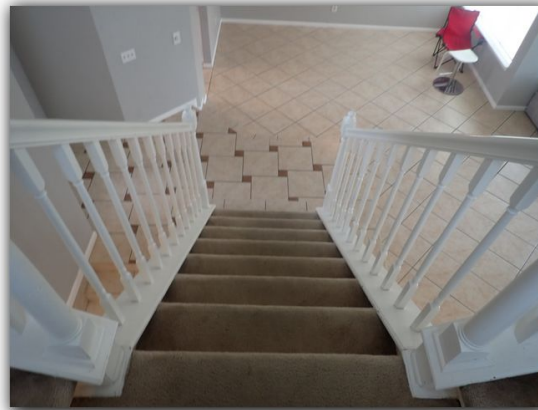
- The stairway guard balusters and/or spindles are installed too far apart under current building standards. This may be an “as-built” condition but per TREC standards of practice we are required to report this condition as a deficiency. You may consider corrective measures for improved safety.
- The handrail and/or guardrail for the stairway is loose and should be better secured for reasons of safety.

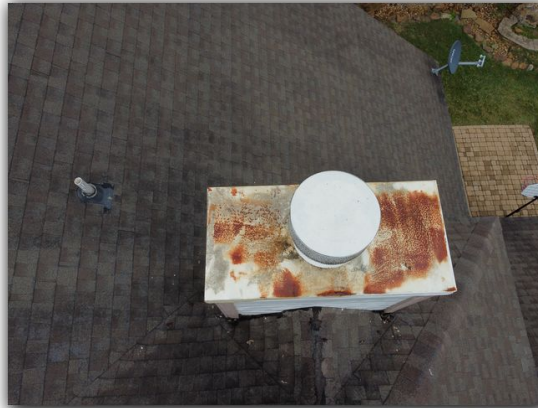
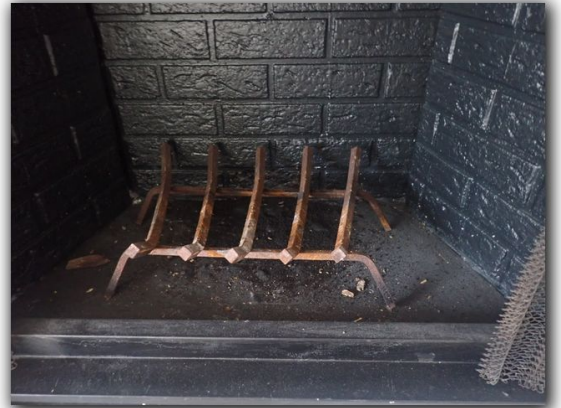
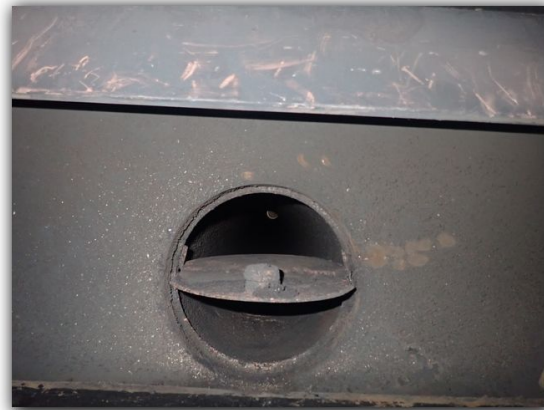
- The chimney flue should be cleaned by a Qualified Chimney Sweep. A creosote / soot build-up was observed in the visible flue area.

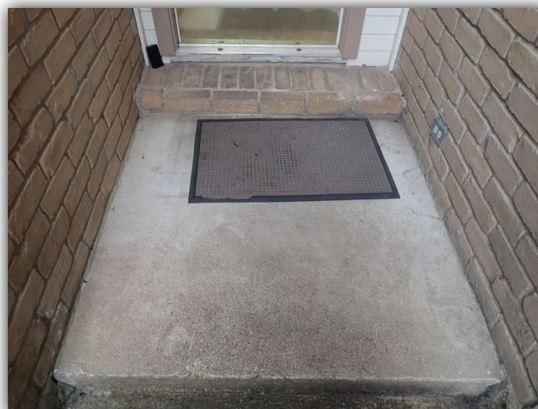
Porches / Patio

- Minor cracks and/or deficiencies were observed in the patio.

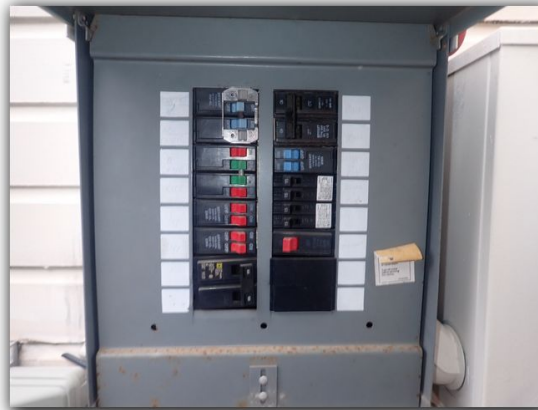
- The breakers (overcurrent devices) in the electrical panel are not properly labeled.
- There is no surge protection device installed at the panel box. Under the current National Electrical Code, all electrical systems should have surge protection. This is an "as built" condition. It is recommended to add a surge protection device to the panel box.
- There is no ground fault interrupter type breaker for the dryer outlet, electric oven installed at the panel box. This does not meet current building standards.

Note: There were circuit breakers in the main electrical service panel that were not listed by the panel manufacturer. Because circuit breakers were made by different manufacturers, they vary in design. Panel manufacturers typically require that breakers manufactured by their company be used in their panel unless otherwise indicated on the panel label. Breakers from one manufacturer used in the panel of another manufacturer may result in poor connections which can create a potential fire or shock hazard. I recommend correction by a licensed electrician.

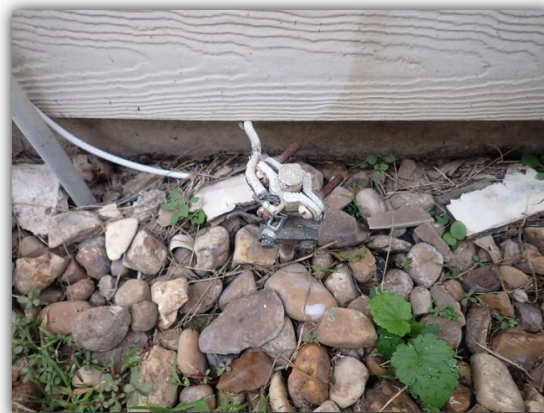
Grounding / Bonding

- I was unable to locate the electrical bond connection for the gas piping back to the grounding electrode system. All bond connections should be accessible for inspection, repair or replacement. This condition should be further investigated and corrected if necessary.

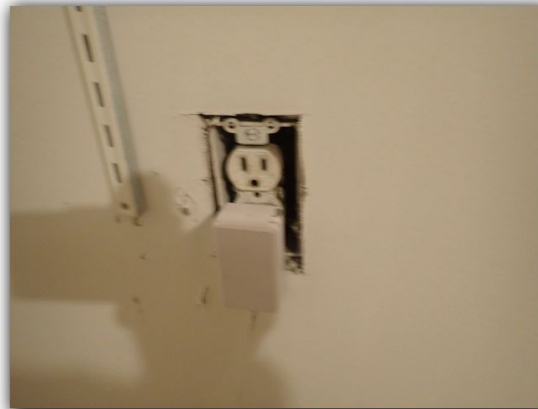
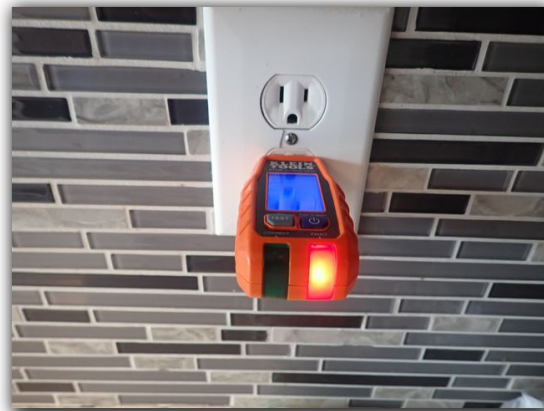
- One or more of the receptacles is missing its cover plate in the garage.
- The kitchen counter top receptacles are not connected to a ground fault circuit interrupter (GFCI) device. Under current electrical standards, all of the kitchen counter top receptacles and any receptacle within 6-feet of the sink should have GFCI protection.

- All exterior receptacles should have weather tight covers. The receptacle weather cover plate is damaged and/or missing on the front porch.
- One or more of the receptacles were observed to have an open ground connection in the kitchen.

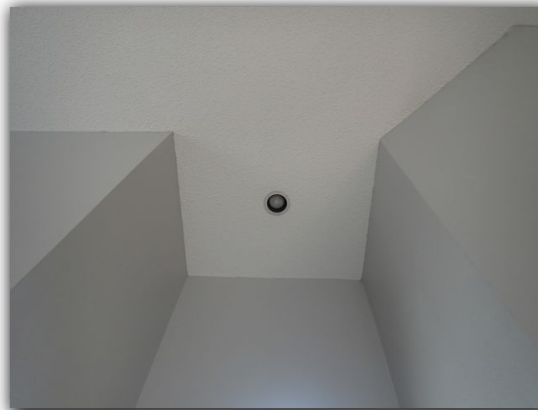
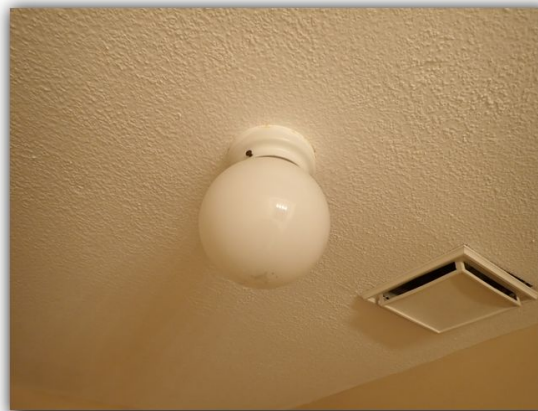
Fixtures

- One or more of the light fixtures are inoperative in the several locations throughout the house. This may be due to a bad bulb or some other unknown condition. This condition should be further evaluated and corrected as necessary.
- The ceiling fan is not balanced properly and wobbles when operated in the upstairs front corner bedroom.
- One or more of the ceiling fan blades are warped in the upstairs side middle bedroom.
- One or more of the closet light fixtures are installed without globes and/or covers. Safety precautions should be taken around these light fixtures.

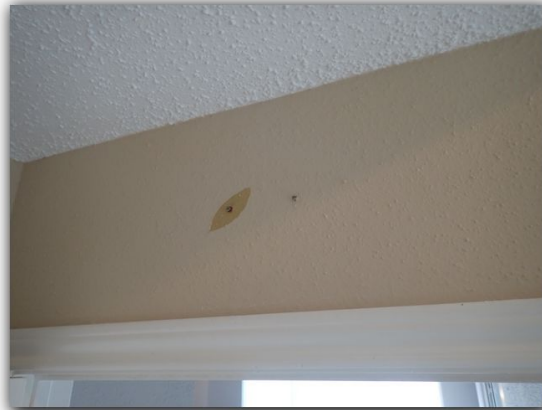
Carbon Monoxide Alarms

- I was unable to locate a carbon monoxide alarm in the immediate vicinity of the bedrooms.

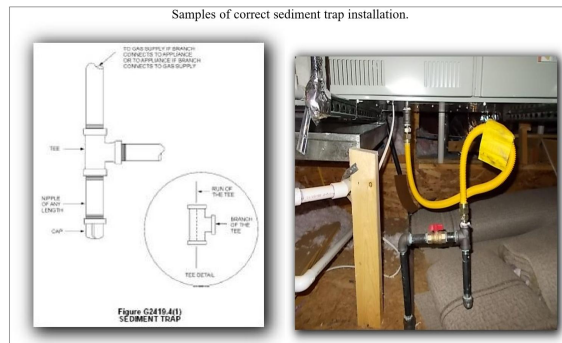
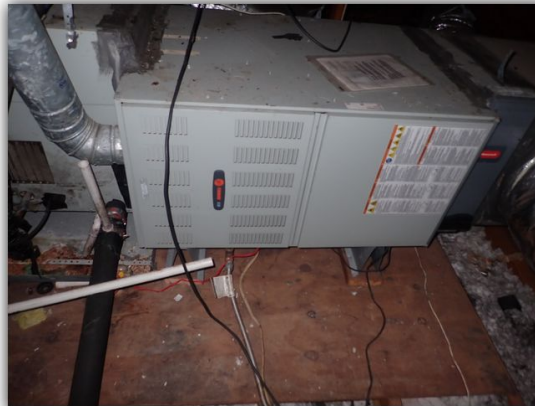
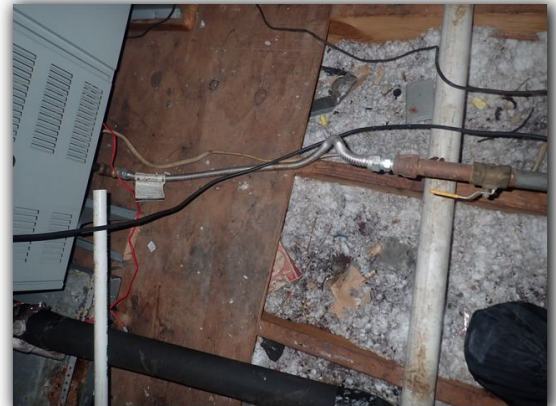
- The dirty air filter should be replaced.
- The air return system currently has two filters in place (Double Filtered). The configuration will adversely affect the return air flow and performance of the HVAC system. This condition should be further evaluated and corrected as necessary.
- The heater gas supply line is not equipped with a sediment trap just before the gas appliance connector. This condition does not meet current installation requirements and should be corrected.

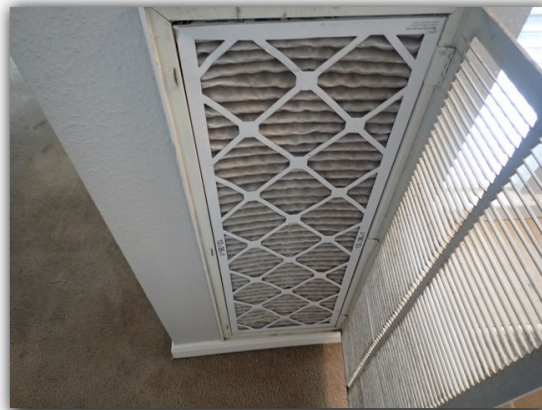
- The air return system currently has two filters in place (Double Filtered). The configuration will adversely affect the return air flow and performance of the HVAC system. This condition should be further evaluated and corrected as necessary.
- The dirty air filter should be replaced.
- There was an unknown mold like substance observed on the outer surface of the HVAC system. Evaluation of this substance is beyond the scope of this inspection. If any concerns exist on the type and/or nature of this substance, we recommend further evaluation by a professional in the Air Quality sampling field.
- The auxiliary/secondary drain pan under the coil housing is rusted through and should be replaced.
- The evaporator coils were observed to be dirty and should be cleaned for air quality and system efficiency.

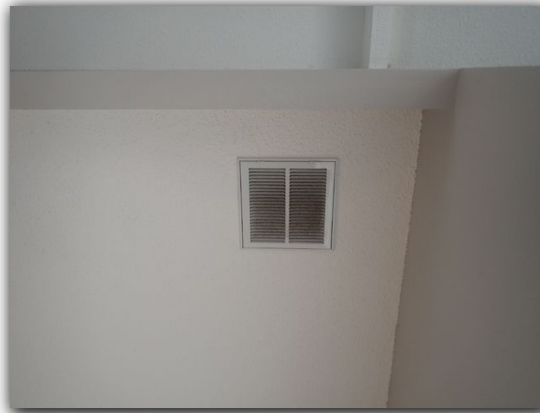
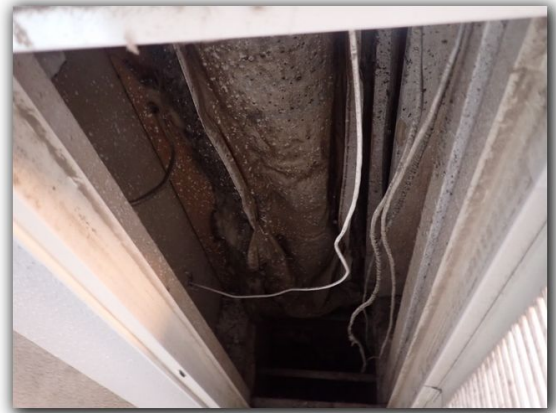
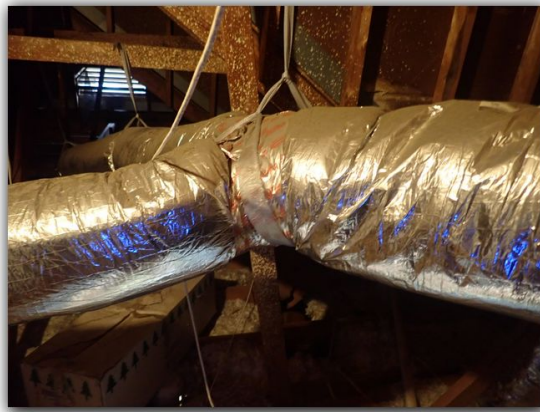
- The air-return chase for the HVAC system is dirty and should be cleaned to help maintain good air quality.

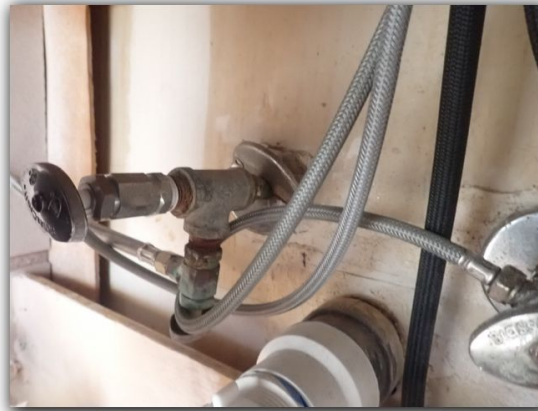
Water Supply System

- There are galvanized water lines in use at the time of this inspection. This is an older obsolete water supply system that is prone to water leaks. Full evaluation of all of the galvanized water line components and the integrity of those components are beyond the scope of this inspection. You are strongly encouraged to have the integrity of all of the galvanized water line components further evaluated by a qualified plumber prior to the expiration of any time limitations such as option or warranty periods. All plumber recommended repairs should be made. It would be wise to budget for replacement of all the older galvanized water supply system and to make a conversion over to a newer type of water supply system as soon as it is financially feasible.

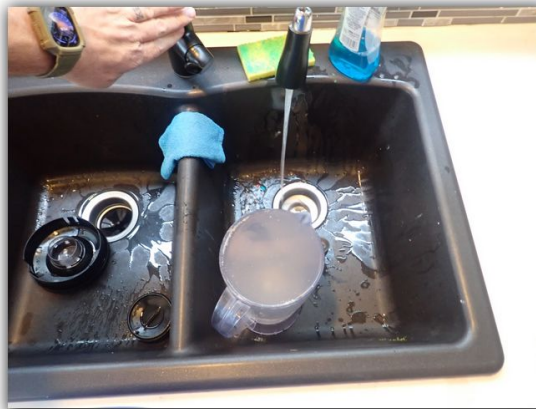
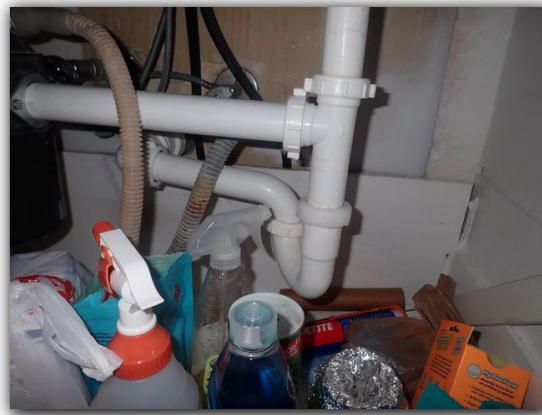
Kitchen Sink

- The faucet assembly is loose.
- The sprayer head is damaged.

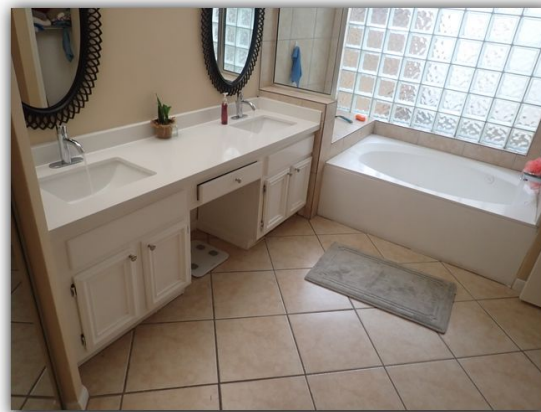
Bathtub

- Cracked, deteriorated and/or missing grout and/or caulking should be repaired or replaced as necessary.
- The tub spout is not properly sealed at the wall. This condition has the potential to allow water to leak back into the wall cavity.
- The stopper is missing.
- The shower head is inoperative.

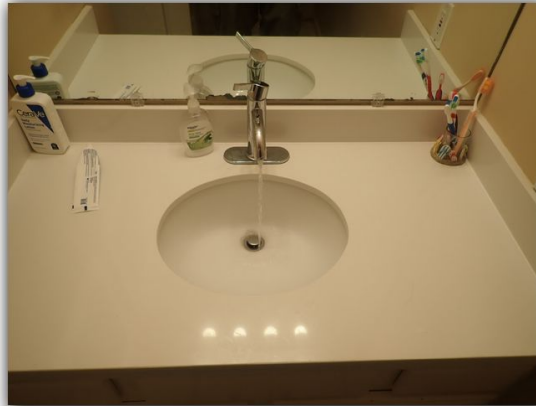
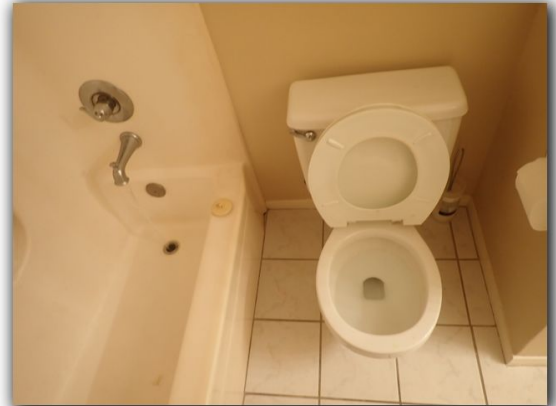
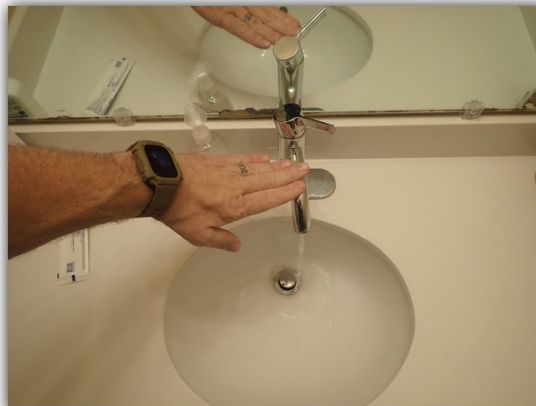
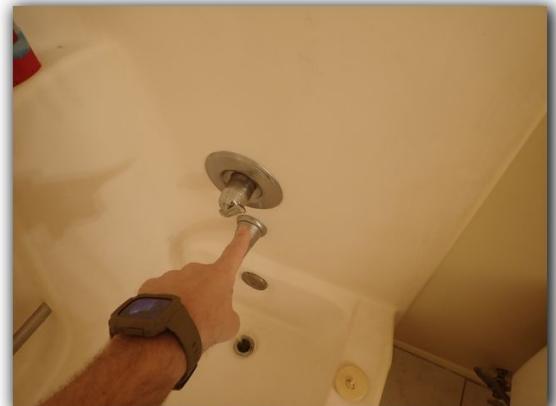
Lavatory / Sink

- The tub spout is not properly sealed at the wall. This condition has the potential to allow water to leak back into the wall cavity.
- The faucet assembly is not properly sealed at the wall. This condition has the potential to allow water to leak back into the wall cavity.

- The faucet assembly is loose.

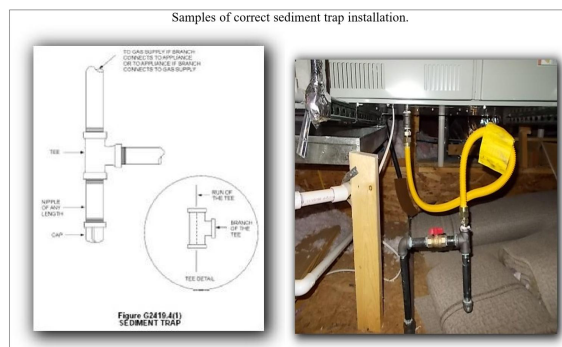
- The water heater flue connector should be mechanically attached to the draft hood with a minimum of three sheet metal screws.
- The temperature and pressure relief (TPR) valve discharge pipe is running in an upwards direction in one or more locations. The TPR discharge pipe should run gravitationally downwards at all points.
- The fittings at the top of the water heater are made of dissimilar metals (galvanized steel connected to copper and/or brass). It is recommended to replace the galvanized steel fittings with brass or copper fittings or install a dielectric union between the two dissimilar metals to prevent electrolysis from occurring.
- The water heater gas supply line is not equipped with a sediment trap just before the gas appliance connector. This condition does not meet current installation requirements and should be corrected.

The water heater and associated components should be checked and serviced by a Qualified / Licensed Plumber. The observations made to support the rendering of this opinion are listed but may not be limited to the following:

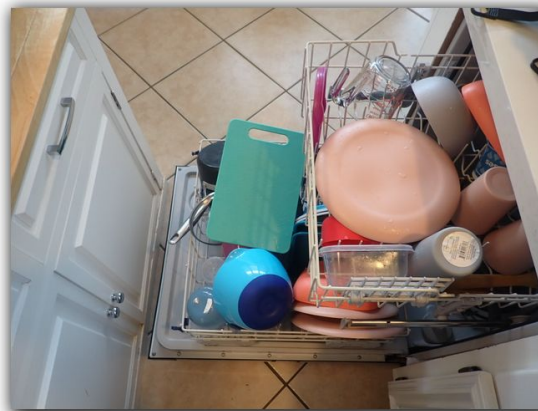
- The dishwasher drain hose is not properly installed to prevent back flow or anti-siphoning. It is recommended that an air gap device or high drain loop be installed in the drain line.

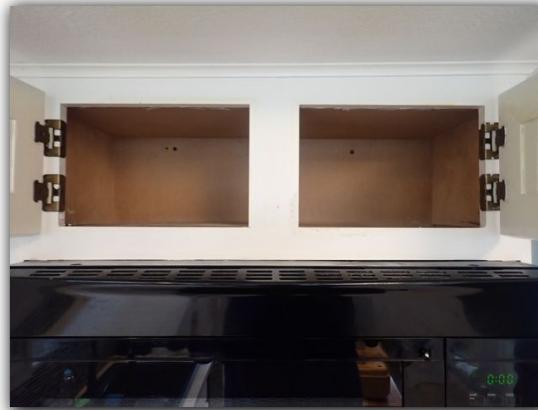
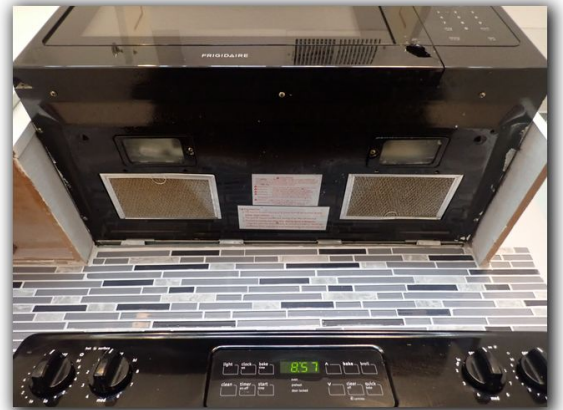
- The light at the range hood is inoperative.

Note: The range exhaust vent is dirty and should be cleaned.

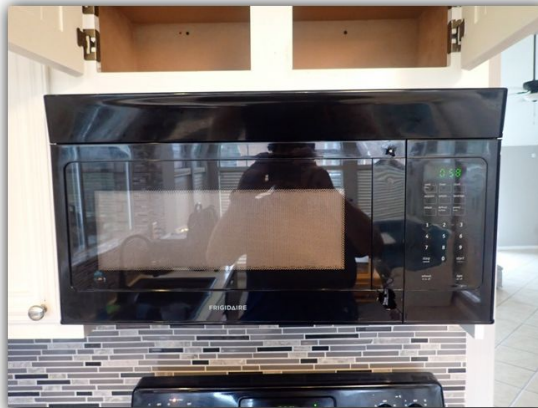
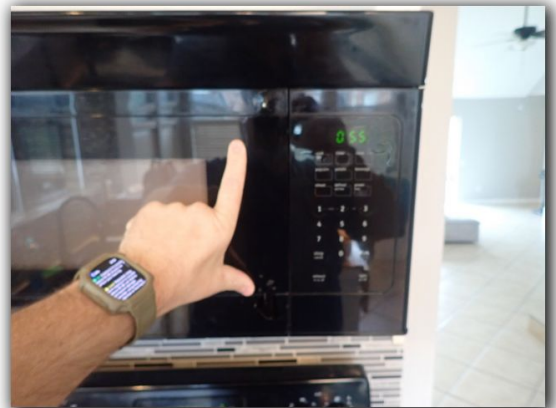
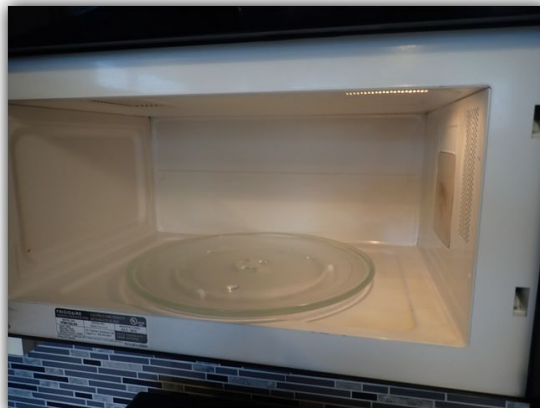
- The microwave oven handle is missing.
- The microwave oven door is damaged.

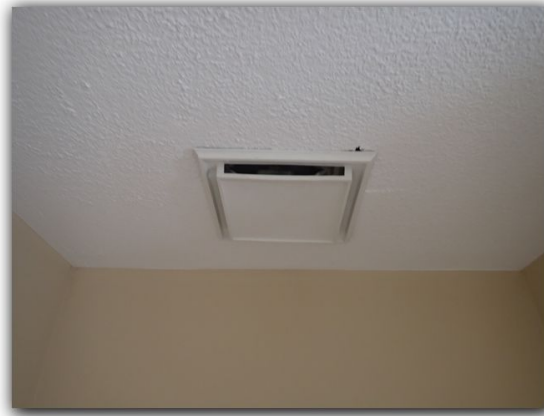
- The mechanical exhaust vent fan was noisy in the half bathroom.
