ANDERSON HOME INSPECTIONS

1227 Avenue H Garage Apt and Game Room
Galveston, TX 77550

PROPERTY INSPECTION REPORT FORM

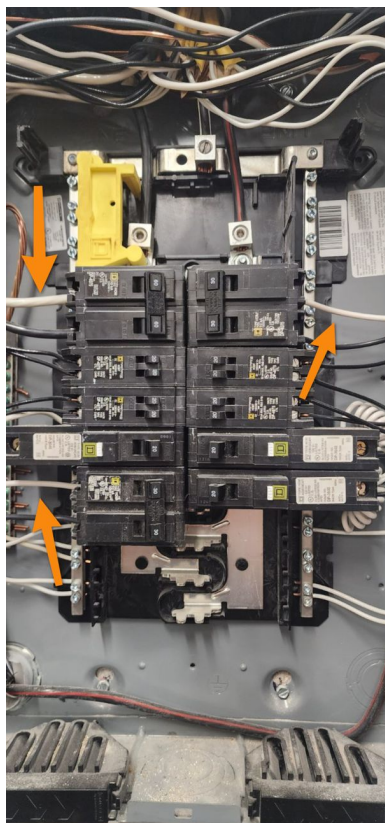
This is a "newer" requirement however it is a good safety upgrade that should be considered.

Recommendation: Contact a qualified electrical contractor.

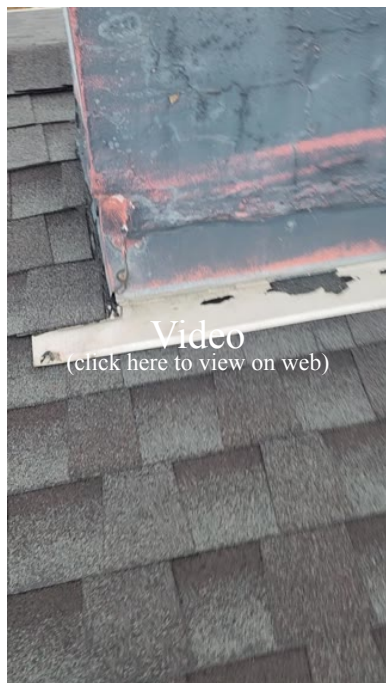
The flashing was lifted at the Southeast corner of the East side chimney. Recommend that the flashing be secured and sealed to help prevent water intrusion.

Recommendation: Contact a qualified roofing professional.

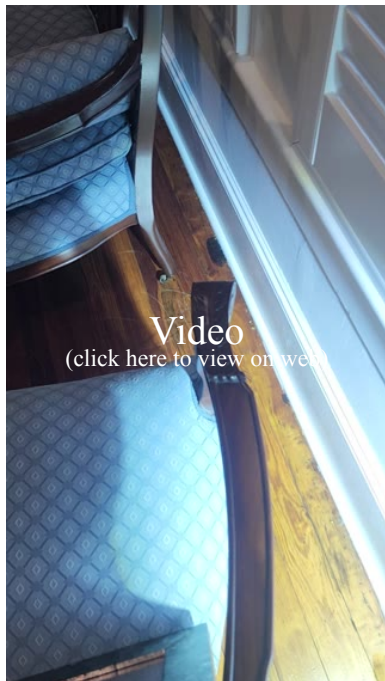
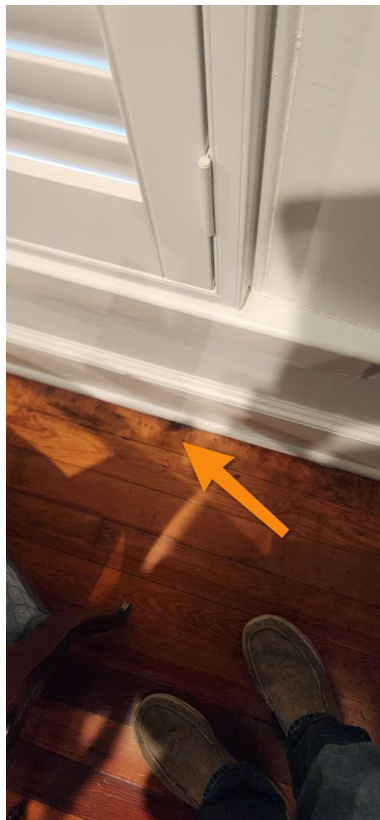
2nd Floor West Bedroom Southwest

There were areas of the interior walls that showed possible moisture water damage. Recommend that these areas be further evaluated and repaired as needed.

Recommendation: Contact a qualified general contractor.

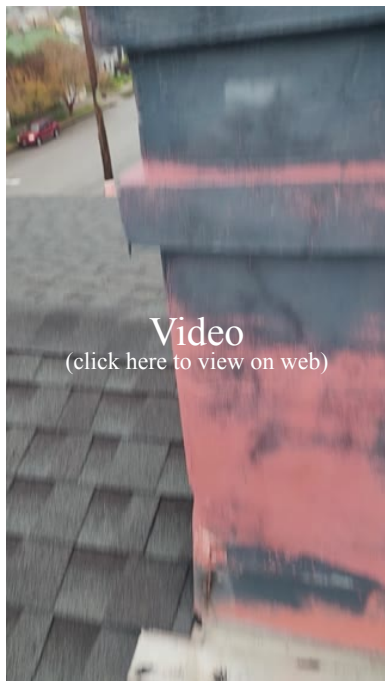
2: Chimneys need repaired

The chimneys up on the roof were in need of repair. There were areas of the concrete that were cracking and are recommended to be replastered. There were also areas where the metal was rusting.

Recommendation: Contact a qualified professional.

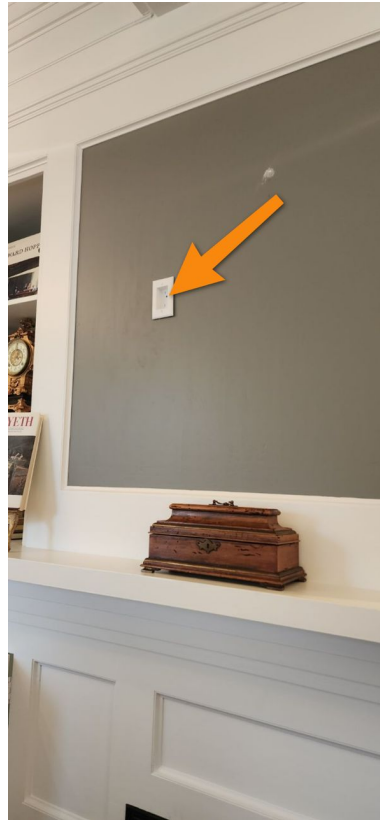
Living Room in cubby for entrainment center

3: Ungrounded Receptacles

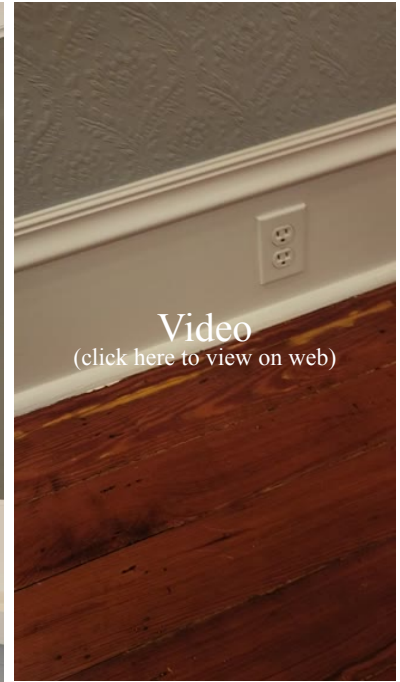
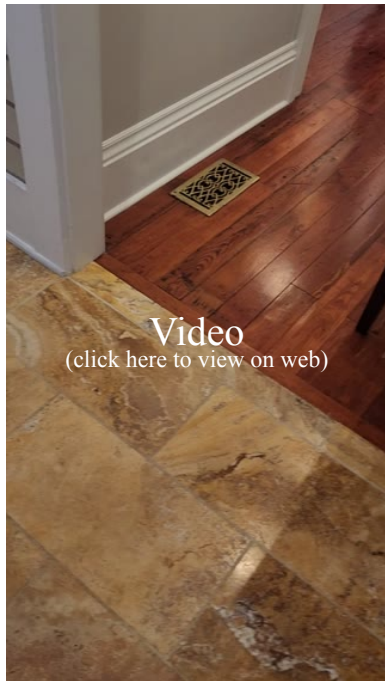
Living Room above fireplace

4: Tamper Resistant

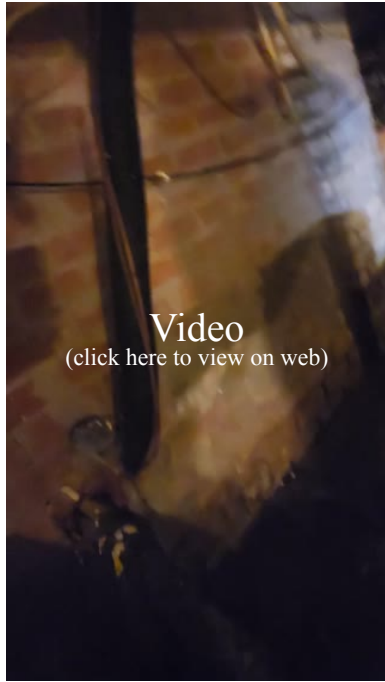
7: Exposed Ends & Splices

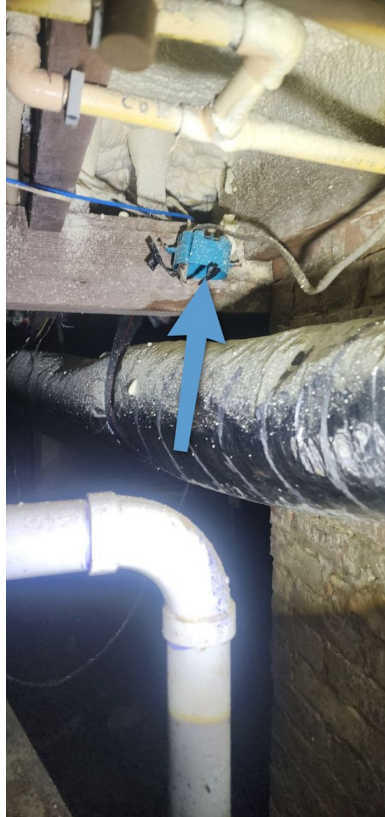
Crawlspace

8: Cover plates missing on junction boxes

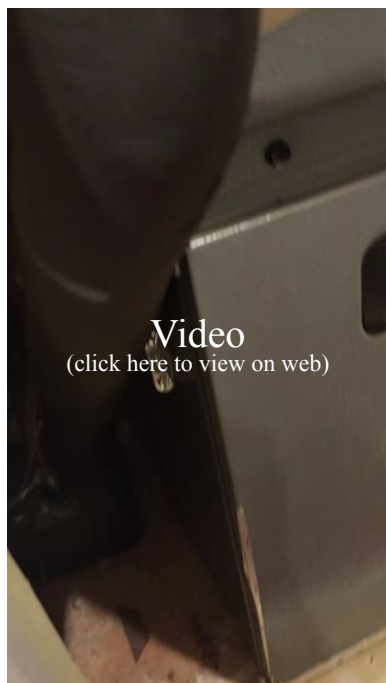
The sump pump drain line appears to be in need of cleaning as it has fungal growth or algae buildup.

Recommendation: Contact a qualified HVAC professional.

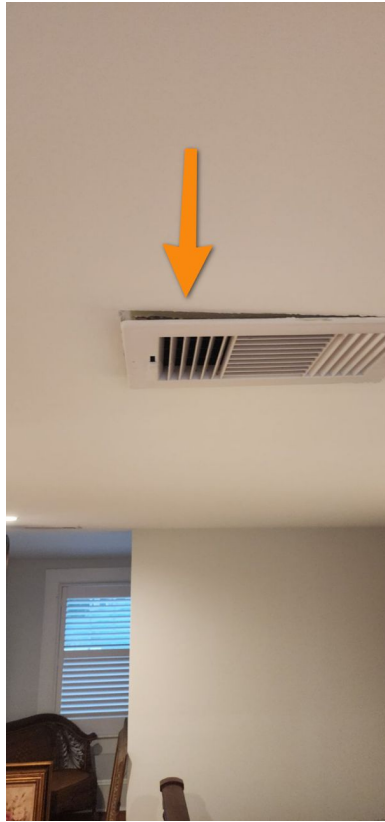
2nd Floor West Bedroom

There were one or more of the hvac vents that were loose at the ceiling connection, recommend that they be secured as air can leak out causing fungal growth.

Recommendation: Contact a qualified general contractor.

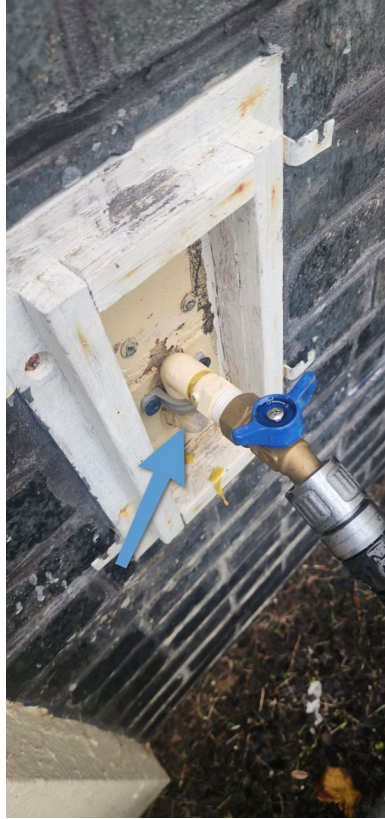
Front porch

The exterior water supply lines are recommended to be insulated to prevent freezing in the winter months.

Recommendation: Contact a handyman or DIY project

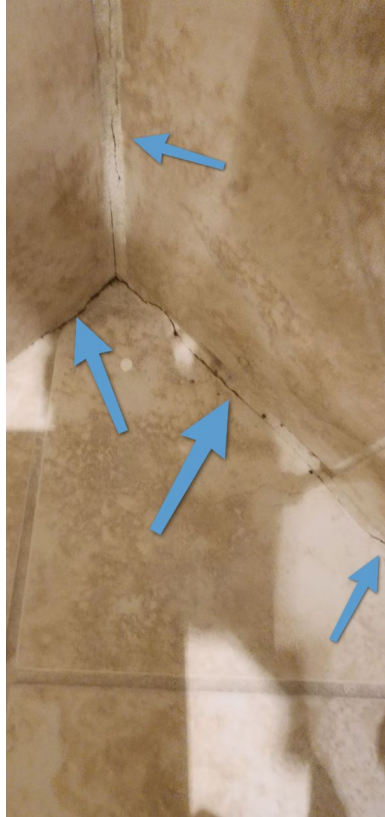
Master Bathroom shower left corner

3: Shower enclosure needs sealed

Recommendation: Contact a handyman or DIY project

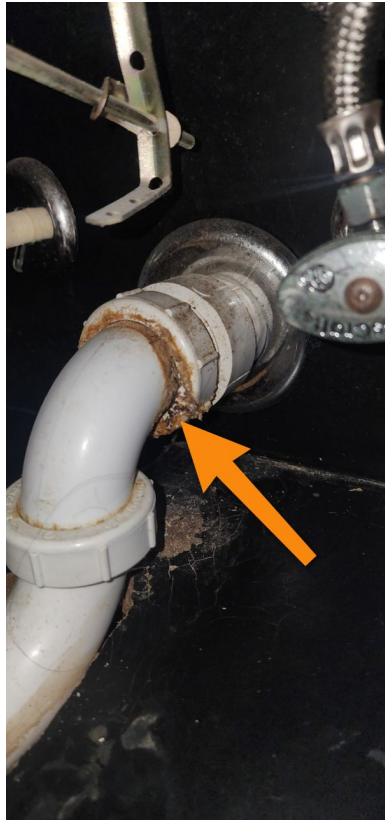
1st Floor half bathroom

2: Growth/previous leak on drain connection

There were one or more areas of drain line connections that had fungal growth/previous leaks and are recommended to be further evaluated for possible repairs.

Recommendation: Contact a qualified plumbing contractor.

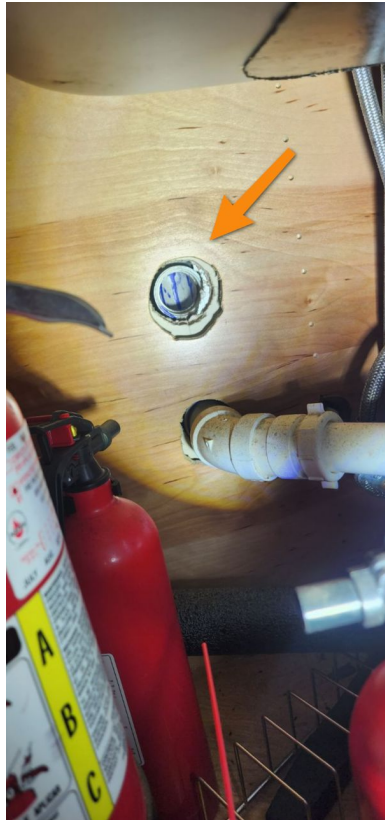
3: Drain waste vent missing call under sink

The drain waste vent underneath the laundry room sink was missing a cap. Recommend that it be added to prevent sewer gases from being released.

Recommendation: Contact a qualified plumbing contractor.

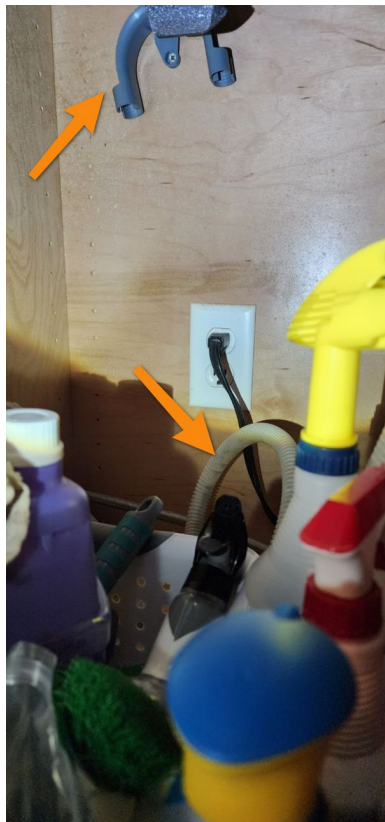
1: High loop/air gap missing

A "high loop" or "air gap" was not present for the dishwasher drain line at visible portions. A high loop or air gap prevents wastewater from siphoning back into the dishwasher during operation. The proper installation of the dishwasher drain line is recommended by a licensed plumber or other qualified person.

Recommendation: Contact a handyman or DIY project
