# Inspection Report

**Property Address:**  
16747 Village View Trail  
Sugar Land TX 77498

## PROPERTY INSPECTION REPORT FORM

12/13/2023

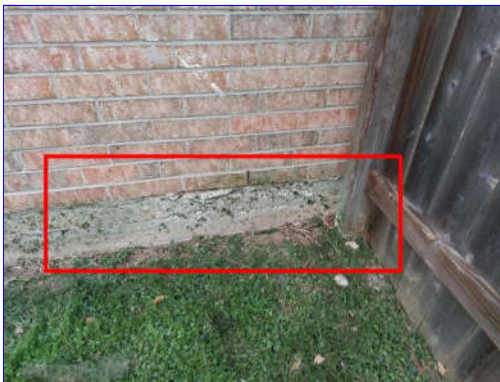
A. Item 35(Picture)

(5) One or more of the foundation perimeter corners were observed to be cracked or sheared off (corner pop). This is a common condition in slab on grade or post-tension foundations. This condition does not adversely affect the performance of the foundation. However, cosmetic improvements can be made.

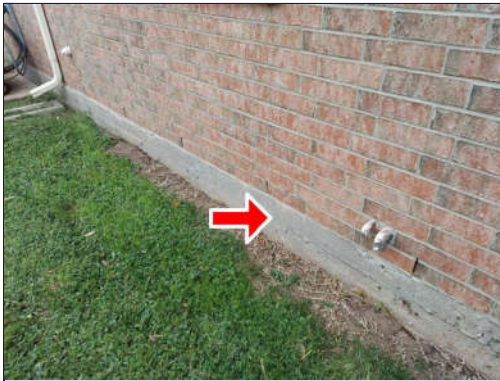
A. Item 38(Picture)

(6) Crack(s) was/were observed in the foundation wall(s). The crack(s) should be monitored. If significant changes occur a foundation specialist should be consulted.

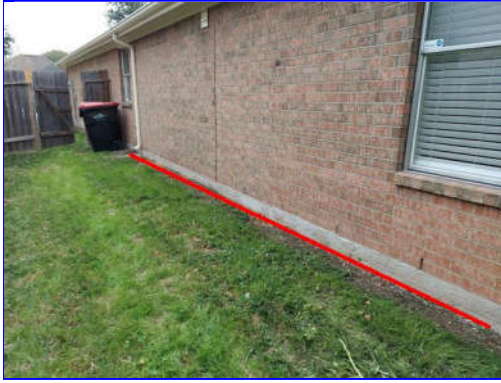
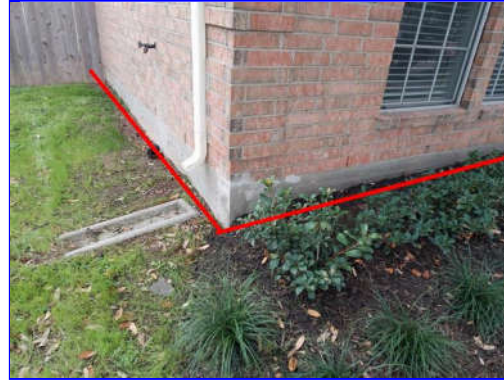
(7) **Buyers Advisory/Limitation Notice:** Parge coat/paint was observed to be present on the foundation walls. Parge coating/paint is usually applied for cosmetic reasons, however parge coating can cover defects. There is no way for the inspector to determine the reason for application of the parge coat. The current homeowner or builder should be consulted regarding this condition.

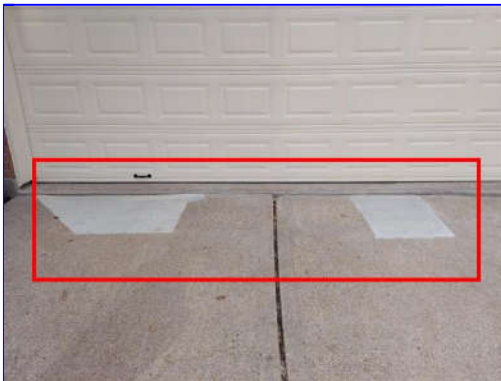
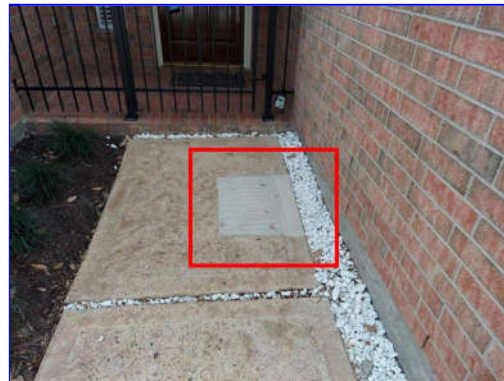
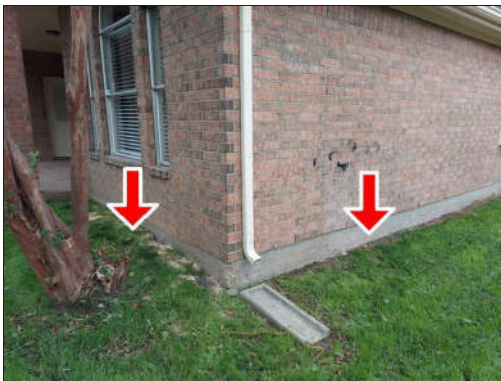
(8) Evidence of previous foundation repair was observed. This inspection was performed without any data regarding the extent or final results of these repairs. Foundations repairs may not leave the foundation completely level and often the indications of excess movement before the repairs are still visible. In my opinion this foundation is not currently demonstrating evidence of defects that will adversely affect the overall performance of the foundation or evidence that suggests recent excessive movement. I do recommend that prospective buyers obtain as much documentation as possible regarding previous repairs and warranty information. The future performance of foundation is difficult to predict and other foundation inspectors, structural engineers or foundation experts may form a different opinion when evaluating this foundation. It may be advisable to consult with a structural engineer or foundation specialist before purchasing the home, regarding both its current condition, and the best measures to prevent further movement in the future.

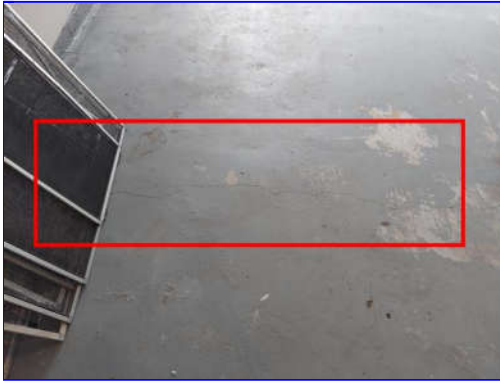
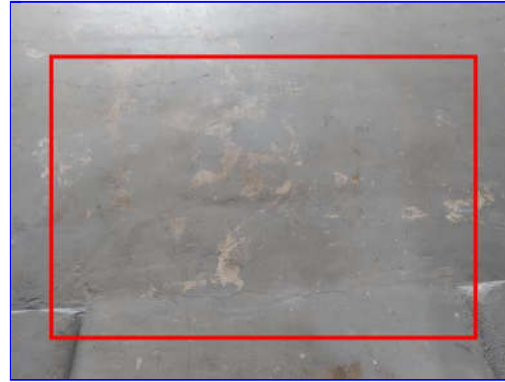
(9) The garage surface was observed to have cracks and damaged surface. Due to the garage surface is painted with epoxy, this condition prevents the inspector to fully inspect the condition of the slab in the garage. Further evaluation is recommended

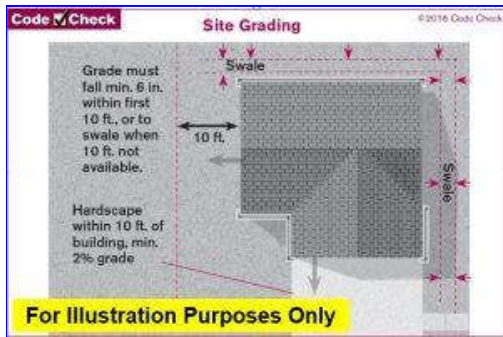
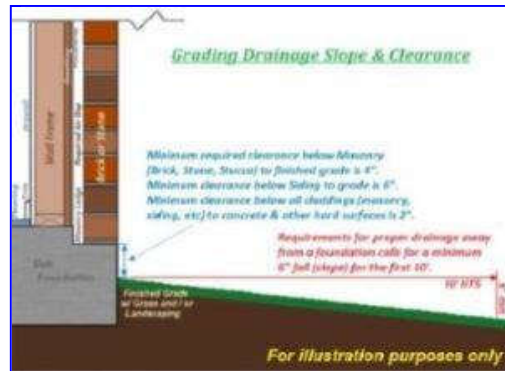
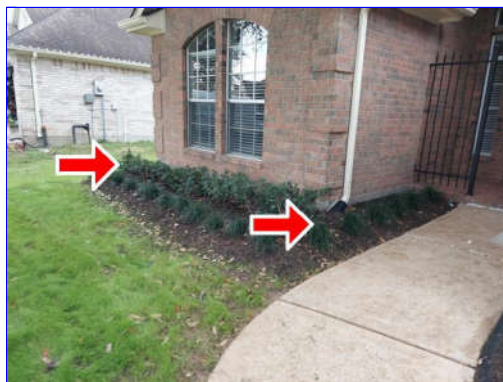
(1) General grade improvements are needed to prevent ponding/standing water. Proper drainage is needed to help prevent water from standing and/or ponding next to the foundation. Corrective measures may be needed if the water stands within 10-feet of the foundation for more than 24-hours. Grading improvements are needed to direct run off water away from the structure. Any area where the ground or grade does not slope away from the structure is to be considered an area of improper drainage. The recommended slope away from the foundation is 6 inches per 10 feet.

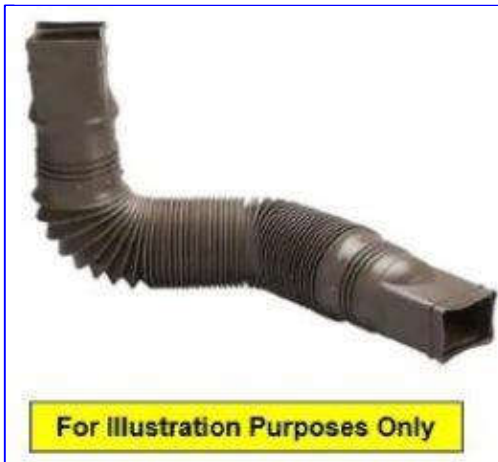
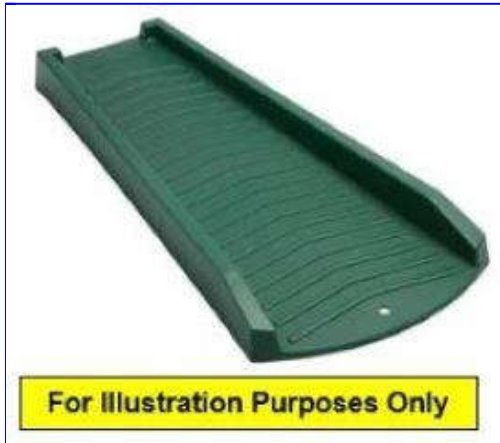
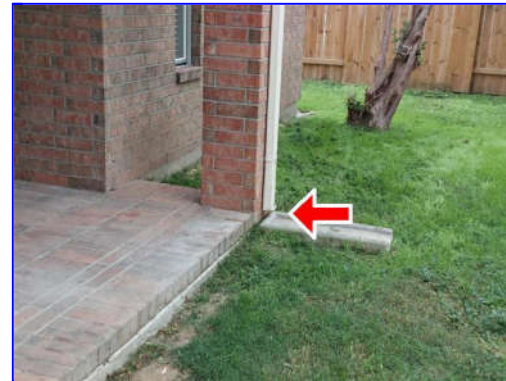
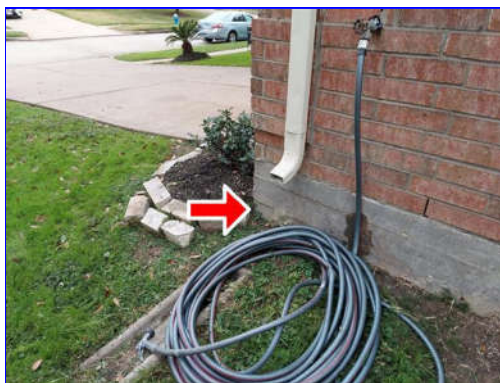
(2) The downspout need an extension with splash block to carry water away from the foundation. Failure to add these extensions may potentially adversely affect the foundation performance long term.

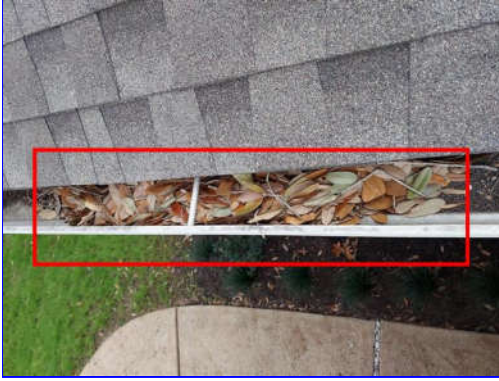
B. Item 9(Picture)

(3) The gutters and down spouts was observed to be in need of cleaning. Gutters and downspouts should be further examined for possible defects after cleaning for proper drainage.

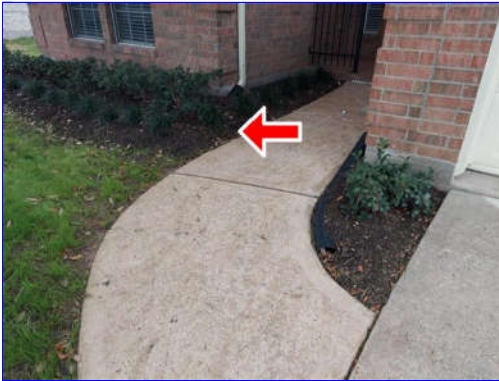
B. Item 11(Picture)

(4) Drain for gutter at front of home was observed to be below the grade of the walk way. This will not allow the drain to properly disburse water. The drain should be installed under the walk way. If installed where the water runs across the walk way, there is a risk of algae growing and becoming a slipping hazard. Repair is needed.

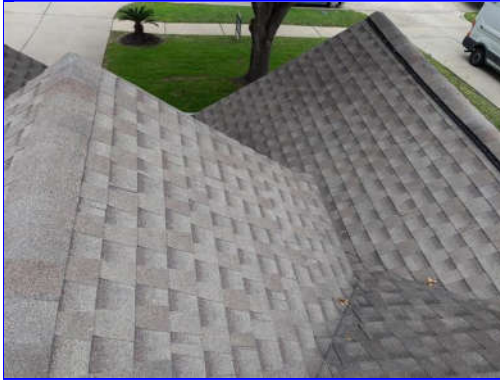
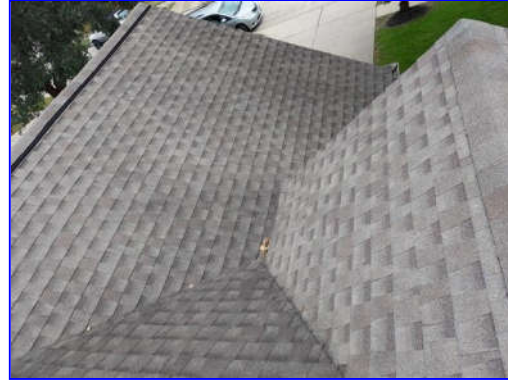
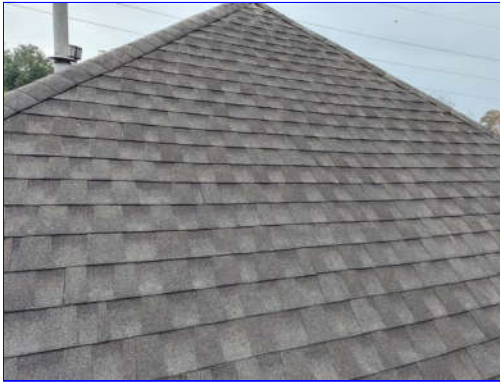
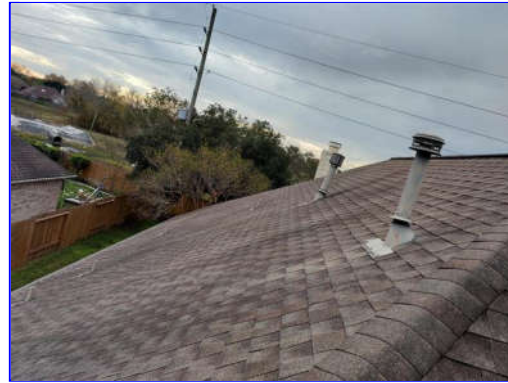
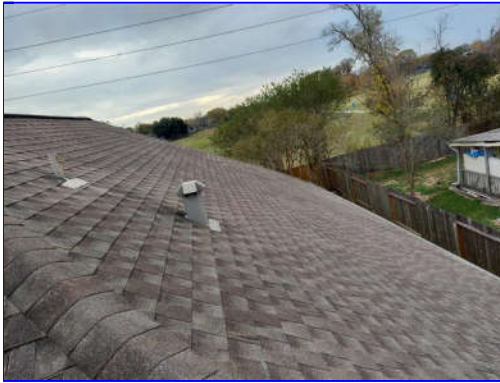
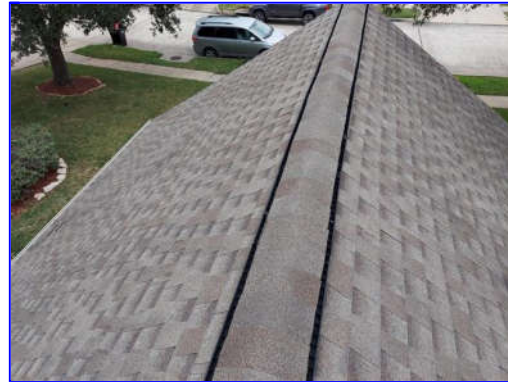
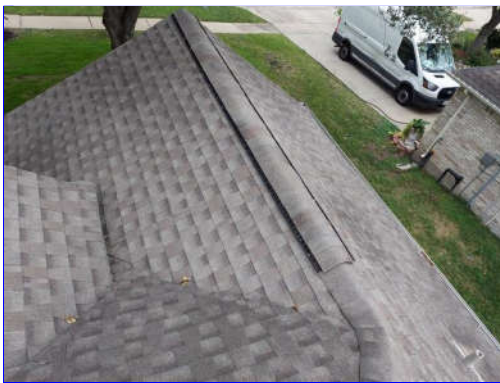
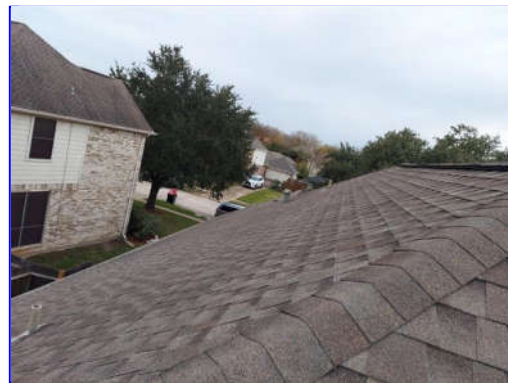
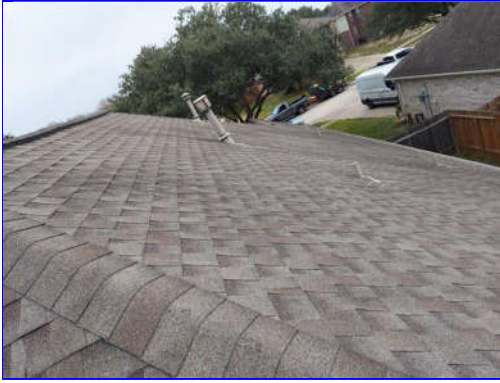
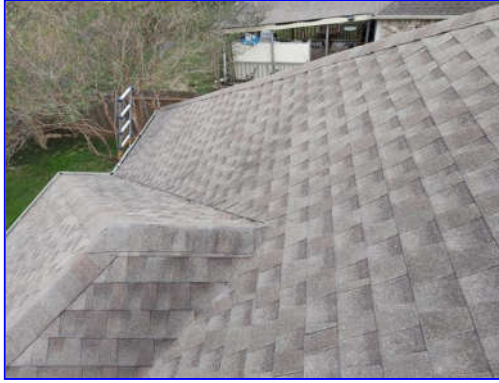
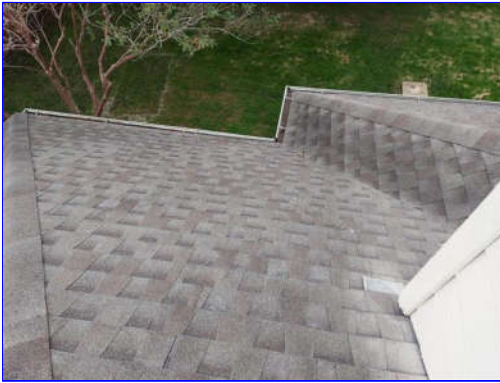
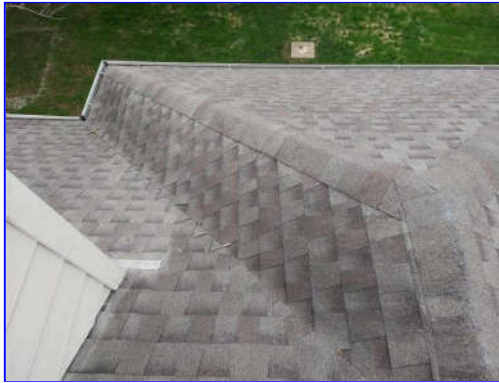
(3) **The roof covering was observed to be near the end of its service life. In the inspectors opinion replacement is needed. When a roof is older, it is always advisable to consult with your insurance company regarding coverage prior to purchase of the home.**

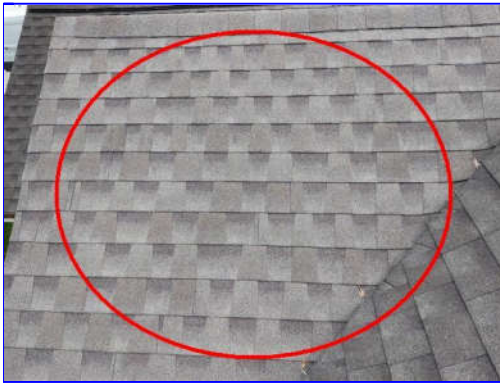
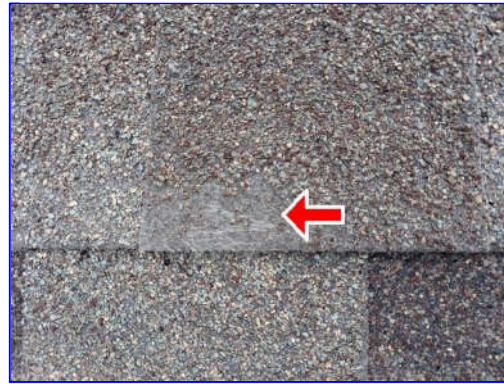
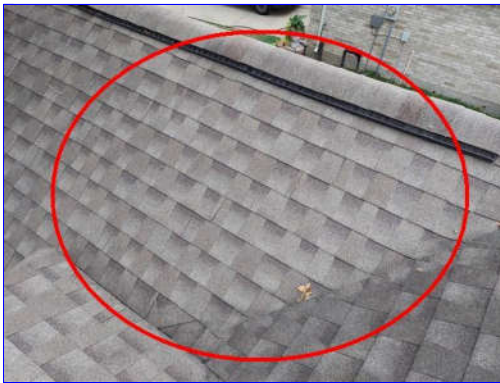
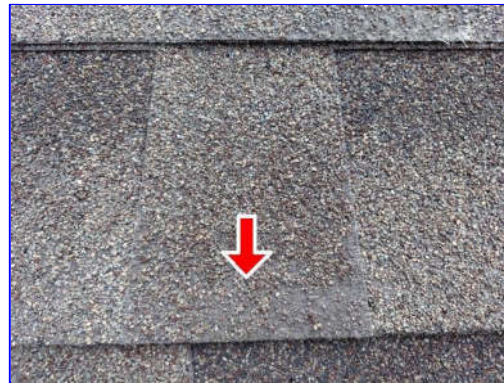
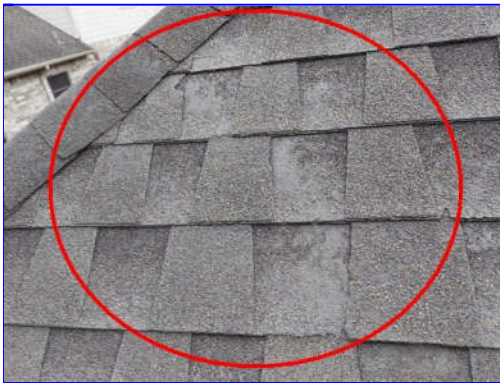
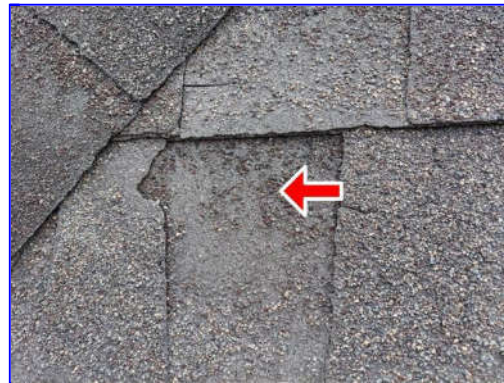
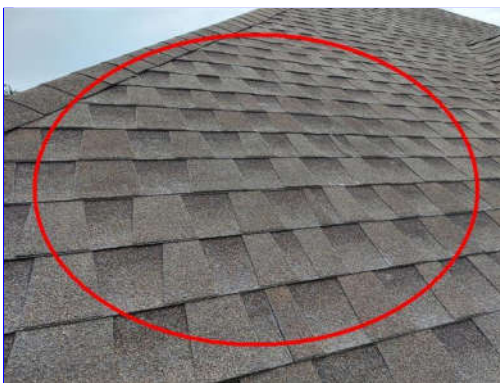
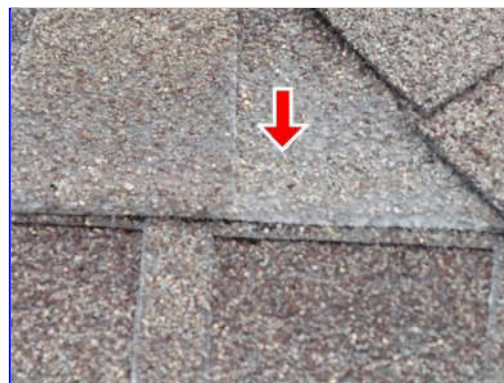
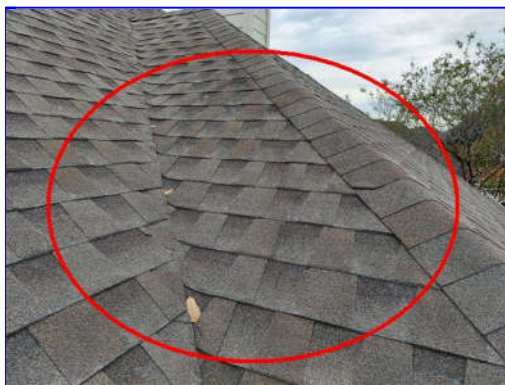
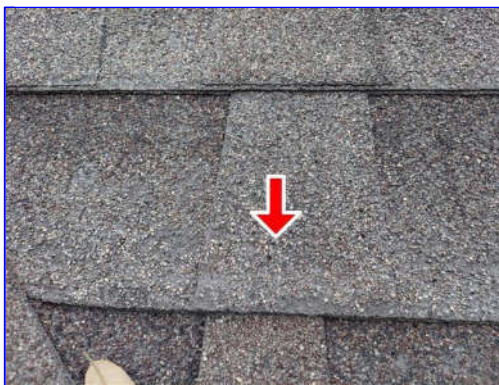
(4) Shingle(s) was/were observed have the following defect(s): abrasion damage, excessive loss of granules, exposed fiberglass and raised. Repairs are needed. A qualified roofer should be consulted to further evaluate these conditions and provide an estimated cost of repairs.

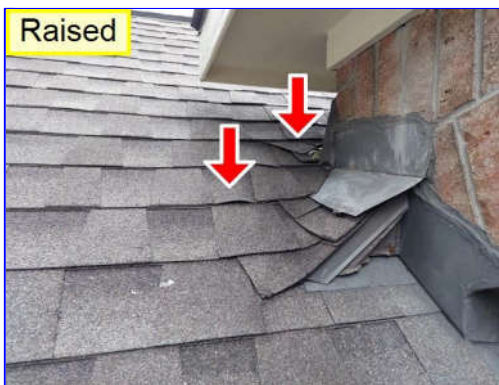
C. Item 30(Picture)

(5) Kick out flashings were observed to be missing. Kick out flashings should be installed to help direct the water away from the home. Bent counter flashing is not a substitute for proper kickout flashings. A qualified, verified roofing contractor should be consulted regarding repairs.

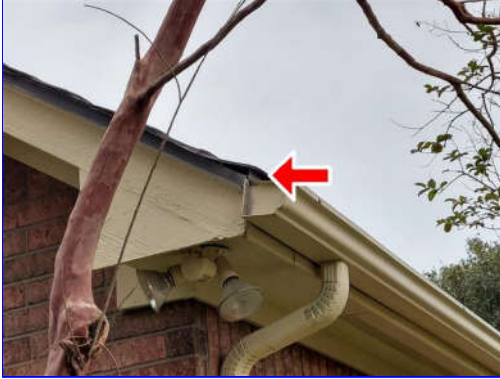
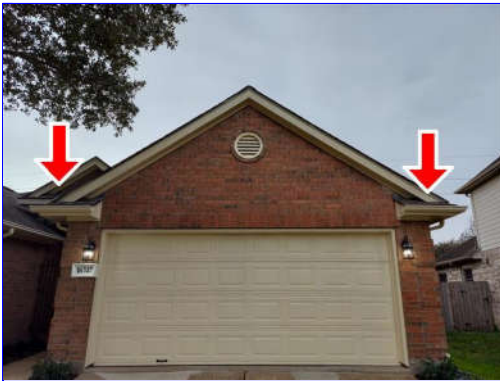
(7) The clearance of the siding and/or trim at the flashing was observed to be insufficient. This condition leaves the siding and/or trim vulnerable to rot. This detail is usually repaired when siding and/or trim needs repair or replacement or when re-roofing work is performed.

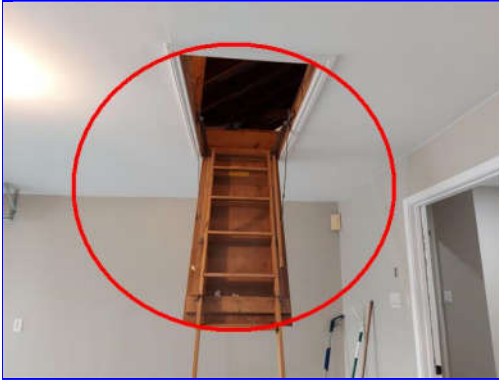
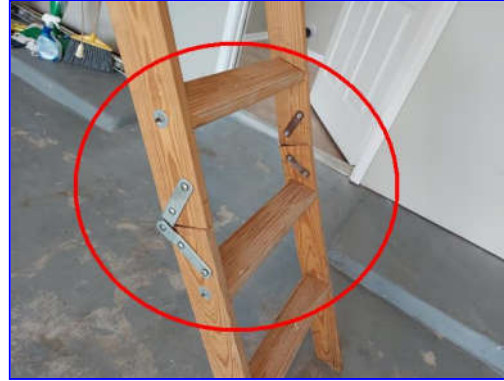
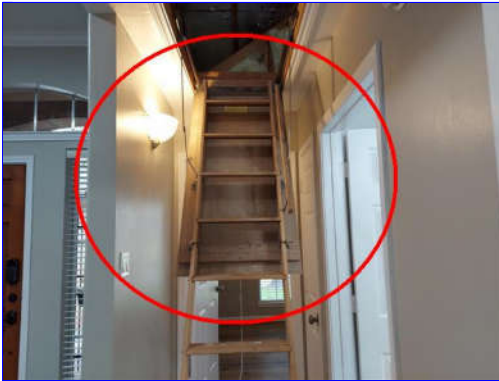
(3) The pull down stairs were observed to have the following defect(s): missing insulation, missing weather stripping and weak and not stable. This can be a potential SAFETY HAZARD.. Repair or replacement should be made.

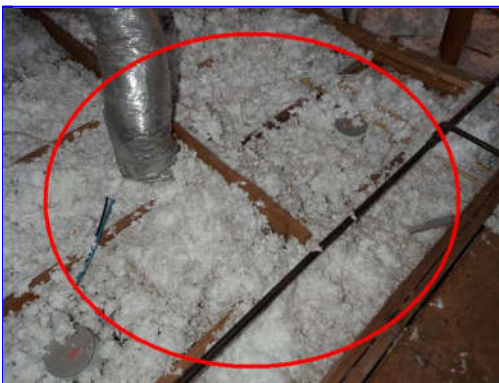
D. Item 13(Picture)

(4) The insulation was observed to be thin or compressed. Insulation improvements may be cost effective, depending on the anticipated term of ownership. Insulation should cover the ceiling joists to prevent potential thermal bridging. Thermal bridging is the movement of heat across the framing that is more conductive than the materials around it. The framing material creates a path of least resistance for heat. Thermal bridging can be a source of energy loss in homes. This can lead to increased energy bills.

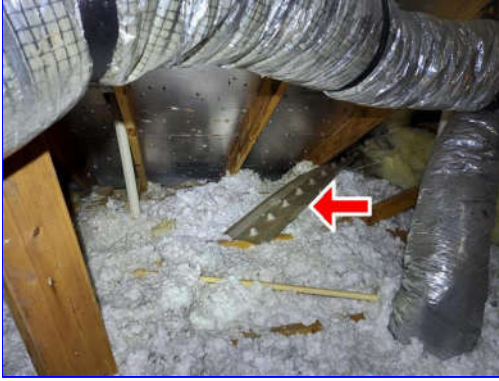
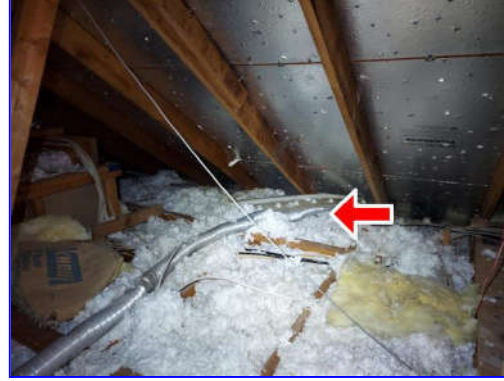
(5) Vent baffle(s) was/were observed to be dislodged or missing. Vent Baffle should be replaced/repared to prevent insulation from obstructing the soffit venting.

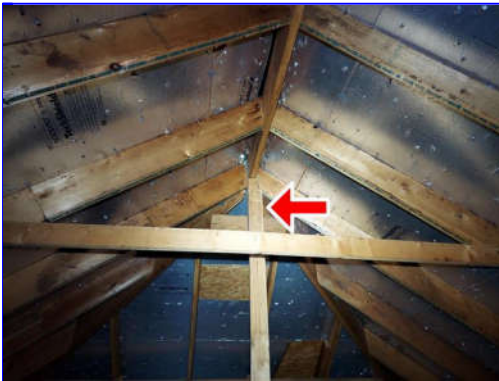
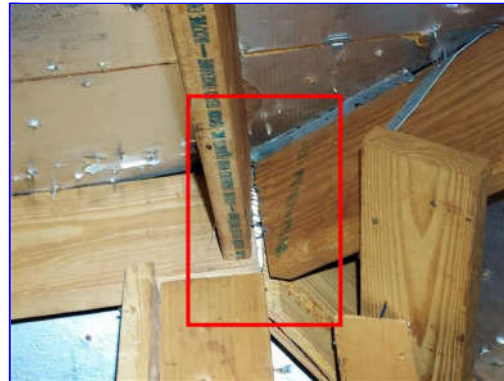
Poorly secured rafter(s) was/were observed. The ridge board or hip rafter should properly support the full face of the rafters. This condition may lead to sag in the roof structure. We recommend evaluation, repairs and further investigations for additional defects by a qualified, licensed contractor.

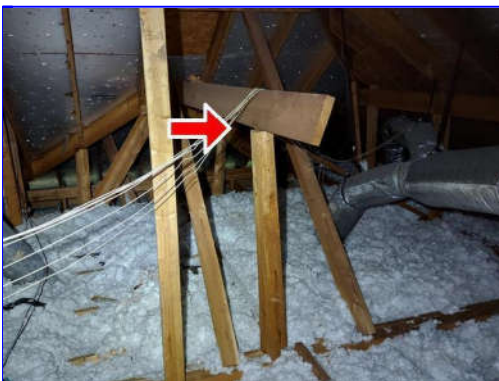
D. Item 19(Picture)

(7) One jack post was observed to be loose. Repair or replacement is needed.

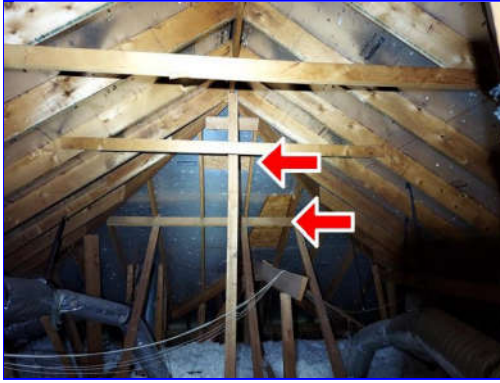
D. Item 20(Picture)

(8) Roof sheathing was/were observed to have previous repairs. The reason or cause for these repairs is unknown. The current home owner should be consulted if further information is required.

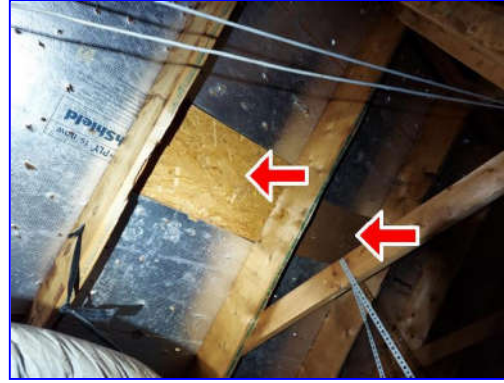
D. Item 21(Picture)

(9) **Buyers Advisory Notice:** A spray on or sheet/foil type silver "radiant barrier" was observed at the time of inspection. This product limits the inspectors ability to inspect the framing members and sheathing, as it covers the surfaces. Certain conditions may not be identified due to limited visual access to the structure.

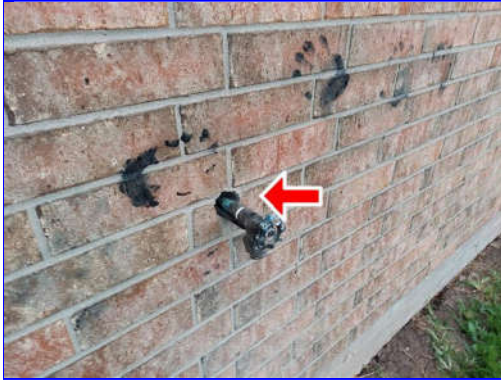
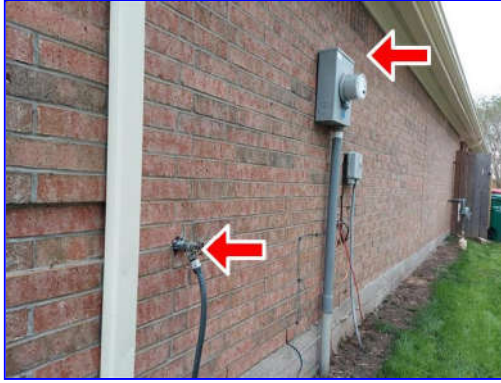
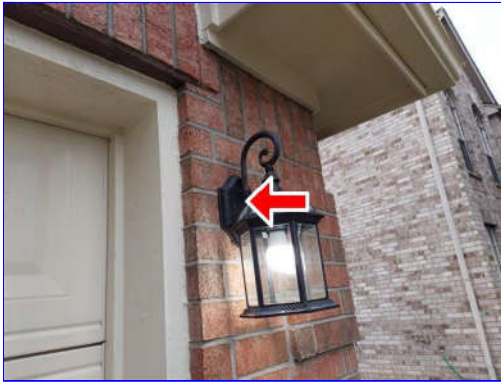
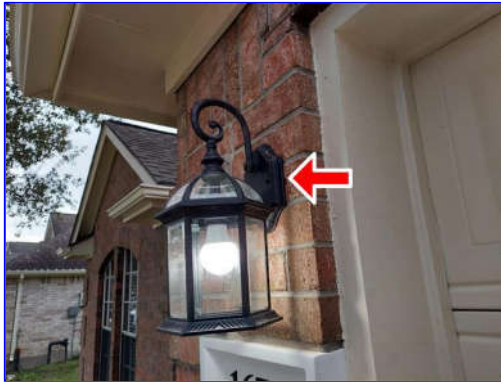
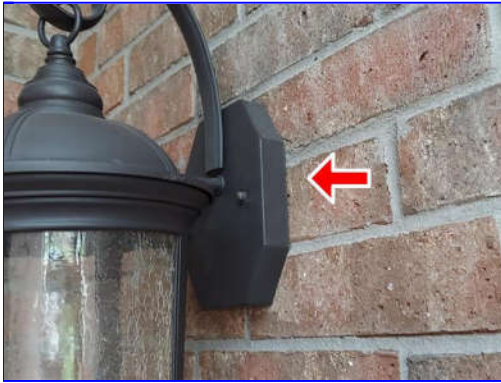
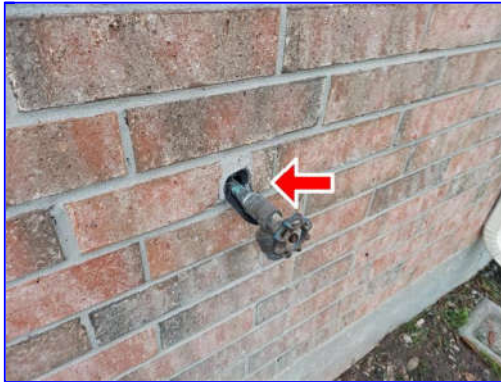
(2) **Caulking was observed to need improvement at various locations. Make improvements as needed.**

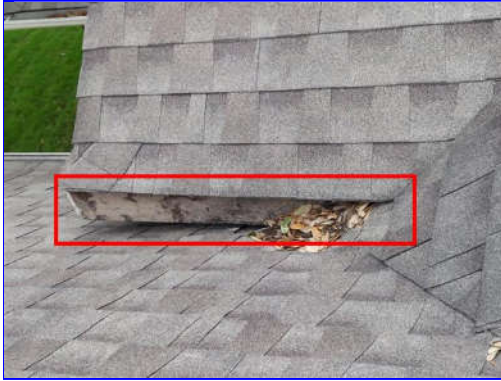
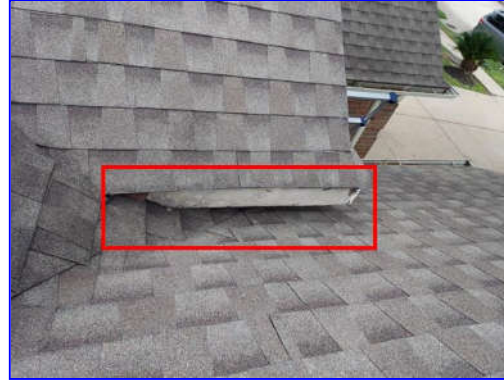
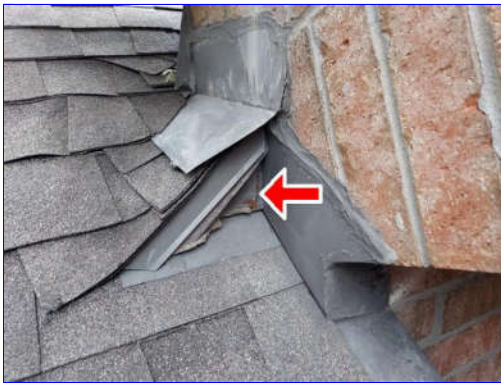
(3) The siding and trim, in various locations, were observed to have the following defects: damaged, detached, in poor condition and needs improvement. This condition could lead to moisture intrusion into the home. While it could not be verified, there may be concealed damage to the underlying structure. A qualified exterior contractor should be consulted regarding repairs.

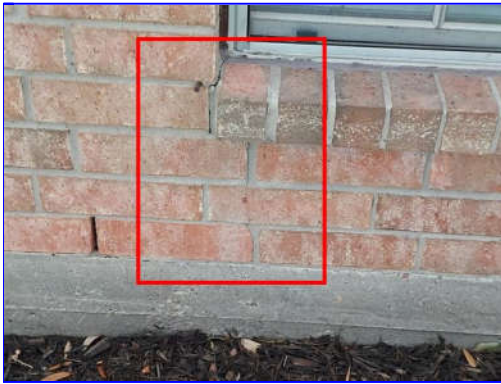
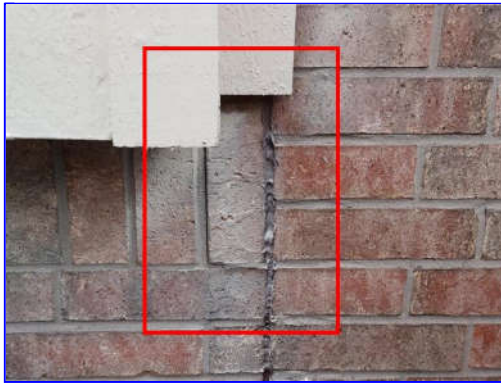
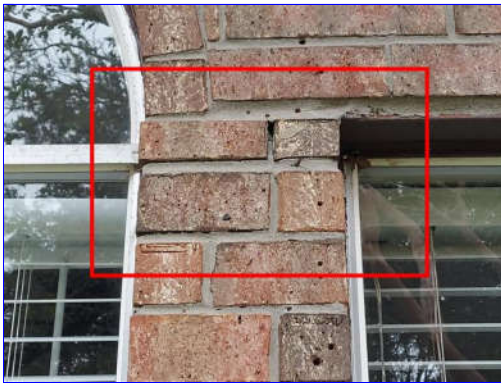
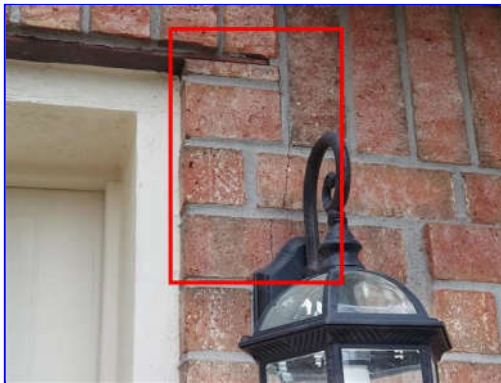
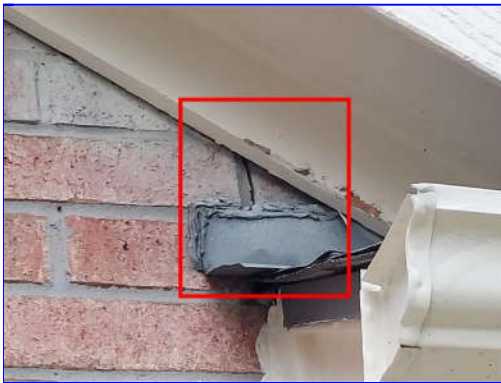
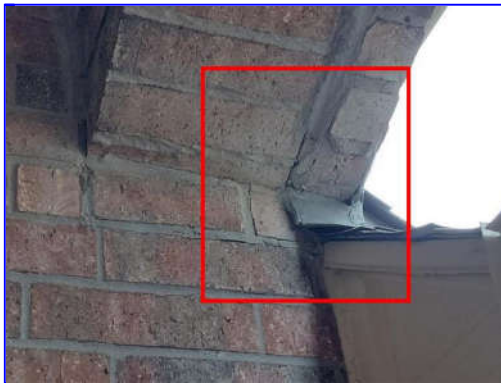
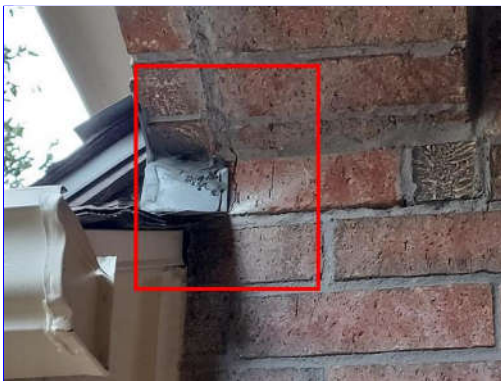
(4) Brick cracks were observed that are likely due to foundation movement.

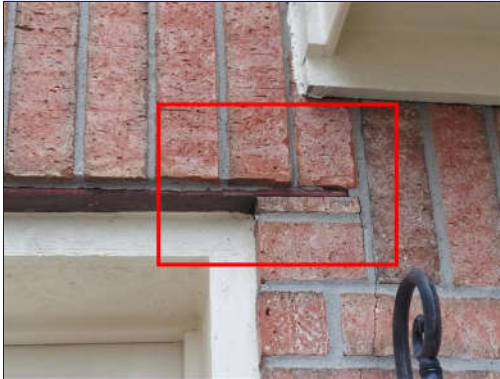
E. Item 20(Picture)

(5) Steel window/door lintels were observed to be rusted or discolored and are in need of cleaning and

paint. Steel window/door lintels are the support for exterior brick/stone veneer siding above doors and should be maintained to prevent deterioration.

An exposed metal lintel end(s) was observed. Exposed lintel ends should be primed with paint and covered with mortar to prevent to corrosion.

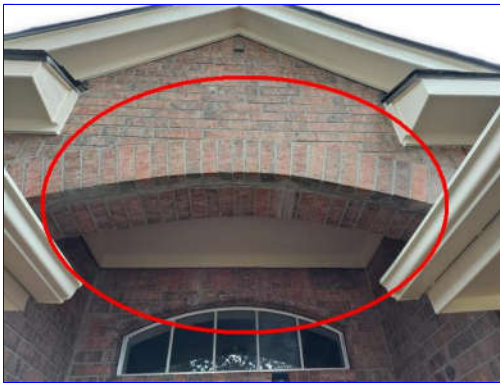
E. Item 22(Picture)

(6) Brick repairs were observed. The reason for these repairs is unknown. Some repairs maybe potentially related to foundation movement or repairs from foundation movement. There is no way for the inspector to determine the exact cause for these repairs.

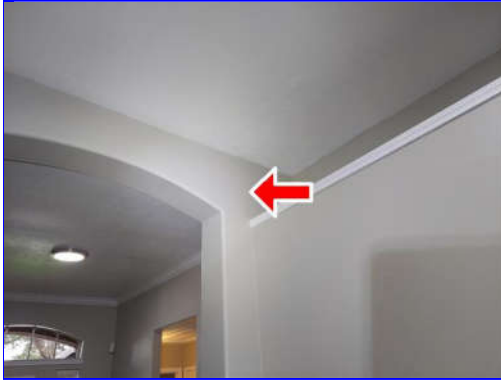
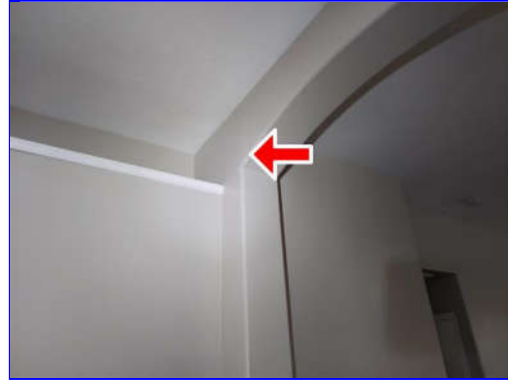
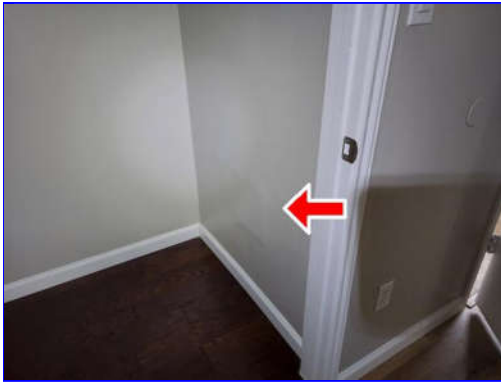
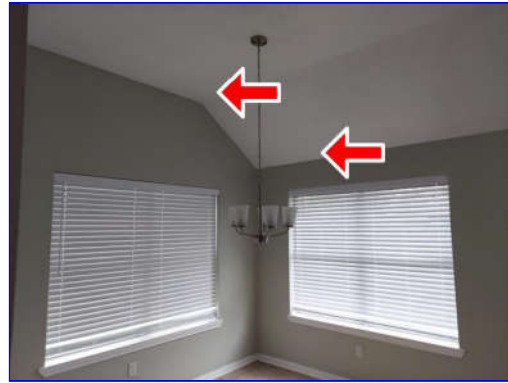
(7) Some repairs were observed at various location. It is not known the exact cause of the repair. If concern, please consult seller for more information.

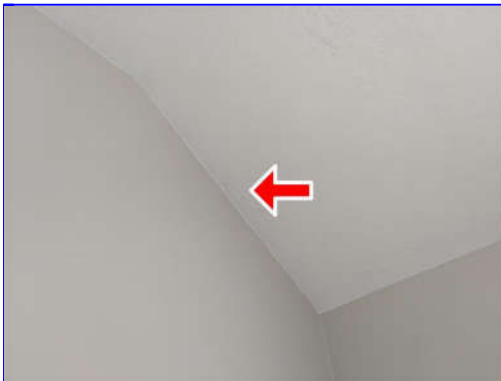
F. Item 1(Picture)

(2) Nail pops were observed in the ceiling. This is cosmetic and is for your information.

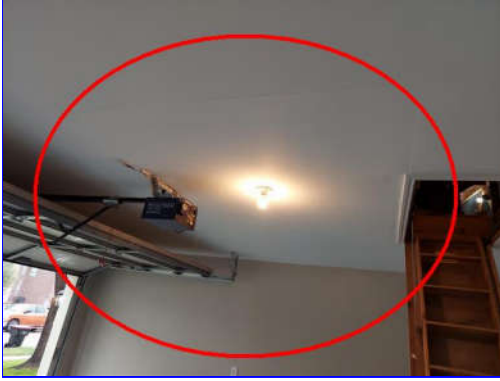
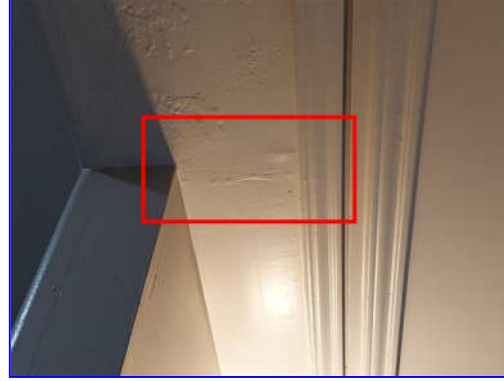
(3) Minor ceiling cracks were observed. These cracks appear superficial in nature.

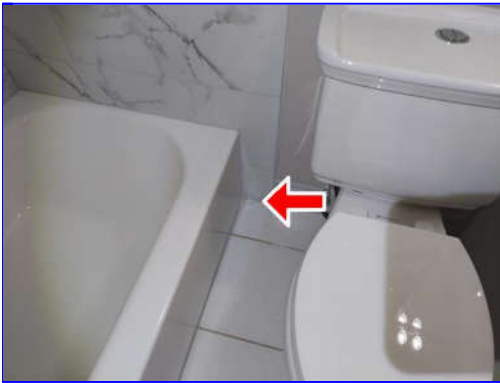
F. Item 4(Picture)

(4) The floor tile(s) was/were observed to have the following defect(s): cracked at hall bathroom.

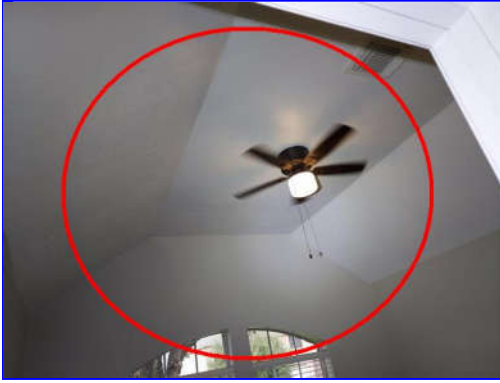
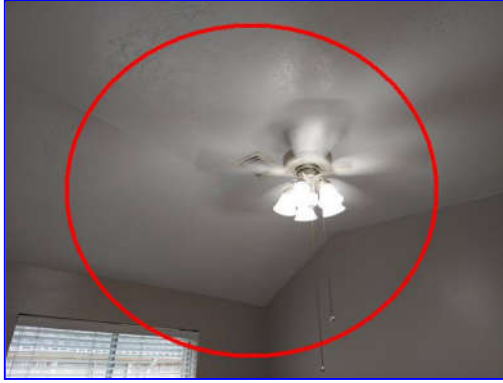
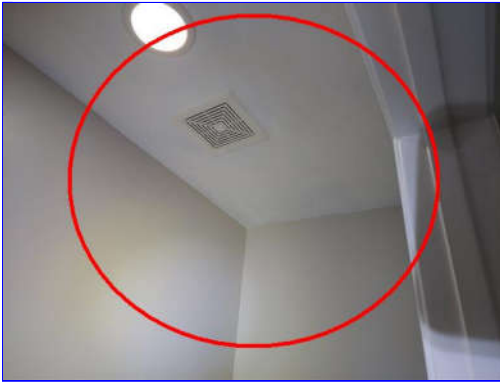
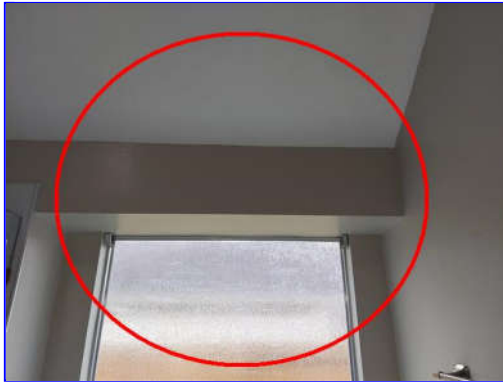
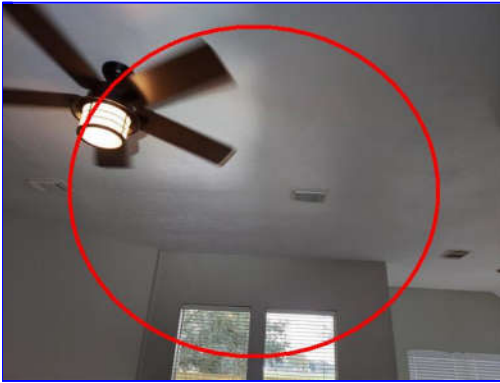
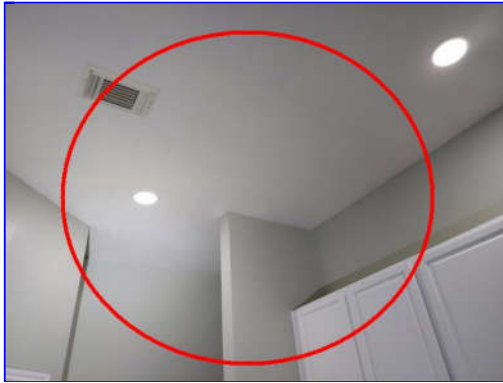
(5) Evidence of repairs/previous damage were observed. The area could not be reached to test with moisture meter. The cause of this condition was not determined. If sheetrock and insulation were affected by moisture, it should be removed, replaced and preventive measures for microbial hazards should be undertaken by a qualified, verified, licensed professional. The structural components related to this condition are not accessible to inspect for quality of installation, or possible component failure. This leave some degree of uncertainty regarding the condition. The buyer should obtain any and all information available regarding this condition prior to closing.

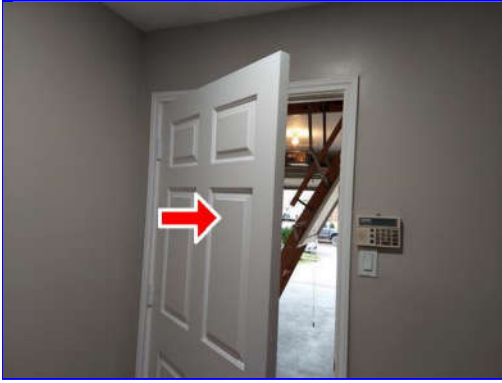
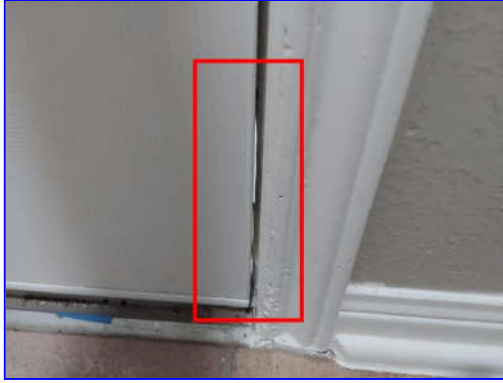
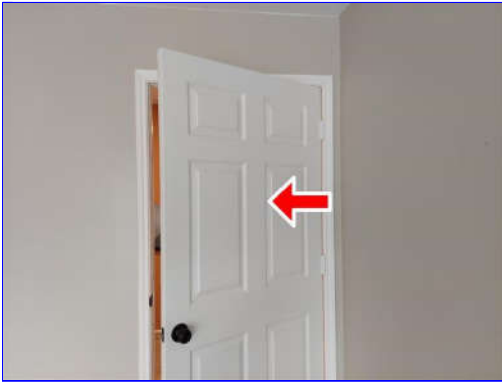
(1) The garage(s) entry door was/were observed to have the following defect(s): damaged weather stripping, excessive air gaps/light outside visible, door does not latch and self closer is missing. this is a potential fire and safety hazard. Repair or replacement is needed.

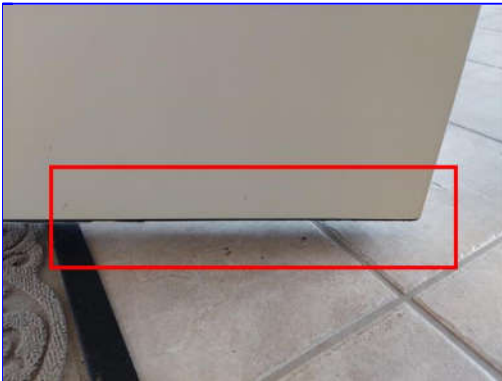
G. Item 5(Picture)

(2) The exterior door(s) at the rear of home was/were observed to have the following defect(s): damaged weather stripping. Repair or replacement is needed.

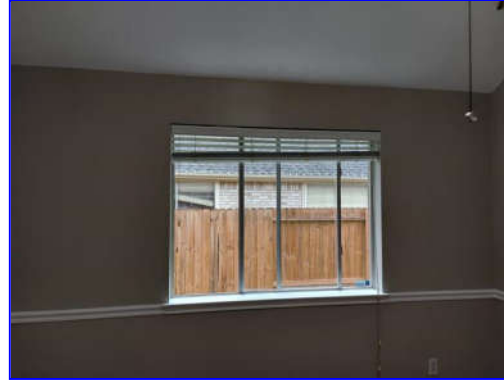
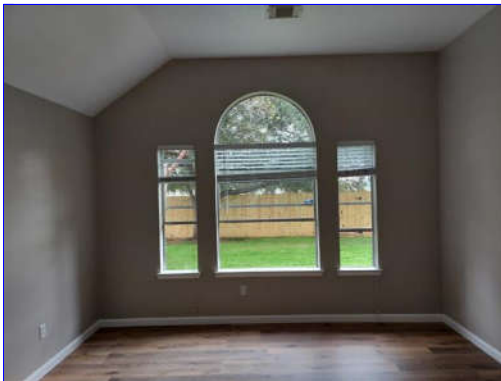
(2) One or more window screens were observed to be missing or damaged at various locations. Repair or replacement is needed.

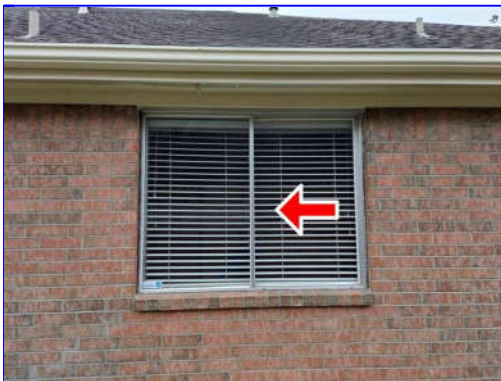
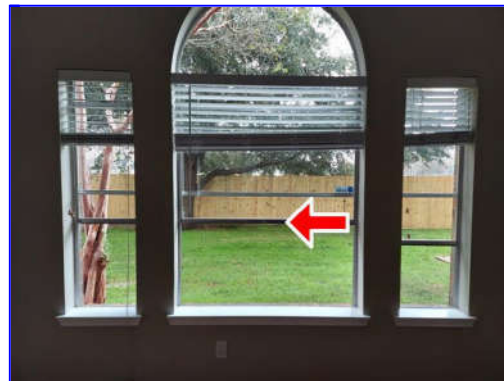
(3) Window(s) was/were observed to have the following defect(s): required excessive force to open at various locations. The window(s) should be repaired as needed.

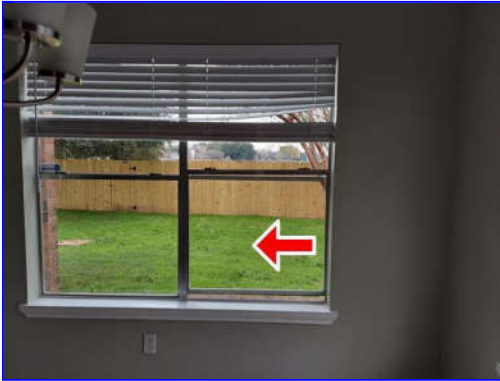
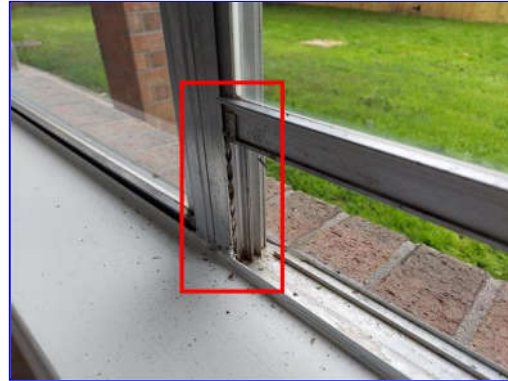
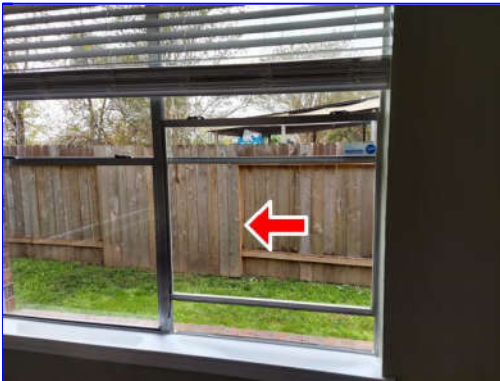
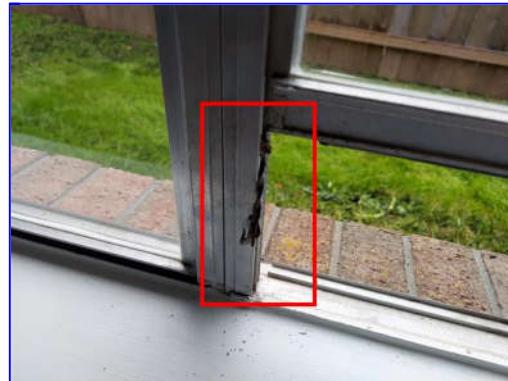
(4) Loose "sprung" window balancers were observed at various locations. This affects proper operation of the window.

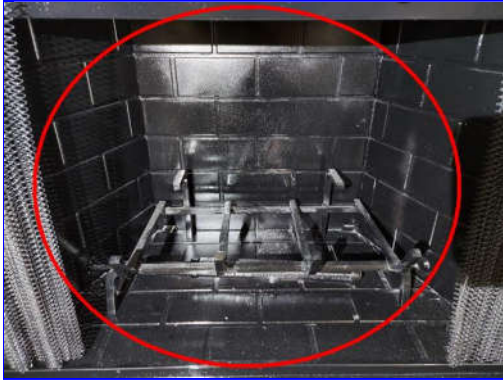
J. Item 4(Picture)

(3) Fire box was observed to be painted. It is unknown if the paint is heat resistant. This can create a potential fire and safety hazard if the proper materials are not used and fire is introduced. Inspector recommends consulting with the seller/homeowner to confirm the type of paint used prior to use of the fire place.

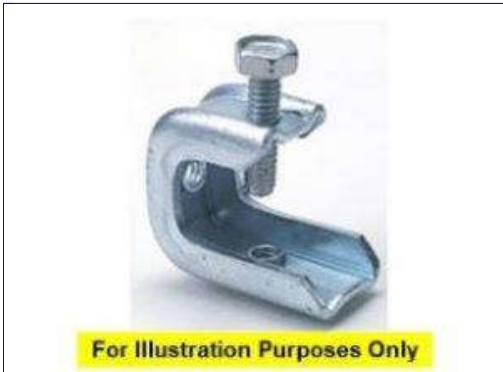
J. Item 5(Picture) Damper stop

(4) The fireplace does not have damper stop installed. Damper stops are needed for fireplace burning hydrocarbon fuels to assure carbon monoxide fumes are vented out of the home.

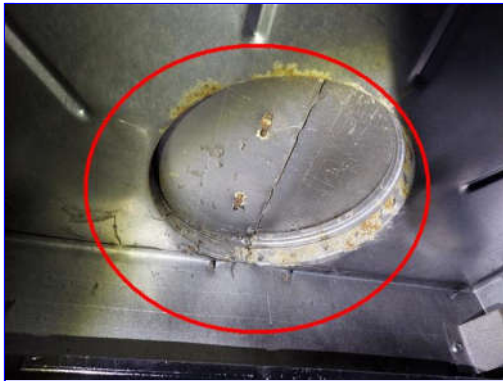
J. Item 6(Picture)

(5) The metal firebox was observed to be rusted at the time of inspection. The degree of this rust is unknown and there is potential for safety and fire hazards should the rust penetrate the firebox during a fire. A qualified, verified chimney sweep/professional should be consulted for a more in depth inspection prior to use.

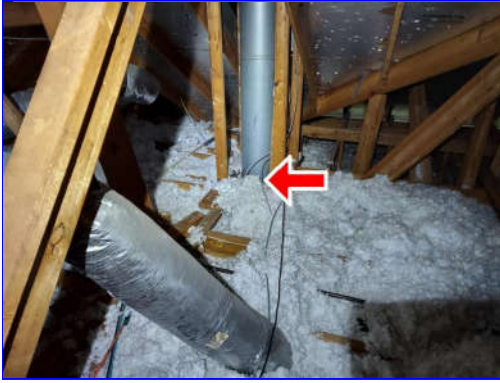
J. Item 8(Picture)

(6) One or more flue vents are in contact with or does not have adequate clearance from combustibles. A minimum of 1" clearance is required per manufacturer instructions. Adjustment is needed to prevent possible safety hazards such as fire.
