# Inspection Report

**Property Address:**  
16747 Village View Trail  
Sugar Land TX 77498

## PROPERTY INSPECTION REPORT FORM

12/13/2023

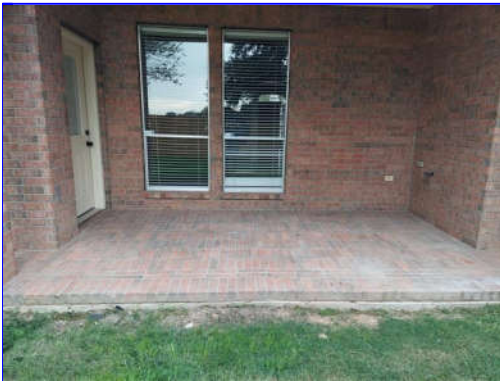
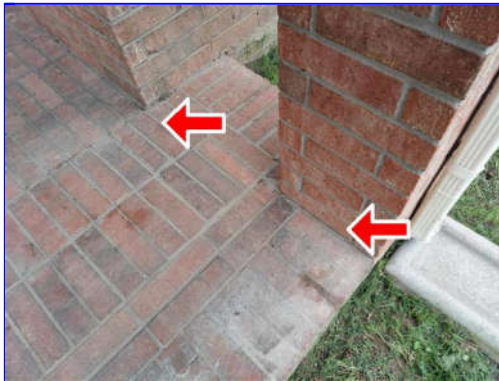
There were cracks in the rear porch floor. This is typical of concrete and is not considered significant. It should be monitored for large separations or differential movement.

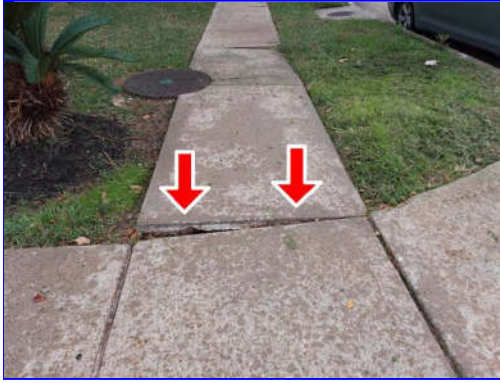
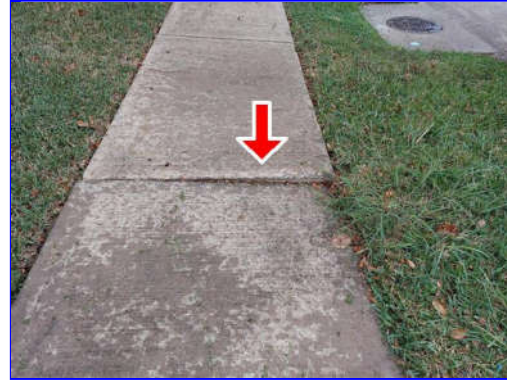
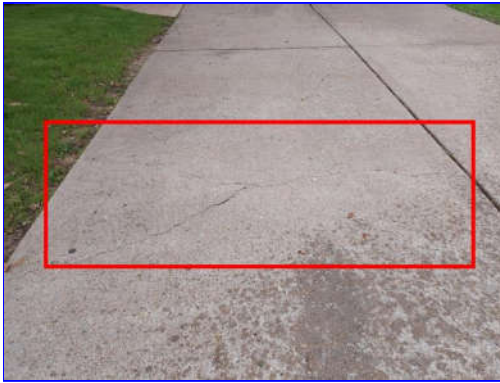
(2) The concrete driveway and concrete walkway in various locations was/were observed to have the following defect(s): excessive gaps, cracks, uneven and can be a tripping hazard. Further deterioration can occur if not repaired. A fall or injury can occur if not corrected.

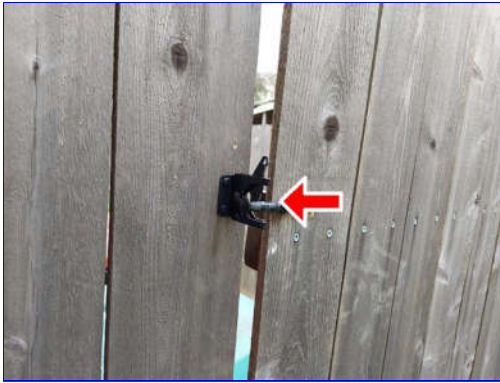
K. Item 7(Picture)

(3) Gate was observed have the following defects: door does not latch. Repairs should be made.

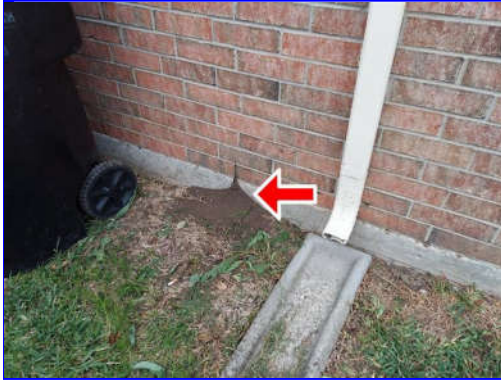
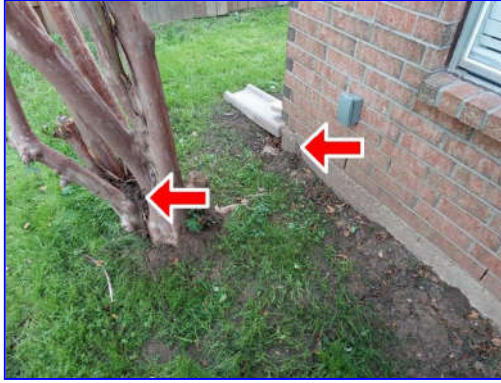
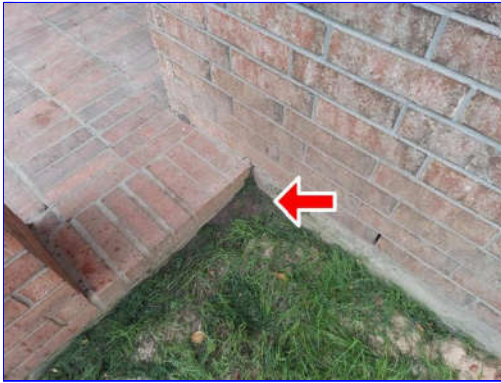
(2) Ants were observed at the foundation. A licensed pest control professional should be contacted regarding this condition.

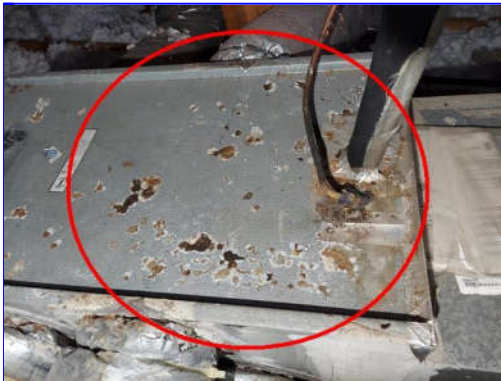
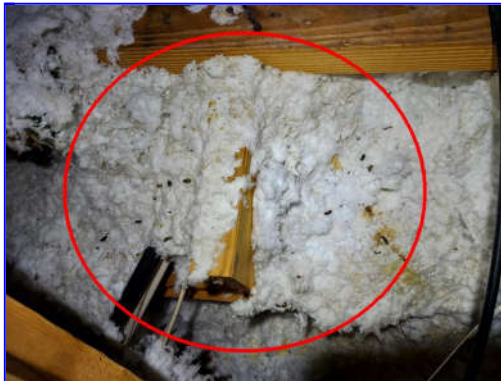
(3) There is evidence of possible vermin activity in the attic. A qualified, verified, licensed pest control specialist should be consulted regarding this condition and remediation.

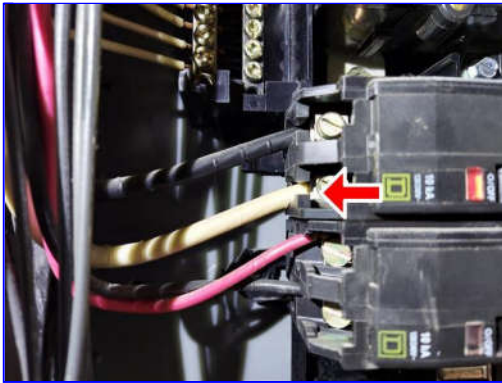
A. Item 6(Picture)

(4) Cables at breakers are white, an improper color code for these cables.

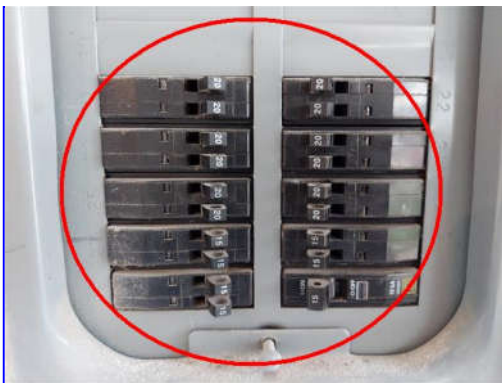
A. Item 8(Picture)

(5) Main breaker and several others were observed to be from different manufacturers. Breakers, particularly main breakers, are not to be substituted for other manufacturers. A qualified, verified, licensed electrician should be consulted regarding further evaluation.

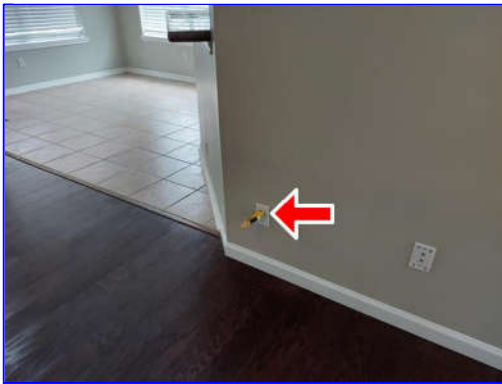
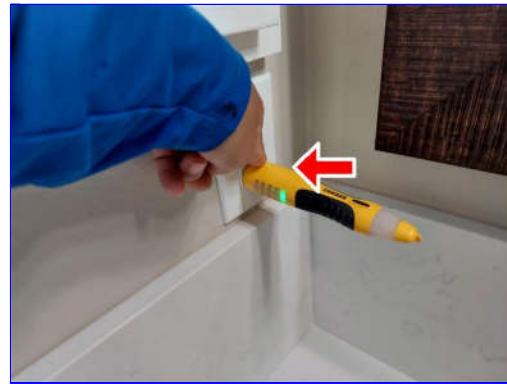
(6) Receptacle(s) in required locations, kitchen countertops, kitchen island, bathrooms, laundry, garage and/or within six feet of a sink is/are not ground fault circuit interrupt (GFCI) protected. This condition is a safety hazard that should be repaired.

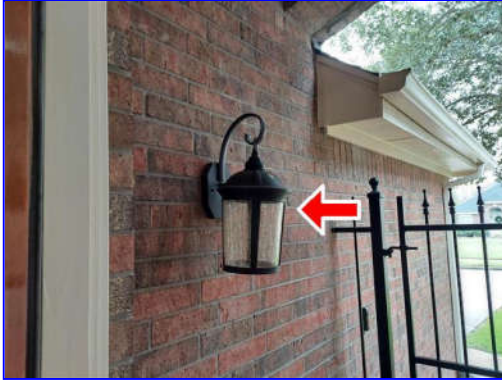
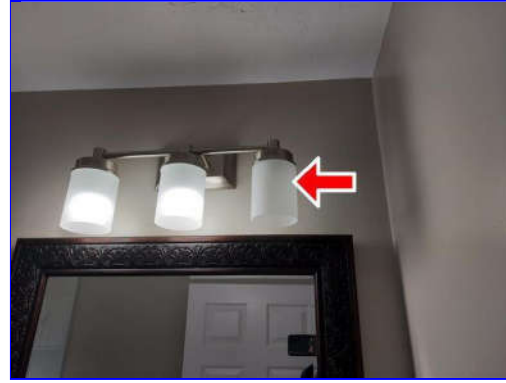
(7) Light fixture(s) in the exterior and interior was/were inoperative. If the fixture(s) does not work after replacing the bulb(s), a licensed electrician should be consulted.

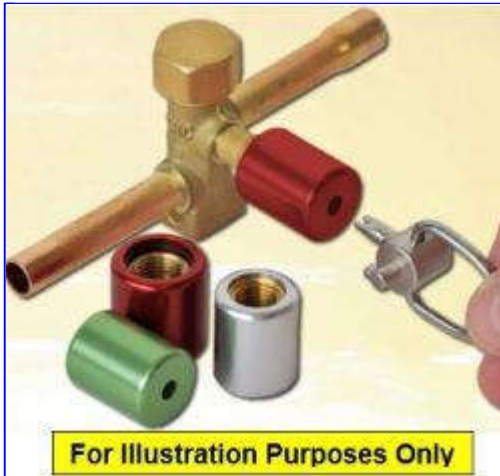
B. Item 9(Picture) Locking cap

(5) Locking caps for HVAC freon ports are missing. As of 2009, any HVAC system is required to have a locking cap on all units in residential or commercial dwellings. Residential and multifamily dwellings may be subject to significant fines stemming from the lack of locking caps. Only a licensed HVAC company/technician may install or remove the locking cap.

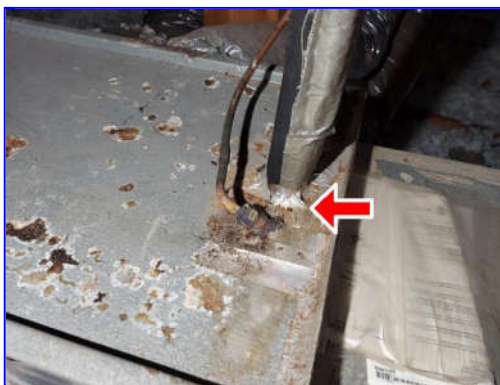
B. Item 12(Picture)

(7) Excessive air leakage at the air handler was observed. Inadequate air seals may allow unwanted air, vapors, or debris to be pulled into the cooling equipment. Inadequate air handler seals may damage the equipment and produce organic growth. We recommend evaluation, repairs, and further investigations for additional defects by a qualified, verified, licensed HVAC technician.

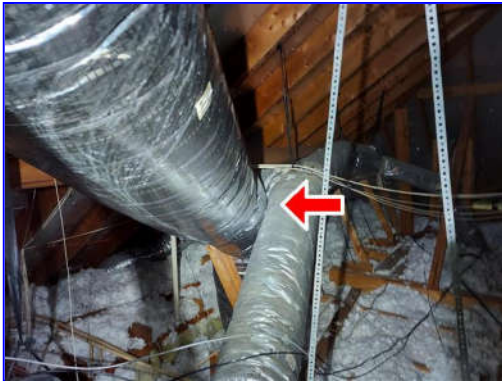
C. Item 1(Picture)

(2) Ductwork was observed to be in contact with other ductwork. Typically ductwork should be separated to prevent condensation between ducts. Condensation can lead to excess moisture in the attic space. This can lead to potential problem, i.e. wet insulation and conducive conditions that can lead to organic microbial growth.

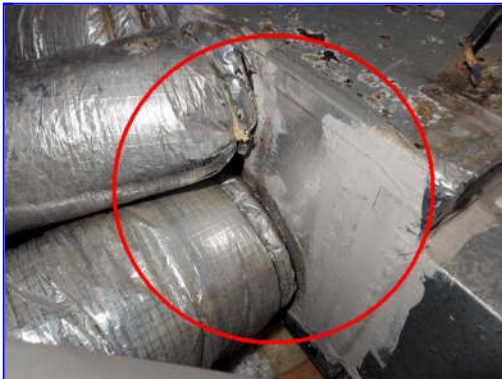
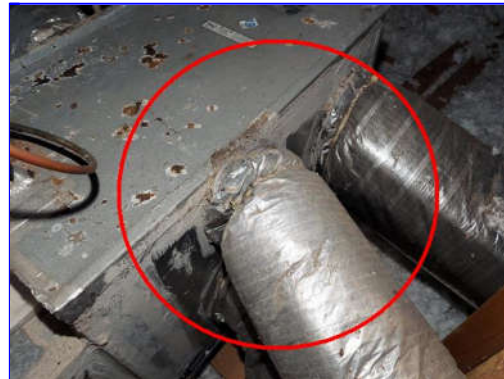
(3) An organic biological substance was/were observed to be present on walls, ceiling or other surfaces. We did not inspect, test or determine if this growth is or is not a health hazard. The underlying cause is moisture or dampness. I recommend you contact a licensed mold inspector for investigation or correction if needed. This is a potential safety hazard and should be investigated further.

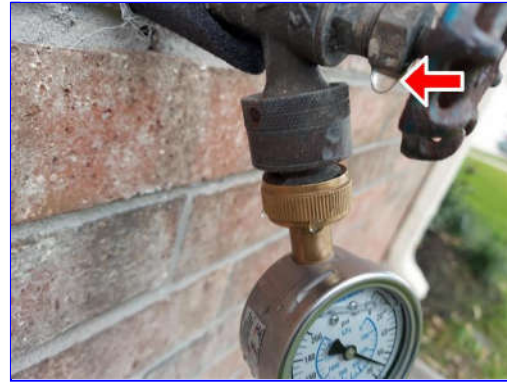
A. Item 4(Picture)

The hose bib(s) was/were observed to have the following defect(s): leaks at anti-siphon and valve when turned on.

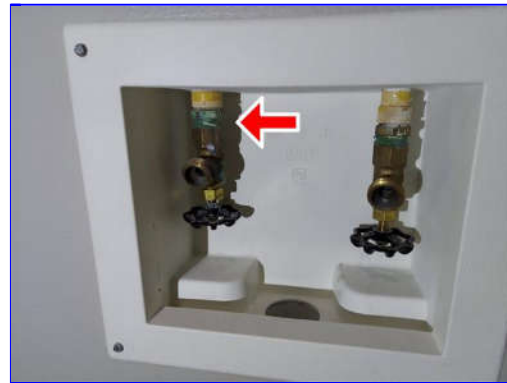
A. Item 6(Picture)

Corroded fitting(s) was/were observed. Fitting(s) was/were not observed to be leaking at the time of inspection but should be monitored. A qualified, verified, licensed plumber should be consulted regarding repairs as needed.

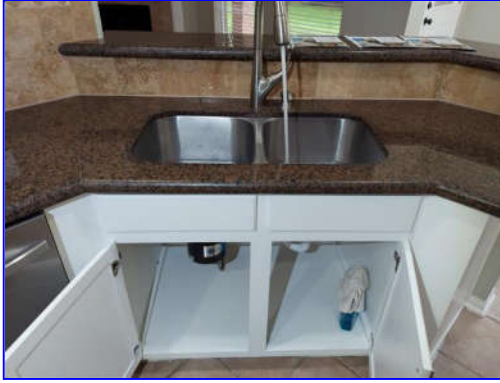
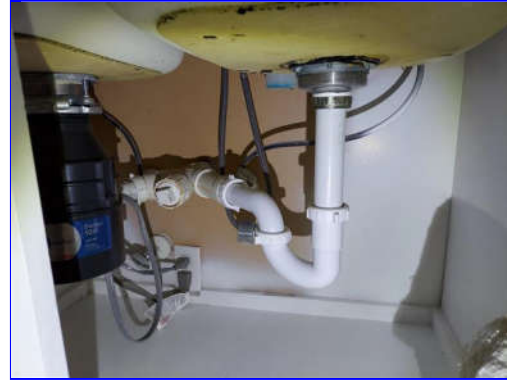
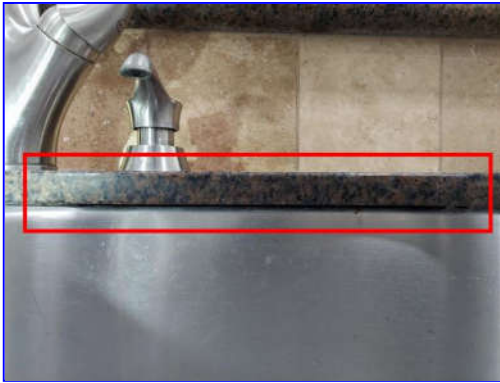
The under mounted sink(s) was/were observed to have deteriorated caulking or not caulked at the counter top. In most cases the sink(s) will need to be removed to be caulked properly.

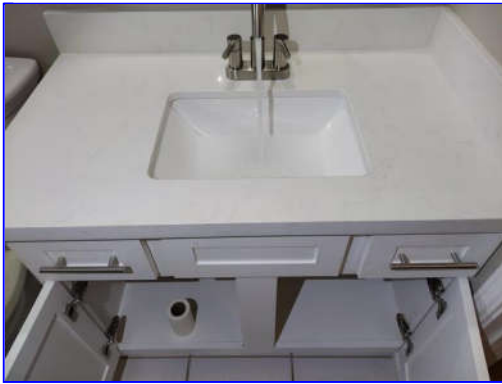
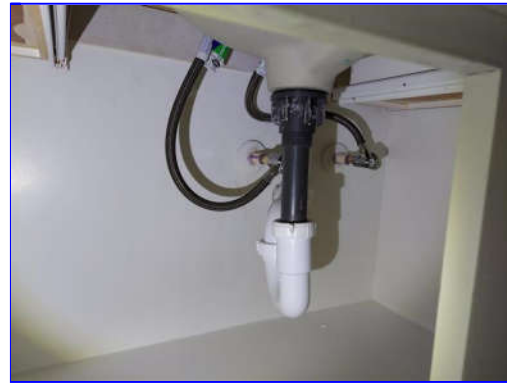
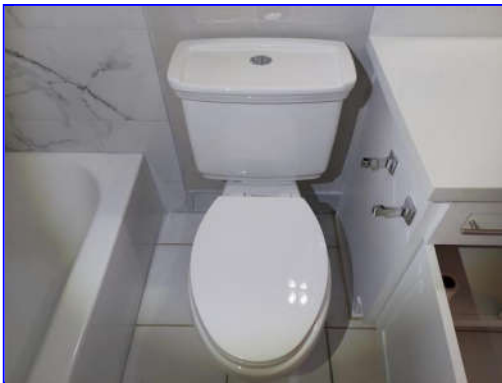
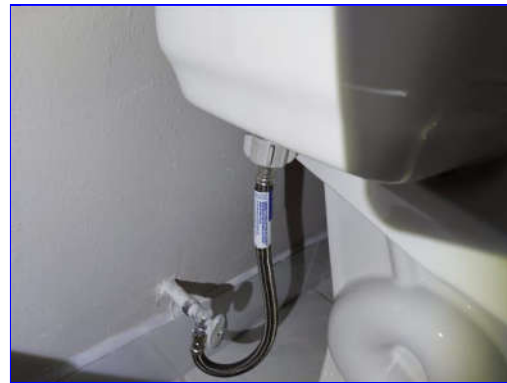
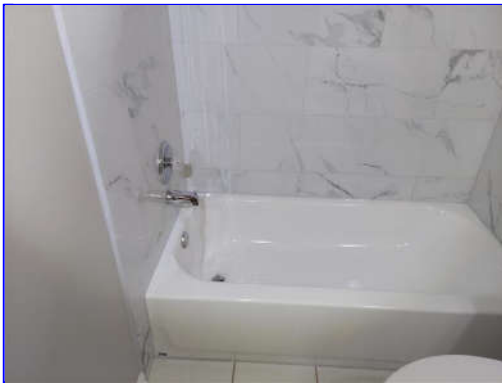
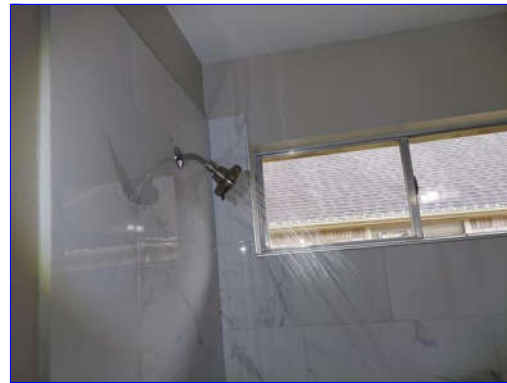
The drain stop is not operated properly. Repair should be made.

The shower/tub faucet assembly is/are not sealed at the wall. This condition has the potential to allow water to leak back into the wall cavity.

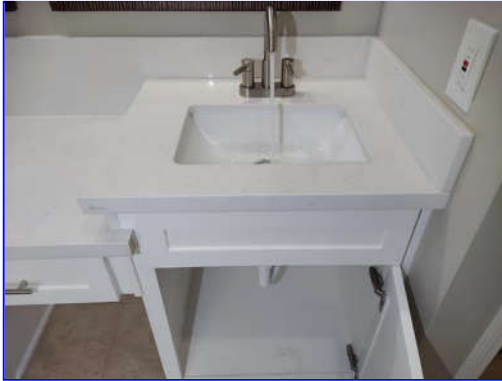
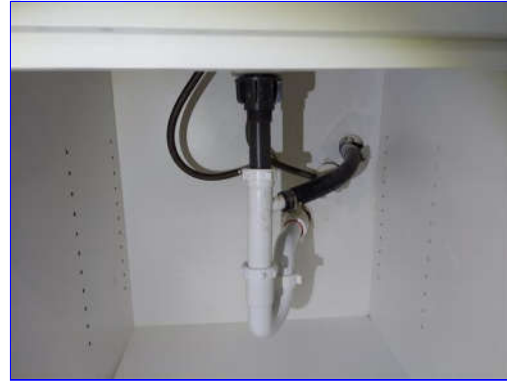
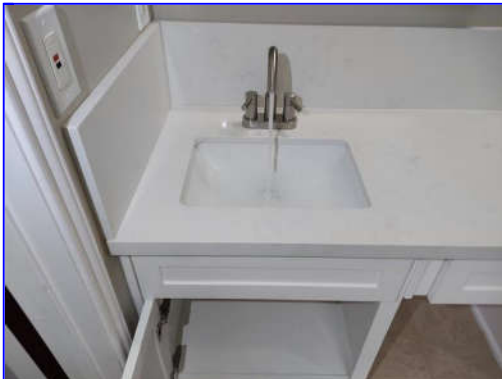
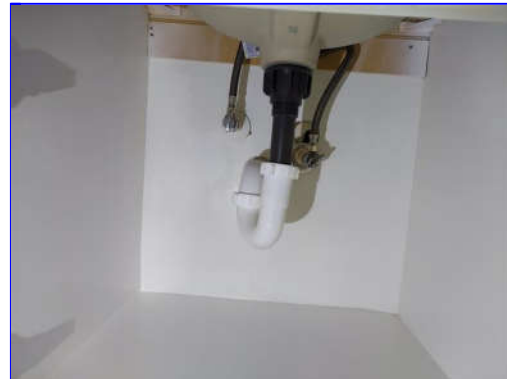
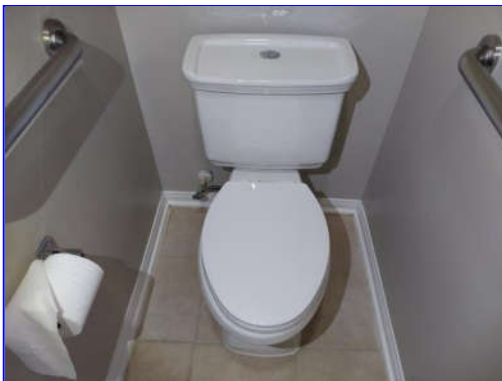
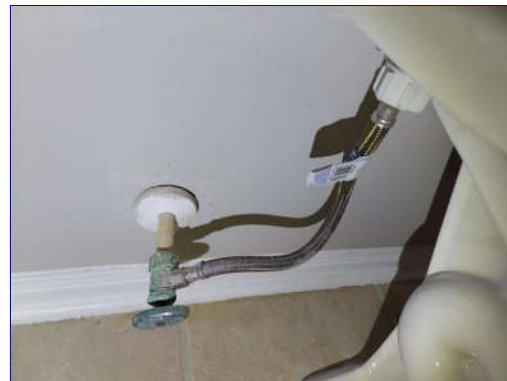
Corroded fitting(s) was/were observed. Fitting(s) was/were not observed to be leaking at the time of inspection but should be monitored. A qualified, verified, licensed plumber should be consulted regarding repairs as needed.

The shower/tub faucet assembly is/are not sealed at the wall. This condition has the potential to allow water to leak back into the wall cavity.

Caulk/grout improvements are needed at shower/tub wall or around/above tub to prevent water leaking back into the wall cavity.

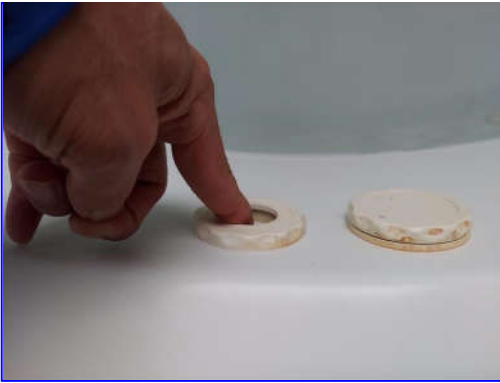
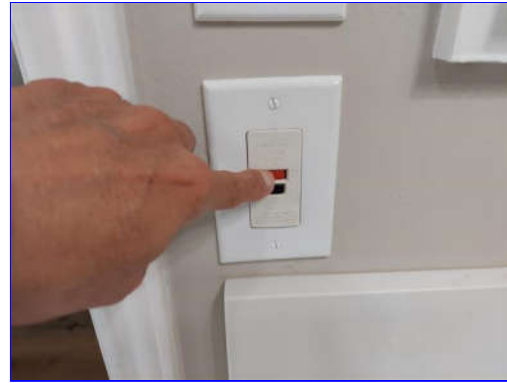
(2) The hydro-massage tub was inoperable at the time of inspection.

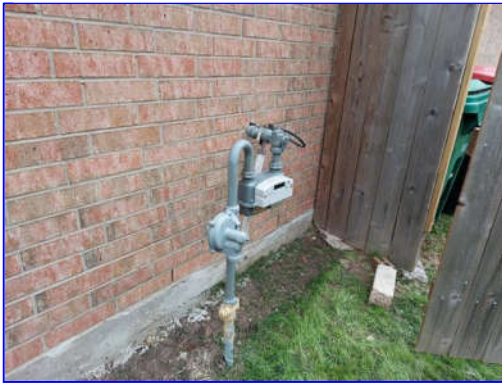
E. Item 1(Picture)

(2) The gas meter and/or clamp were observed to be painted. Direct metal to contact is required for this system to function properly. A potential safety hazard exists if this is not corrected. Repair should be made.

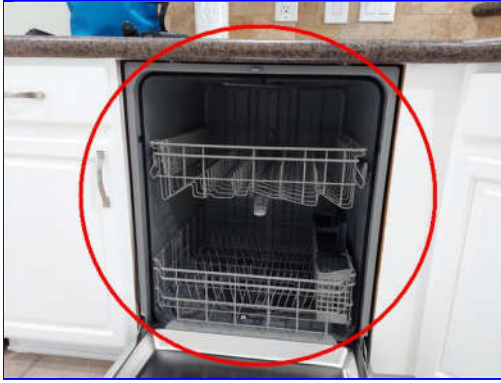
A. Item 5(Picture)

(3) The dishwasher was observed to have the following defect(s): loose and needs securing to the underside of countertop (using a proper length screw). I recommend repair as necessary.

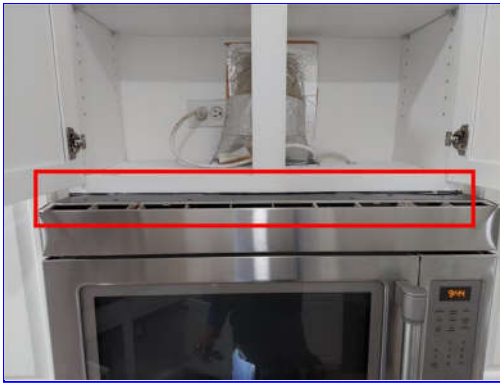
C. Item 3(Picture)

(3) The range hood vent was observed to have the following defect(s): not properly installed and is venting into the interior of the home/cabinet space. The range hood vent should be sealed where needed.

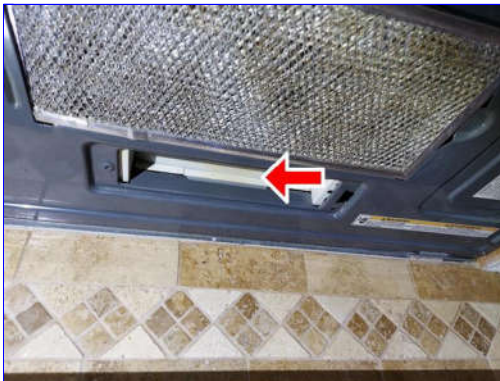
C. Item 4(Picture)

(4) The bulb for the range hood was observed to be inoperative. I recommend repair or replacement as needed.

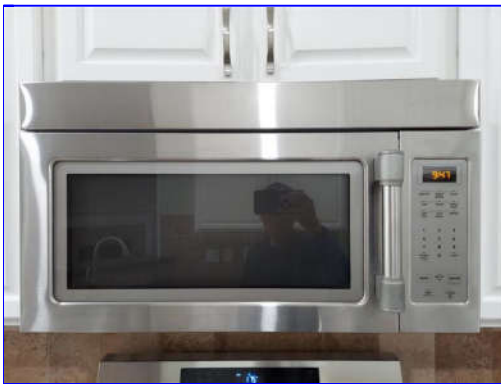
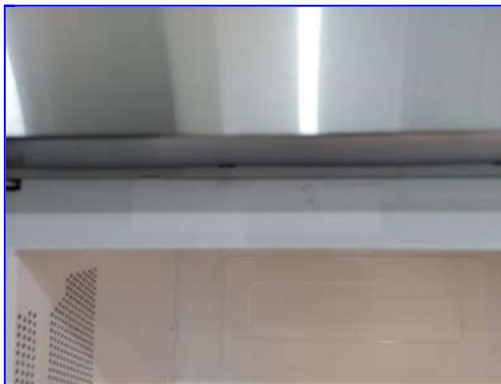
(1) View of Microwave and Data Plate (if available)

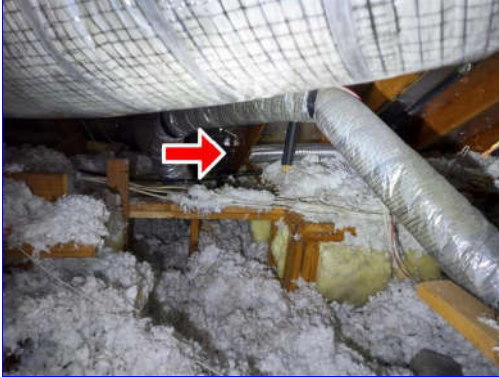
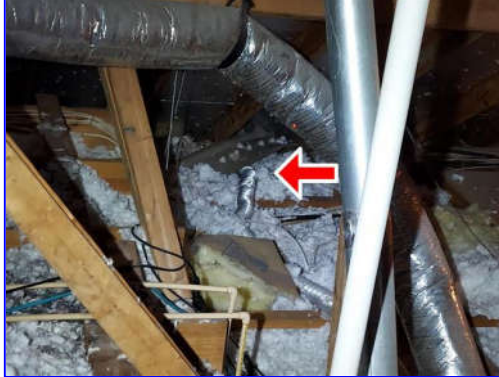
(1) Exhaust fans were observed to be functioning as intended at the time of the inspection.  
 (2) The exhaust fan(s) was/were observed to discharge into the attic. Repairs should be undertaken to vent the exhaust fans to the exterior of the home. Venting to the soffit is not the best practice. Exhaust fans are intended to remove moisture from the home, if the vent discharges into the attic it can lead to unwanted microbial growth. A qualified, verified contractor should be consulted regarding this repair.

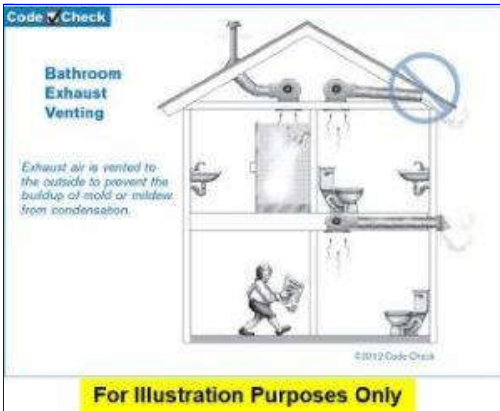
F. Item 3(Picture) Exhaust fan

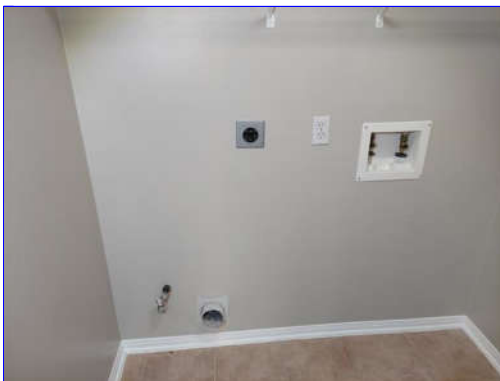
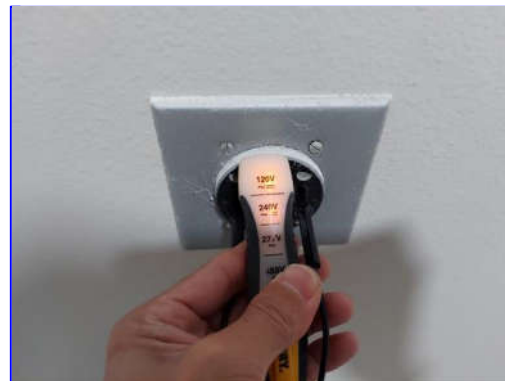
(1) View of Dryer System

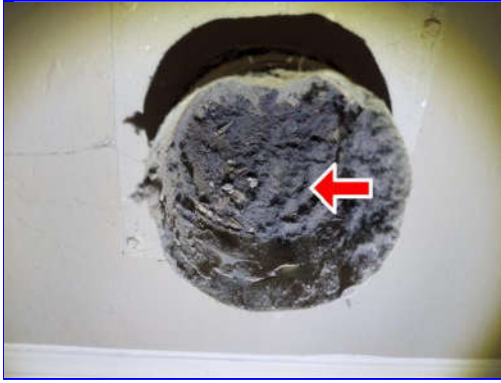
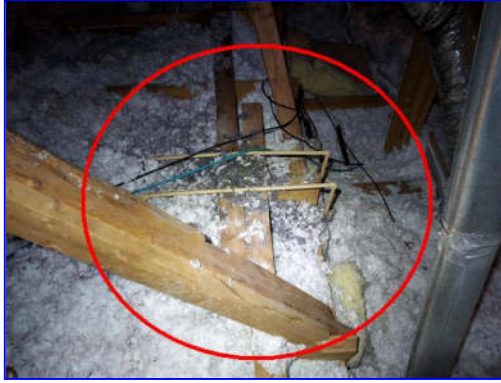
(3) The clothes dryer vent was observed to be in need of cleaning. Clogged dryer vents can be fire hazards.
