HOME INSPECTION REPORT

Prepared For:	Ken Goolsby
	(Name of Client)
Concerning:	6075 Fm 222 Loop S, Shepherd, TX, 77371
	(Address or Other Identification of Inspected Property)
By:	David Jones (# 22116) Charles Rowden (# 22155)
	(Name and License Number of Inspector)
	10-8-2019
	(Date)
	(Name, License Number of Sponsoring Inspector)

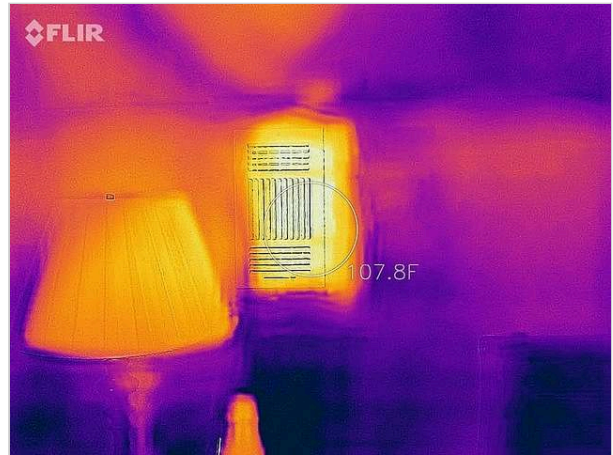
Thermal showing 100+ degrees of temperature output (upstairs guest bedroom)

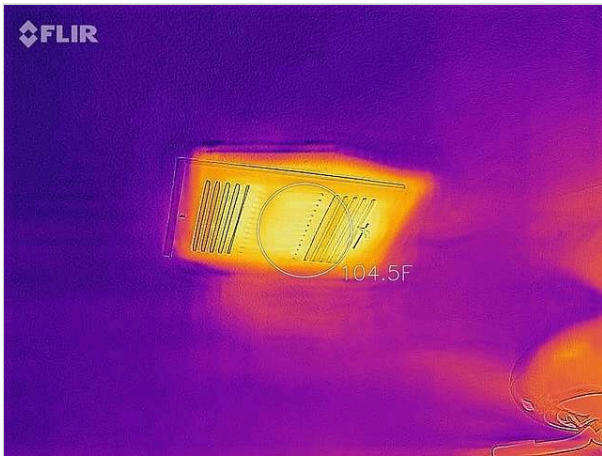
Thermal showing 100+ degrees of temperature output (downstairs guest bedroom)

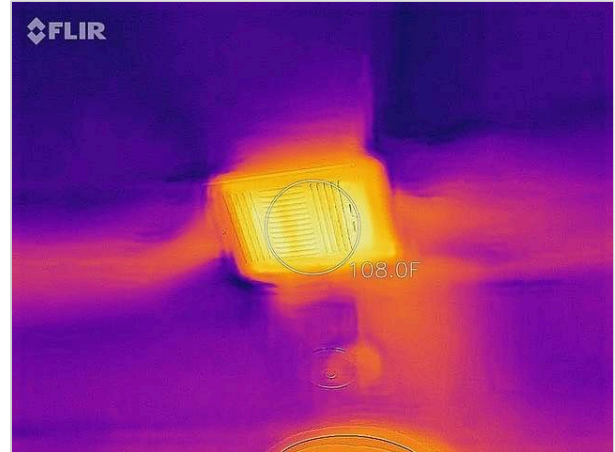
Thermal showing 100+ degrees of temperature output (kitchen)

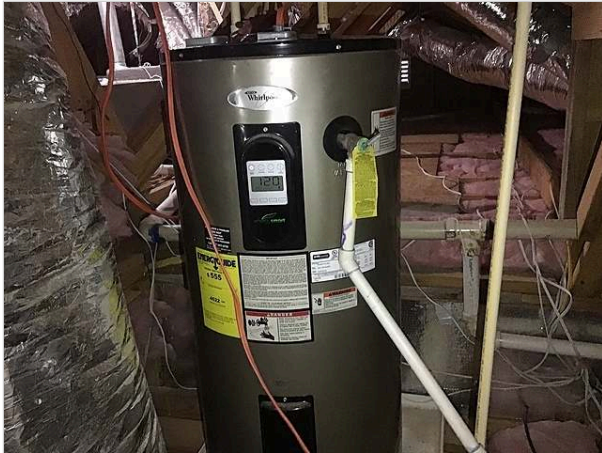
Relief valve was not tested (unit in the attic).

Unit in attic

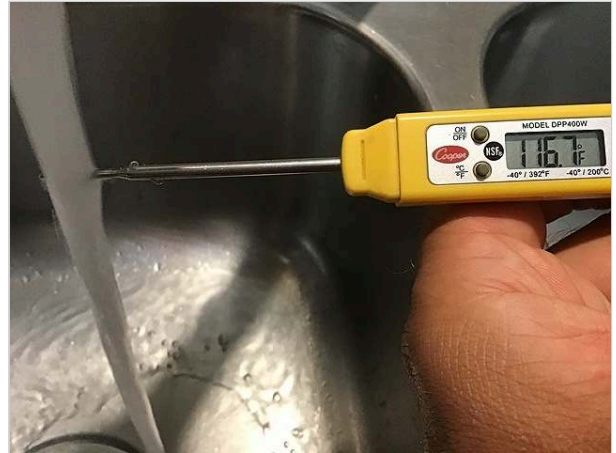
Hot water temperature reading at the kitchen sink (116.7 degrees)
