GREATER HOUSTON AREA - NOBLE PROPERTY INSPECTION REPORT

7414 Canary Cir
Texas City, TX 77591

PROPERTY INSPECTION REPORT FORM

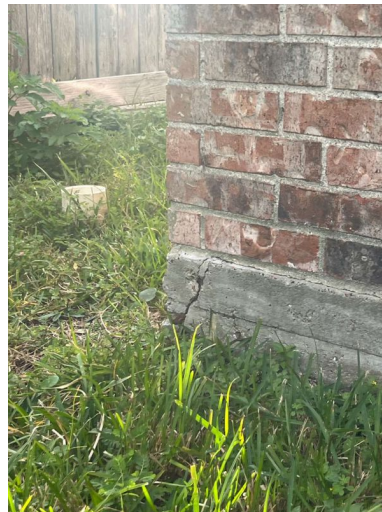
Back Right

1: Slab - foundation cracks - corners

Corner cracks are visible in the foundation slab but are of minimal structural concern. Shrinkage is a natural part of the curing process of concrete and cracks located in corners of structures are common. Recommend patching the corner cracks to prevent moisture/pest intrusion. Also recommend monitoring to confirm the cracking does not worsen.

Recommendation: Contact a qualified Houston - Foundation Contractor

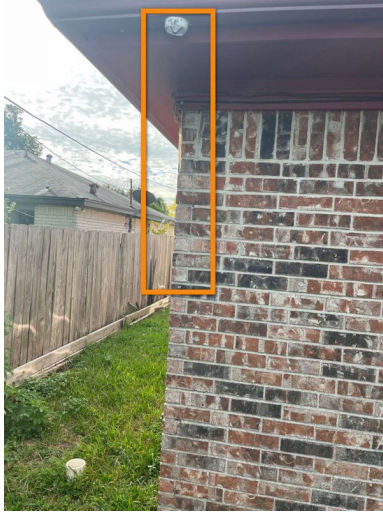
Back Right

1: Gutter is broken

The gutter is broken at this location and should be replaced or fixed. Recommend a gutter contractor to resolve the issue.

Recommendation: Contact a qualified Houston - Handyman Service

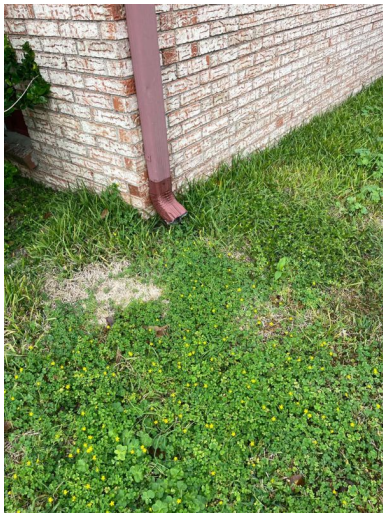
Right Front

2: Gutter missing splashblock

Some or all of the gutter downspouts are missing splashblocks. Splashblocks help to disperse the water away from the foundation and prevent erosion of soils. Recommend installation.

Recommendation: Contact a qualified Houston - Handyman Service

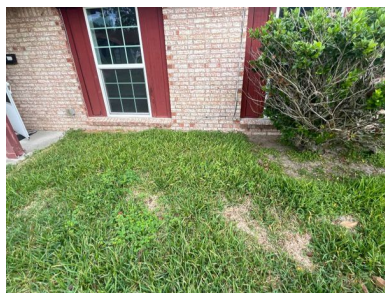
Front Right

The clearance from the finished floor elevation (i.e. top of slab) to the exterior grade (i.e. ground) should be 6-inches or greater. This will prevent pooling surface water runoff from storm events from entering the structure. Recommend regrading the build-up of material to expose the foundation and create a greater clearance.

Additionally the soil and vegetation should not be in contact with the siding or any wood.

Recommendation: Contact a qualified Houston Area - Landscaping Contractor

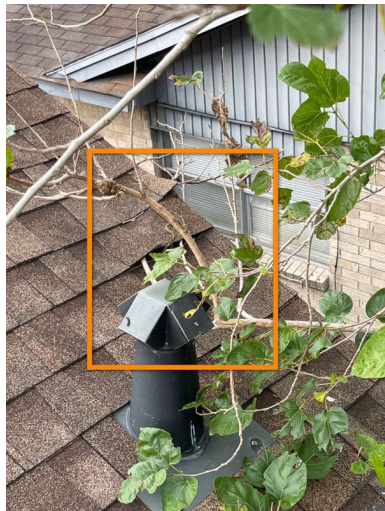
Left Middle

1: Damaged coverings

Roof coverings exhibited general damage that could affect performance. Recommend a qualified roofer evaluate and repair.

Recommendation: Contact a qualified Houston - Roofing Professional

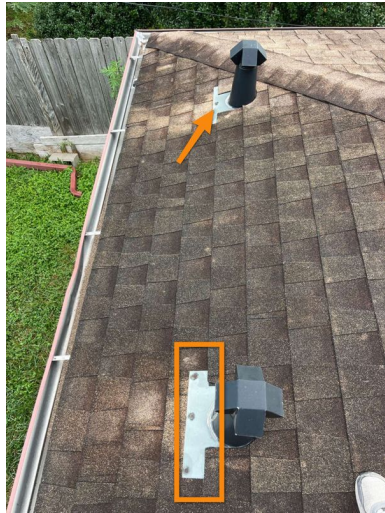
Back Right

2: Exposed nails

Under-driven or exposed nails were found in one or more roof coverings. Recommend a qualified roofer evaluate and correct.

Recommendation: Contact a qualified Houston - Roofing Professional

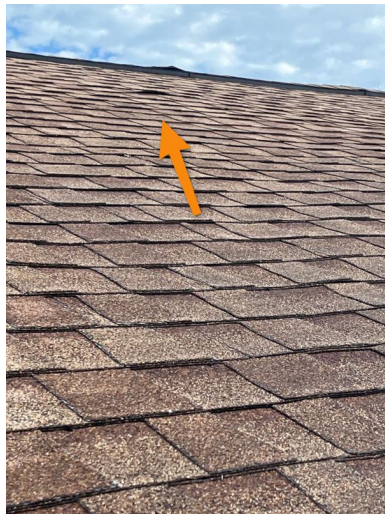
Front Middle

3: Lifted shingles

Areas of the roof show lifted shingles. This is typically caused by high gusts of wind. Lifted shingles will not seal with the lower shingles and allow for water intrusion. Recommend a roofing contractor to replace.

Recommendation: Contact a qualified Houston - Roofing Professional

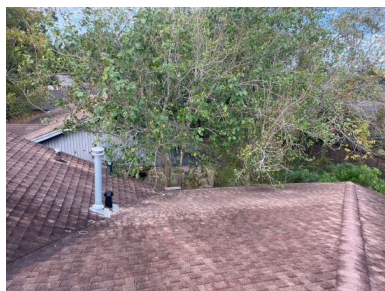
Tree limbs are touching the roof. Tree limbs can drag the roof creating rapid delamination, damages to the roof shingles, or even holes in the roof. Recommend removing all limbs that are touching the roof by 5-feet or more (to account for wind movement and future growth).

Recommendation: Contact a qualified Houston Area - Landscaping Contractor

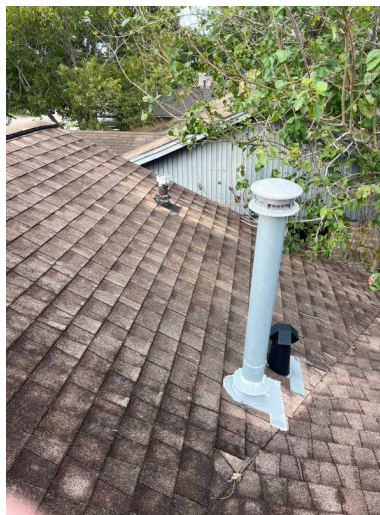
5: Vents unpainted or should be repainted

Roof vents are unpainted or should be repainted with a rust preventative paint (typically matching the roof color or black). Unpainted vents are more likely to cause discoloration of the roof by runoff as vents rust and rubber deteriorates.

Recommendation: Contact a qualified Houston - Roofing Professional

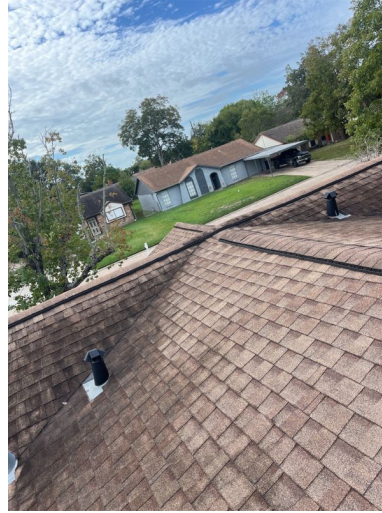
6: Improper plumbing vents

Any other installation may not allow for sufficient venting and will lead to an eventual leaking around the outside of the pipe material and water intrusion into the structure. Vents that depend on sealant alone to prevent moisture intrusion are considered incorrect installations. Recommend replacing all these vents with proper vent boots.

Recommendation: Contact a qualified Houston - Roofing Professional

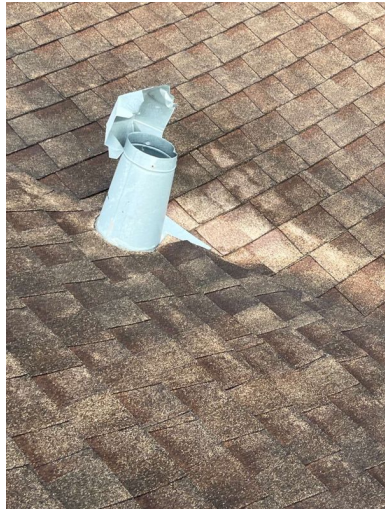
Back Middle

7: Vent damage

Vent gas been damaged and needs to be replaced to prevent further water intrusion, mold growth and damage to home

Recommendation: Contact a qualified roofing professional.

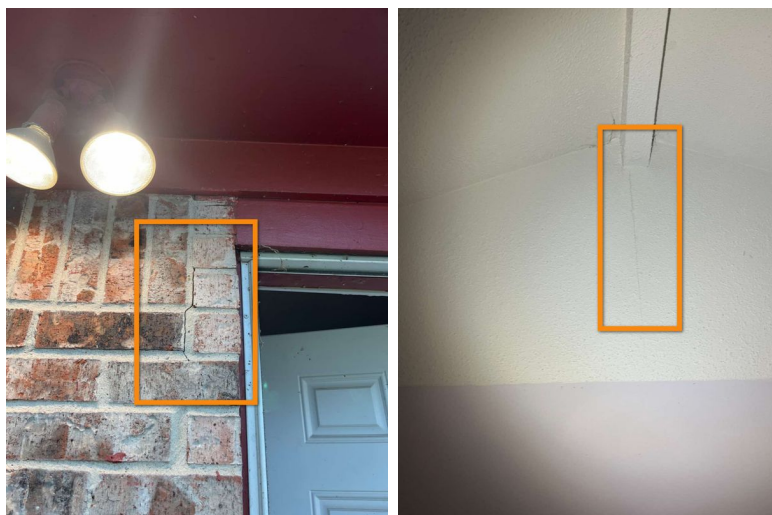
Left Middle

Minor cracking was observed in wall structure. This is common in structure this age and is often determined to be cosmetic. That said, cracking is a first sign of foundation failure and cracks can grow over time; recommend monitoring. The best way to monitor a crack is to patch it (with mortar or caulk) and repaint it, to see if the crack reappears.

Recommendation: Contact a qualified Houston Area - Painting Contractor

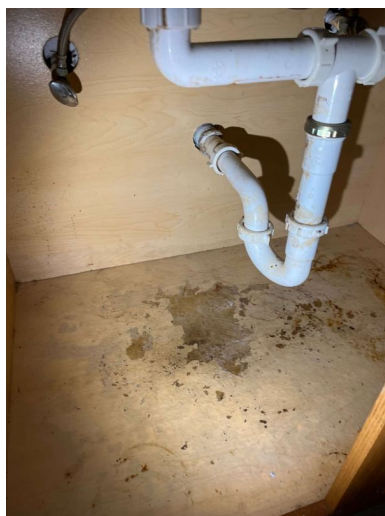
Kitchen

One or more areas of the cabinet show signs of water damage. This may be caused by rain water inundation or leaking of the plumbing fixtures from above. Particularly in older structures, signs of water damage under the sink cabinets including stains, warping, and sagging flooring could be from previous leaks and are common discoveries. An active leak could mean the presence of mold. Recommend monitoring for future leaking, repainting, mold testing, and replacement depending on clients opinion and severity.

Recommendation: Contact a qualified Houston Area - Painting Contractor

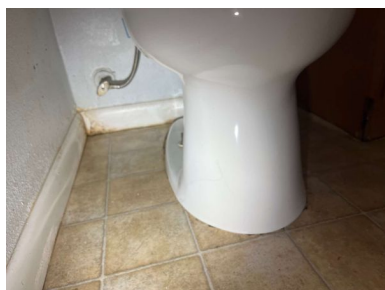
Front Right Hall Back Bedroom Bathroom

Flooring showed signs of water intrusion / damage (stained areas, baseboard warping, tile popping, mold odor, etc.), which could lead to the discovery of present mold and/or more serious structural damages. Recommend a qualified flooring contractor identify source or moisture and remedy.

Recommendation: Contact a qualified Houston Area - Siding/Framing Contractor

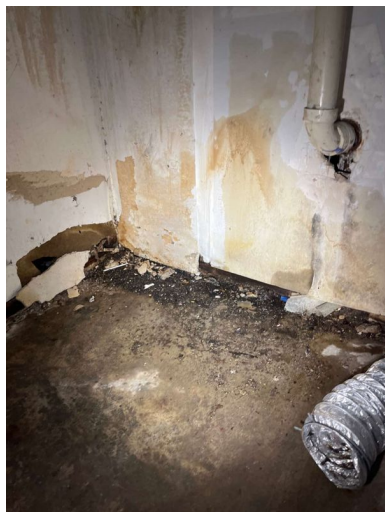
Laundry

2: Flooring - high levels of moisture present

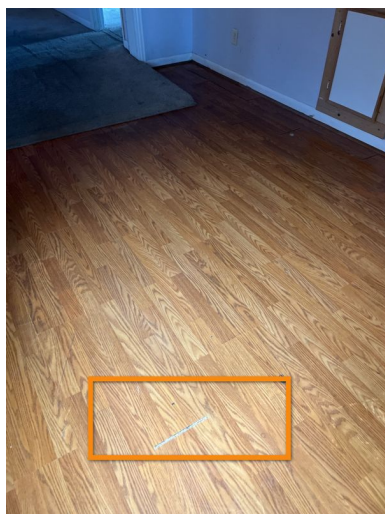
Middle

3: Flooring - separation

The flooring planks/tiles have separated. Correct installation depends on the material type. Separation could be due to no underlayment, foundation shifting, or no floating floor shrink swell area. Recommend a flooring contractor to evaluation as necessary.

Recommendation: Contact a qualified Houston Area - Siding/Framing Contractor

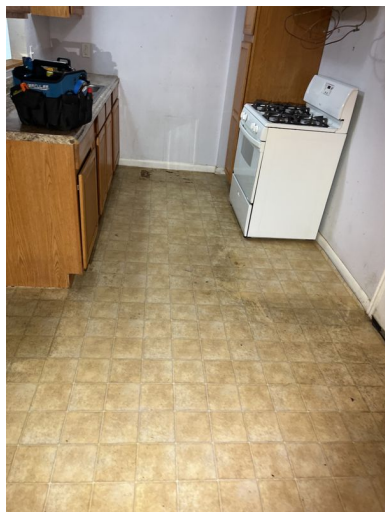
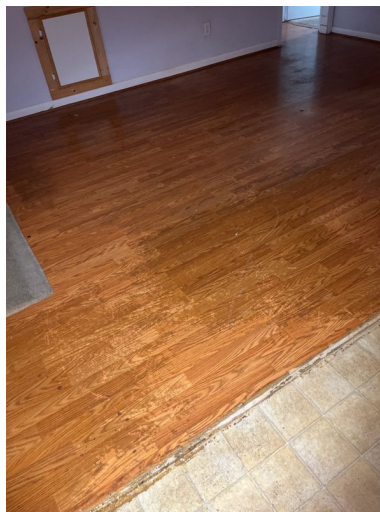
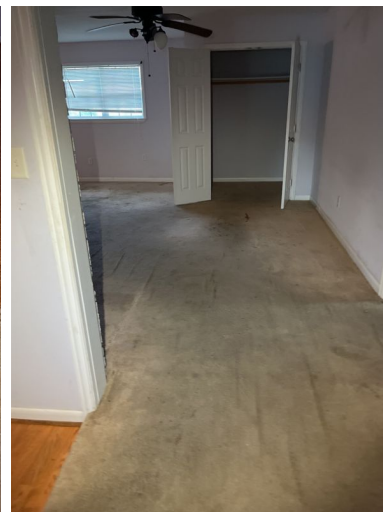
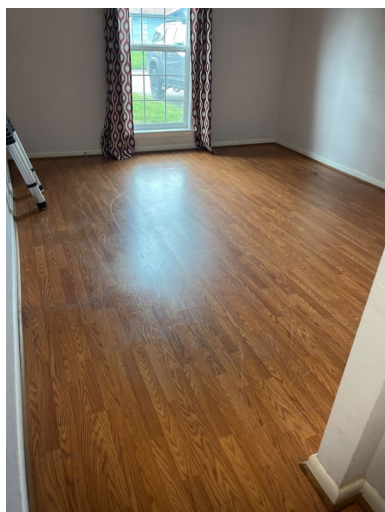
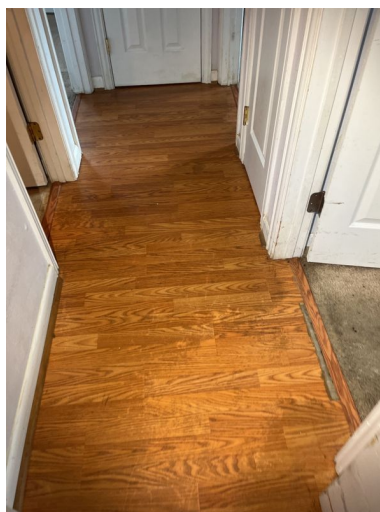
4: Flooring - damaged (Throughout Home)

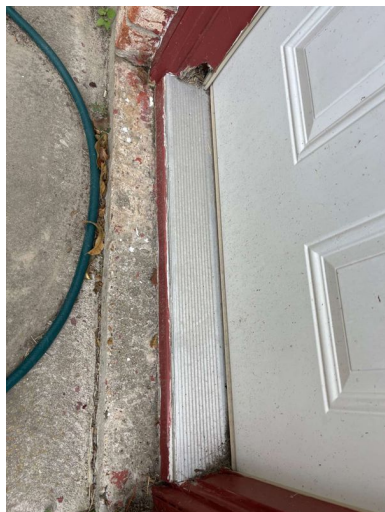
Garage Left

4: Door damaged

Door is damaged, recommend replacing

Recommendation: Contact a qualified door repair/installation contractor.

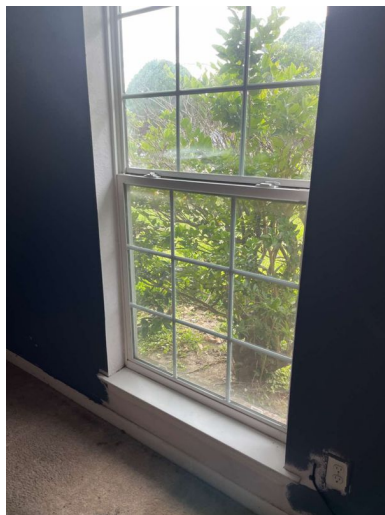
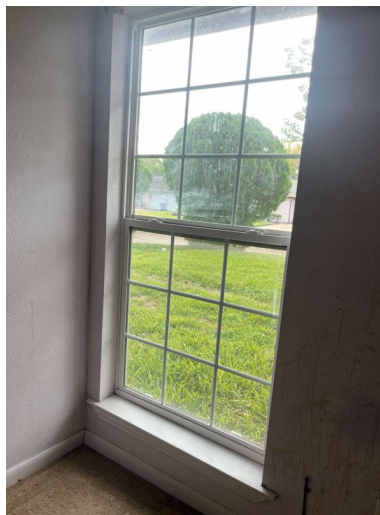
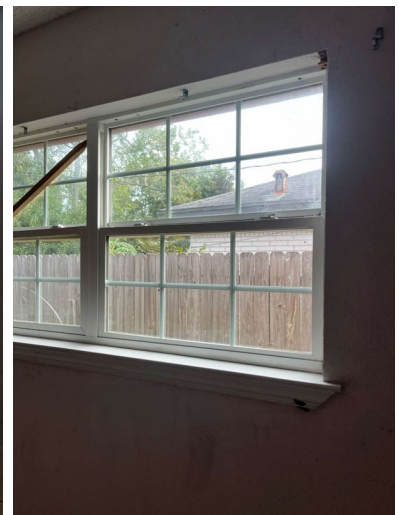
One or more windows won't close completely. This could be caused by a number of reasons including structural deficiencies, windows that are broken, broken latches, or the frames that are misaligned. Recommend windows be restored to functional use by a window repair and installation contractor.

Recommendation: Contact a qualified Houston - Handyman Service

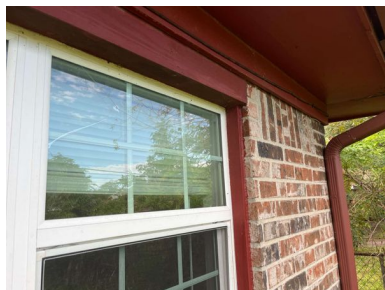
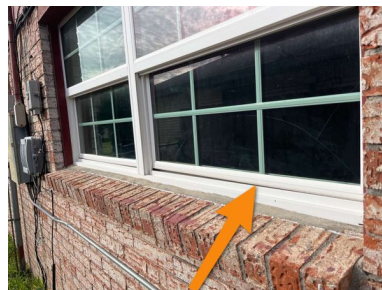
3: Window glass is broken

One or more windows appears to have broken glass. Recommend a window professional replace the window glass as necessary.

Recommendation: Contact a qualified Houston - Handyman Service

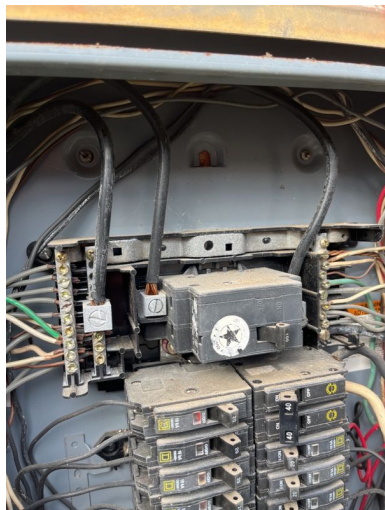
Neutral wires have been double lugged. This means there are two or more neutral wires under each screw on the bus bar. Ideally only one wire should be under each screw.

Recommendation: Contact a qualified Houston - Electrical Contractor

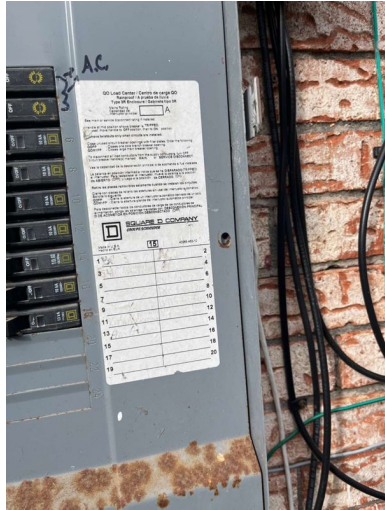
4: Panel cover / dead front missing screws

The cover / dead front of the main service panel or sub-panel is missing screws. As such, the cover is not fastened correctly and/or can be removed too easily. Recommend installing missing screws.

Recommendation: Contact a qualified Houston - Electrical Contractor

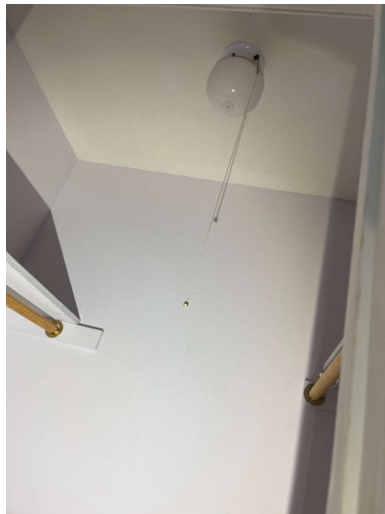
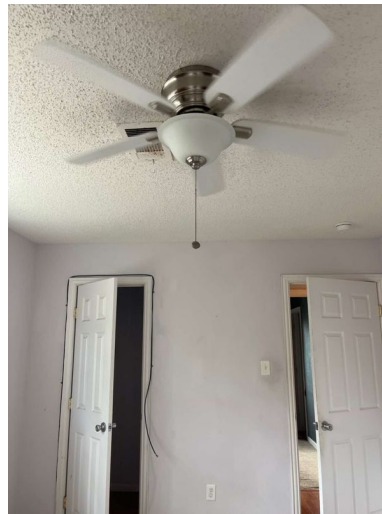
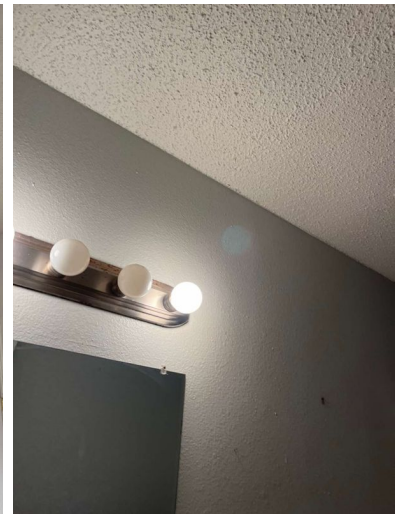
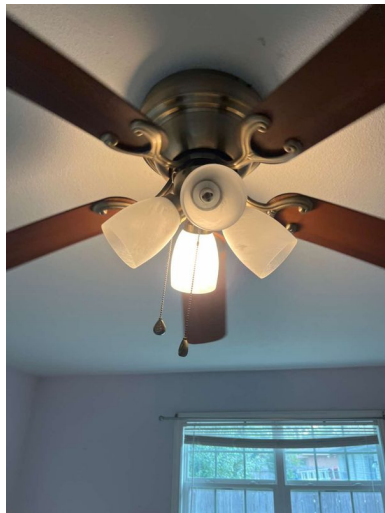
1: Fixture - light inoperable / bulb needs replacement

One or more light fixtures were inoperable (didn't turn on when nearby switches were operated). Recommend further evaluation by replacing bulbs and/or consulting with the property owner. If replacing bulbs doesn't work and/or no other switch(es) can be found, then recommend that a qualified electrician evaluate and repair or replace light fixtures as necessary.

Recommendation: Contact a qualified Houston - Electrical Contractor

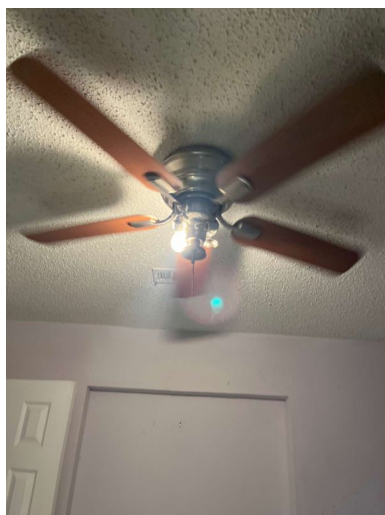
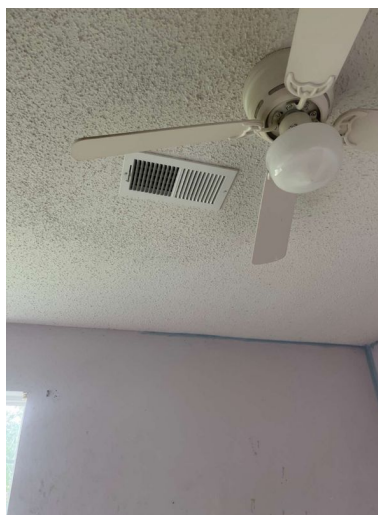
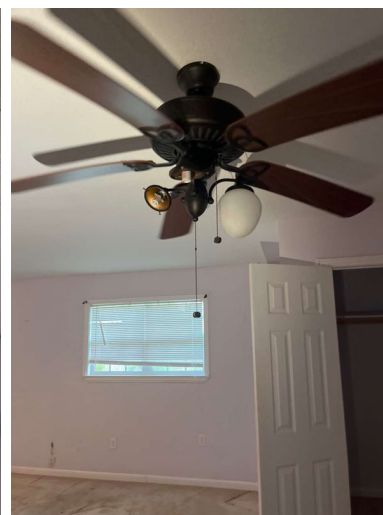
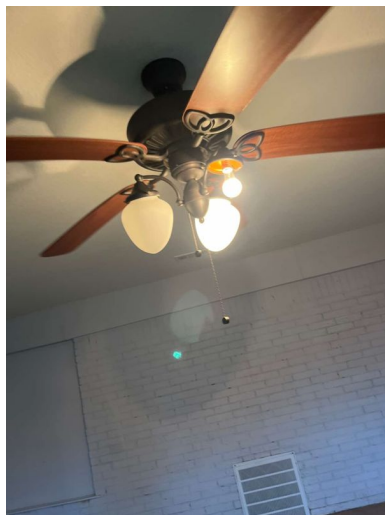
2: Fixture - damaged and/or inoperable

Lighting fixture and/or ceiling fan is inoperable or damaged. Recommend replacement.

Recommendation: Contact a qualified Houston - Electrical Contractor

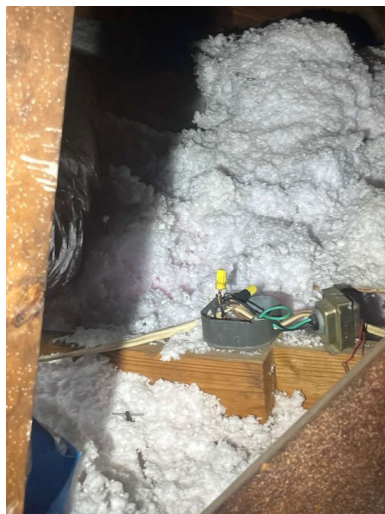
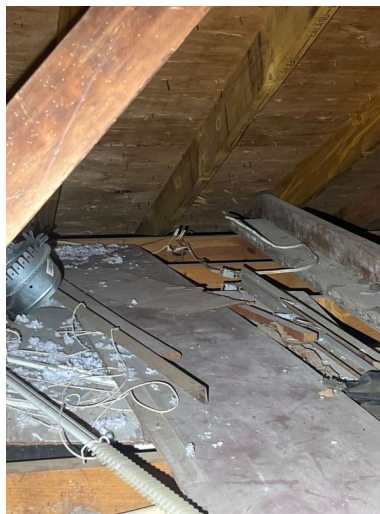
3: High-voltage exposed ends & splices

All wire connections & charged wires with exposed ends and splices should be covered in junction boxes for safety. Recommend a qualified electrician correct.

Recommendation: Contact a qualified Houston - Electrical Contractor

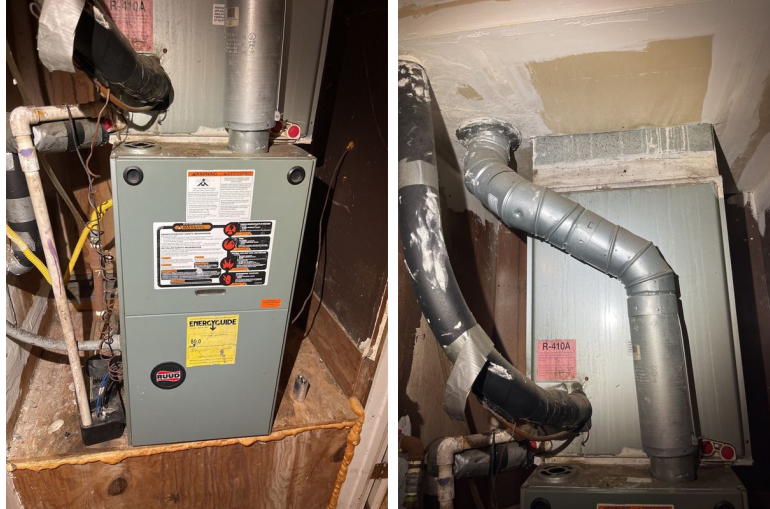
The natural gas to the entire property is turned off. Inspector performed an inspection to the best of their ability under the circumstances. Due to liability considerations, inspector was unable to turn on gas to the furnace. As such, inspector is limited in their ability to locate deficiencies.

Recommend rescheduled inspection to evaluate the furnace.

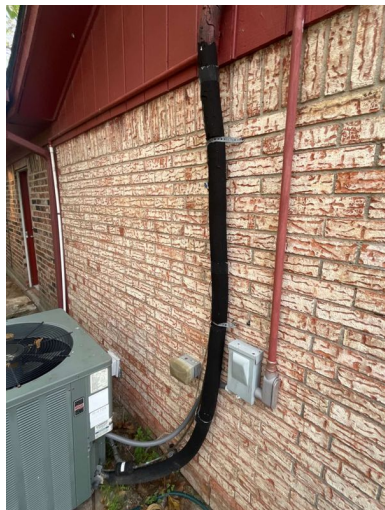
1: Condenser - freon insulation missing or damaged

Missing or damaged insulation on the refrigerant line can cause energy loss and condensation. Recommend contacting an HVAC professional to replace the missing or damaged insulation.

Recommendation: Contact a qualified Houston - HVAC Professional

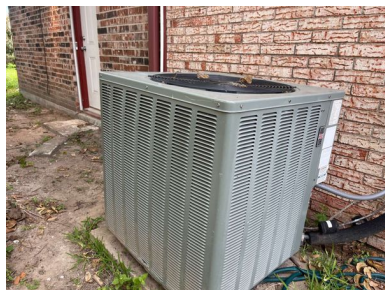
2: Condenser - unit not level

Concrete pad supporting the outdoor condensing unit is not level. This can cause accelerated deterioration of components. Recommend licensed HVAC contractor level the unit.

Recommendation: Contact a qualified Houston - HVAC Professional

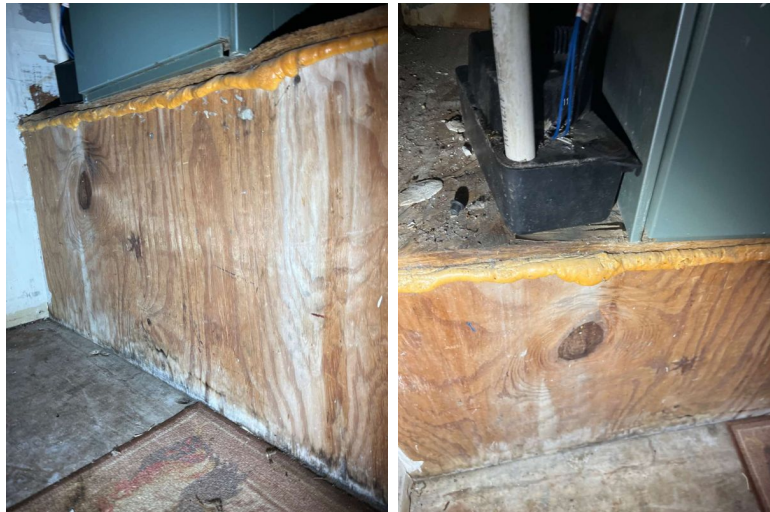
6: Water damage beneath HVAC

The area Beneath HVAC shows signs of water damage. This indicates there is likely a condensation leak issue causing water damage to area. I rec Having HVAC professional evaluate and repair as needed

Recommendation: Contact a qualified HVAC professional.

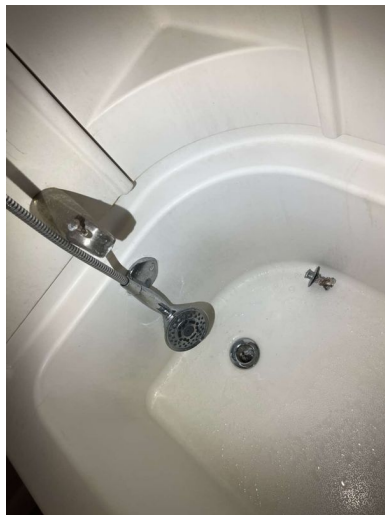
Hall Bathroom

2: Faucet / fixture / spigot dripping / leaks

A faucet, fixture, or spigot is dripping / leaks. Recommend qualified handyman or plumber evaluate and repair.

Recommendation: Contact a qualified Houston - Plumbing Contractor

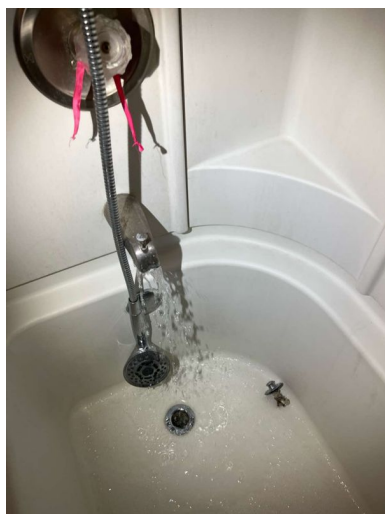
Hall Bathroom

4: Surface defect

There is a surface defect noted. Most surface defects are considered cosmetic, but some surface defects will eventually cause leaking or weeping through the surface. Recommend patching-to-match or replacement.

Recommendation: Contact a qualified Houston - Handyman Service

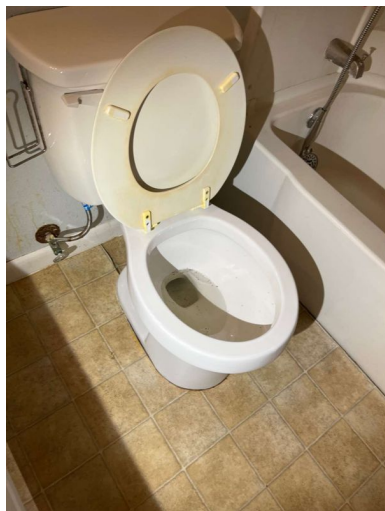
Hall Bathroom

5: Toilet is loose

The toilet is loose and not stable. This could be at the connection with the ground or at the bowl connection with the tank. Recommend tightening the toilet bolts or hiring a qualified plumbing contractor to tighten and further investigate.

Recommendation: Contact a qualified Houston - Plumbing Contractor

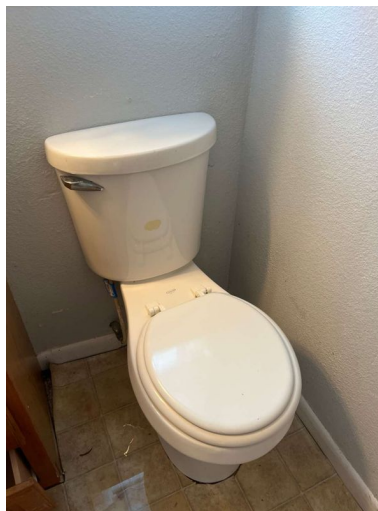
Back Right Bedroom Bathroom

6: Toilet leaking

Toilet appears to be leaking with significant amount of water on floor. I recommend having plumber evaluate and repair to prevent further water damage to home

Recommendation: Contact a qualified plumbing contractor.

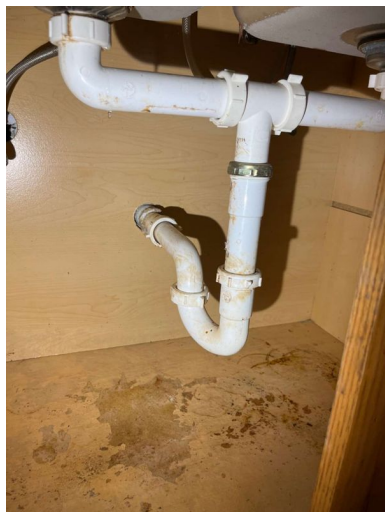
Kitchen

2: Under-cabinet sink drain leaks

There is an active drain leak underneath the sink. Recommend plumbing contractor to remediate.

Recommendation: Contact a qualified Houston - Plumbing Contractor

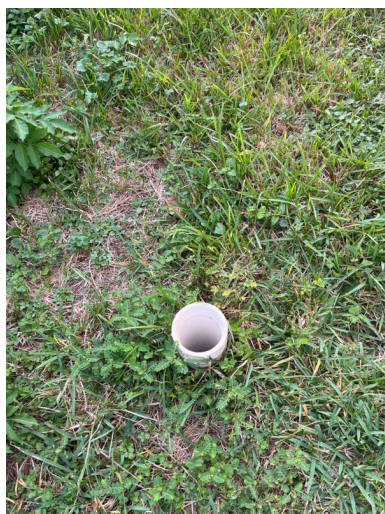
Right Back

3: Damaged or missing cleanout cap

A cleanout cap is damaged or missing. Cleanout caps should remain closed to prevent the release of methane gasses from the sewer system and prevent the entry of stormwater into the septic drain system. Recommend replacement.

Recommendation: Contact a qualified Houston - Plumbing Contractor

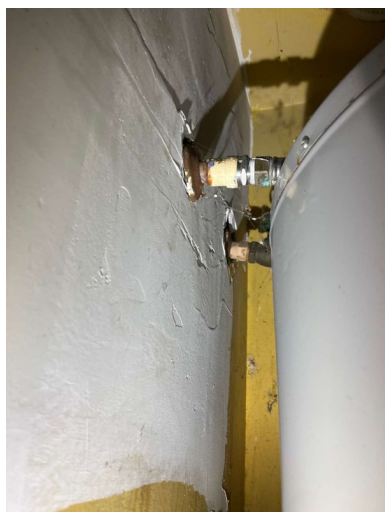
1: Pipe insulation damaged / missing

The water heater distribution water pipes (both the hot side and the cold side) should be insulated. Recommend installing insulation on the pipes to protect in the event of a freeze.

Recommendation: Contact a qualified Houston - Plumbing Contractor

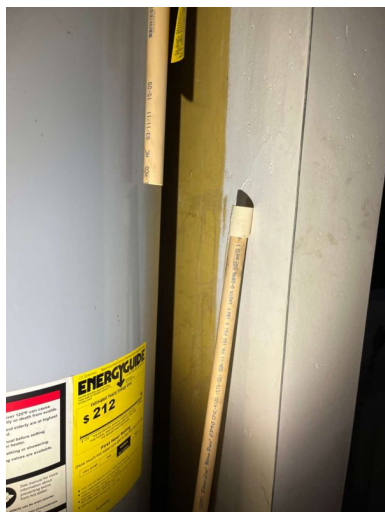
2: Pressure relief valve and/or drip pan not routed outside

Water heater drip-pan and pressure relief valve must be routed externally. Recommend plumber to route outside.

Recommendation: Contact a qualified Houston - Plumbing Contractor

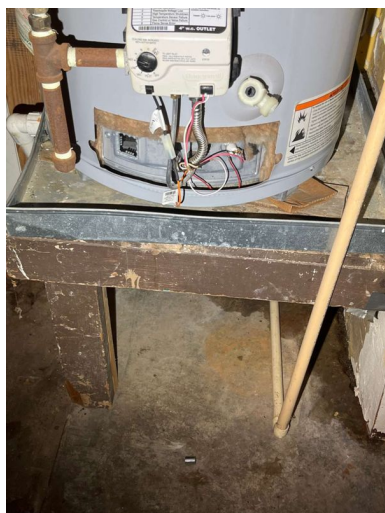
3: Cover is incorrectly installed or missing

The water heater cover is incorrectly installed or missing. The cover is an important safety element to containing the water heater flame or heating element / electrical connections. Recommend reinstallation.

Recommendation: Contact a qualified Houston - Plumbing Contractor

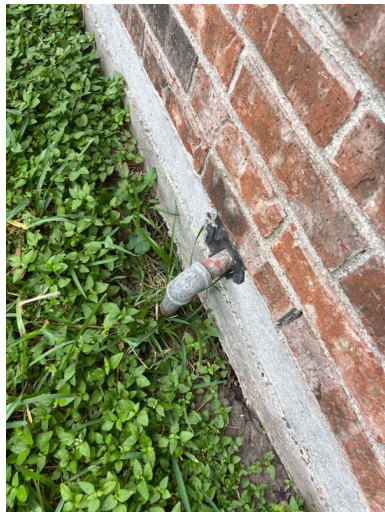
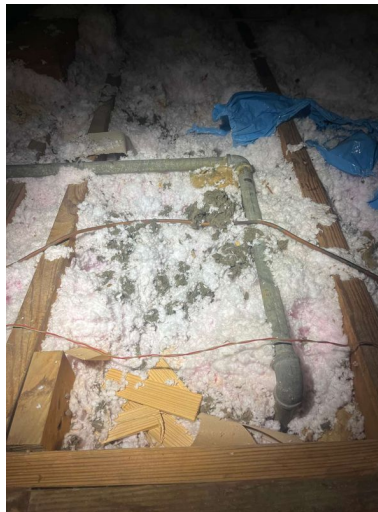
1: Evidence of galvanized piping

Property has evidence that galvanized pipe was used for gas line. Galvanized water pipe contains a zinc coating that helps keep the pipe from corroding from contact with water. However, over time, pieces of the coating will flake off and clog gas regulators and burner units. Additionally, the use of both types of pipe can cause accelerated corrosion where they touch. Recommend replacement of the areas that are galvanized with the correct black pipe material.

Recommendation: Contact a qualified Houston - Plumbing Contractor

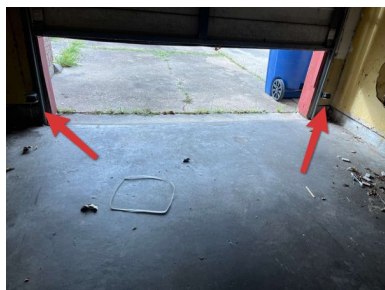
▲ Safety Hazard

The auto reverse sensor laser should be installed at a 6-inch height off of the ground to best-protect against obstructions entering the path of the garage door. This is a safety hazard to children and pets. Recommend a qualified garage door contractor evaluate and lower. This may be a DIY project for the right client.

Recommendation: Contact a qualified Houston - Handyman Service
