Property Inspection Report

5515 Council Grove Ln, Houston, TX, 77088

*Inspector: Kory Knapp
TREC License: 25691
Agent: Cindy Raimon
Property Size: 2492
Property Age: 1974
Inspection Date: 3/7/2024
Inspection Time: 1:30 PM*

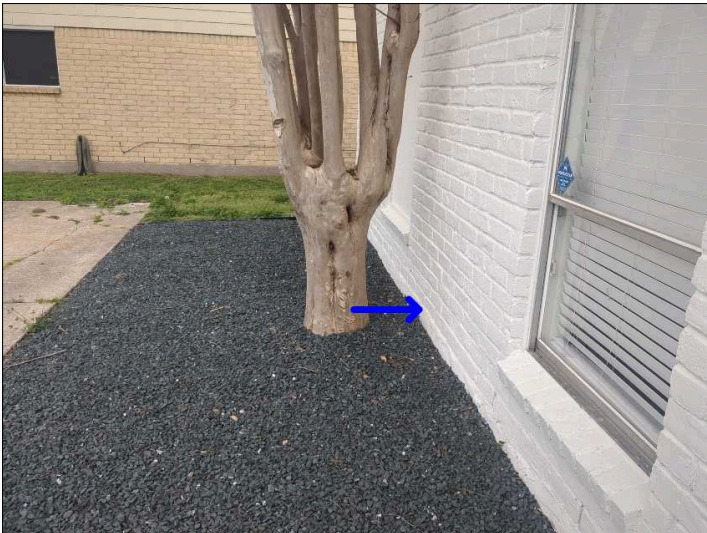
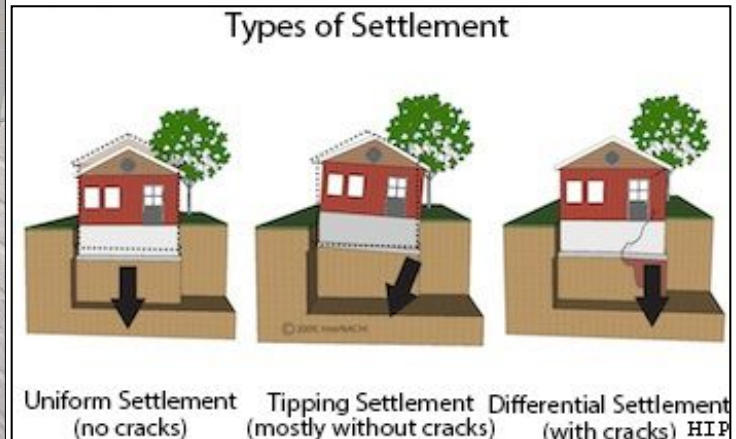
All trees should be located no closer than 15' from structure to help prevent foundation movement.

You may want to keep larger trees trimmed to help slow further root growth and future foundation movement as removing older trees may cause voids under the slab from dying root systems.

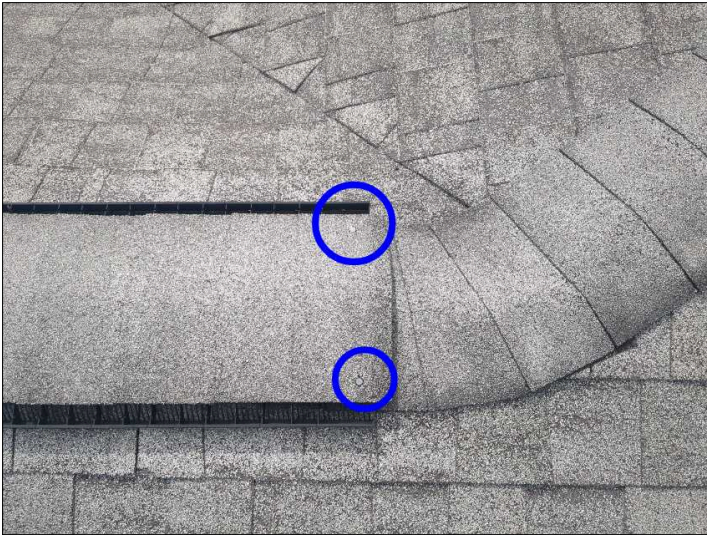
C.4. There were exposed nails noted on the roof. It is recommended that all exposed nails and fasteners on roof be sealed at all penetrations, ridges and roof to wall connections.

There were exposed nails noted on the roof. It is recommended that all exposed nails and fasteners on roof be sealed at all penetrations, ridges and roof to wall connections.

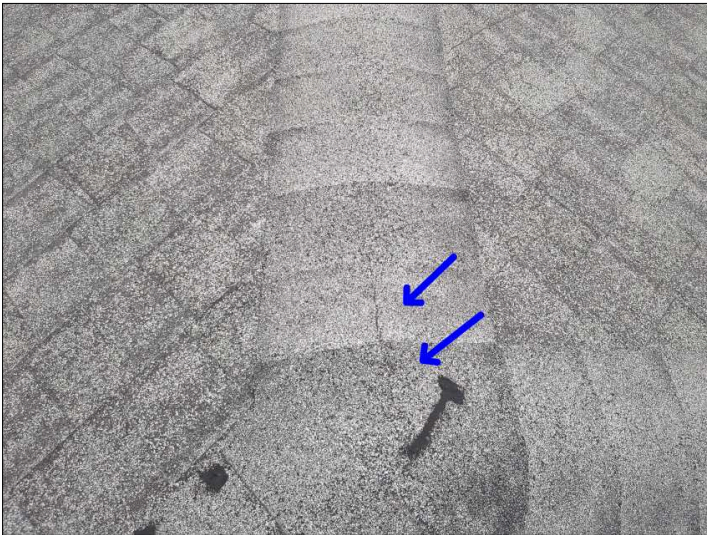
C.8. Some ridge shingles are cracked and or split on the roof, recommend repairs of replacement of damaged ridge shingles.

Some ridge shingles are cracked and or split on the roof, recommend repairs or replacement of damaged ridge shingles.

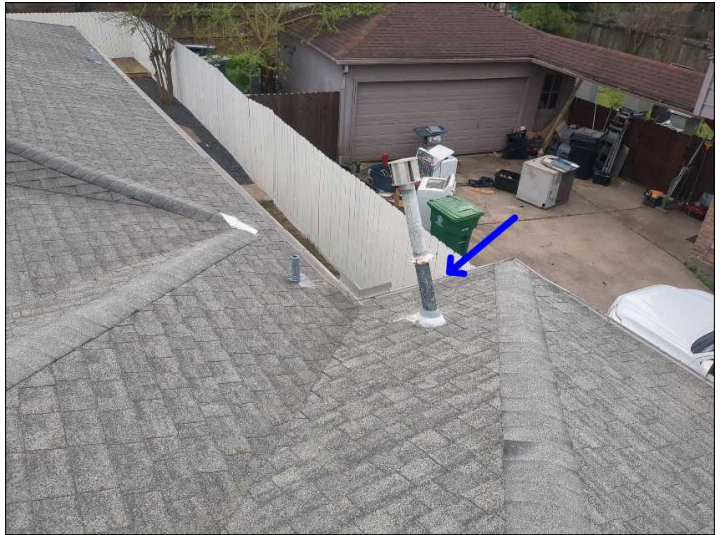
C.5. One or more of the vents and or flashing is unpainted, recommend painting all unpainted vents and flashing to help prevent damage due to UV rays or rust.

One or more of the vents and or flashing is unpainted, recommend painting all unpainted vents and flashing to help prevent damage due to UV rays or rust.

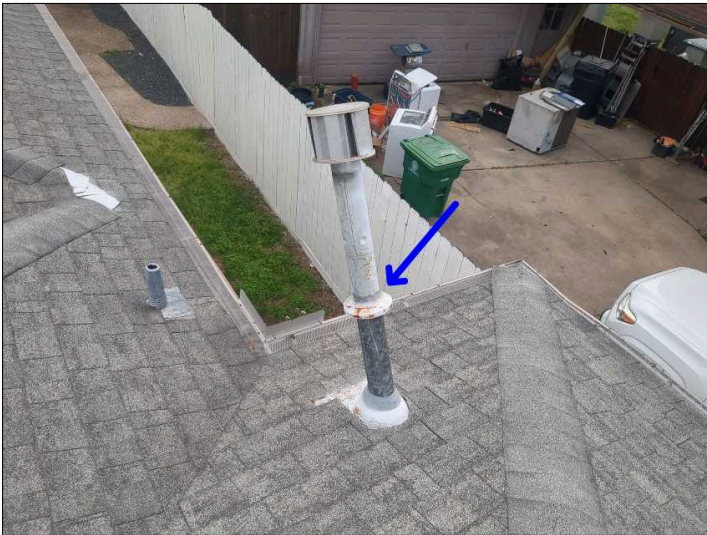
C.6. There are signs of rusted vents or flashing on the rooftop. We recommend painting or replacing all rusted or deteriorated vents or flashing as needed.

There are signs of rusted vents or flashing on the rooftop. We recommend painting or replacing all rusted or deteriorated vents or flashing as needed.

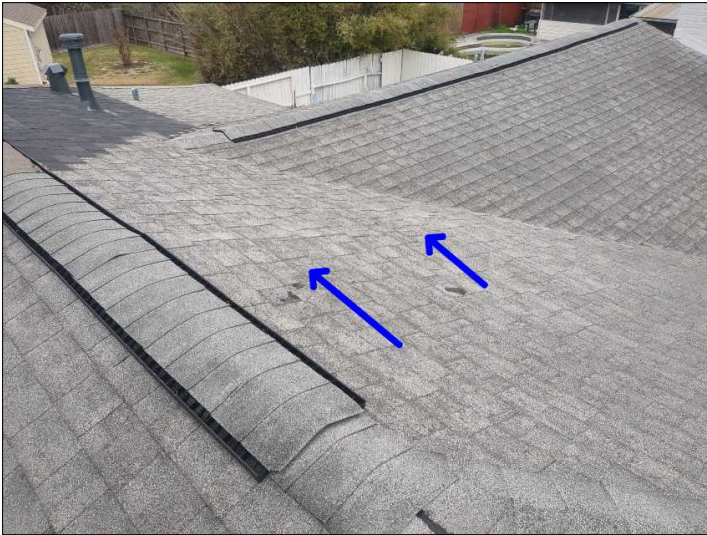
The decking is buckling on the roof, this is often caused by an improper gap for expansion of the decking materials, recommend consulting a roofing contractor for evaluation and repairs as needed.

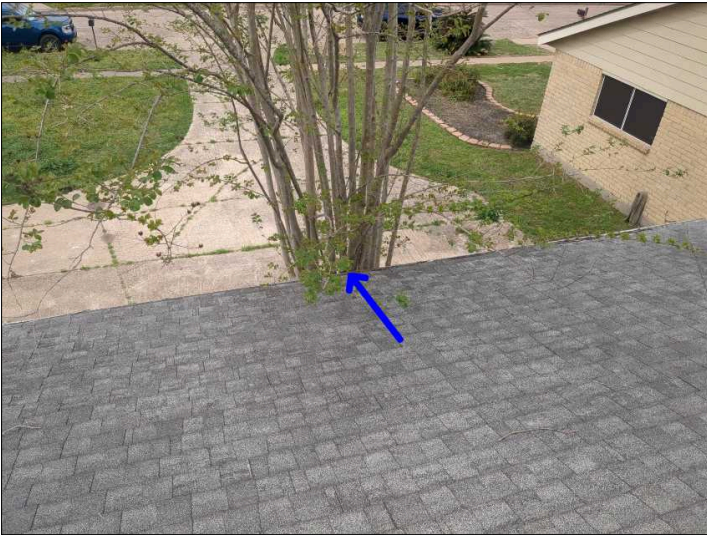
C.2. Tree limbs should be kept trimmed at least 5' from roof to help prevent damage to the roof during windy conditions.

Tree limbs should be kept trimmed at least 5' from roof to help prevent damage to the roof during windy conditions.

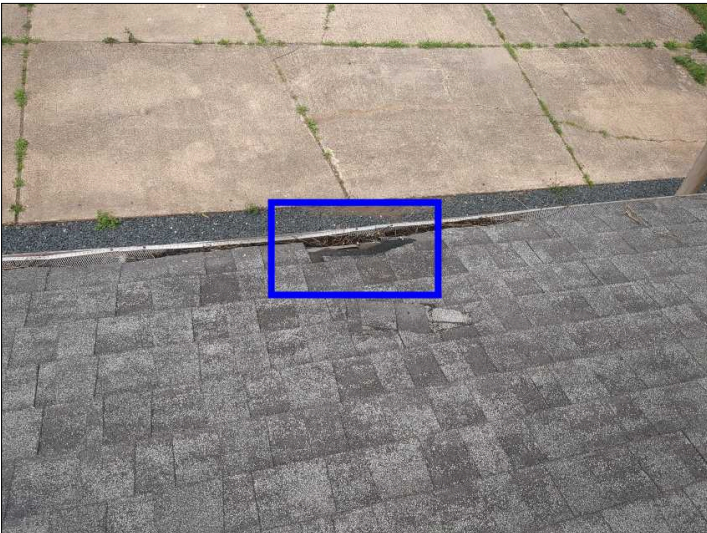
There are damaged or missing shingles on the roof, recommend repairs or replacement of damaged shingles.

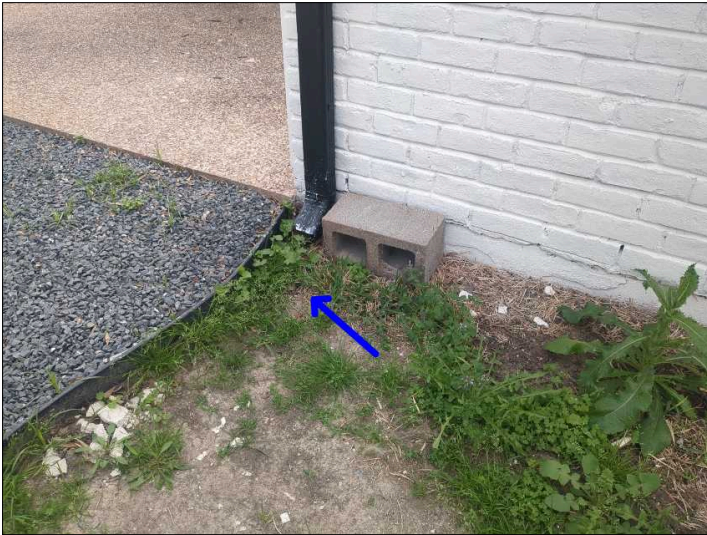
C.18. The gutter is bent/damaged. Mainly at - rear left

Splash blocks or downspout extensions should be installed to direct water away from foundation.

The gutter is bent/damaged. Mainly at - rear left

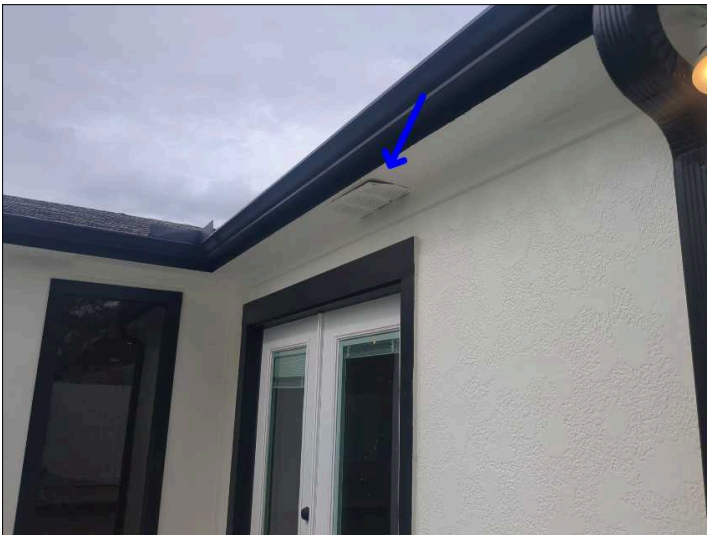
The attic vent screen is loose, damaged or missing, recommend repairs to help prevent unwanted entry.

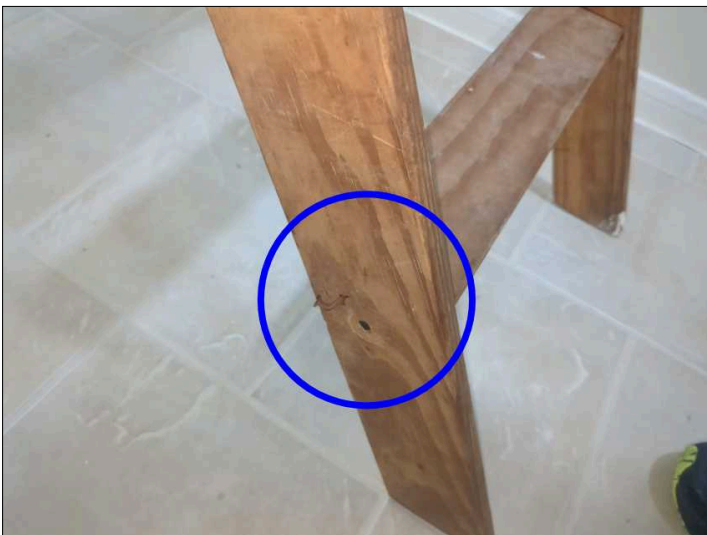
There is at least one nut loose or missing on the attic stairway, recommend checking all nuts and bolts to make sure they are all present and tightened.

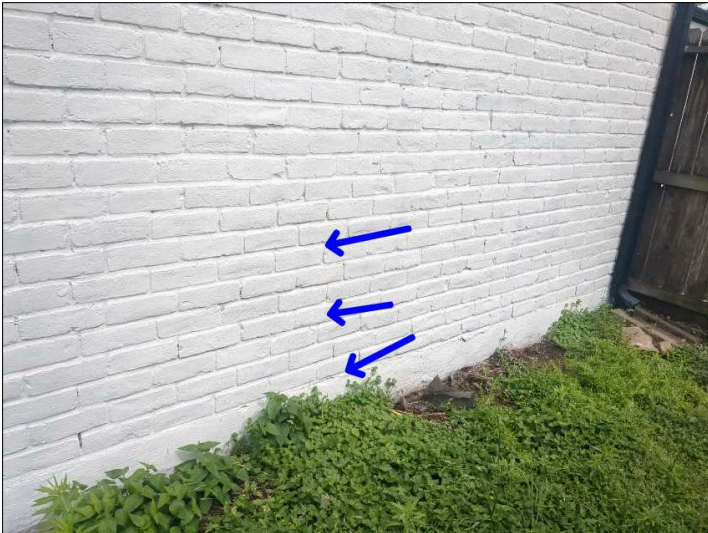
Settlement cracks were noted in the brickwork.
Mainly at - right side front

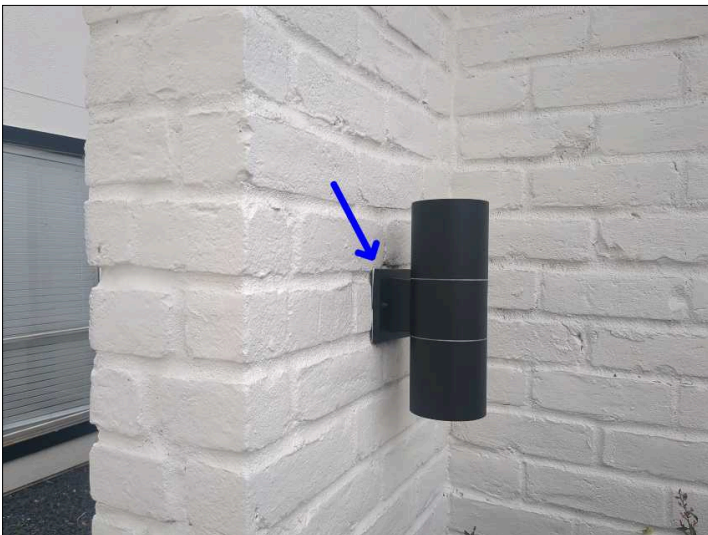
Seal all electrical lighting fixtures at wall connection to help prevent water penetration. It is a good idea to leave a small opening at the bottom to allow any water penetrating to escape.

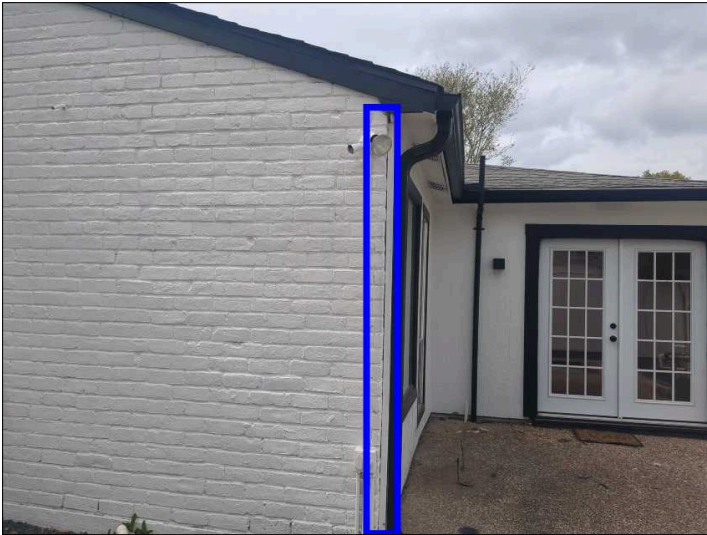
Recommend sealing between the trim and brickwork to help prevent water penetration. Mainly at - rear

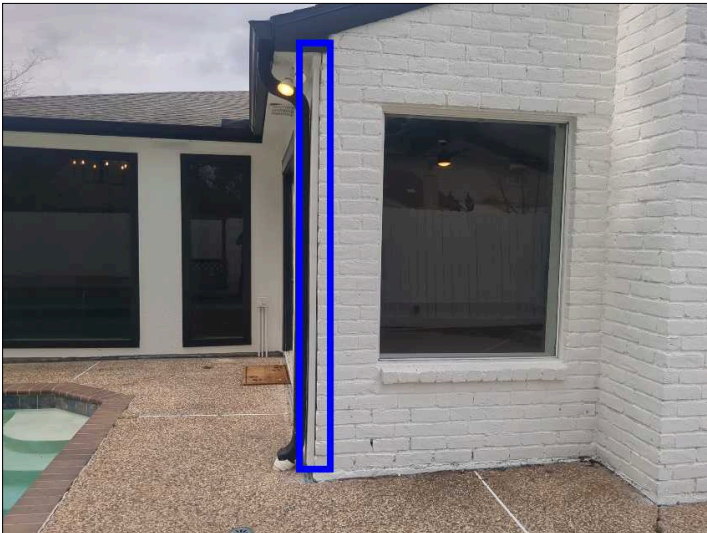
Recommend sealing between the trim and brickwork to help prevent water penetration. Mainly at - rear

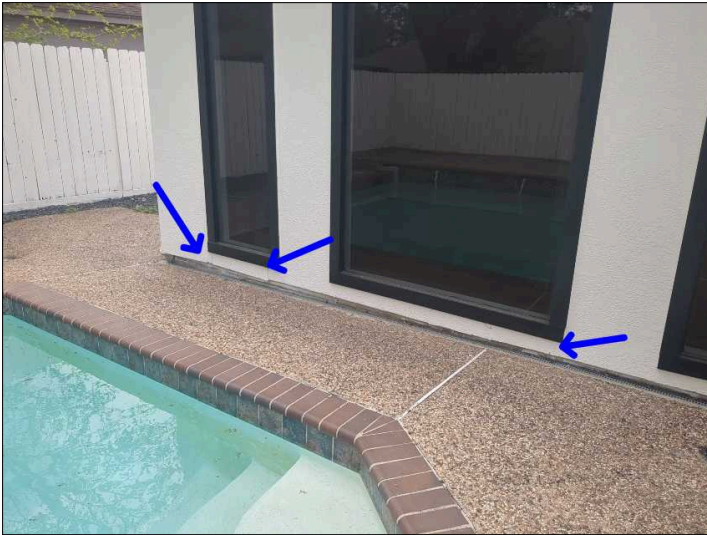
There is some damage to the exterior siding, recommend repair or replacement to help prevent water penetration. Unable to determine the condition of the underlying materials. Mainly at - rear right

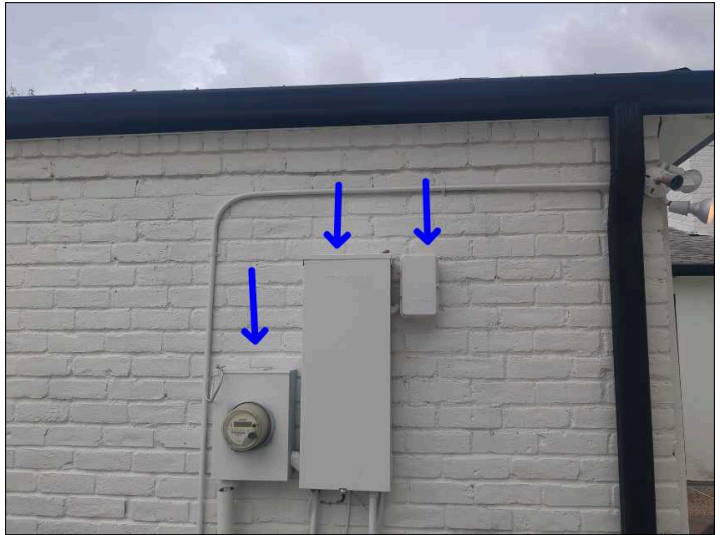
It is recommended that Electric Panels, Meter Boxes and Disconnects be sealed between the box and the Exterior cladding to help prevent water penetration.

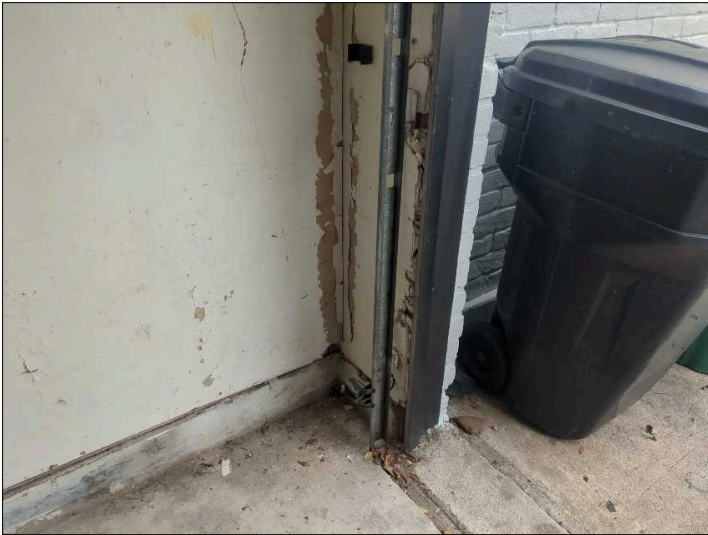
There is damage to the drywall, recommend repairs as needed. Mainly at - garage

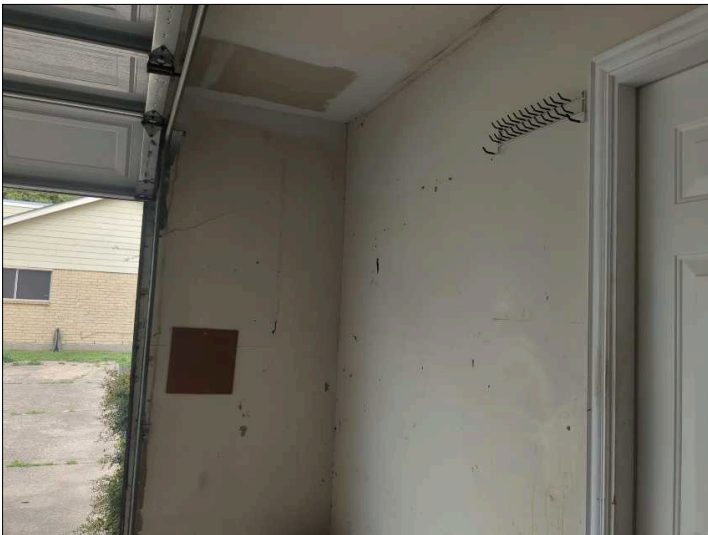
Paint is peeling in the garage walls. This is often a common occurrence due to high moisture of unconditioned garage space, recommend repainting to help prevent further deterioration.

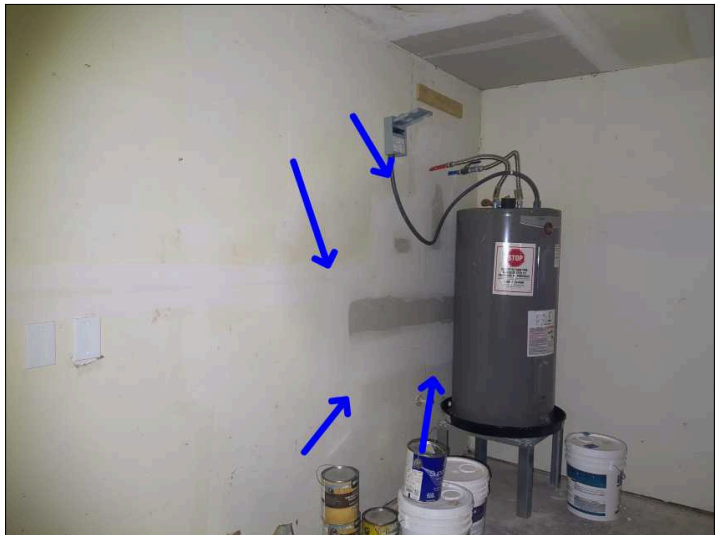
There is evidence of previous patch work and or painting on the interior finishes. Recommend contacting homeowner for more information. Mainly at - garage

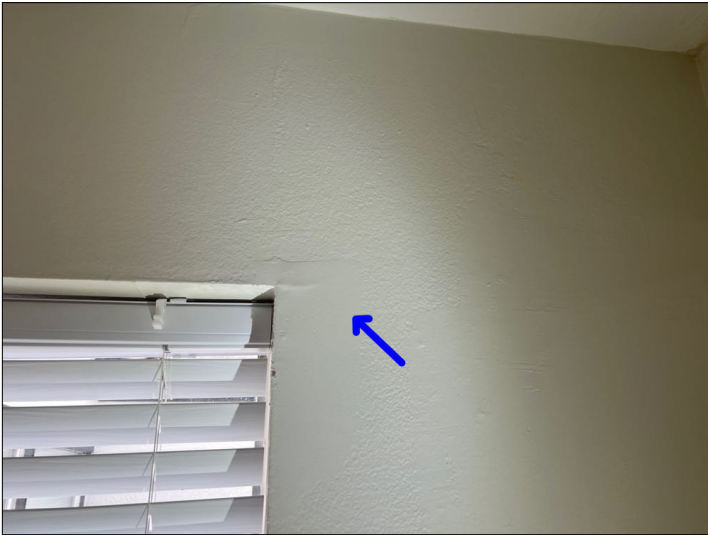
There is evidence of previous patch work and or painting on the interior finishes. Recommend contacting homeowner for more information.
Mainly at - front entry

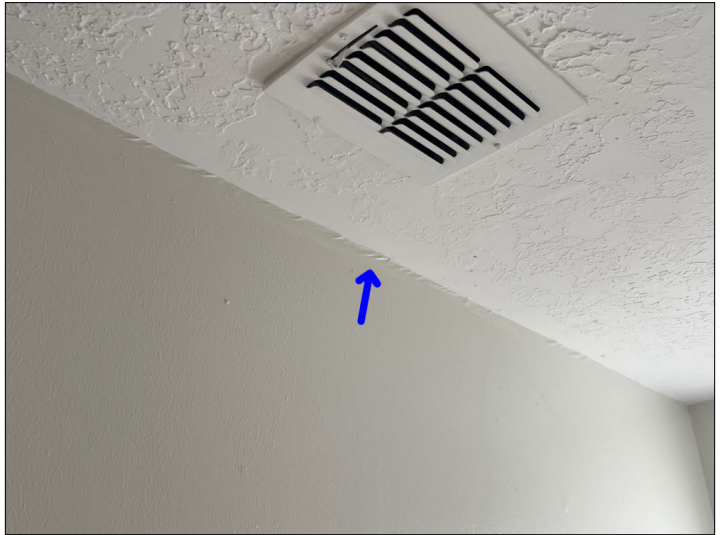
Tape is twisting due to movement in the corners of the drywall, this is normally a sign of foundation movement or structural settlement, other movement noted may give signs of the cause.
Mainly at - laundry

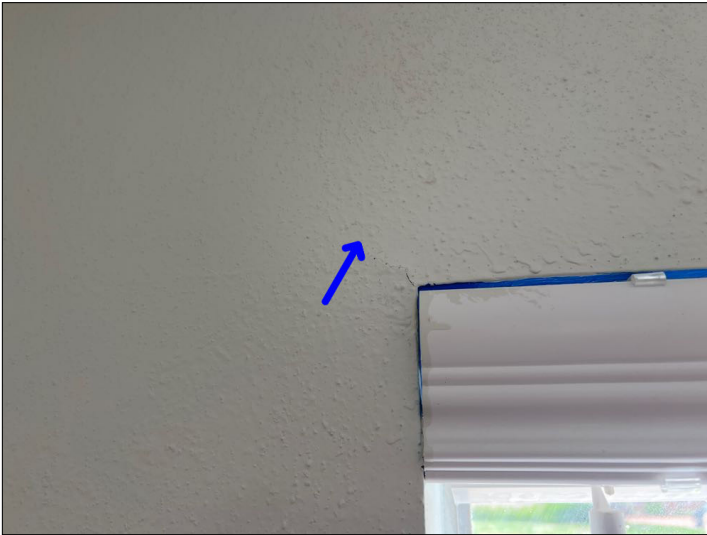
Settlement cracks were noted in the drywall.
Mainly at - front middle bedroom

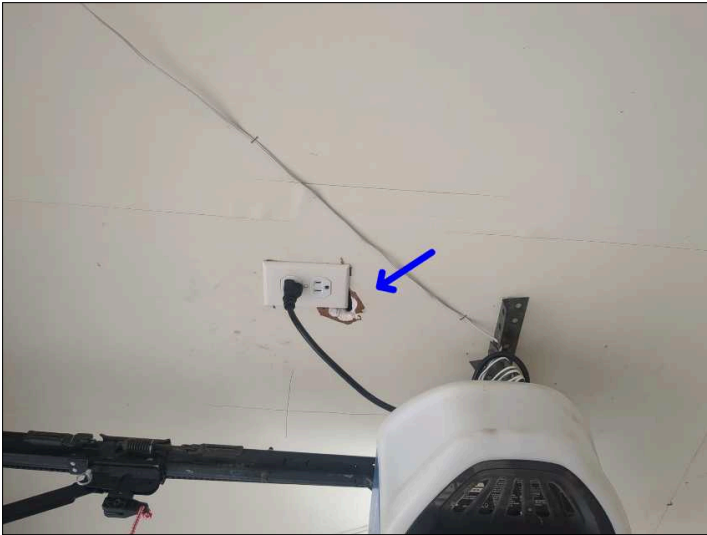
There is at least one hole in the ceiling in the garage. All holes in the garage ceilings or wall against living areas should be patched to help keep the recommended fire barrier between the home and garage.

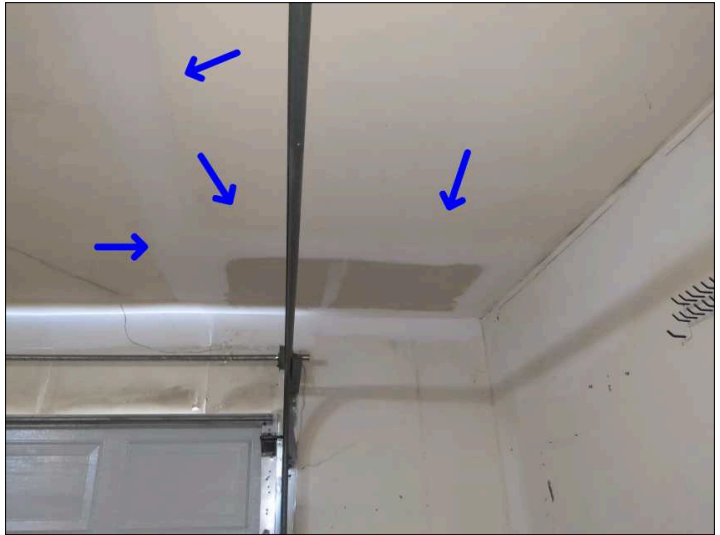
There is evidence of previous patch work and or painting on the interior finishes. Recommend contacting homeowner for more information. Mainly at - garage

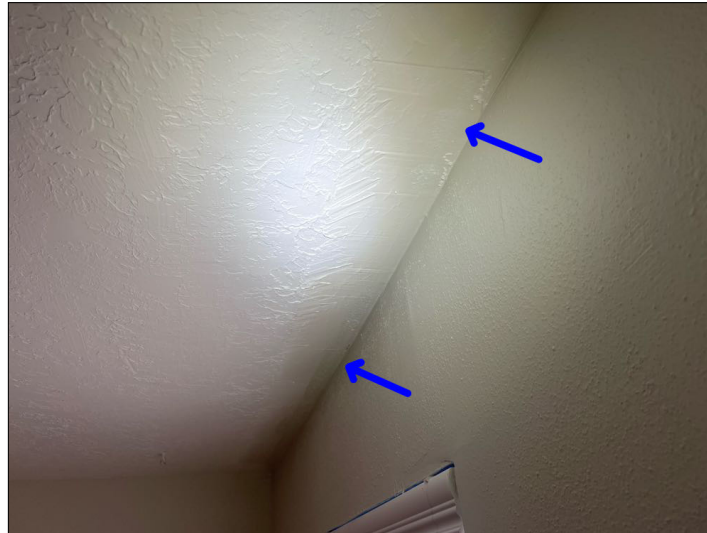
There is evidence of previous patch work and or painting on the interior finishes. This condition may limit the inspector's visual observations and ability to render accurate opinions as to the performance of the structure. Recommend contacting homeowner for more information. Mainly at - front middle bedroom

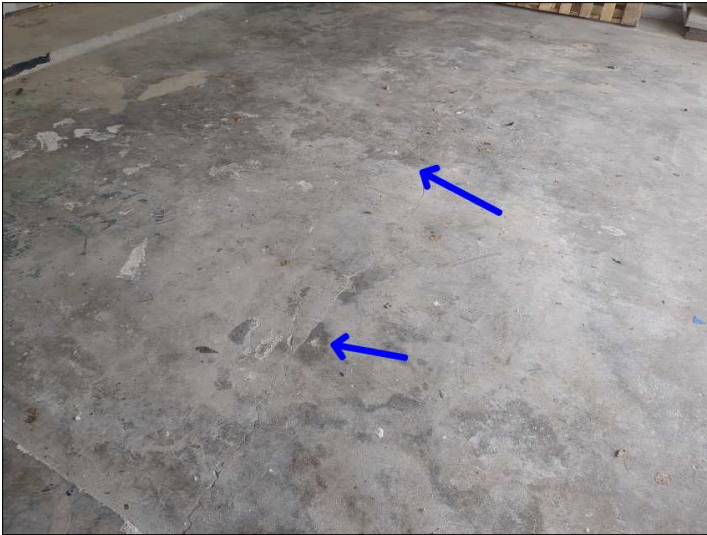
Cracks were noted in the pavement. These are cosmetic in nature at this time. Recommend sealing to help prevent further deterioration. Mainly at - garage

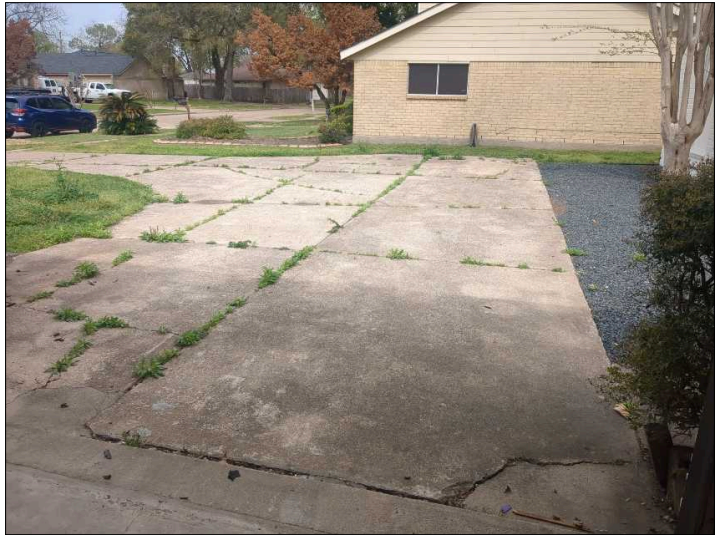
Uneven pavement was noted, recommend repairs to help prevent tripping. Mainly at - driveway

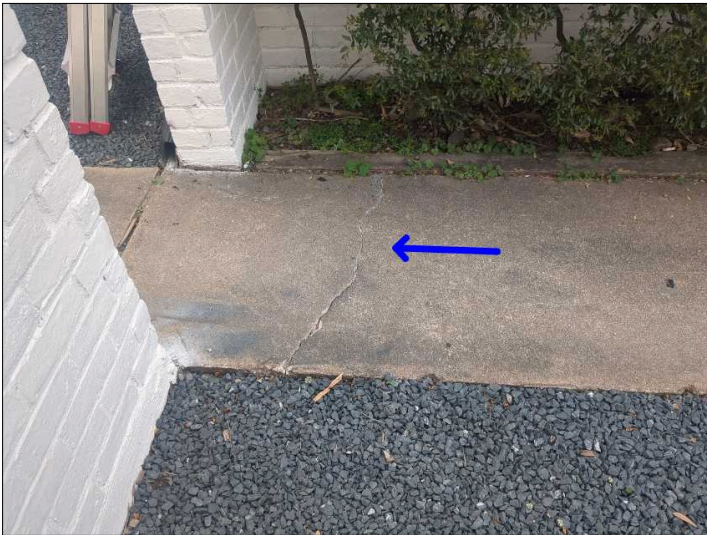
Cracks were noted in the pavement. These are cosmetic in nature at this time. Recommend sealing to help prevent further deterioration. Mainly at - front sidewalk

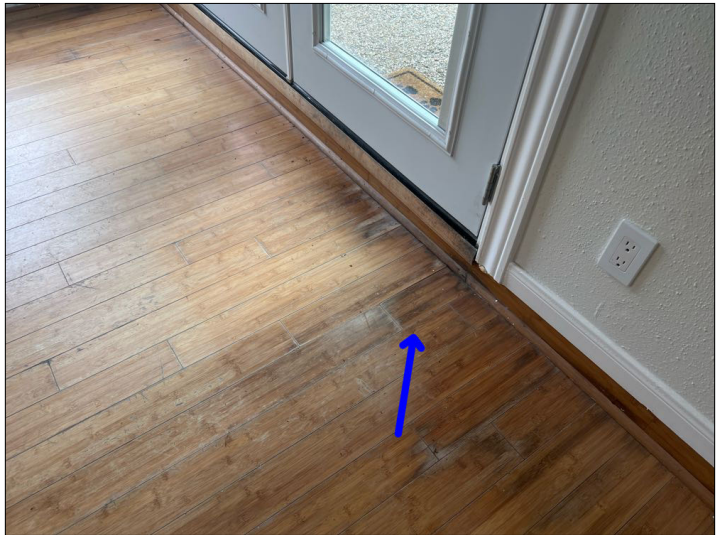
There are signs of discoloration or moisture damage on the floor. Mainly at - living room

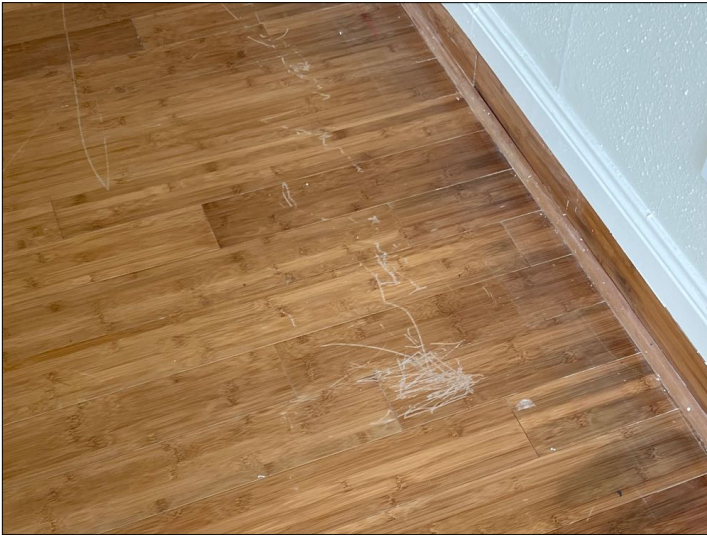
There are scratches noted in the wood flooring.
Mainly at - living room

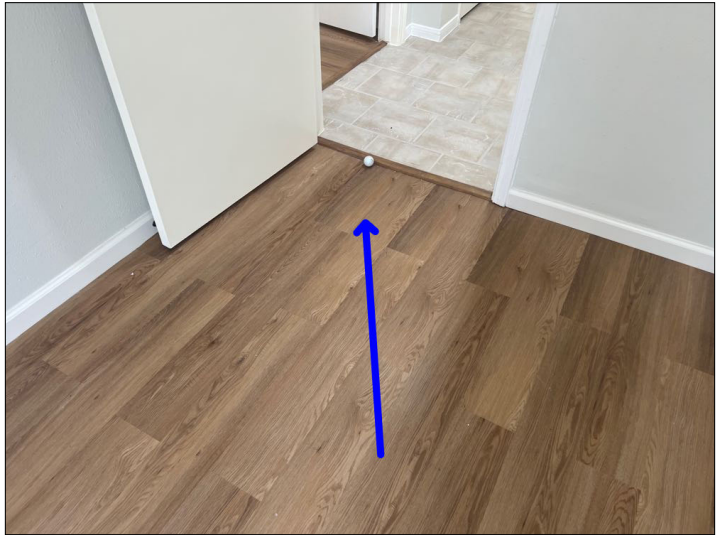
Uneven or sloping floors were noted. Some times in older homes minor slopes may be due to construction methods at that time, however if floors are sloping more than normal it is recommended that some follow up investigation be made. Sloping floors can be caused by foundation movement or from structural issues usually on upper floors. Floors were noted to be sloped. Mainly at - front middle bedroom

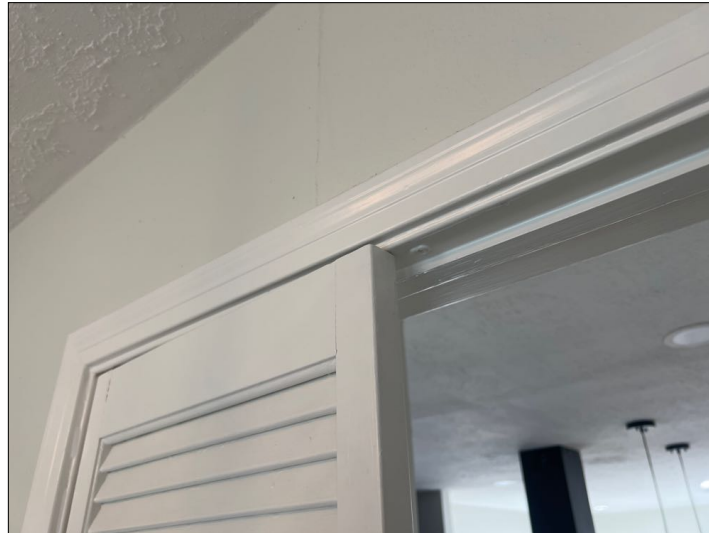
The door hits the frame when closing. Mainly at - dining

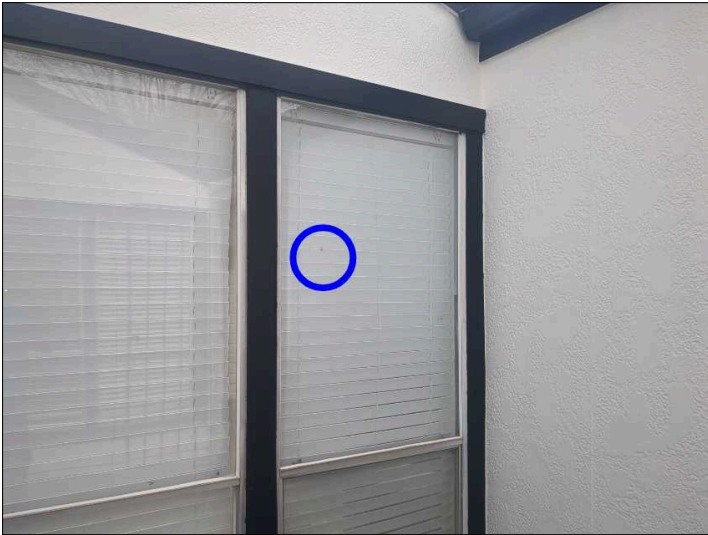
J.3. A hole was noted in a window pane. Mainly at - front

A hole was noted in a window pane. Mainly at - front

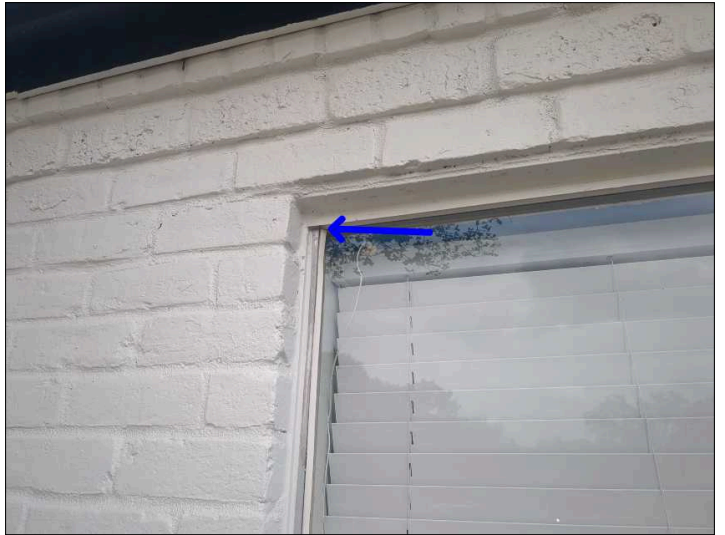
J.1. Glazing bead is loose,damaged or deteriorated. Recommend replacing or sealing damaged glazing bead to help prevent moisture penetration.

Glazing bead is loose, damaged or deteriorated. Recommend replacing or sealing damaged glazing bead to help prevent moisture penetration.

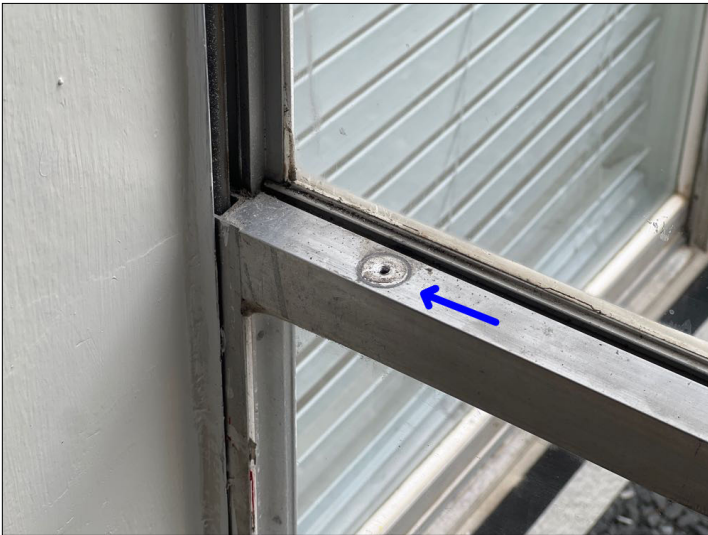
J.6. The window lock/latch is missing. Mainly at - front entry

The window lock/latch is missing. Mainly at - front entry

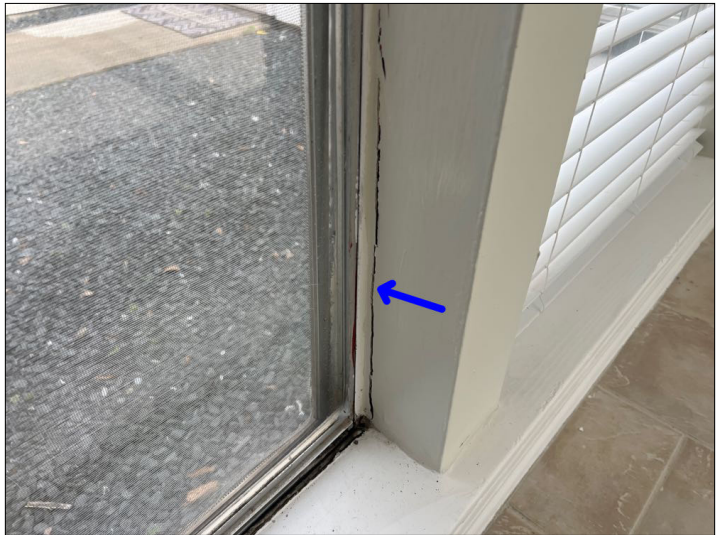
Sealant is needed around the interior of the windows between the window framing and the drywall to help prevent water penetration.

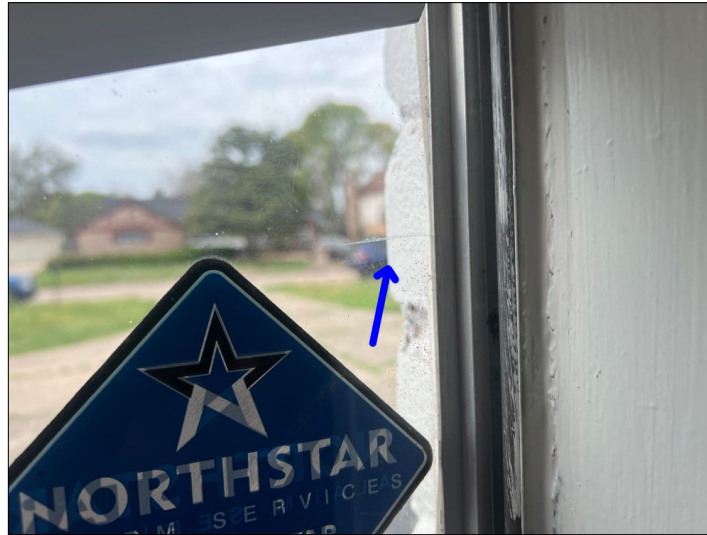
J.4. Cracked windowpane(s) were noted. Mainly at - front middle bedroom

Cracked windowpane(s) were noted. Mainly at - front middle bedroom

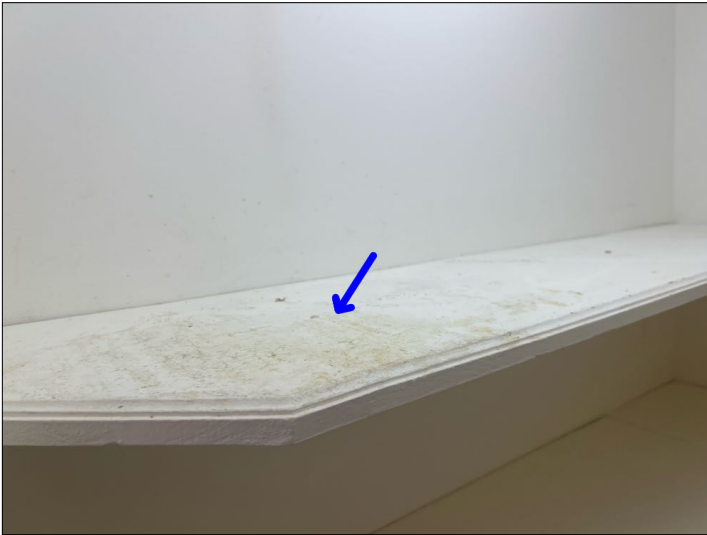
Mold like stains are present. Recommend contacting our office to schedule an evaluation and mold testing to determine the type of mold and identify the source of contamination. Mainly at - pantry

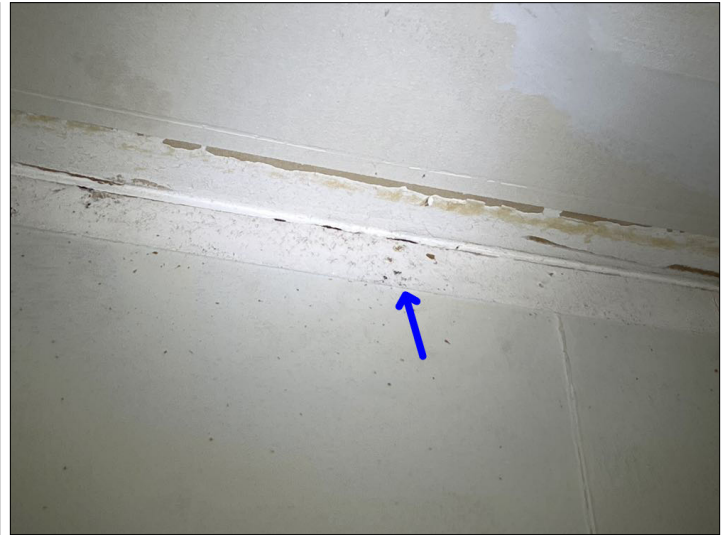
Mold like stains are present. Recommend contacting our office to schedule an evaluation and mold testing to determine the type of mold and identify the source of contamination. Mainly at - garage

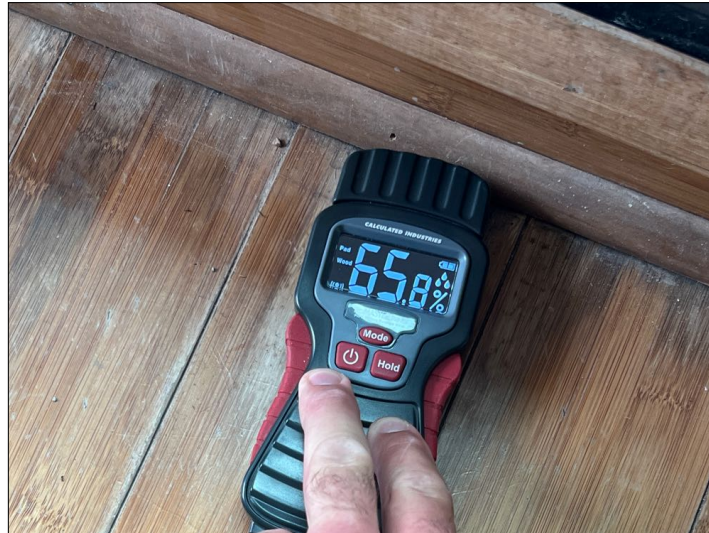
Checked water stain with a moisture meter and found it to be at a high moisture level. Unable to determine condition of the underlying materials. Mainly at - living room

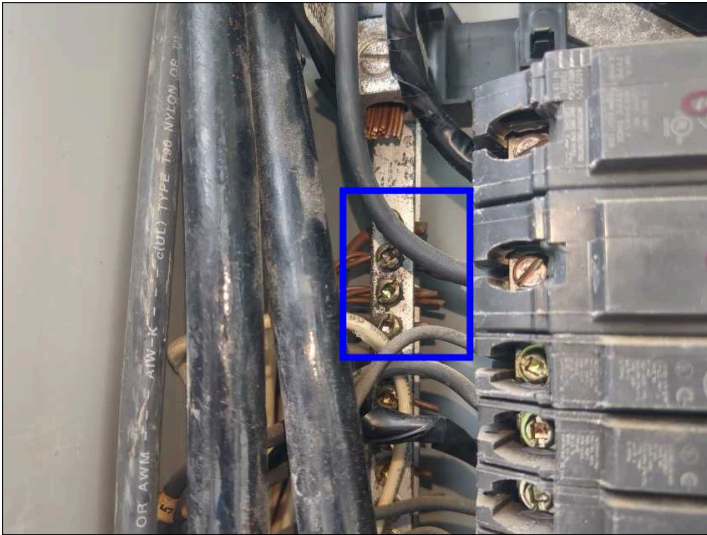
There are more than two ground wires located under the same screw on the ground bar. Ground wires should have no more than two wires under an individual screw.

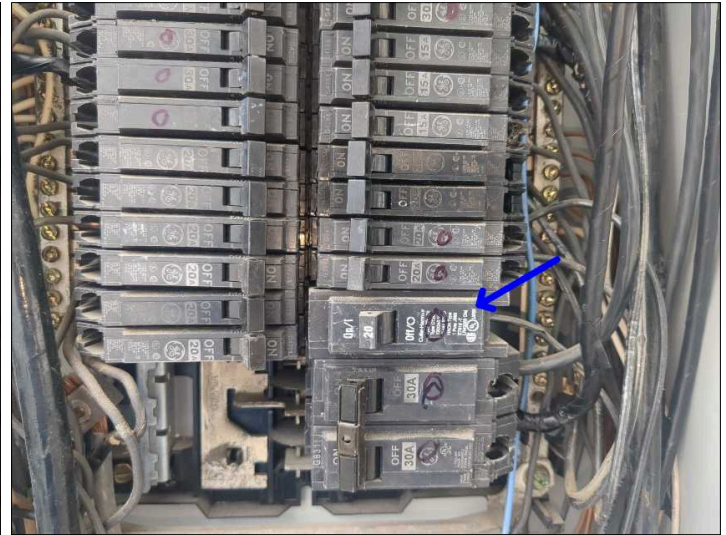
A.3. There are different brands of breakers installed in the main electrical panel. Although functional, this is widely considered an improper practice as the breakers being used should match the manufacturer type of panel to maintain proper fit and connection and help reduce the risk of future electrical issues.

There are different brands of breakers installed in the main electrical panel. Although functional, this is widely considered an improper practice as the breakers being used should match the manufacturer type of panel to maintain proper fit and connection and help reduce the risk of future electrical issues.

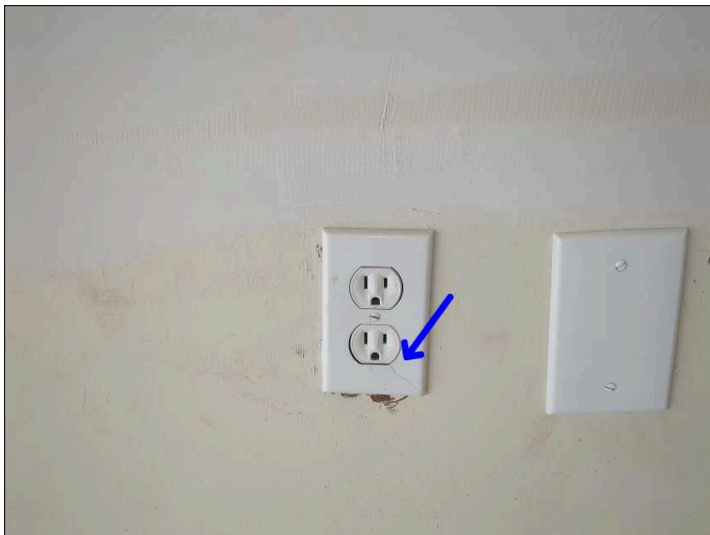
B.4. Receptacle plate is broken or missing, recommend replacing covers to help prevent electrical shock. Mainly at - garage

Receptacle plate is broken or missing, recommend replacing covers to help prevent electrical shock. Mainly at - garage

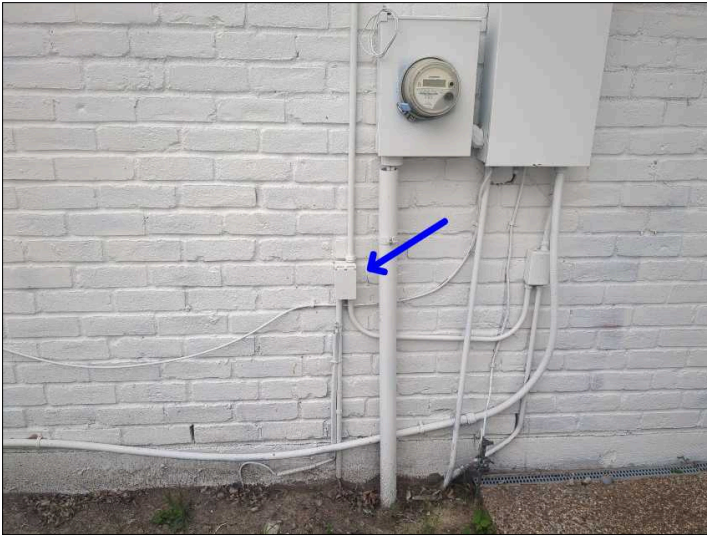
The GFCI (Ground Fault Circuit Interrupter) electrical outlet does not trip when tested. Mainly at - right side exterior

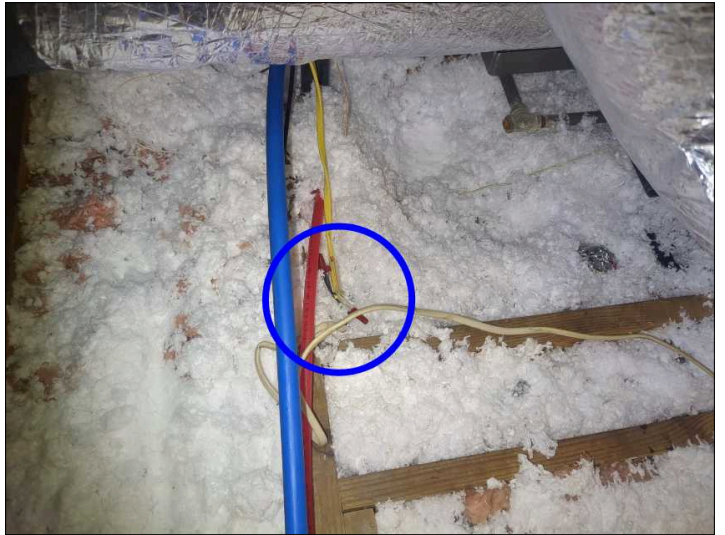
B.10. There are visible unprotected wiring splices. Recommend the wiring be properly enclosed. Mainly at - attic

There are visible unprotected wiring splices. Recommend the wiring be properly enclosed. Mainly at - attic

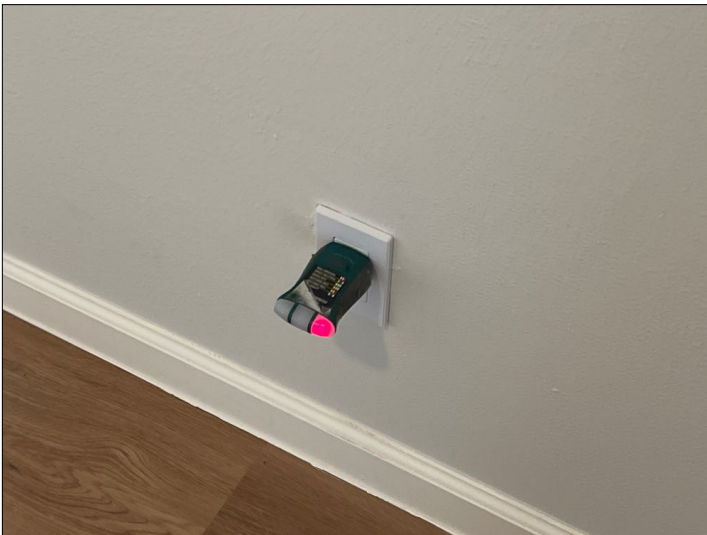
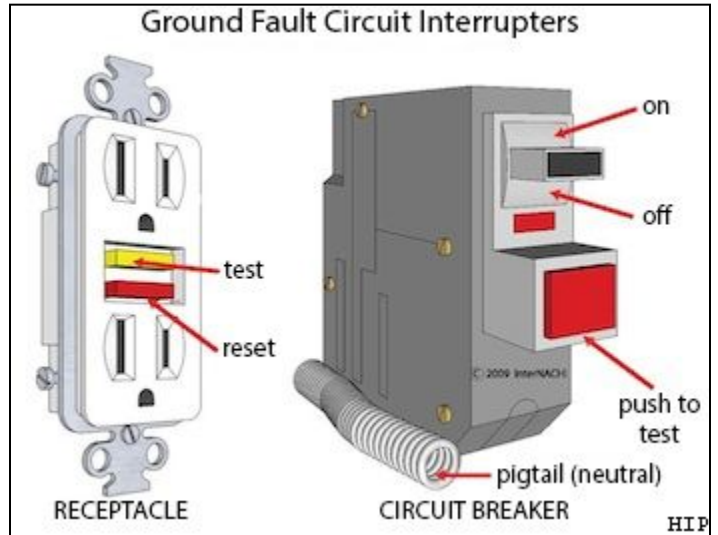
Electrical receptacle(s) are registering an open ground. Mainly at - hall side room

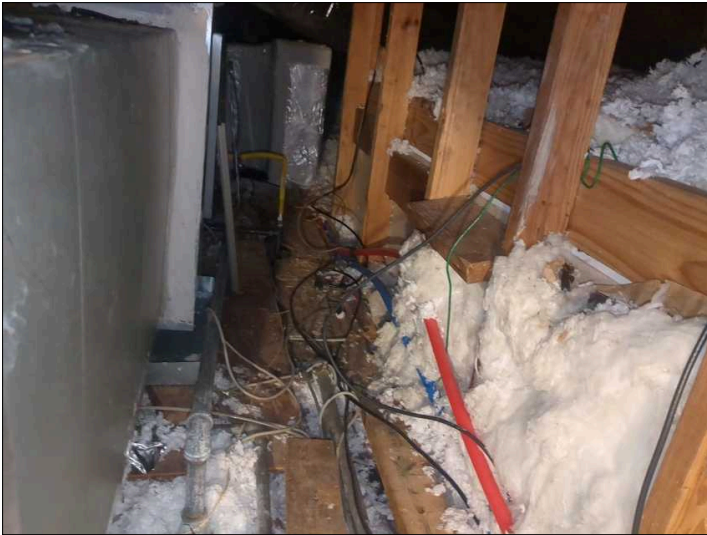
A.2. There is not an adequate workspace and/or pathway to the furnace , located in the attic as recommended.

There is not an adequate workspace and/or pathway to the furnace, located in the attic as recommended.

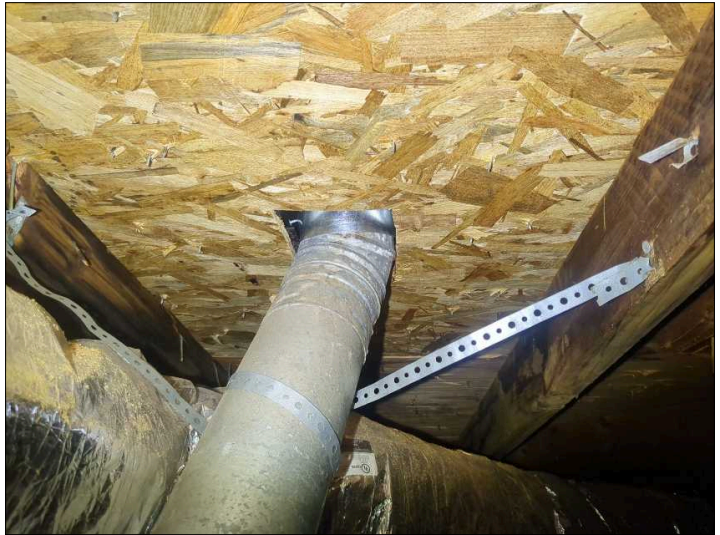
A.1. There is improper clearance around the flue pipe, the furnace vent should have at least 1" clearance to combustibles.

There is improper clearance around the flue pipe, the furnace vent should have at least 1" clearance to combustibles.

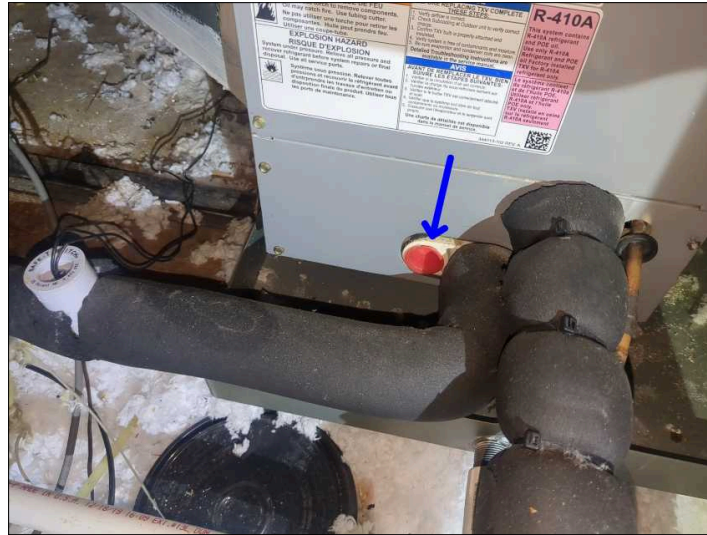
B.1. The evaporator is missing the secondary drain line to the exterior or to the pan in case main condensation line becomes clogged, recommend adding a secondary drain or high water shutoff to drain line to help prevent water damage to ceilings.

The evaporator is missing the secondary drain line to the exterior or to the pan incase main condensation line becomes clogged, recommend adding a secondary drain or high water shutoff to drain line to help prevent water damage to ceilings.

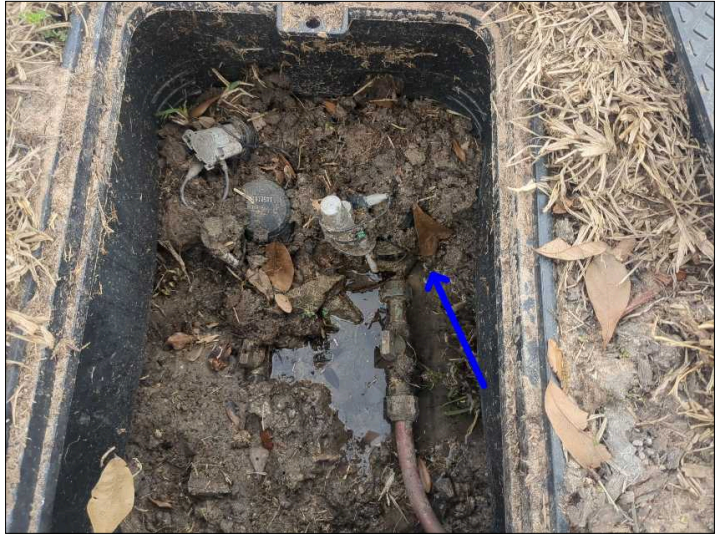
- The water meter is located at the left curb.
- The water meter was checked for any movement to check for possible leaks and movement was noted. Recommend a licensed plumber to evaluate and repair as needed.
- The gas meter is located on the left.
- The gas distribution pipe is Black Iron.

Leak/water movement noted in the meter box at the water meter.
