Property Inspection Report

5515 Council Grove Ln, Houston, TX, 77088

*Inspector: Kory Knapp
TREC License: 25691
Agent: Cindy Raimon
Property Size: 2492
Property Age: 1974
Inspection Date: 3/7/2024
Inspection Time: 1:30 PM*

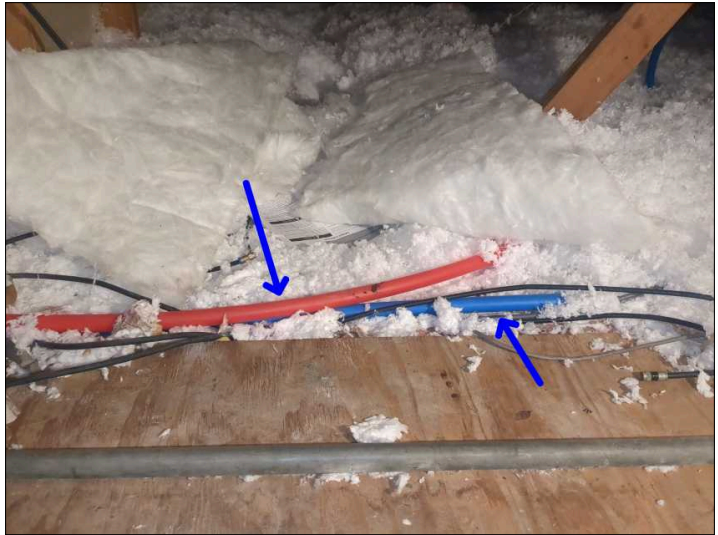
A.7. There are uninsulated water supply lines routed through the attic. Recommend all uninsulated supply lines be properly insulated to help prevent damage to the pipes in freezing weather.

There are uninsulated water supply lines routed through the attic. Recommend all uninsulated supply lines be properly insulated to help prevent damage to the pipes in freezing weather.

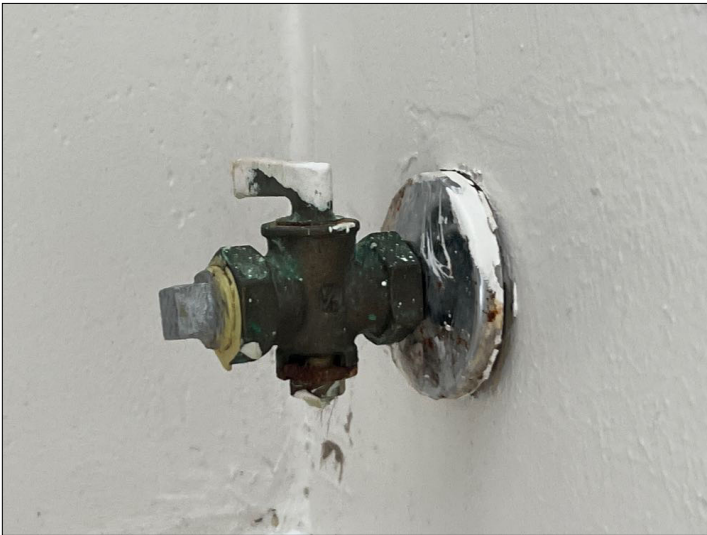
A.6. Unapproved gas valves were noted, recommend changing all unapproved gas valves. These valves are designed with a spring at the bottom of the valve which weaken over time causing gas to leak when operated. Although they may not be leaking at the time of inspection they have a high likely hood of leaking when operated. Mainly at - laundry

Unapproved gas valves were noted, recommend changing all unapproved gas valves. These valves are designed with a spring at the bottom of the valve which weaken over time causing gas to leak when operated. Although they may not be leaking at the time of inspection they have a high likely hood of leaking when operated. Mainly at - laundry

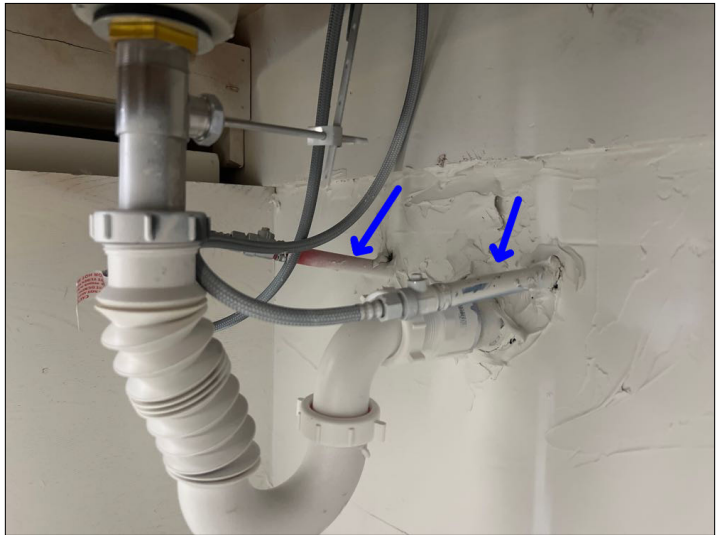
A.3. Although the home is equipped with a main shut off valve to the dwelling, it is recommended that individual fixtures be equipped with isolation or emergency shut off valves. Current standards requires shut-off valves on any or all faucets, toilets, and any other water feature such as the washing machine and outdoor hose bibs. Mainly at - hall bath

Although the home is equipped with a main shut off valve to the dwelling, it is recommended that individual fixtures be equipped with isolation or emergency shut off valves. Current standards requires shut-off valves on any or all faucets, toilets, and any other water feature such as the washing machine and outdoor hose bibs. Mainly at - hall bath

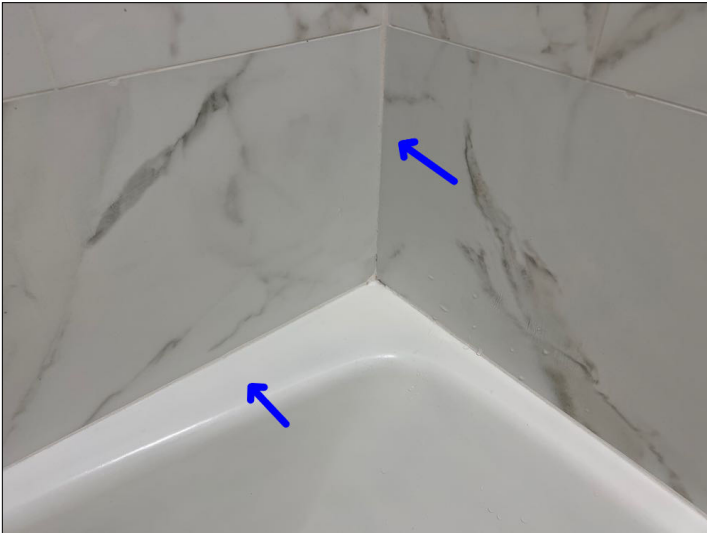
A.5. Grout was used in the corners of the tub/shower. It is recommended that a flexible sealant be used in the corners to allow for movement to help prevent future cracking in the corners of shower stalls and tub surrounds due to settlement.

Grout was used in the corners of the tub/shower. It is recommended that a flexible sealant be used in the corners to allow for movement to help prevent future cracking in the corners of shower stalls and tub surrounds due to settlement.

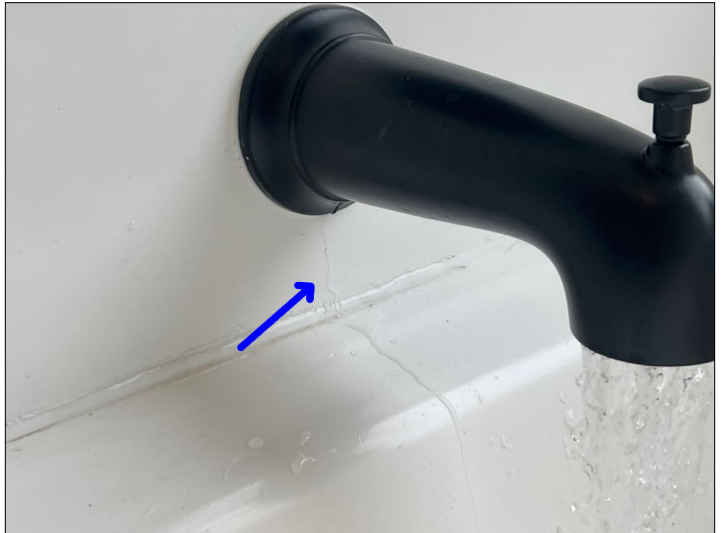
A.4. There is a water leak at the base of the faucet, recommend repair or replacement. Unable to determine condition of underlying materials. Mainly at - primary bath

There is a water leak at the base of the faucet, recommend repair or replacement. Unable to determine condition of underlying materials. Mainly at - primary bath

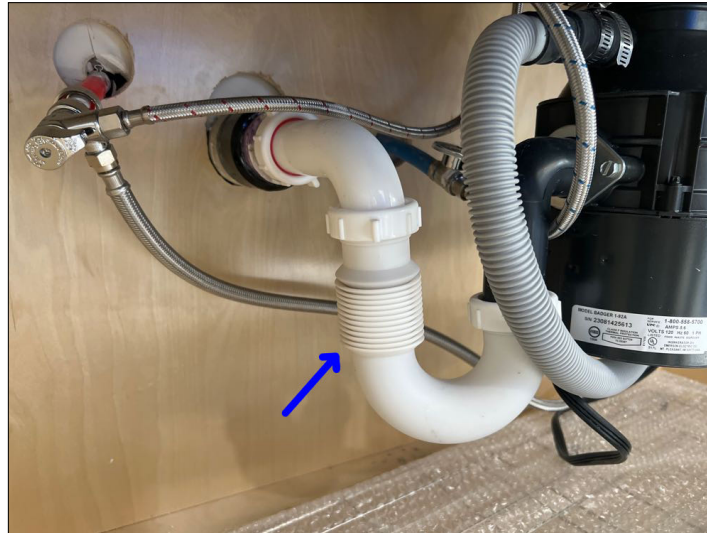
Drainage fittings shall have a smooth interior waterway of the same diameter as the piping served. All fittings shall conform to the type of pipe used. Drainage fittings shall have no ledges, shoulders or reductions which can retard or obstruct drainage flow in the piping.

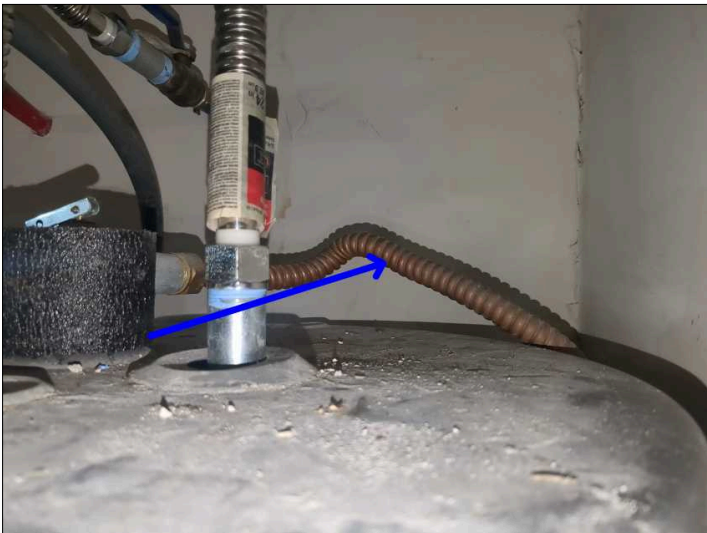
The water heater T&P (Pop-Off) valve drain line is plumbed uphill, therefore was not tested.

C.2. Recommend a licensed plumber be consulted for further evaluation and/or repairs.

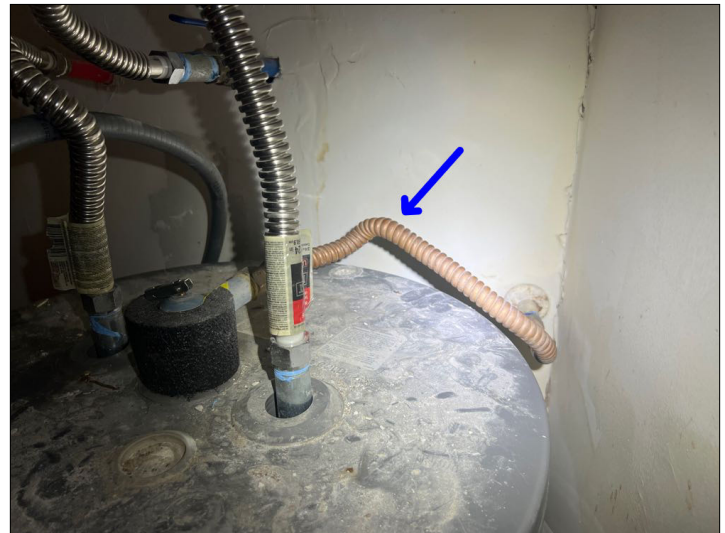
The water heater T&P (Pop-Off) valve drain line has been reduced in size, therefore was not tested.

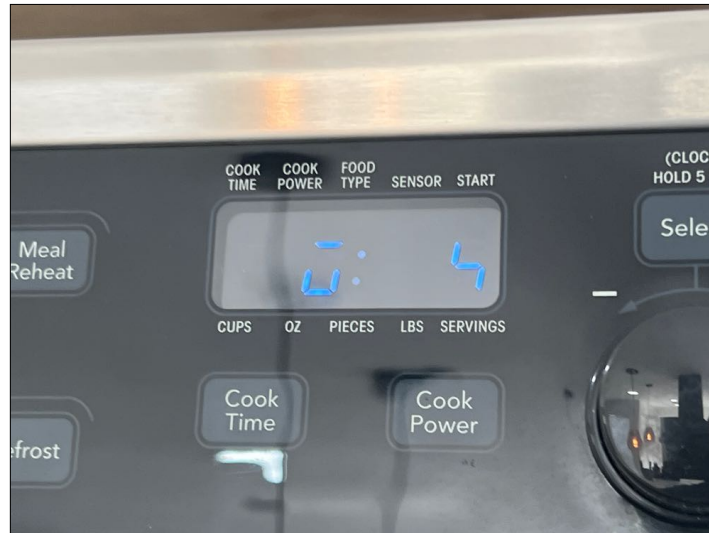
E.2. The clock numbers are damaged.

The clock numbers are damaged.

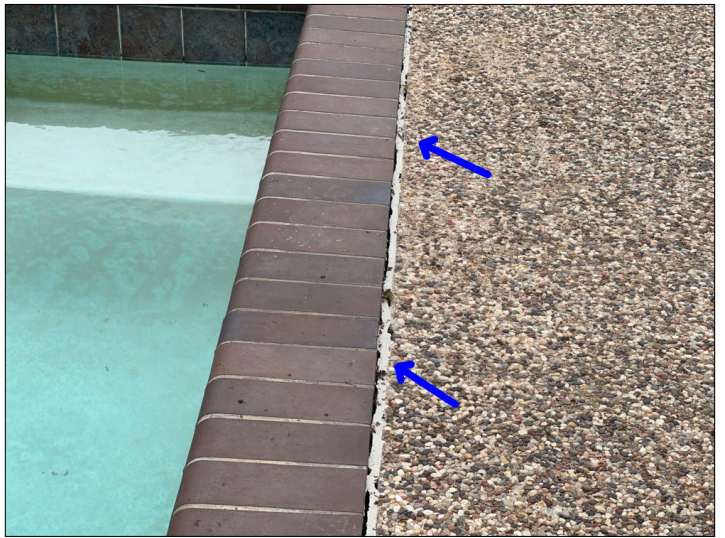
B.7. Recommend sealing between deck and coping to help prevent water penetration between causing soil to wash away and pavement to settle.

Recommend sealing between deck and coping to help prevent water penetration between causing soil to wash away and pavement to settle.

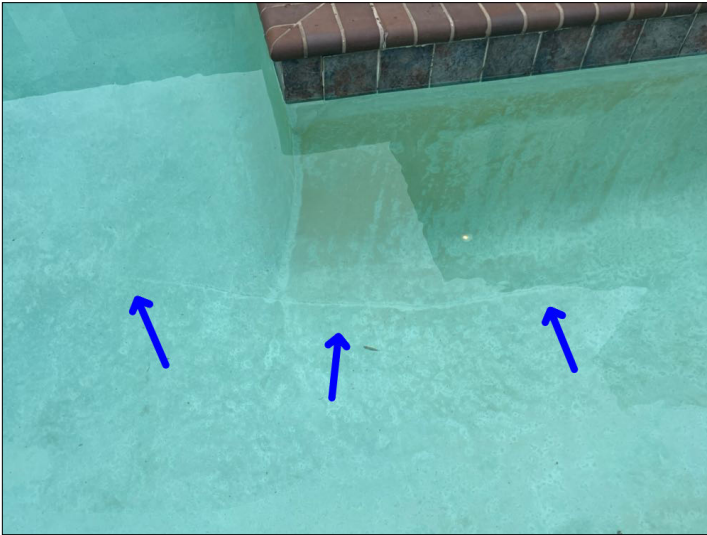
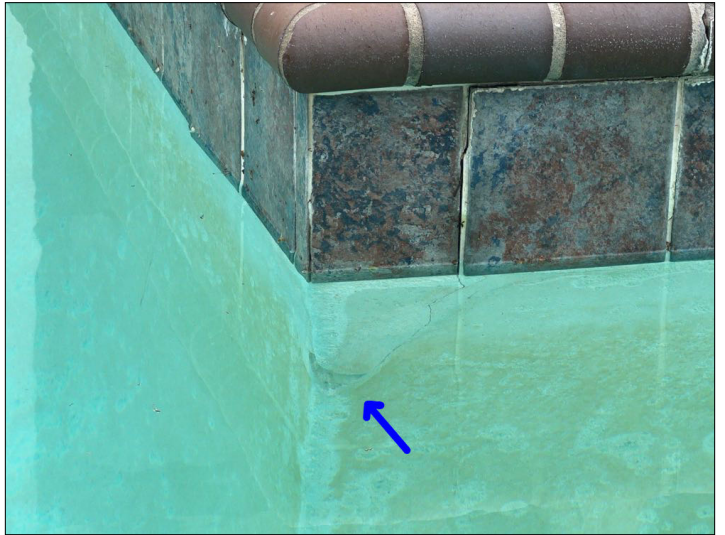
B.12. There are indications of a crack(s) in the pool surface. Unable to determine the condition of the underlying materials. Mainly at - left

There are indications of a crack(s) in the pool surface. Unable to determine the condition of the underlying materials. Mainly at - left

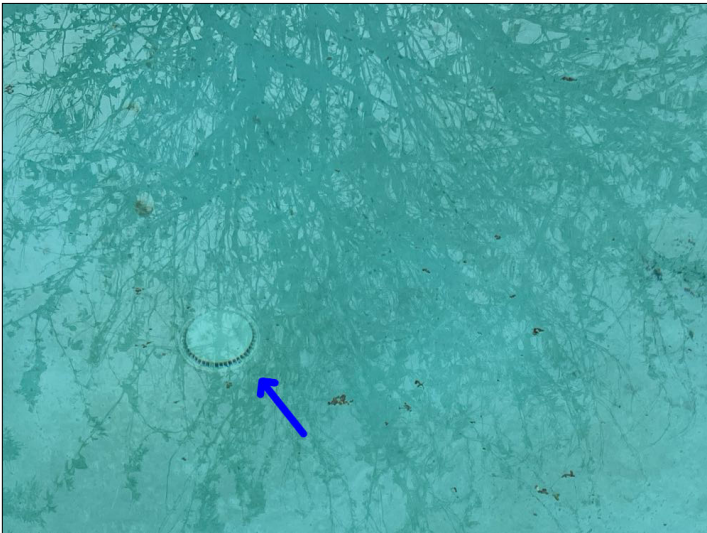
B.3. The pool only has a single drain installed, it is now recommended that all new installs be outfitted with a minimum of two drains for the pool and spa to help prevent an entrapment hazard. Recommend drains be replace with the proper code approved drain covers.

The pool only has a single drain installed, it is now recommended that all new installs be outfitted with a minimum of two drains for the pool and spa to help prevent an entrapment hazard. Recommend drains be replaced with the proper code approved drain covers.

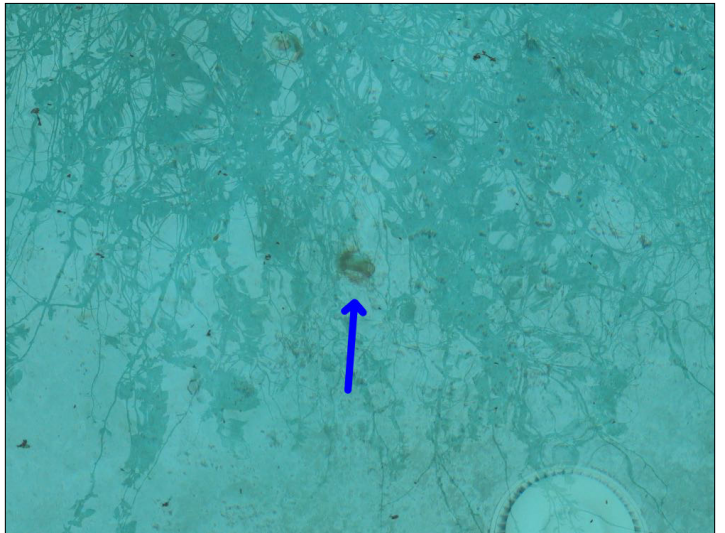
B.16. Pool walls/floors have rust present.

Pool walls/floors have rust present.

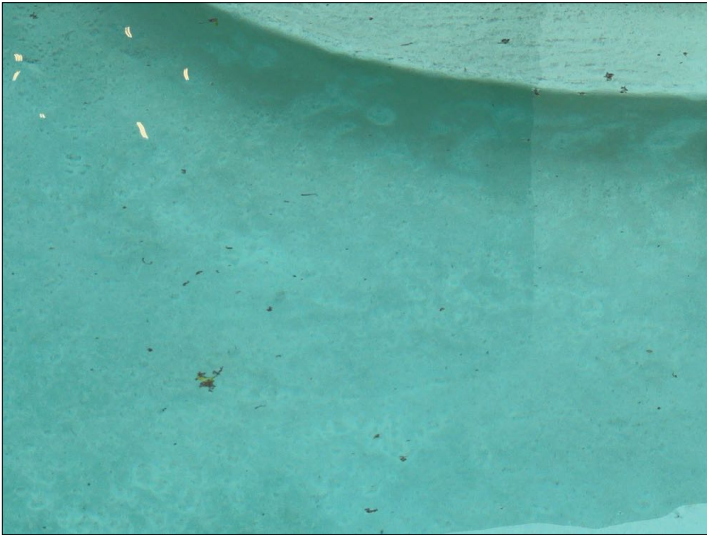
B.14. The surface of the pool is worn. Unable to determine the condition of underlying materials.

The surface of the pool is worn. Unable to determine the condition of underlying materials.

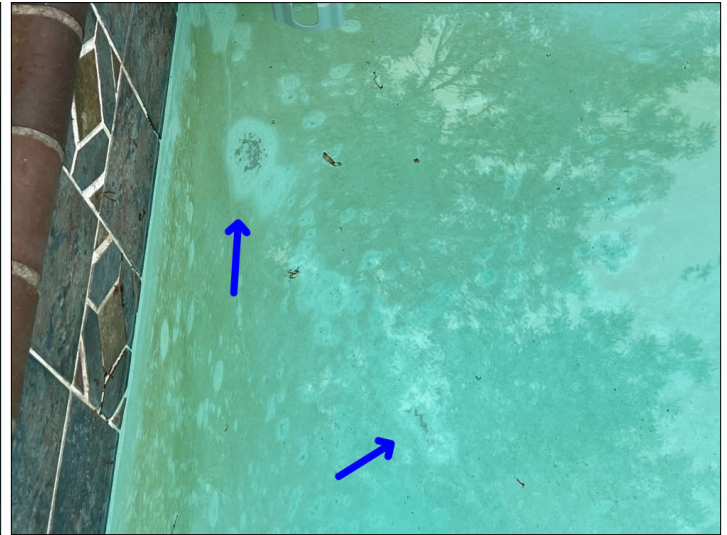
B.13. The surface of the pool is damaged. Unable to determine the condition of underlying materials. Mainly at - various locations

The surface of the pool is damaged. Unable to determine the condition of underlying materials. Mainly at - right

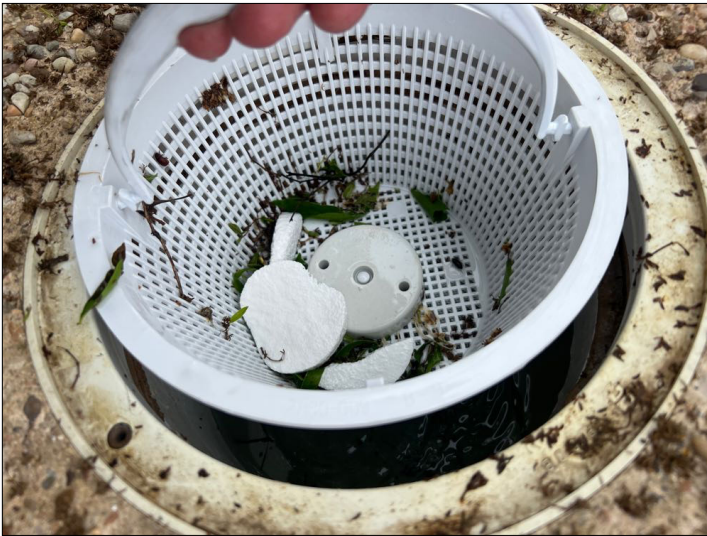
B.11. There are sanitizer tablets located in the skimmer basket. It is not recommended since this causes a strong concentration of chlorine to enter into the pump system damaging components.

There are sanitizer tablets located in the skimmer basket. It is not recommended since this causes a strong concentration of chlorine to enter into the pump system damaging components.

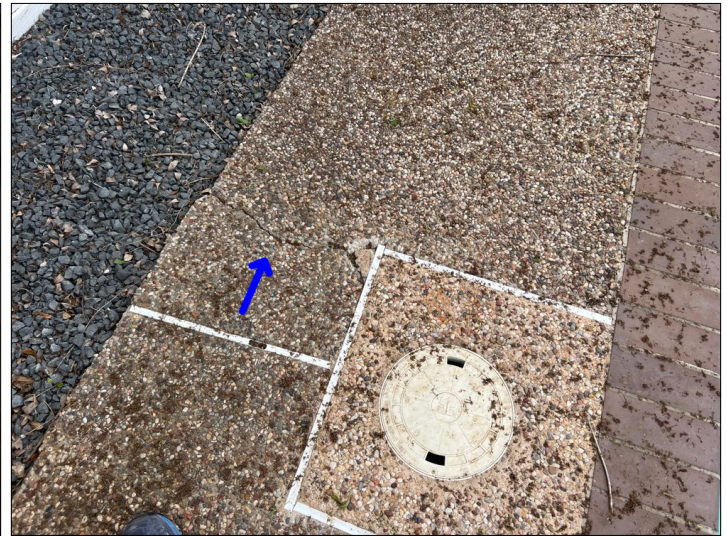
B.9. There are settlement cracks in the pool decking and coping.

There are settlement cracks in the pool decking and coping.

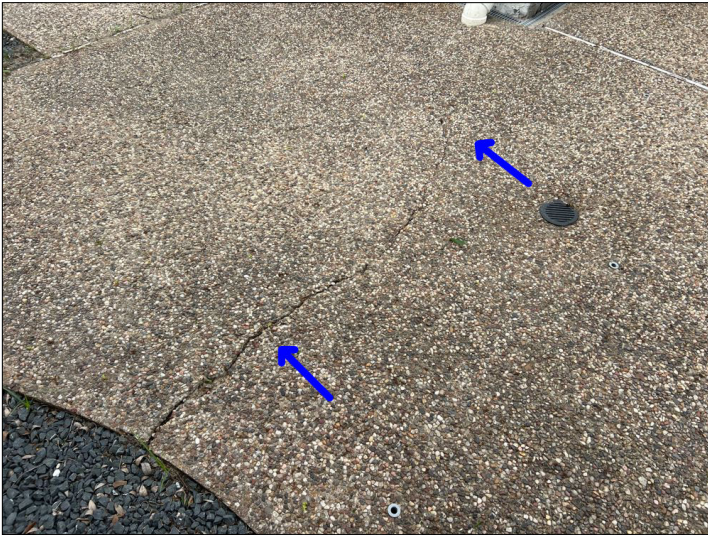
There are settlement cracks in the pool decking and coping.

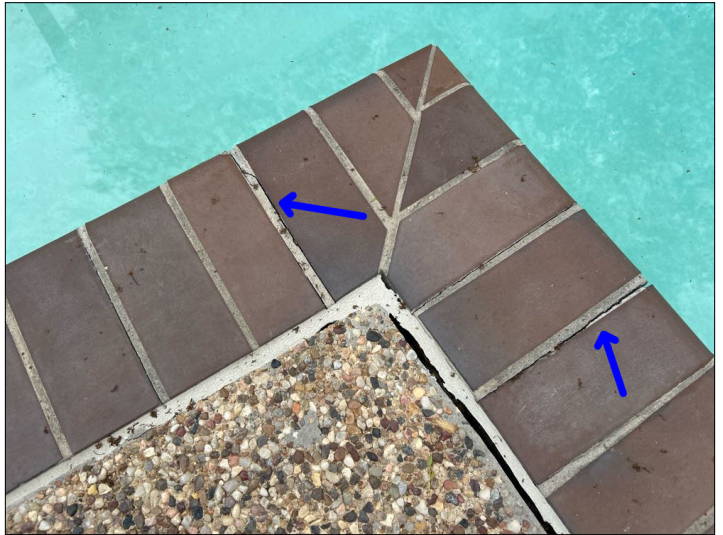
The grout is deteriorated in several locations around the pool decking and tiles.

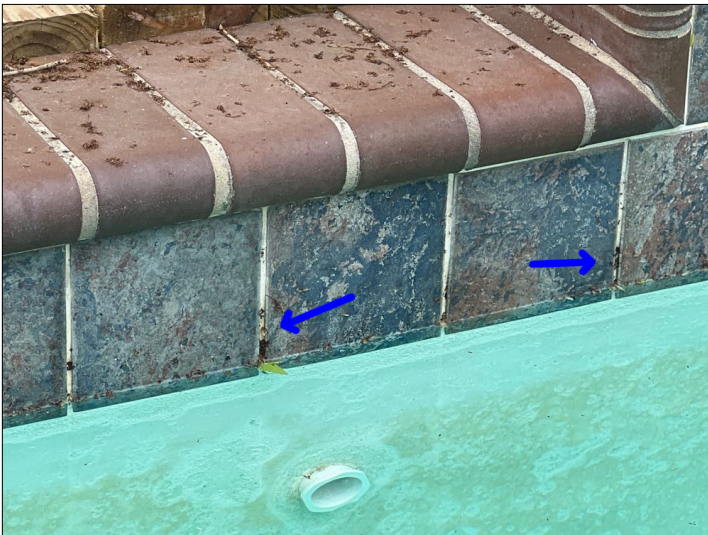
The grout is deteriorated in several locations around the pool decking and tiles.

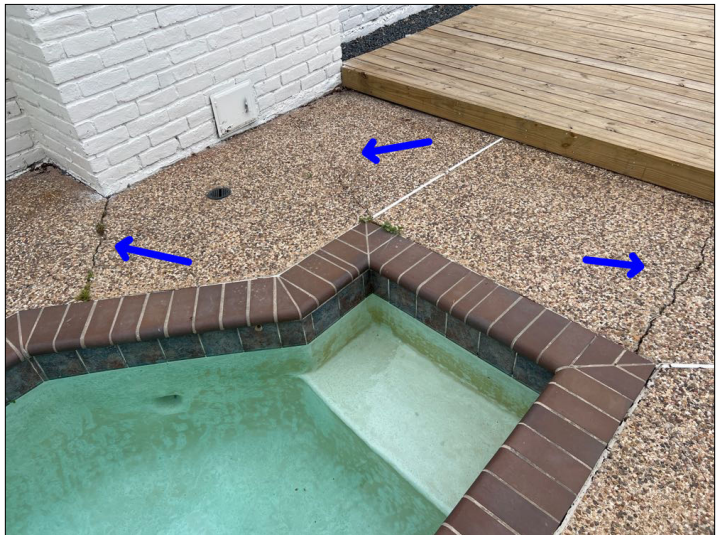
There are settlement cracks in the pool decking and coping.

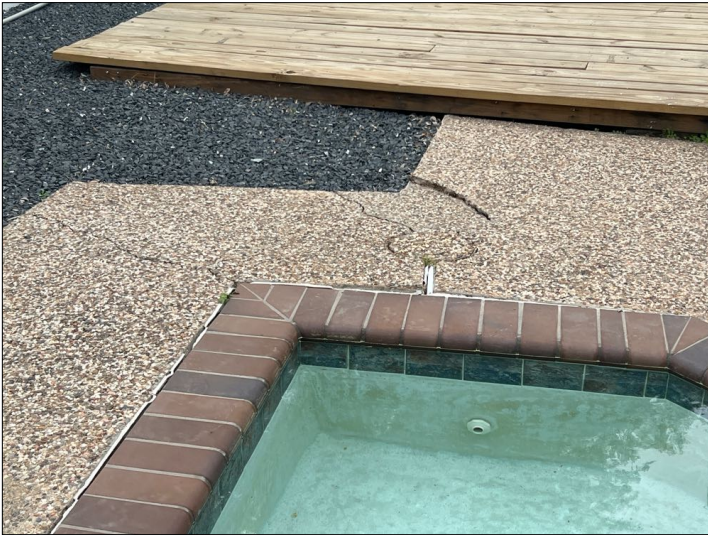
There is uneven pavement noted around the pool or spa.

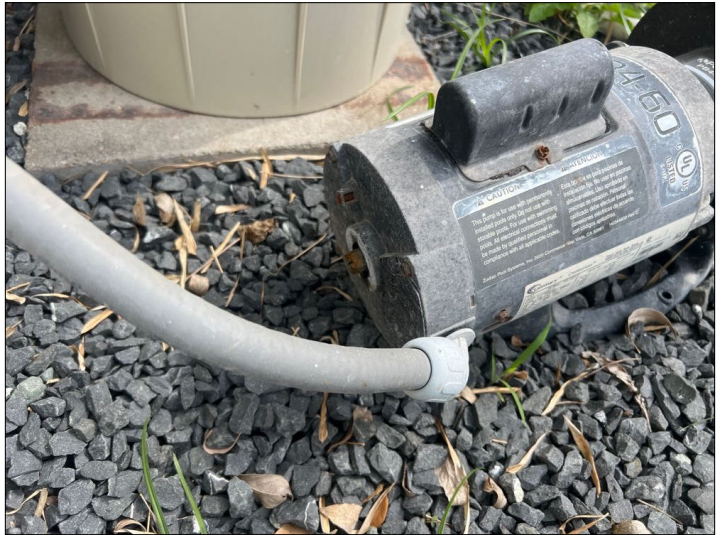
There is no evidence of electrical bonding between the pool and the pool equipment.

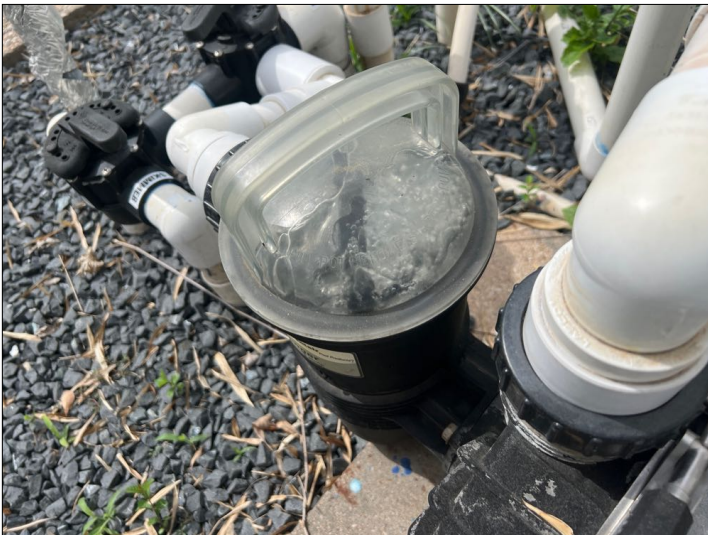
B.19. The pool equipment is sucking air, recommend sealing by applying grease to o-ring seals on the filter and strainers.

The pool equipment is sucking air, recommend sealing by applying grease to o-ring seals on the filter and strainers.

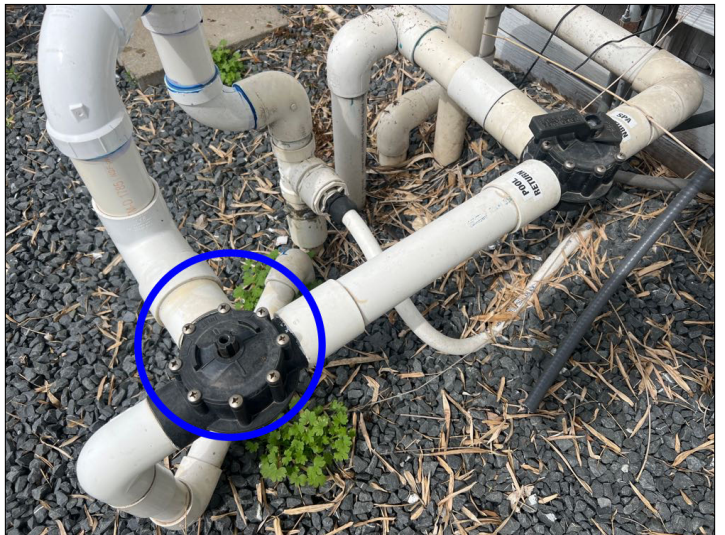
B.23. The valve handle is missing.

The valve handle is missing.

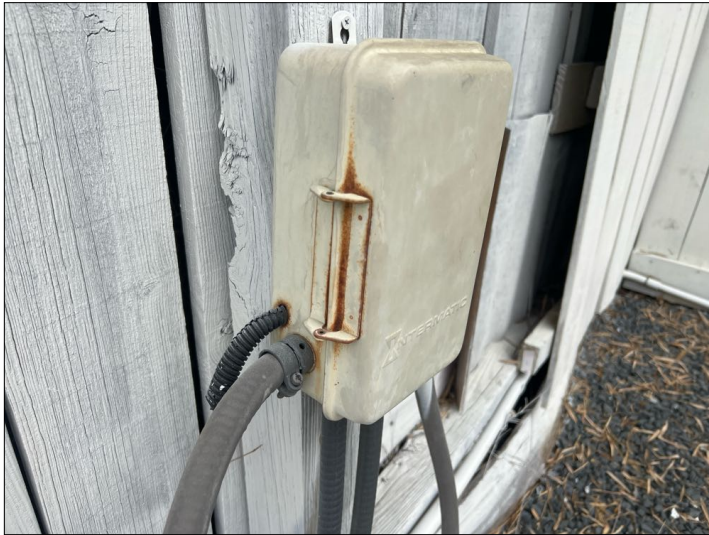
B.21. Pool timer is rusted.

Pool timer is rusted.

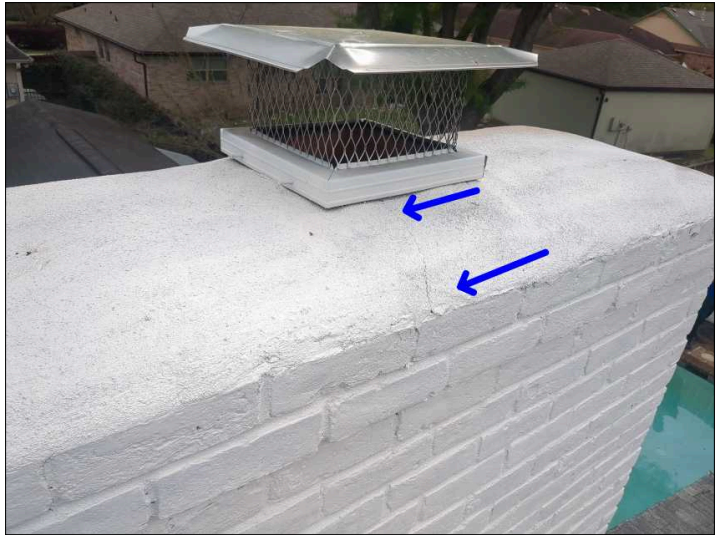
G.5. Seal all cracks in mortar cap to help prevent further deterioration.

Seal all cracks in mortar cap to help prevent further deterioration.

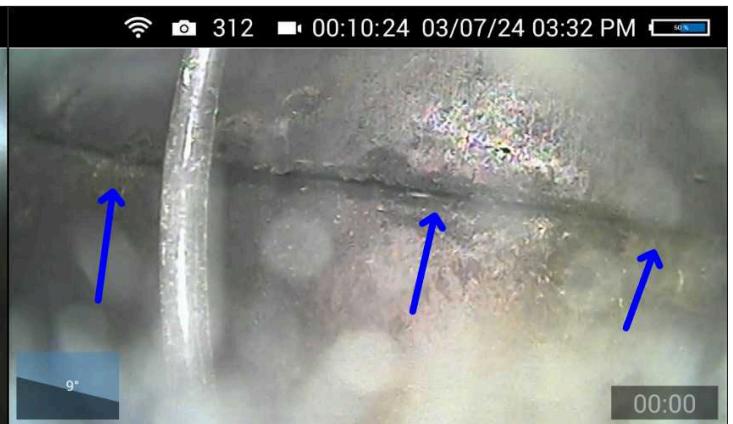
G.4. There are one or more flue tile joints in the flue of the chimney that are not sealed properly. Recommend repairs by a licensed fireplace specialist to ensure proper flue exhaust/gas flow.

There are one or more flue tile joints in the flue of the chimney that are not sealed properly. Recommend repairs by a licensed fireplace specialist to ensure proper flue exhaust/gas flow.
