Wildcat Inspections

**107 Hillcrest Ln.
Livingston, TX 77351**

April 1, 2021

PROPERTY INSPECTION REPORT

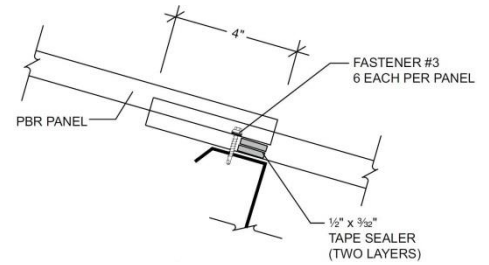
There was no visible tape seal at the bottom of the panels. According to manufacturers' two layers of field applied tape sealant are required at eaves to help prevent wind damage.

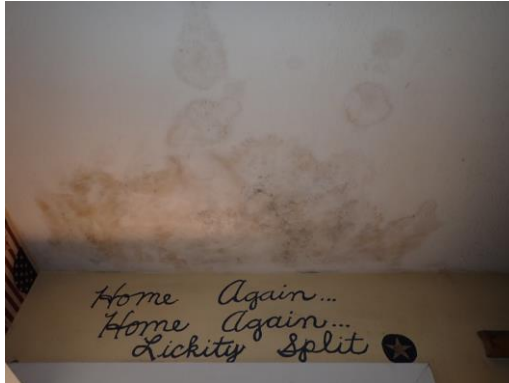
Laundry Room Walls & Ceiling

Staining that included probable organic growth was visible at multiple locations including in the water heater closet (all walls and ceiling), in the laundry room (wall and ceiling), under the cabinet for the laundry sink, in the stairwell (wall and ceiling) and in the garage (walls and ceiling). Immediate attention is needed. Type(s) of mold are not tested for or otherwise specifically identified during this type of inspection. The extent of damage to the unseen areas within the walls, ceilings, under flooring, behind cabinets and other wall coverings cannot be determined with a visual inspection such as this one. Further investigation of a destructive nature would be needed to determine the full extent of damage, if any. The affected areas are larger than 10 square feet therefore we recommend that a licensed Mold Assessment Consultant be contacted for further assessment and to develop a mold management plan or remediation protocol.

We recommend that a licensed Mold Consultant assess the conditions throughout the building and make recommendations for possible mold remediation by licensed remediators.

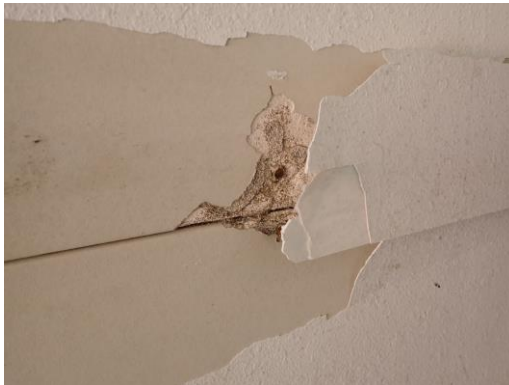
Garage Walls & Ceiling

Damage to the drywall cladding in the garage appears to be a combination of structural movement and excessive moisture.

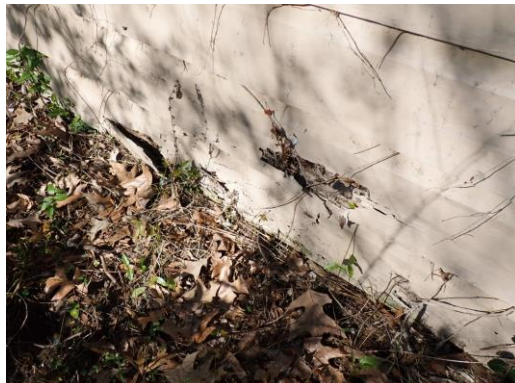
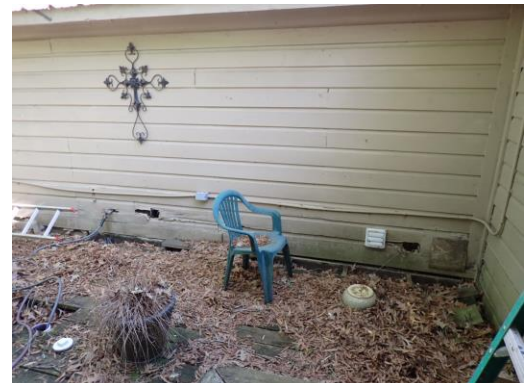
Localized rotting was observed at the exterior siding and trim. Rotted materials should be replaced or otherwise repaired promptly to prevent additional damage and reduce the risk of attracting insects. A qualified contractor should be contacted for an estimate to make repairs as necessary. This report is not intended to provide a complete list of all rotted materials. Some water damage may not be visible due to any previous partial repairs or recent caulking and painting.

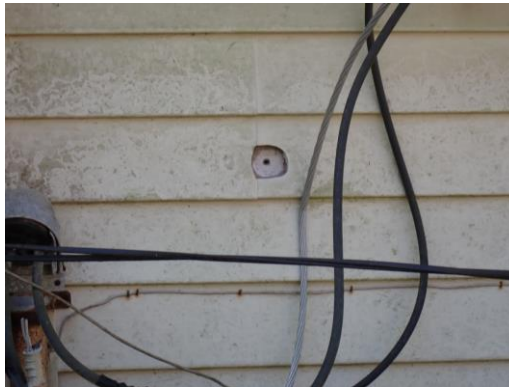
Holes in the exterior cladding should be repaired to prevent water migration and insect entry.

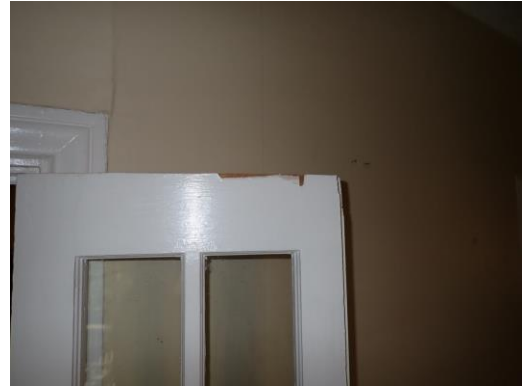
Skewed margins and other door related problems were observed. Four doors were hitting the jambs at the top. The condition appears to be related to excessive movement of a pier and beam foundation. Trimming of doors should be discouraged unless foundation “leveling” is ineffective.

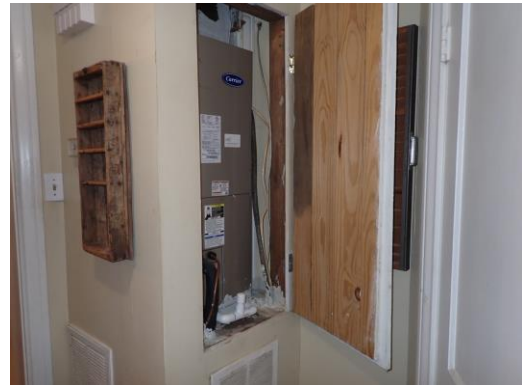
There was no weather-stripping on the door to the furnace closet and the door does not latch tightly and the ceiling is incomplete.

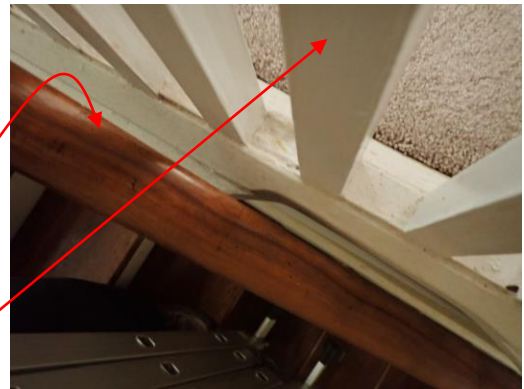
The handrail attached to the wall at the inside stairway is not considered to be safe because it is not graspable. A graspable handrail requires clearance of at least 1-1/2" between the handrail and wall or other obstruction.

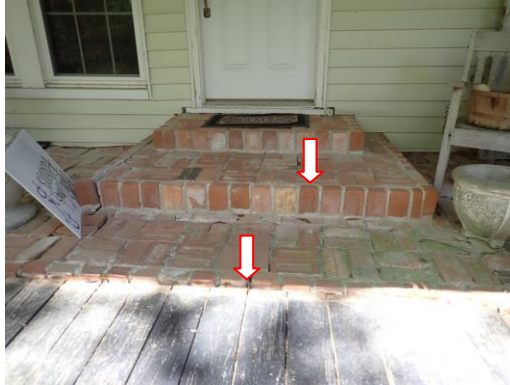
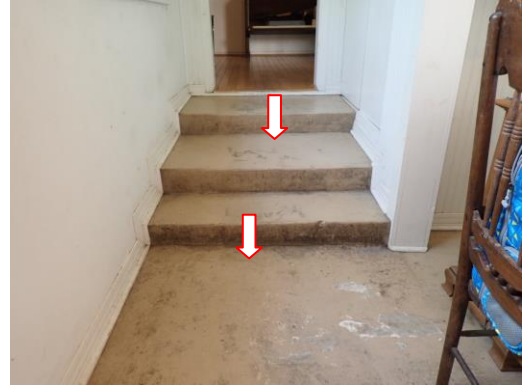
The size and/or orientation of the stairway risers at the front porch and garage stairways may make the stairway difficult to negotiate. Although this condition might have met industry standards at the time of construction it could pose a safety issue to some families and guests. By modern standards the maximum allowable riser height is 7-3/4 inches. The maximum variable between the largest and smallest risers that is considered safe is 3/8".

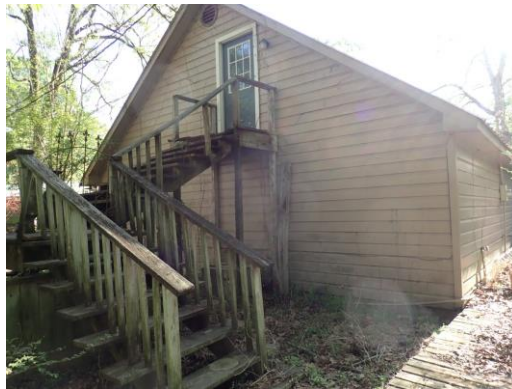
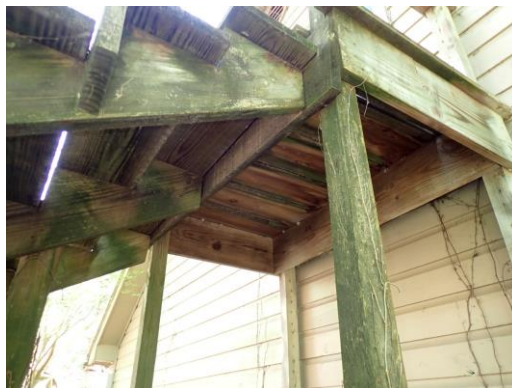
The exterior stairway to the room(s) over the garage is dilapidated. The life expectancy of a wood stairway is 10 to 15 years. That could be stretched to 20 years with regular maintenance and keeping it sealed with weatherproof coating. It is obvious that this maintenance on this stairway has been neglected. Given its condition and the advances made in safety requirements of stair construction over the years this stairway and landing should be replaced right away.

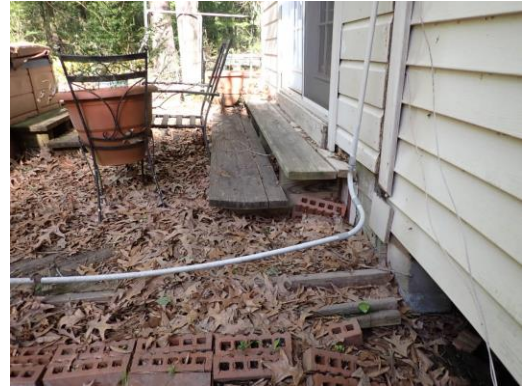
It appears that the stairway along the left side of the house has reached the end of its life expectancy. We recommend that it be replaced as well.

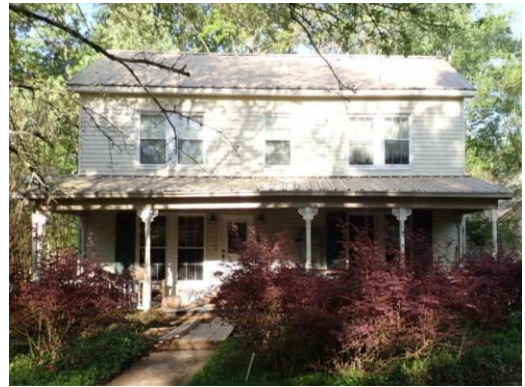
The front porch wood deck and roof structure are visibly settled toward the left end. A structural engineer and/or qualified structural repair specialist should further assess this condition and make recommendations for repair.

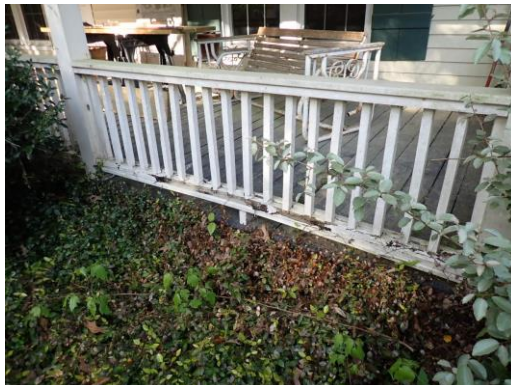
The porch rail shows evidence of rot. Replacement may eventually be desired. In the interim, localized repairs should be undertaken to insure safety. Rusted fasteners should be replaced.

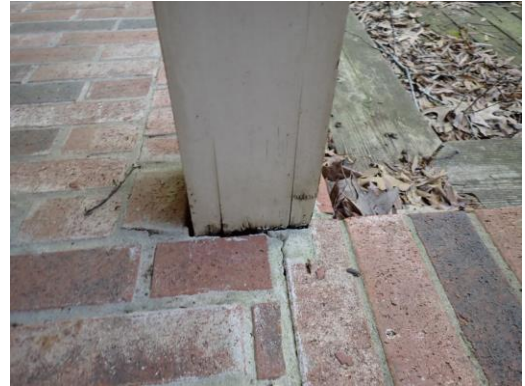
The roof support column at the back porch has signs of rot. The brick floor was placed above the column allowing water to be trapped and promoting wood decay. Further investigation is needed to determine the extent of the damage.

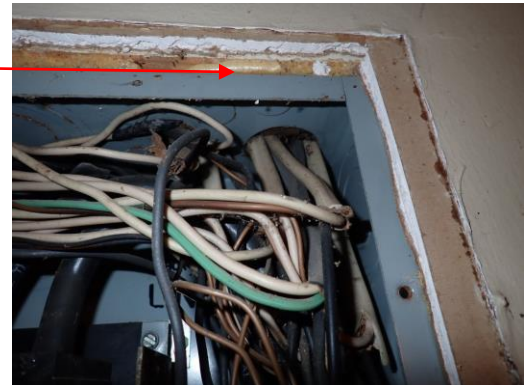
The panelboard is set too far back from the face of the wood-framed wall with drywall cladding and the gap around the panelboard is excessive. The enclosure and cover must be capable of containing electrical arcing. In walls of concrete, tile or other noncombustible material, cabinets and panelboards must be installed so that the front edge of the cabinet will not set back of the finished surface more than $\frac{1}{4}$ inch. In walls constructed of wood or other combustible material, cabinets must be flush with the finished surface or project therefrom. Noncombustible surfaces that are broken or incomplete must be repaired so that there will not be gaps or open spaces greater than $\frac{1}{8}$ inch at the edge of the cabinet or cutout box employing a flush-type cover.

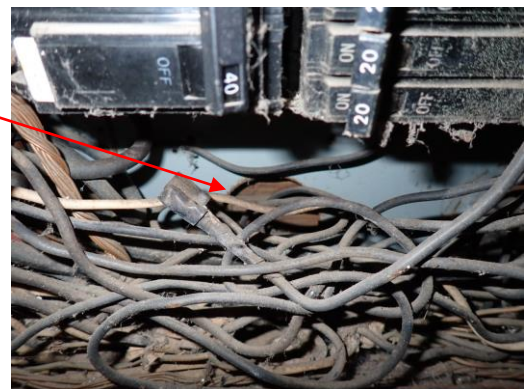
Unused openings in the panelboard enclosure are not adequately covered. Unused openings, other than those intended for the operation of equipment, those intended for mounting purposes, and those permitted as part of the design for listed equipment, must be closed to afford protection substantially equivalent to that of the wall of the equipment. Metal plugs and plates used with nonmetallic cabinets must be recessed at least $\frac{1}{4}$ inch from the outer surface. Unused openings for circuit breakers and switches must be closed using identified closures, or other approved means that provide protection substantially equivalent to the wall of the enclosure.

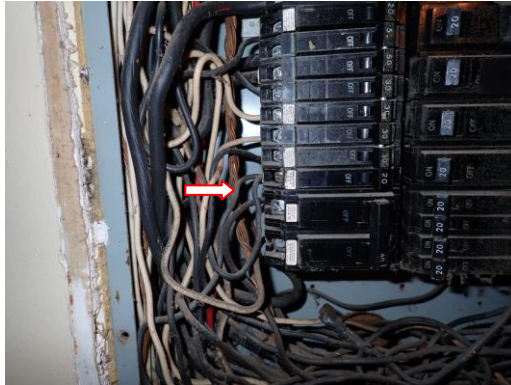
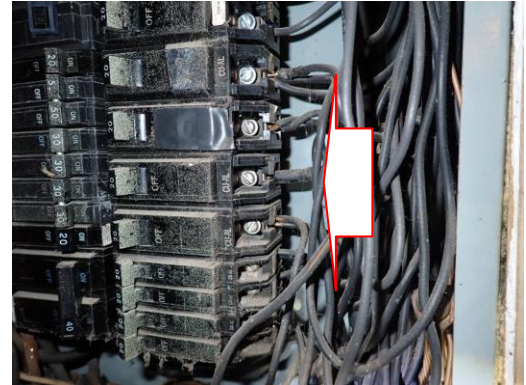
It appears there are an insufficient number of circuit breakers for this distribution system where two wires are connected to the same breaker at 6 breakers. This should be investigated and repairs made as needed. It is likely that a new panelboard will be required. Circuits within the main distribution panels that are doubled up (AKA double taps) should be separated unless the terminal is specifically identified for two conductors, either within the equipment instructions or on the terminal itself. (Very few are) Otherwise a separate fuse or breaker should serve each circuit.

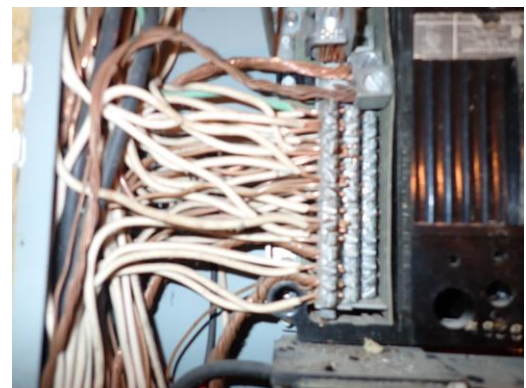
Neutral and ground wires are connected together under a single terminal at the main panelboard. Each grounded conductor (does not mean “ground wire”) should terminate within the panelboard on/in an individual terminal that is not also used for another conductor. (There is an exception for circuits with parallel conductors if the panel so allows.) When the neutral is disconnected, the objective is to still have the equipment ground connected. If both the neutral and grounded conductor is under the same terminal, this cannot be accomplished. Multiple grounding conductors are usually allowed to be in one terminal, but only if the same gauge. A qualified electrician should further research this to determine if an exception is allowed. If not, then conductors should be separated and installed under individual terminations.

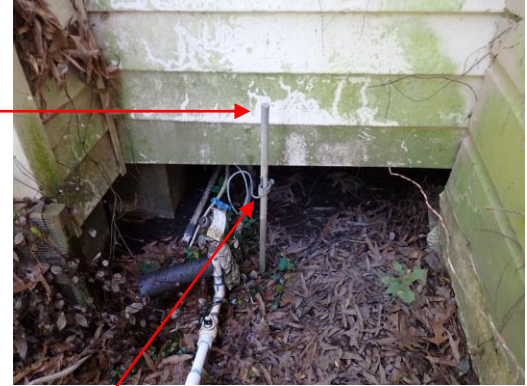
It appears that the ground rod is not driven to its full capacity and the exposed aboveground end of the ground rod and the grounding electrode conductor attachment are not protected against physical damage. The grounding electrode (rod) must be driven a minimum of 8 feet into the soil. Ground rods are typically 8 feet long. Additional protection is required when the upper end of a ground rod longer than 8 feet is not flush with or below ground level. Protection can be as simple as driving a pipe into the ground in front of the GEC or placing an obstacle (such as a large rock) to prevent damage caused by lawn equipment, etc.

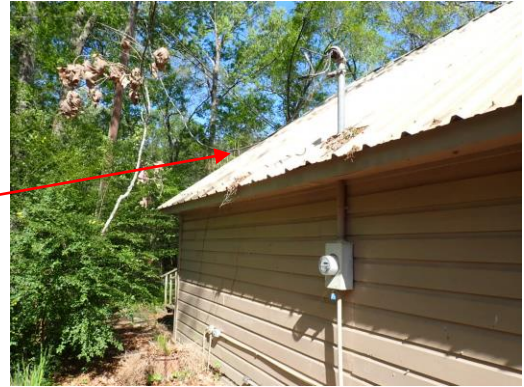
The service wires do not appear to have adequate clearance above the roof. A qualified electrician should investigate this further and make recommendations.

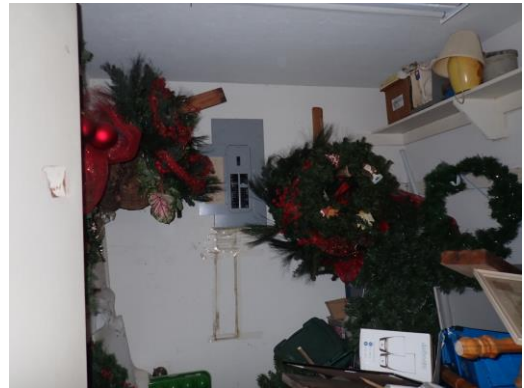
The electrical Distribution Panel should not be located in a closet or any area where it may be in close proximity to combustibles. Ideally it should be moved to an appropriate location. In the meantime never place clothes or other combustibles over an electrical panel.

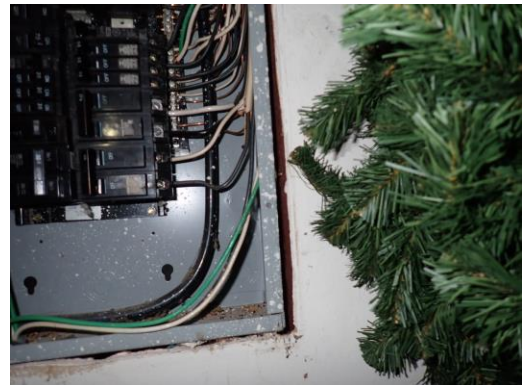
The main disconnect and all circuit breakers within the distribution panelboard should be labeled in a concise manner. See related information in the Main House Service comments.

Unused openings in the panelboard dead-front (inner) cover are not adequately covered and the opening around the perimeter of the enclosure is excessive. See related information in the Main House Service comments.

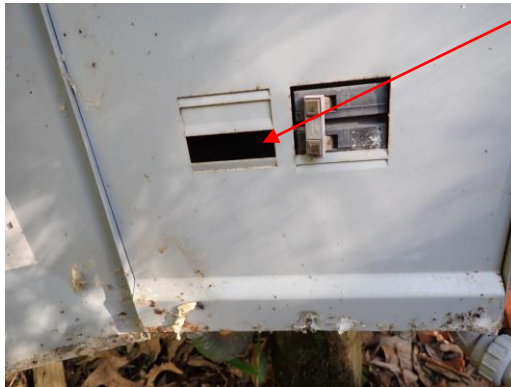
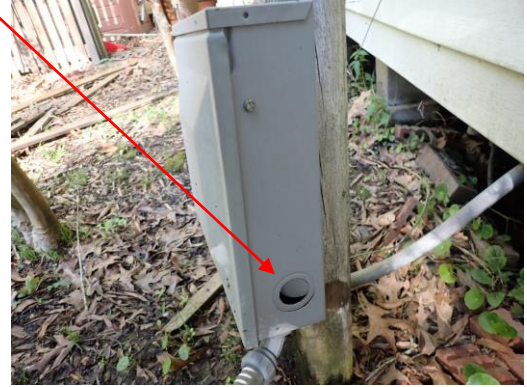
SUBPANEL AT LEFT A/C UNIT

Unused openings in the panelboard dead-front (inner) cover and enclosure are not adequately covered. See related information in the Main House Service comments.

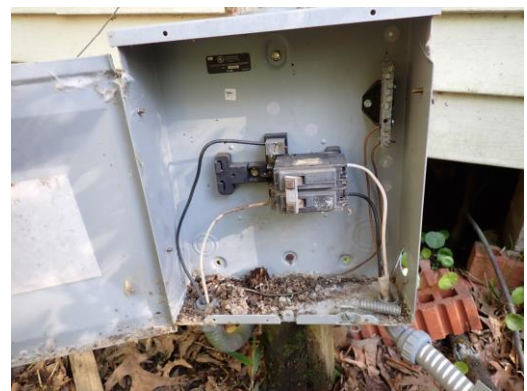
White wires within the panelboard are not appropriately color-coded. See related information in the Main House Service comments.

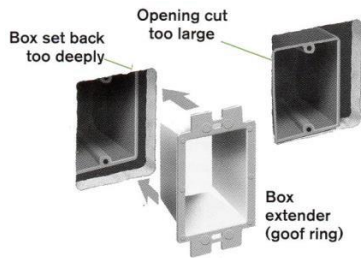
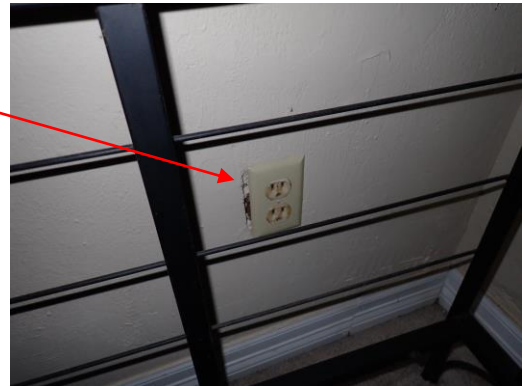
The opening cut in the wall was oversized resulting in a poor fit at one electrical box at the upstairs hallway. A possible hazard exists that should be addressed when boxes are too far from the face of the wall and/or the space around the box is more than 1/8 inch. Box extenders (goof rings) such as shown in the graphic could be installed so that the perimeter flange fills the space around the existing box and the front edge is less than 1/4 inch from the face of a noncombustible wall and flush or protruding from a combustible wall. Upon completion the device yoke should be supported firmly against the box and not the wall cladding. When faceplates are installed they must completely cover the opening and seat against the mounting surface of the receptacle.

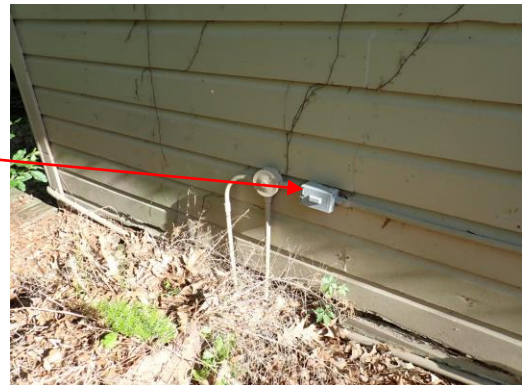
NOTICE: A switch along the left side of the garage exterior did not appear to activate a light or device. Circuits at any inoperative switches should be investigated to be sure that the electrical cables terminate in a safe location. It is not uncommon in an older home to find abandoned or unused switches. Switches are sometimes added during original construction for future use of light kits on fans or exterior lighting.

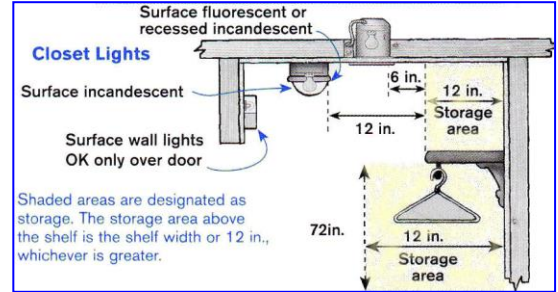
A closet light fixture upstairs presents a possible fire hazard due to its proximity to the storage area. All incandescent lights in closets should have covers and be a minimum of 12" from the edge of storage shelving measured vertically to prevent fires due to overheating. This was a requirement before 1995. Fluorescent lighting and enclosed LED lighting can be as close as 6". Discuss options with a qualified electrician.

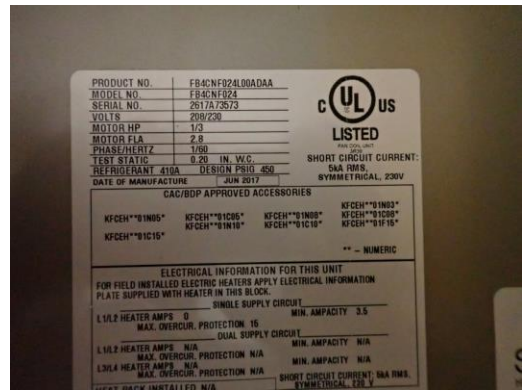
Dates of furnace manufacture taken or estimated from the data plates – 2017 at the downstairs. The age is unknown at the upstairs because it was not accessible. Downstairs data is shown.

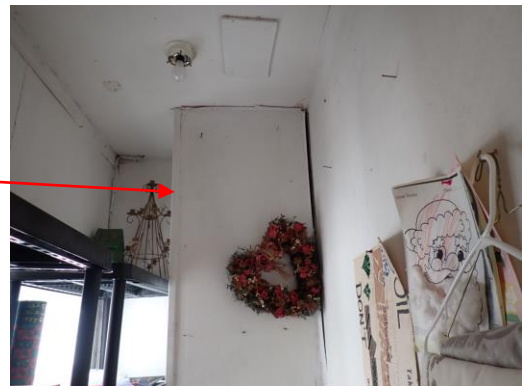
The upstairs furnace was inaccessible behind drywall and could not be inspected. Appliances should be readily accessible for service. We recommend that a licensed HVAC contractor assess the age and condition of the furnace after access is made available.

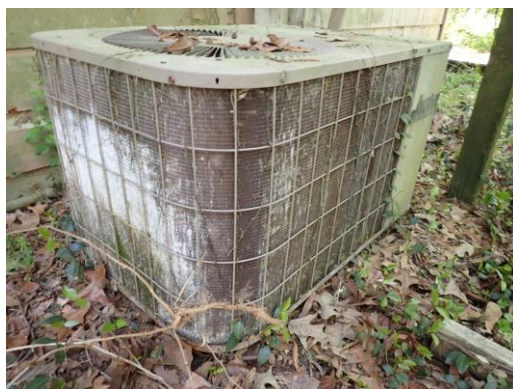
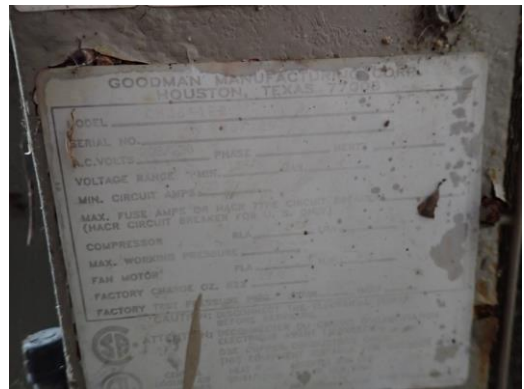
Over Garage - Unknown

NOTE THAT: The air conditioning condensing unit for the rooms over the garage is older. The exact age is unknown because the data plate was not legible. It may require a slightly higher level of maintenance, and may be more prone to major component breakdown. Predicting the frequency or time frame for repairs on any mechanical device is virtually impossible.

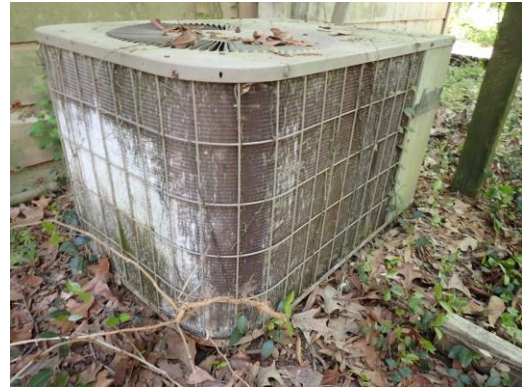
The cooling fins of the condensing unit for the rooms above the garage are dirty and damaged. Discuss this with a qualified HVAC contractor as this condition can reduce the efficiency of the system. The fins are there to help dissipate the heat in the refrigerant. A small amount of fin loss will not appreciably hurt the unit, but it does decrease the amount of heat transfer that takes place and it increases the energy used.

It is not economically practical to try to replace the fins when they are press fitted onto the copper piping during the assembly process. The coil itself can be replaced but that could also prove to be expensive. Therefore depending on its age and condition, it may be wiser to consider replacing the condenser unit entirely.

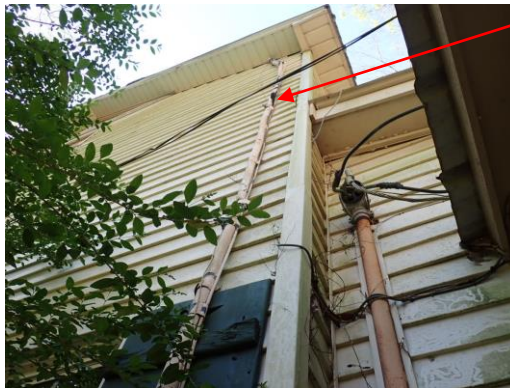
Insulation on the refrigerant lines at the condensing units is damaged. It should be repaired to fully cover the pipes. The insulation currently installed on the refrigerant line would not meet today's energy requirements. Therefore it is also recommended that the insulation be upgraded to a denser, thicker material. This can save energy dollars.

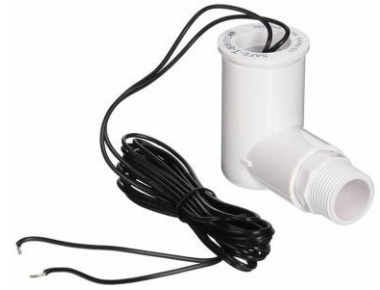
The overflow (secondary) condensate drain line for the evaporator coil is not fitted with a drain pipe. A qualified HVAC contractor should make corrections to prevent condensate damage to the building. The overflow drain pipe from the evaporator coil drain pan should be piped to discharge into the emergency pan (with a shut off float switch in the pan) or other approved location. If not possible to route the overflow drain line install a low voltage overflow switch kit (similar to image) so if it does back up the float switch rises and shuts the system down alerting you that there is a problem and you need to call an HVAC company for repairs. Of course the emergency pan should also have a float switch as well for the best property protection.

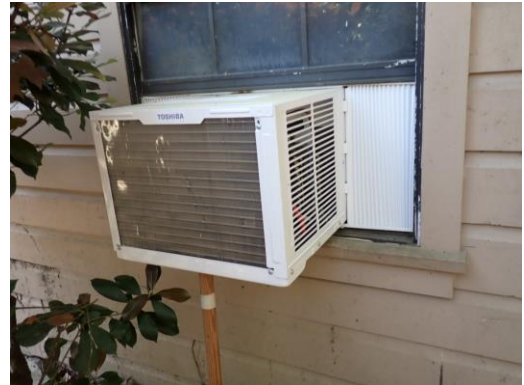
The window unit in the office (garage conversion) did not function at the time of the inspection. A qualified repair contractor should investigate and repair as needed.

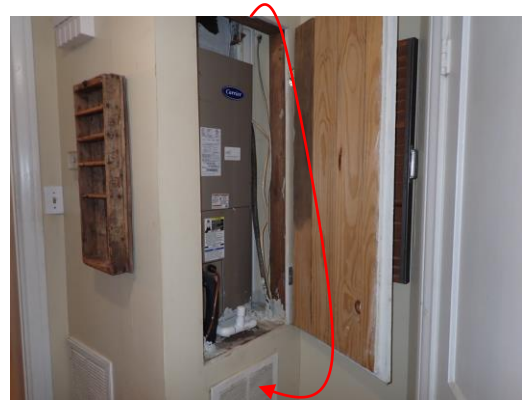
Unfiltered air is being drawn into the air conditioning equipment from the open structure. The door should be weather-stripped as discussed in the Doors section or the ceiling should be sealed to prevent this infiltration and provide a better fire break between stories. This type of infiltration usually leads to a problem with dust buildup on coils and other components, which can damage the equipment. Besides the potential for mechanical failure, this type of air infusion creates improper pressures within the envelope of the house that can contribute to energy loss and damage associated to elevated moisture within the dwelling.

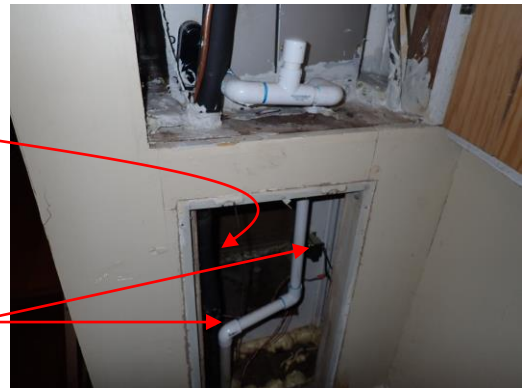
Hazardous materials (PVC, electrical wiring, transformer, etc.) are in the return air chase. The only equipment and devices permitted within fresh air ducts or plenum chambers are those specifically necessary for their direct action upon, or sensing of, the contained air. Where equipment or devices are installed and illumination is necessary to facilitate maintenance and repair, enclosed gasketed-type luminaires are permitted.

While probably an acceptable practice at the time of construction this has been determined that things like PVC, electrical wiring, alarm system horns, etc. in the fresh air chase are unsafe. Electrical wiring can cause fires and if a fire occurs it can spread quickly through the duct chase into the attic and other parts of the house. Even if a fire did not occur, plastics and coatings on non-approved wire types can smolder under a system overload and release toxic gasses into the system that can be distributed throughout the house. While PVC is hard to ignite, when it does burn it releases hydrogen chloride and carbon monoxide. Therefore all wiring, devices and equipment located within the return air chase and not specifically rated as suitable for use within an environmental air chase should be replaced with approved materials or sealed behind drywall, within conduit or other approved methods of containment.

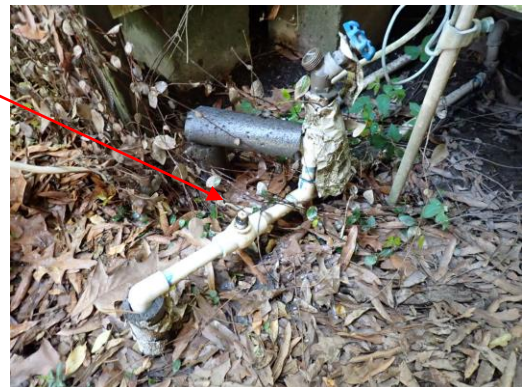
Exposed exterior water pipes should be insulated. Pipes often freeze even though winters in this area are considered to be mild. Insulation should be made waterproof in order to be effective.

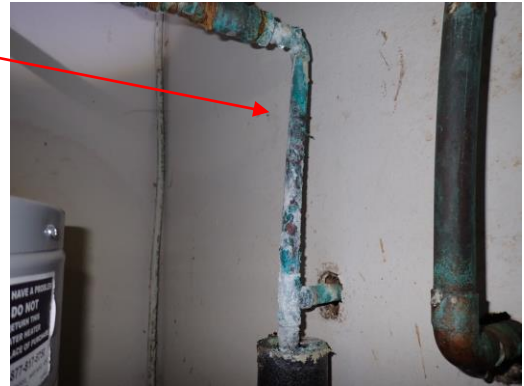
Copper pipe in the water heater closet have copper oxide (green) spots. This might have been caused by water leaking into the insulation. Further investigation is needed to determine the cause and correct path to prevent damage. These spots can occur for various reasons that range from condensation (usually more on the cold pipes than the hot) to water leaks from above the pipes. Copper plumbing touching dissimilar metal can also cause the copper to corrode, induce noise transmission and produce rattle. A licensed qualified plumber should further assess the condition of the piping and make recommendations.

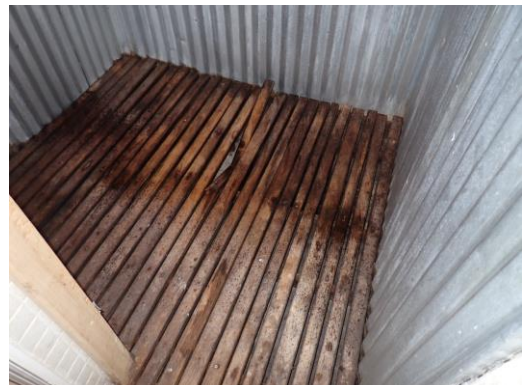
The wooden base of the shower stall in the owner's bathroom should be rebuilt. Wall or floor damage beneath the enclosure should also be repaired.

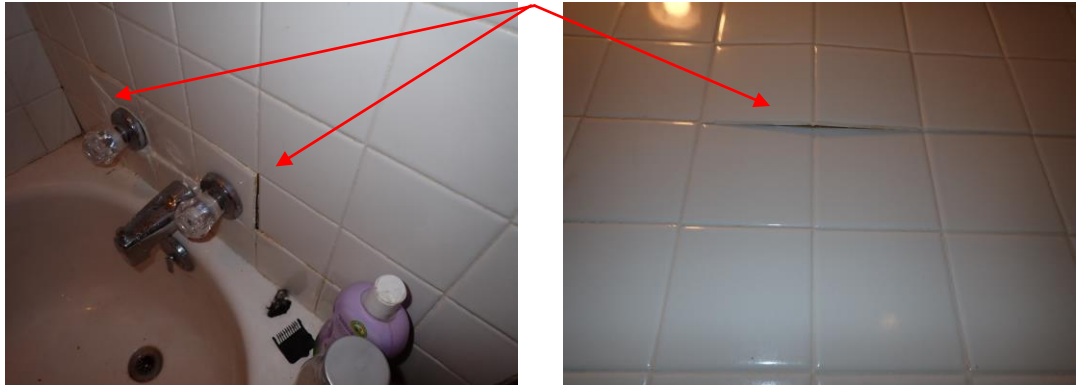
The tile bathtub enclosure in the downstairs bathroom requires repair. Damage appears to be related to structural settlement. Loose or damaged tile, grout and caulk should be repaired or replaced as necessary. Any damage to the wall behind the tile should also be repaired as necessary.

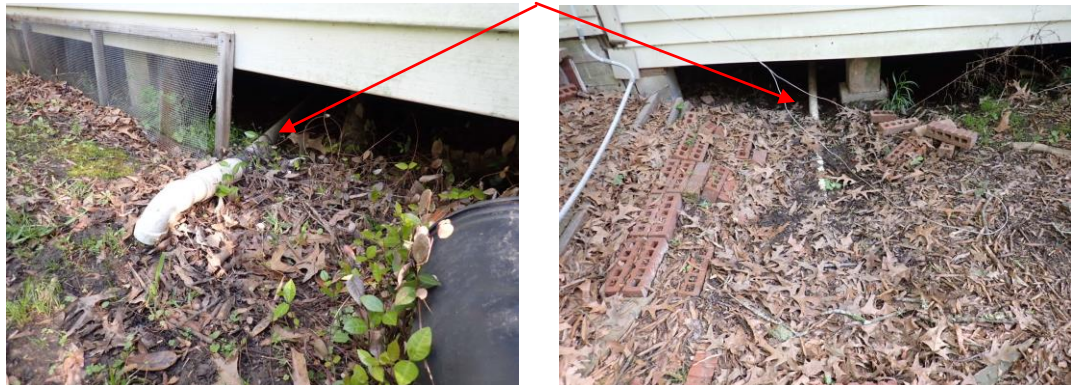
There were two drain pipes that exit the crawlspace along the left side of the house when the septic system is at the right rear. This could indicate that there is a second septic system or that the waste water is not properly disposed of. Further investigation is recommended. Contact a licensed plumber or qualified septic system inspector to assess this further.

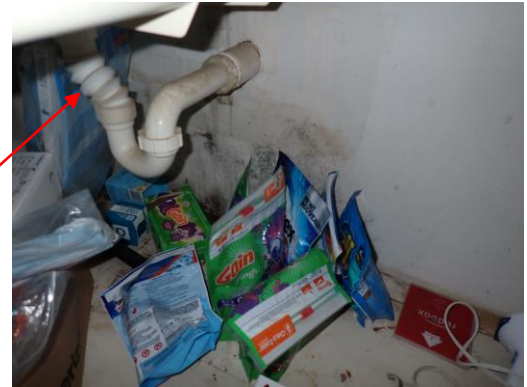
A flexible drain connector is installed at the laundry sink. This should be repaired by a professional plumber. Drainage fittings must have no ledges, shoulders or reductions which can retard or obstruct drainage flow in the piping.

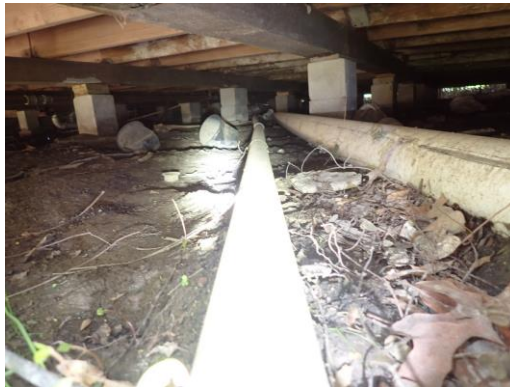
The waste piping under the home does not have sufficient slope for proper drainage. This condition should be repaired.

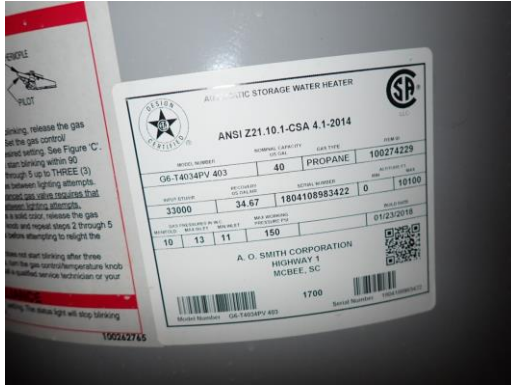
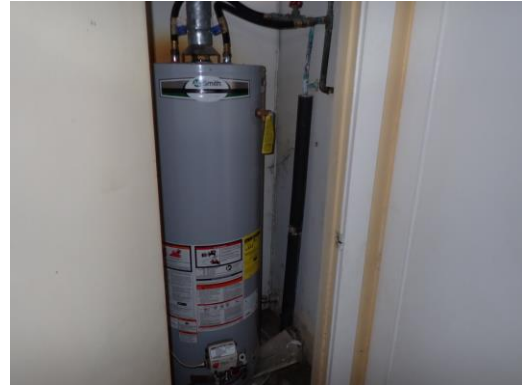
The water heater is located in the laundry room closet. The manufacturing date for water heater taken or estimated from the data plate – 2018

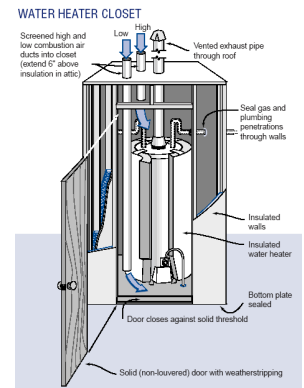
Combustion and ventilation air for the water heater is inadequate for the confined space in which it is installed. Provide intake venting according to the manufacturer’s instructions. In the event that the instruction manual is not obtainable a minimum installation should include the following: Combustion air should be provided through two openings using smooth metal pipes. One inlet pipe should be within 12” of the top of the enclosure and another within 12 “of the bottom of the enclosure. They should extend at least 6 inches above the insulation and/or joist. Be sure to secure the pipes against unwanted movement. When communicating with the attic, the pipes must have free openings equal to 1 square feet per 3,000 BTUH. (55K = 18.33, 100K = 33.33) (A 5” pipe = 20 square feet, 6” pipe = 28 square feet.)

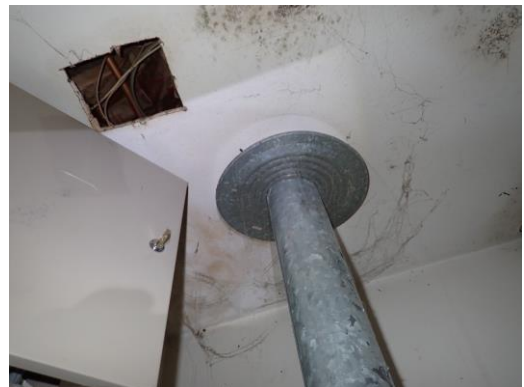
The metal fire stop collar for the water heater is not positioned against the ceiling. This creates a fire safety concern as well as an energy concern.

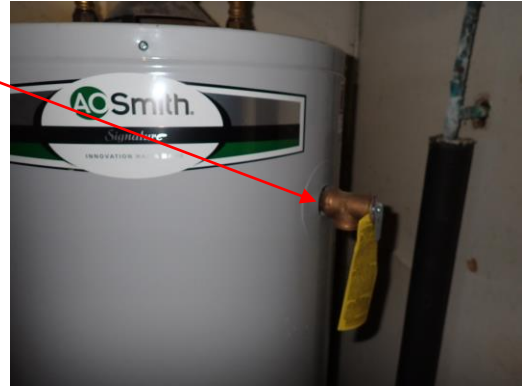
There was not a discharge pipe connected to the Temperature Pressure Relief (TPR) safety valve for the water heater. A 3/4" CPVC, Copper or other approved type of tube should be installed promptly for safety reasons. It should discharge with positive gravity slope to a termination point that is readily observable by the building occupants, in a manner that does not cause personal injury or structural damage and terminate not more than 6 inches and not less than two times the discharge pipe diameter above the ground or waste receptor flood level rim. Other rules apply. A qualified plumbing contractor should make this repair.

If it proves to be too difficult to get the discharge for the safety valve for the water heater to the exterior while maintaining adequate drainage you might consider an alternative solution, such as a WAGS .

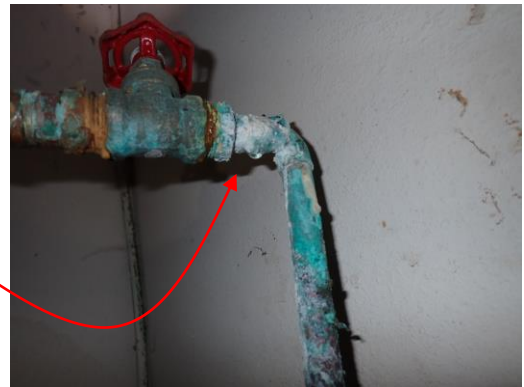
The supply piping is leaking at the shut off valve. This should be repaired right away to prevent property damage.

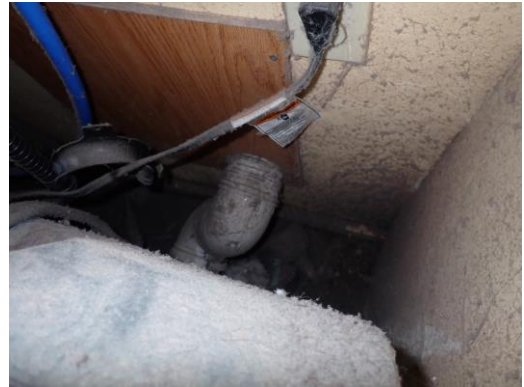
The flexible pipe for the dryer exhaust is concealed in the combustibile wall. This presents a possible hazard. This material is a recognized hazard in its current configuration. This should be replaced with an approved type of exhaust pipe for fire safety reasons.

Dryer exhaust systems should convey the moisture to the outdoors. Exhaust ducts should not be connected with sheet metal screws or fastening means which extend into the duct. Exhaust ducts should be equipped with a backdraft damper. Exhaust ducts should be constructed of rigid metal having a minimum thickness of 0.016 inches and should have smooth interior surfaces with joints running in the direction of airflow. Clothes dryer transition ducts (flex between the dryer and wall fitting) should be limited to single lengths not to exceed 8 feet in length and should be listed and labeled. Flexible transition ducts should not be concealed within construction or used anywhere except in the room to connect the dryer to the duct.
