# Home Inspection Report

3610 Ave Q Rear, Galveston , TX 77550

# PROPERTY INSPECTION REPORT

**Concerning:** 3610 Ave Q Rear, Galveston , TX 77550  
(Address or Other Identification of Inspected Property)

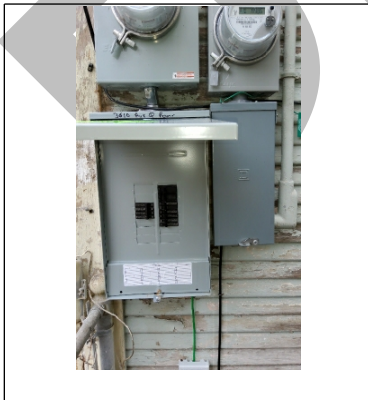
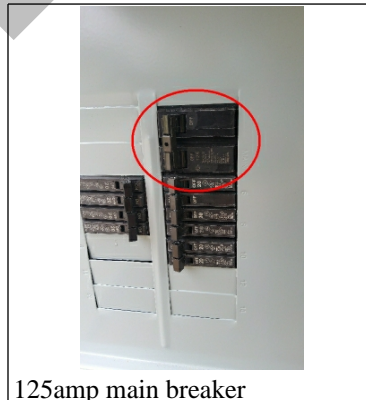
The panel box, breakers and wiring were all functioning properly on the day of the inspection. Info only there were two separate meters for each home.

125amp main breaker

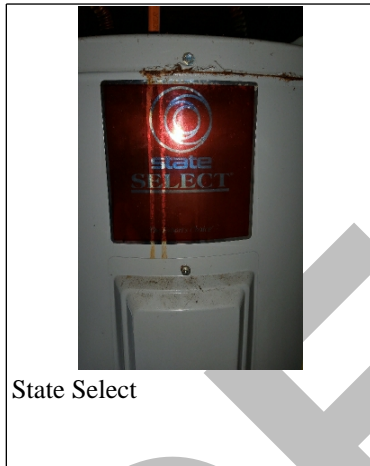
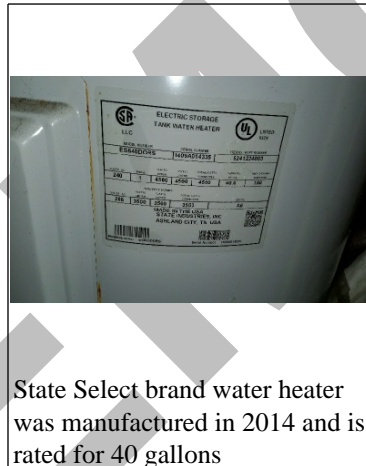
Water heaters have a typical life expectancy of 7 to 12 years. The existing unit is approaching this age range. One cannot predict with certainty when replacement will become necessary. The hot water supply line is rusting or corroding, recommend that the line be replaced by a qualified professional.

State Select brand water heater was manufactured in 2014 and is rated for 40 gallons

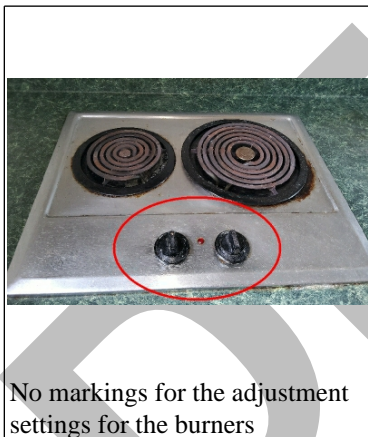
*Comments:* The small two burner rangetop was functioning properly on the day of the inspection however the setting adjustment knobs had no markings. It is recommended that the knobs be replaced so you can read the settings for the burners.
