I. STRUCTURAL SYSTEMS

According to HAR, the house was built in 1968.

II. ELECTRICAL SYSTEMS

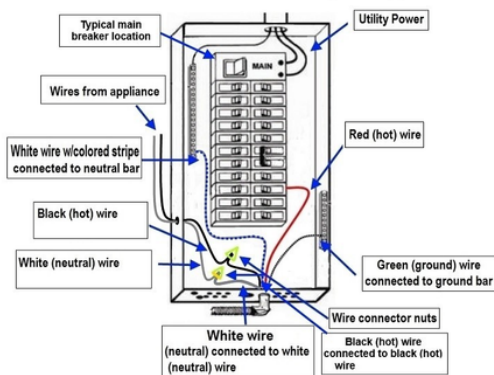
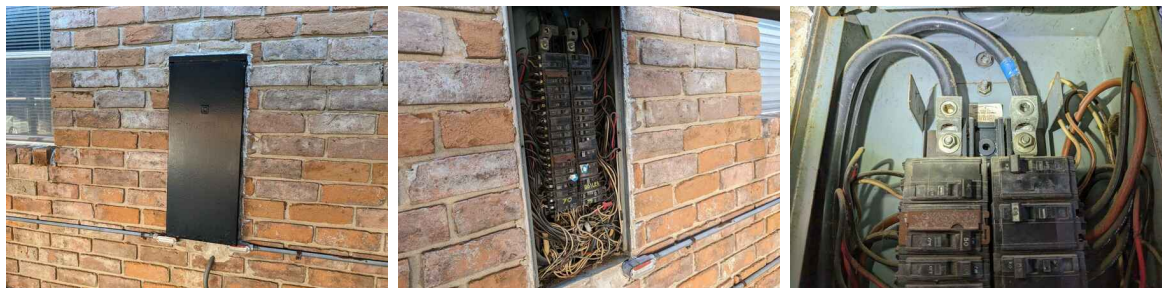
Circuit Breaker Wiring Diagram

<u>Location</u>	<u>Manufacturer</u>	<u>Rating - Amps</u>
Garage behind the house	Square D	Not visible

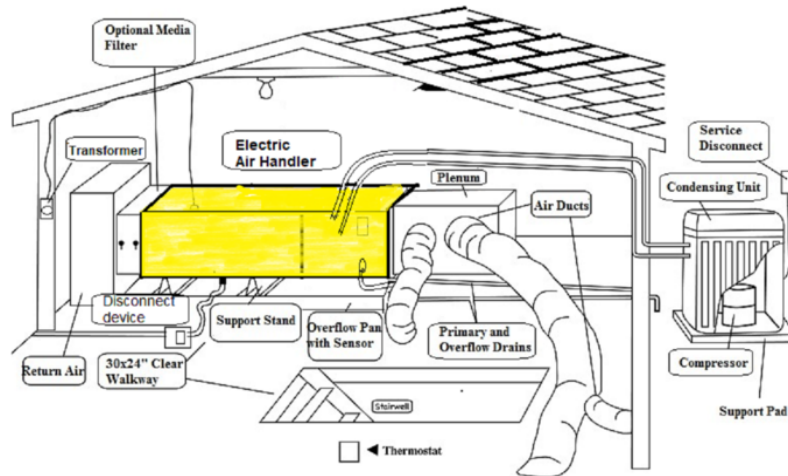
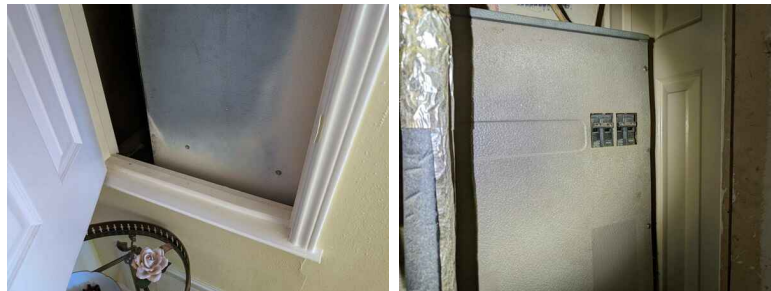
<u>ZONE</u>	<u>BRAND</u>	<u>DATE</u>	<u>LOCATION</u>
House	Goodman	1997	Hallway closet

The electric heating equipment was observed to be operating and functional at the time of the inspection. The electric heating equipment was heating the air 25+ degrees, which is adequate.

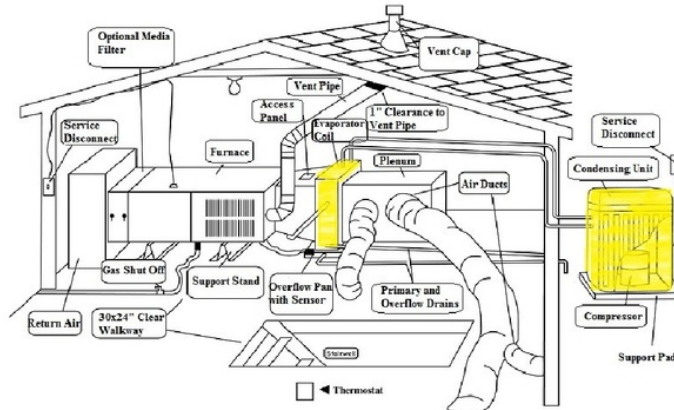
It is pointed out that the Ac was not checked at the time of the inspection and we could not determine which of the two condensing units at the rear of the house correspond to the house. Check with HOA to determine which condensing unit is correct. The following description is for the two units present.

ZONE	CONDENSING UNIT			EVAPORATOR COIL		TEMP DELTA
	BRAND	TONS	DATE	TONS	DATE	
House	Goodman	2.5 3	2002 2004	3	1997	N/A

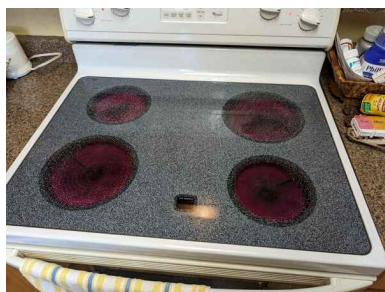
The electric oven was observed to be functioning and no items requiring repair were visible at the time of the inspection.
