**Elevation Readings  
14333 Memorial Drive #75**

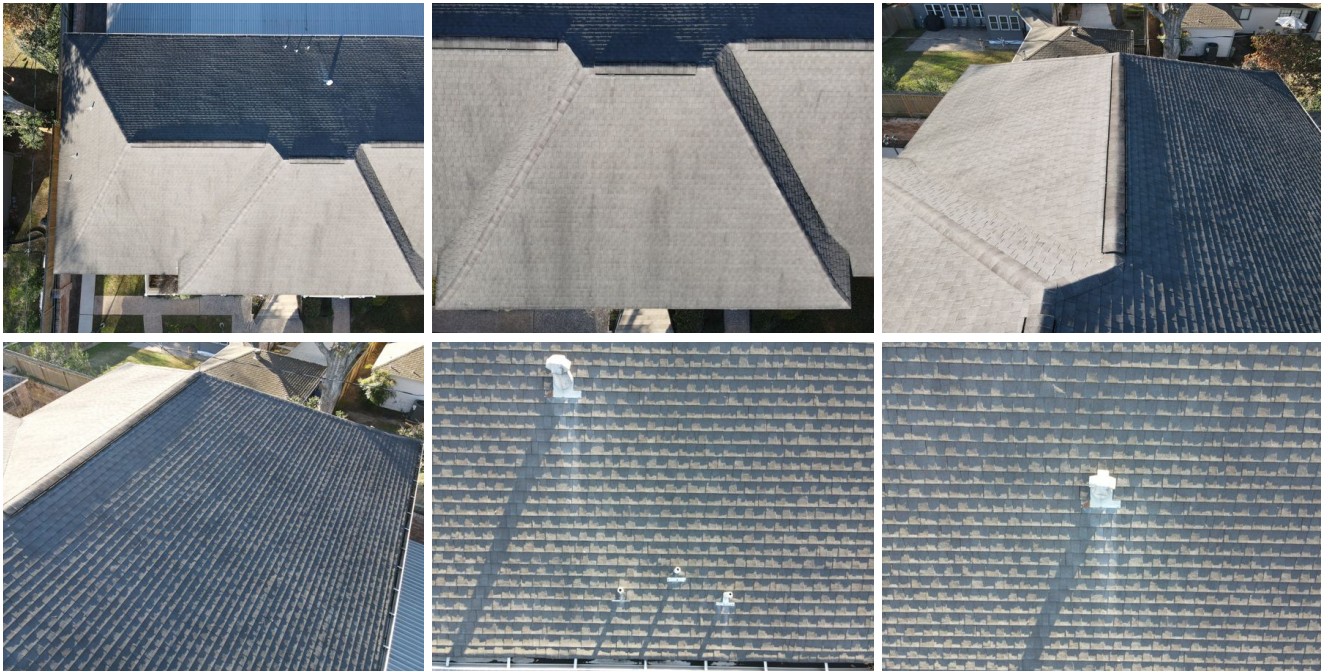
#### Roof Description: Composition Shingles

The pitched roof surface was constructed of composition shingles. The life expectancy of a composition shingle roof has been observed to vary from 15 to 20 years, with most requiring replacement at about 17-20 years.

#### Age of Roof-Estimated by Inspector: Age of Roof: 7-8 years

The seller's disclosure statement was not available at the time of the inspection, and the age of the roof was unknown to the inspector at the time of the inspection. The roof appeared to the inspector to be approximately 7-8 years old.

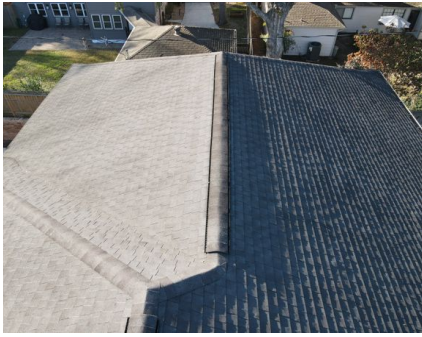
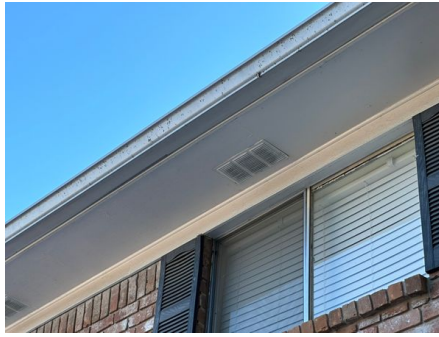
#### Roof Ventilation: Continuous ridge vents/Soffit screens

The ventilation for the attic included continuous ridge vents at the top of the roof and screens in the soffits.

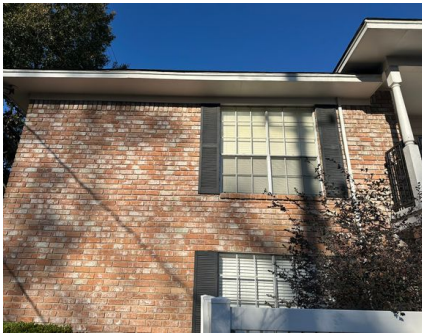
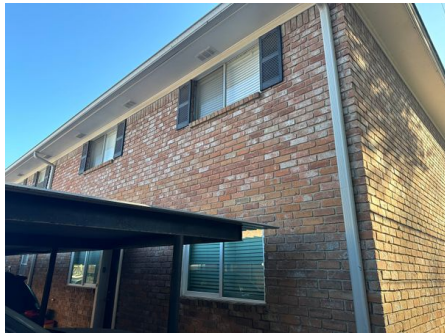
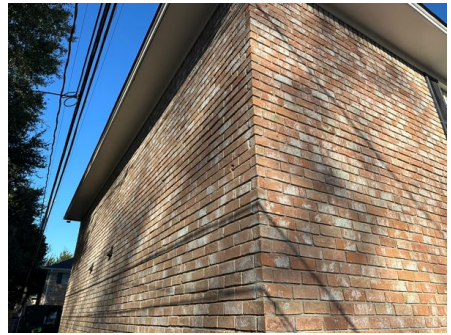
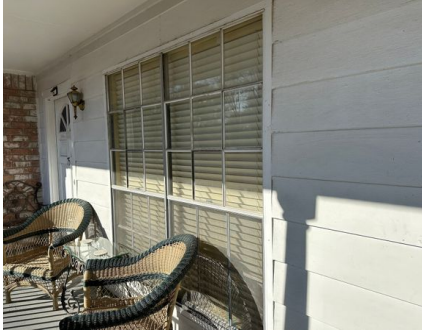
**Cladding Material: Cladding Material**

Brick Veneer, Wood
