## **PROPERTY INSPECTION REPORT**

**Report#:** 005329

**Concerning:** 1650 Rancho Grande, Houston TX 77049  
(Address or Other Identification Inspected Property)

**By:** John Bennett License# 7171 10/31/23  
(Name and License Number of Inspector) (Date)

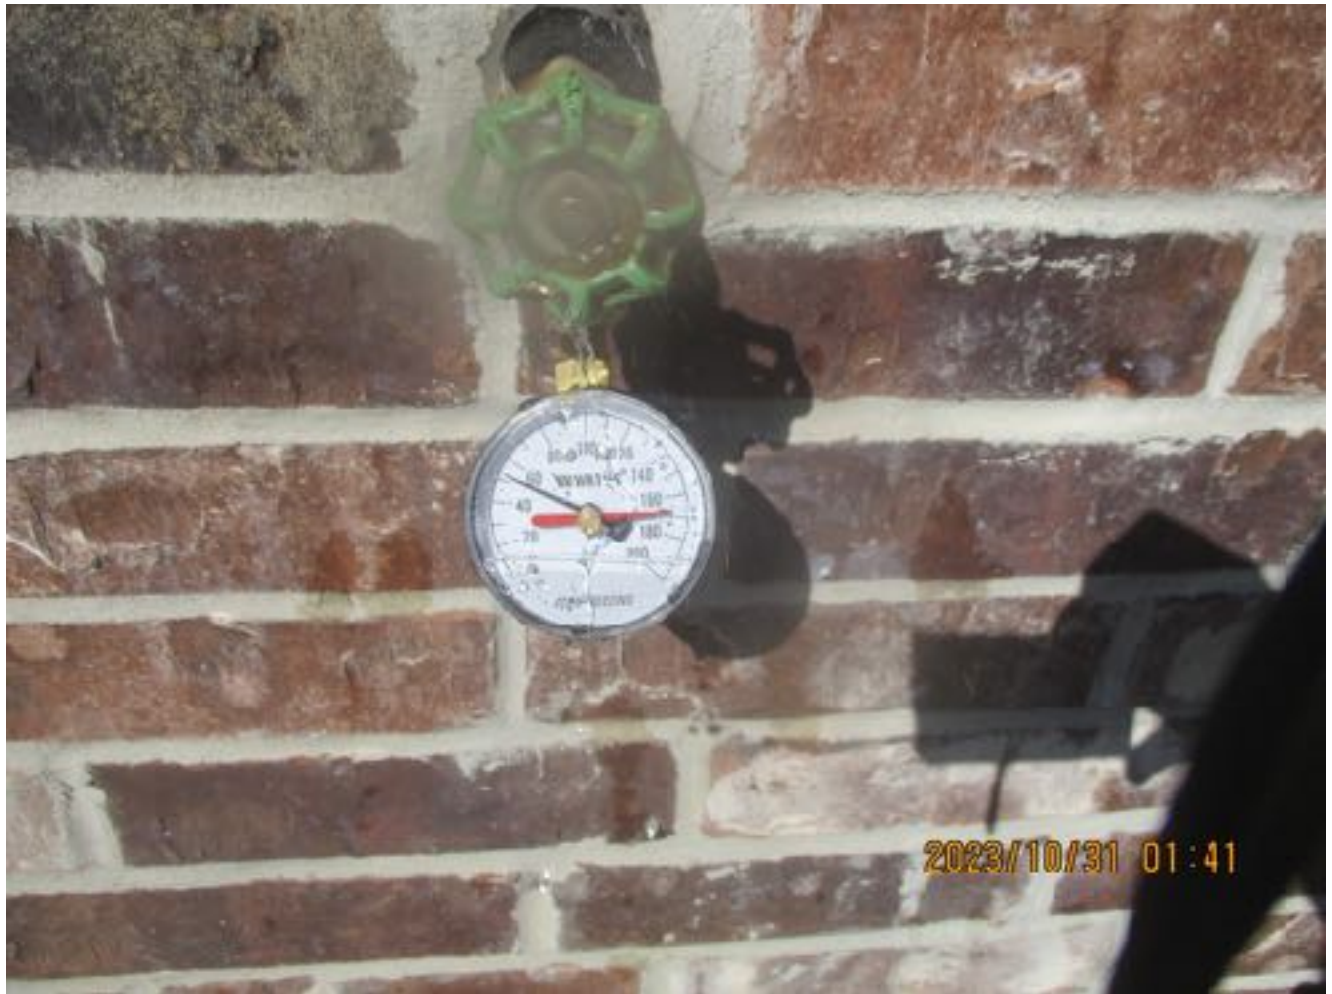
Picture 22

<input checked="" type="checkbox"/> <input type="checkbox"/> <input type="checkbox"/> <input checked="" type="checkbox"/>	<p><b>A. Plumbing Supply, Distribution System, and Fixtures</b>  <i>Location of Water Meter: Front Street</i>  <i>Location of Main Water Supply Valve: Left Exterior</i>  <i>Static Water Pressure Reading: 53 lbs</i>  <i>Type of Supply Piping Material: Plastic - Picture 21</i>  <b>Comments:</b>  <i>Exterior hose bibs were missing the anti-siphon or air gap valves that prevent cross contamination of the potable water system (Picture 22).</i></p>
---	--

11. Plumbing Supply, Distribution System, and Fixtures: Exterior hose bibs were missing the anti-siphon or air gap valves that prevent cross contamination of the potable water system (Picture 22).
