SELLER'S DISCLOSURE NOTICE

CONCERNING THE PROPERTY AT: 2808 Marble Brook Lane, Pearland, Texas 77584

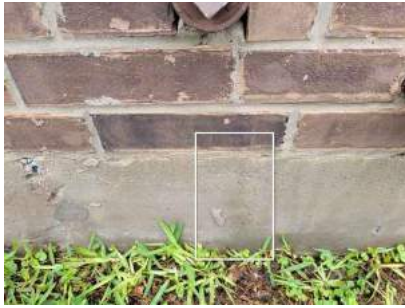
Left Side

The foundation has experienced movement as evidenced by separation/cracking in one or more of the following locations:

Slab perimeter (i.e. hairline crack(s))

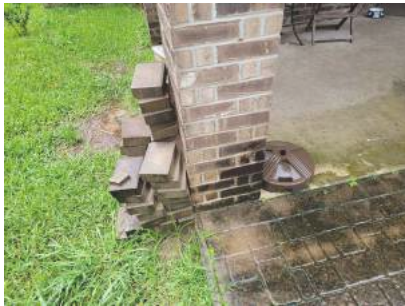
Portions of the slab perimeter was not visible due to stacked bricks and high soils.

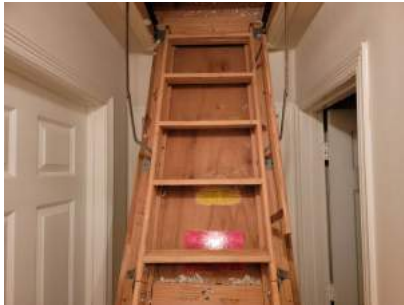
2: Ins <10"

Insulation at the attic access stairs / hatches is missing or less than the depth of insulation in the attic. Informational: Access doors from conditioned spaces to unconditioned spaces (e.g., attics) shall be weather-stripped and insulated to a level equivalent to the insulation on the surrounding surfaces. Up to 25% of the total heat gain or loss can occur at the attic access stairs, hatches and doors. IECC Section R402.2.2 & IRC Section N1102.2.4

Recommendation: Contact a qualified professional.

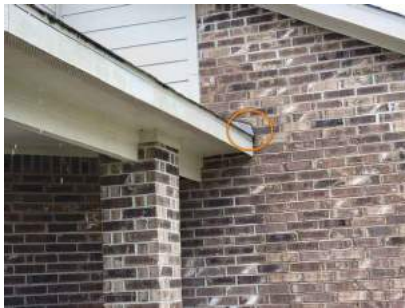
Flashing detail at the end of the masonry / vertical sidewall(s) doesn't direct water away from the sidewall. Informational: IRC R905.2.8.3

Recommendation: Contact a qualified professional.

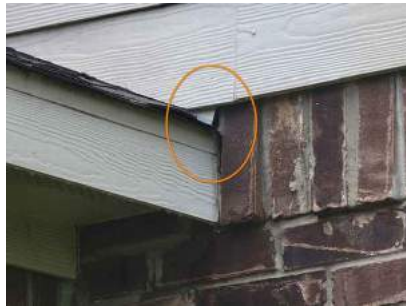
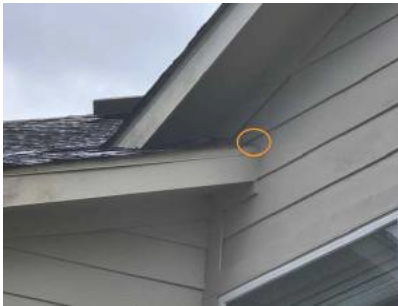
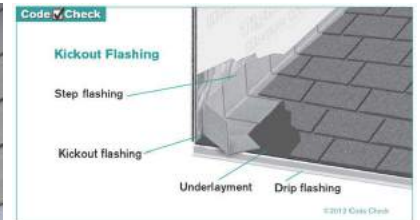
Right Side

Kickout flashing is not in use at the end of the flashing at the roof/sidewall junction(s) – per manufacturer’s installation requirements. Informational: To prevent water entry behind the siding at the end of the roof intersection, a kickout" of sufficient length and angle is intended to direct the water running down the roof away from the siding or to a gutter if present. IRC R905.2.8.3 [Plank Install](#)

Recommendation: Contact a qualified professional.

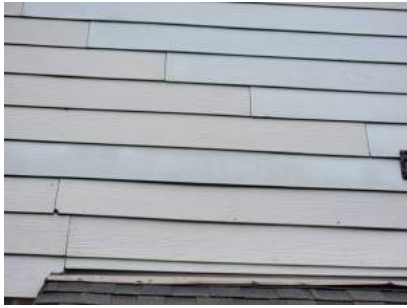
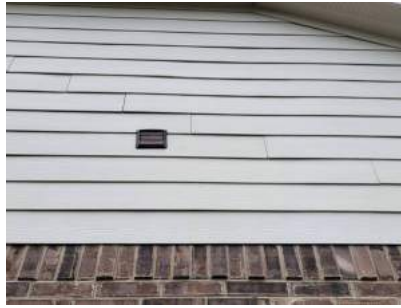
Unpainted nail heads or cement planks were noted. Informational: Painting is required per manufacturer’s installation instructions.

Recommendation: Contact a qualified professional.

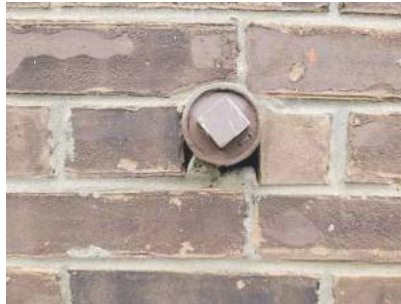
Right Side

Voids were noted at one or more locations. Informational: All exterior veneers should be properly sealed to provide a barrier against weather, insects, rodents and provide environmental control of the interior.

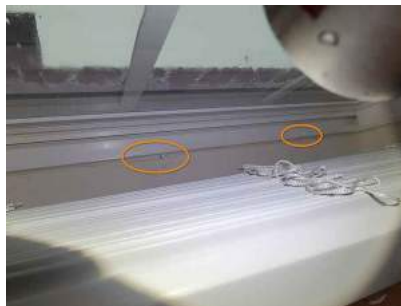
Dining room

Water came into an area above a window during a heavy rain.

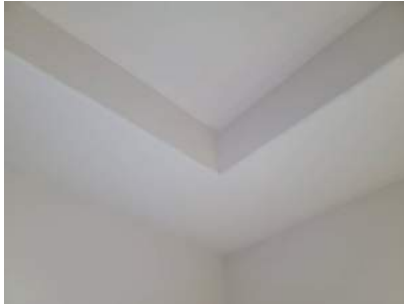
Primary Bedroom

Staining (evidence of water penetration) was noted at the ceiling. Informational: Infrared and or a non-destructive moisture meter did not indicate high levels of moisture at the time of the inspection. False negatives are possible due to lack of precipitation, direction precipitation, lack of use of plumbing, etc.

Recommendation: Contact the seller for more info

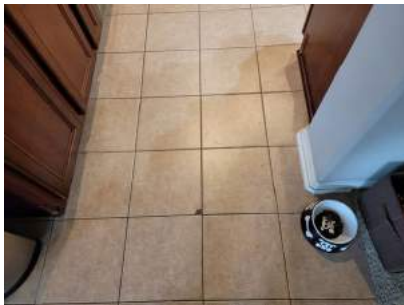
Kitchen

Broken tile was noted.

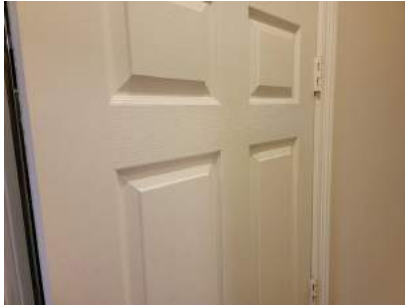
Portions of the garage entryway door are less than 1 3/8" solid core door (i.e. around panels). Informational: A data plate wasn't observed. A 1 3/8" solid core or 20 minute fire-rated type door is required. IRC R302.5.1

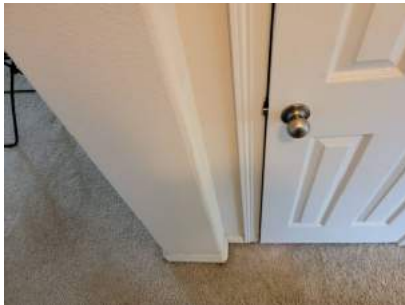
Linen Closet

Door(s) doesn't latch.

Recommendation: Contact a handyman or DIY project

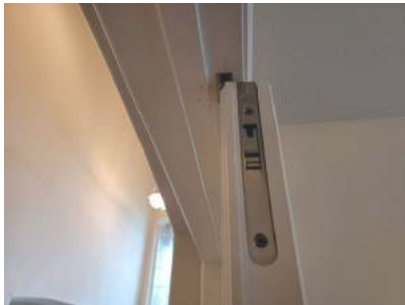
The latch is difficult to engage.

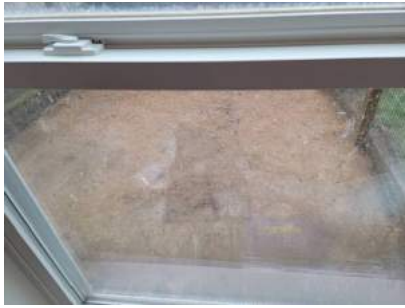
Observed damaged/missing items at one or more of the following window components:

Recommendation: Contact a qualified window repair/installation contractor.

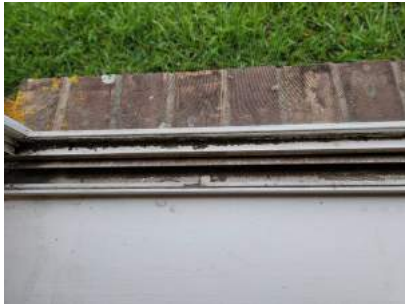
Penetrations were noted at the bottom/sill of the windows due to alarm contacts. Informational: Penetrations typically void the manufacturer's performance warranty.

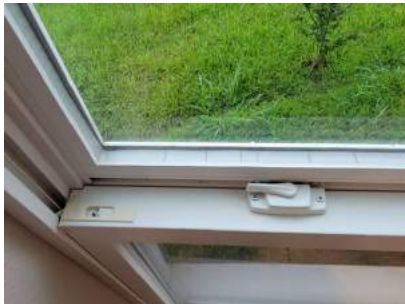
Cracks were observed at the desiccant seal between panes.

Recommendation: Contact a qualified window repair/installation contractor.

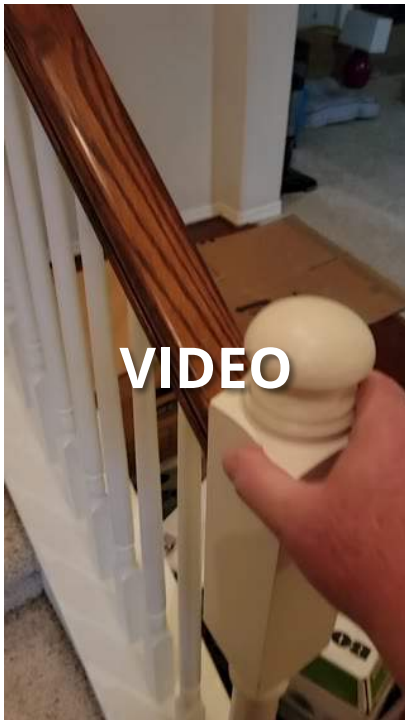
Give was noted at the handrail(s) and or railing(s) when pushed from side to side. Informational: The amount of live load placed was less than noted in the code requirements of 200 lbs. side to side. IRC R 301.5

Recommendation: Contact a qualified professional.

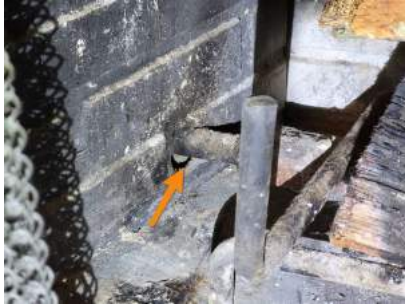
Gap was observed between the gas supply pipe and firebox. Informational: Most manufacturers require this to be filled with either a high temperature caulk or unfaced fiberglass insulation.

Recommendation: Contact a qualified fireplace contractor.

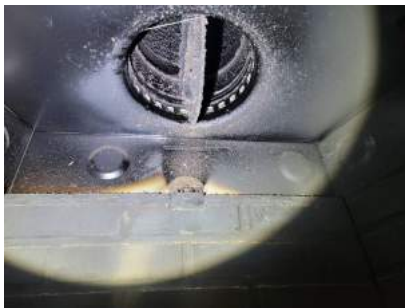
Observed soot buildup at visible portions of the flue and fireplace. Informational: Recommend cleaning by a qualified chimney sweep. Annual cleaning is recommended for the fireplace depending upon usage.

Recommendation: Contact a qualified chimney sweep.

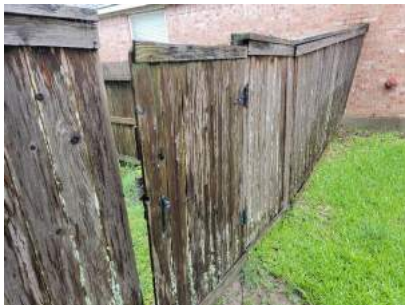
The gate only partially opens.

Recommendation: Contact a qualified fencing contractor

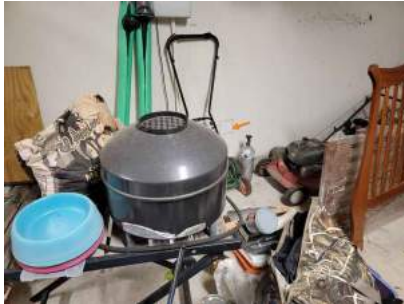
A concrete encased electrode (CEE or Ufer ground) is installed (behind access plate at the garage interior). Informational: If the concrete is placed with a vapor barriers or similar items separating the concrete from the earth it is not considered to be in "direct contact" with the earth. Where concrete encased electrodes are installed, areas near the home if struck by lightning may cause a hazard (property and/or person(s). Although this item has been a National Electrical Code requirement for a number of years, it has now been better clarified (NEC 2011 Section 250.52 & 250.53) that it should not be installed where a moisture barrier is used with the foundation and also in the IRC 2006 IRC E3508.1.2 Many municipalities require a concrete encased electrode. When two ground rods are installed or the resistance value is 25 ohms or less, it is not required to be verified by the electrician installing the rods. Informational: If a single rod is installed, (without a supplemental rod) it becomes the duty of the installing Electrician, to measure and certify the resistance value of the rod to be 25 ohms or less, as required by the National Electrical Code and IRC E3608.4

Recommendation: Contact a qualified electrical contractor.

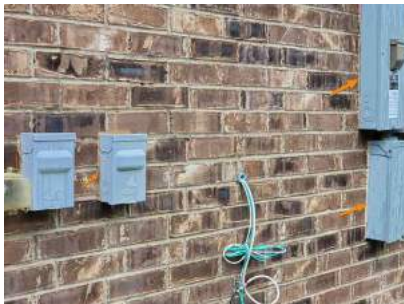
Panelboards, service disconnect(s) are sealed at the wall. Informational: Sealing is generally not recommended at the service disconnects, around the can for the electrical meter and panel boards to allow for heat dissipation.

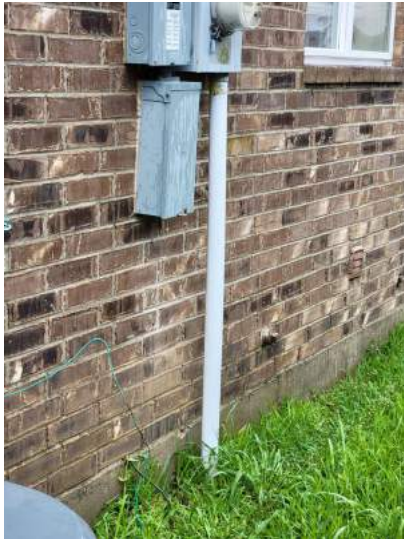
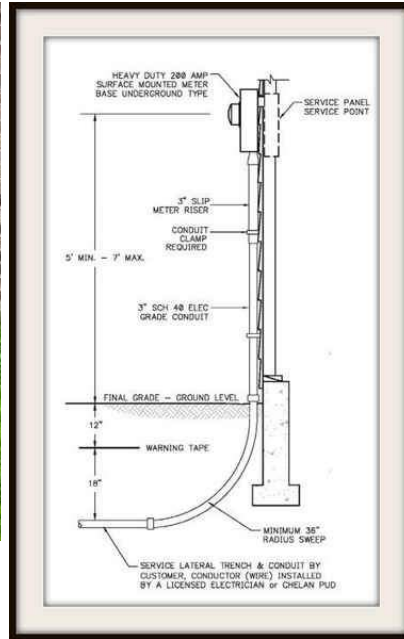
The conduit for the underground service doesn't have a slip joint to allow for movement of the foundation. Informational: Where direct-buried conductors, raceways, or cables are subject to movement by settlement or frost, direct-buried conductors, raceways, or cables shall be arranged so as to prevent damage to the enclosed conductors or to equipment connected to the raceways. NEC 300.5

Recommendation: Contact a qualified electrical contractor.

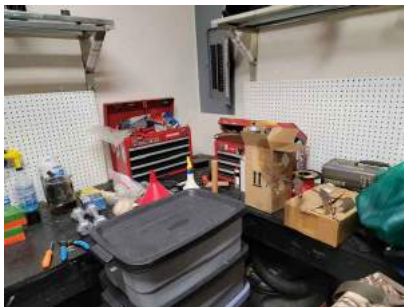
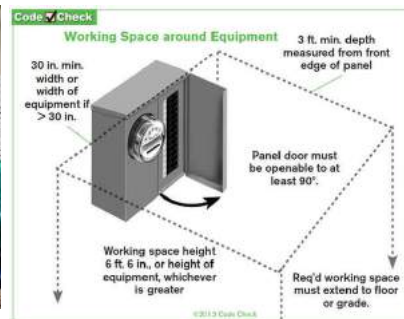
The working space and clearances requirements aren't meet. Informational: Clearance requirements are 36" in front and 30" in width maintained to a height of 6' 6". IRC E3405.1

Recommendation: Contact a qualified professional.

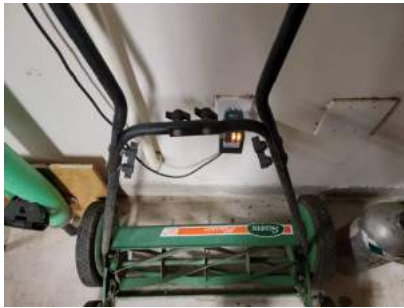
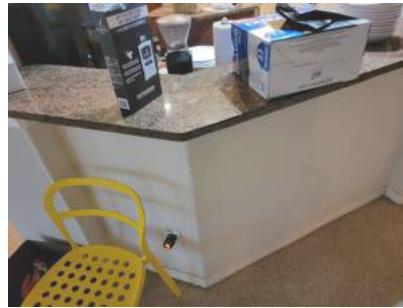
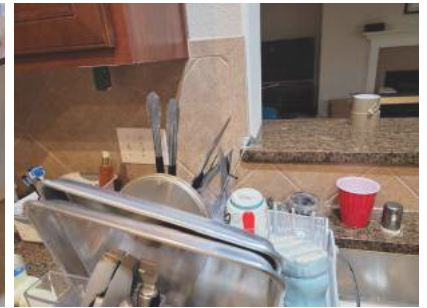
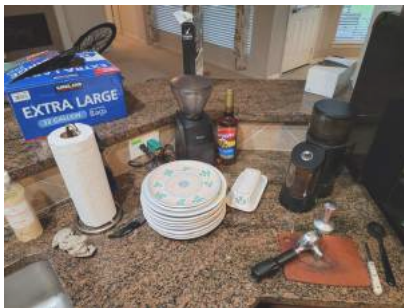
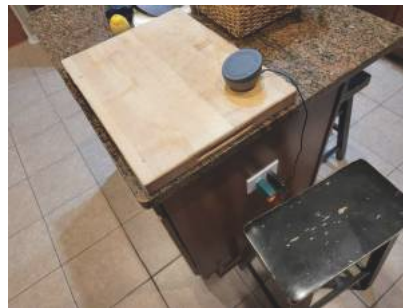
Missing ground fault circuit interrupters (GFCI) noted. Informational: This is an important safety feature that provides protection by shutting off current to the circuit. Ground fault protection is required at kitchen countertops, bathrooms, garage, exterior receptacles, utility rooms, within 6' of a sink, etc. Please note that these requirements have changed since their inception and will likely change in the next code cycle. IRC Section E3902 and NEC Chapter 210.8(A) (1) through (10) 09/2014. Find out more here: [GFCI / TR](#)

Recommendation: Contact a qualified electrical contractor.

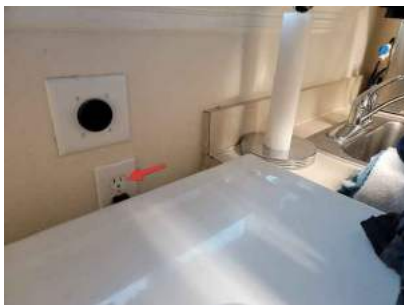
Utility room

Ground fault circuit interrupters (GFCI) are not provided at portions of the garage (overhead light fixture), under kitchen sink and 15 / 20 amp receptacles in the laundry room. Informational: This is an important safety feature that provides protection by shutting off current to the circuit. Ground fault protection currently required by the NEC Chapter 210.8(A) (1) through (10) 09/2014. Find out more here: [GFCI / TR](#)

Recommendation: Contact a qualified electrical contractor.

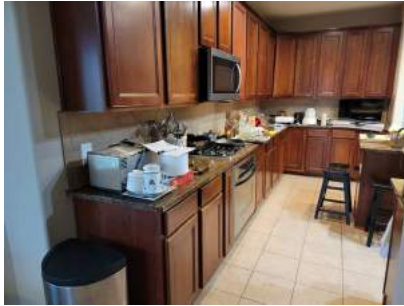
Kitchen

GFCI was tripped somewhere serving a kitchen circuit but the reset was not located.

Recommendation: Contact a qualified electrical contractor.

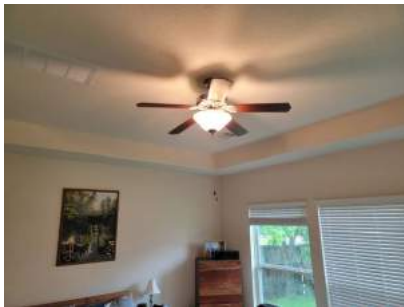
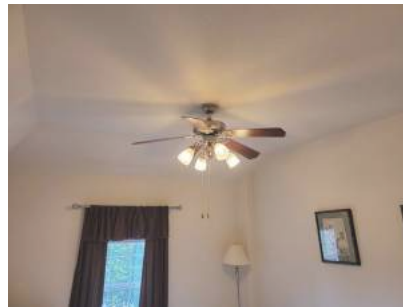
The ceiling fan is inoperable and or the remote if any wasn't located.

Recommendation: Contact a qualified professional.

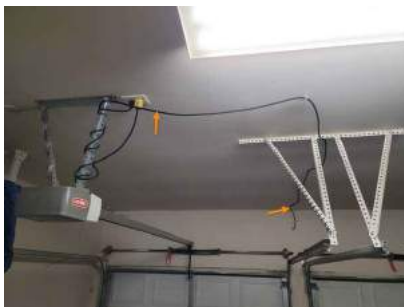
Garage

Extensions cords are not designed for permanent use or to pass through a wall. Informational: Extension cords are for temporary use only.

Recommendation: Contact a qualified electrical contractor.

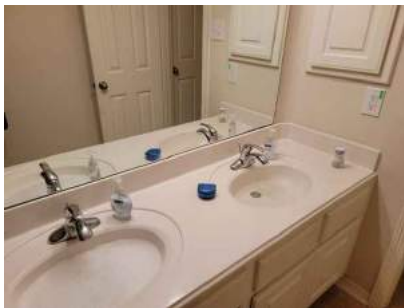
Rear Hall Bathroom Upstairs

Convenience receptacle isn't provided within 3' from the edge of a sink. Informational: IRC E3801.6

Recommendation: Contact a qualified electrical contractor.

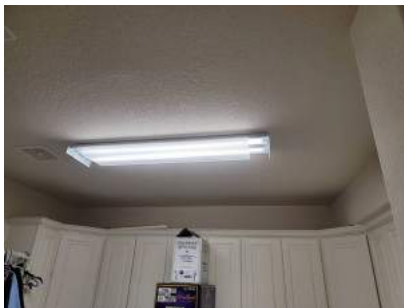
Utility room

Cover is damaged.

Recommendation: Contact a qualified electrical contractor.

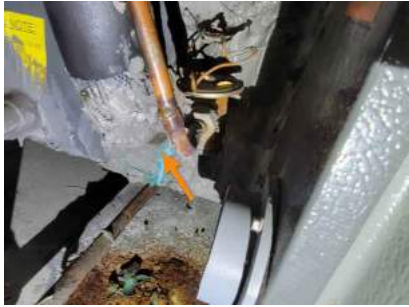
Rust and corrosion was observed at the emergency overflow drain pan(s). Informational: Pans that are rusted out can allow water into the dwelling causing damage.

Recommendation: Contact a qualified heating and cooling contractor

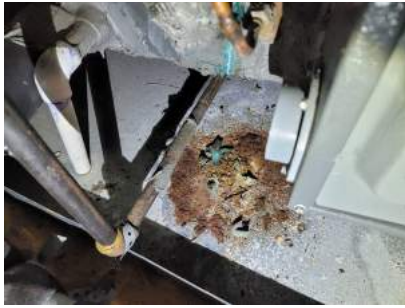
Water was observed in one of the emergency overflow drain pans.

Recommendation: Contact a qualified heating and cooling contractor

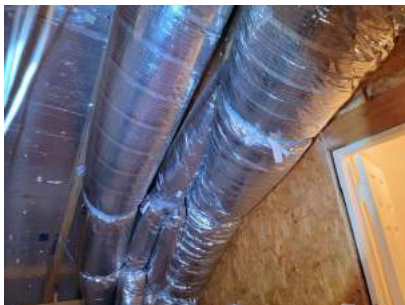
The A/C supply ducts are in contact with one another in the attic. Informational: Contact can cause condensation between the ducts. The ducts should be separated.

Recommendation: Contact a qualified heating and cooling contractor

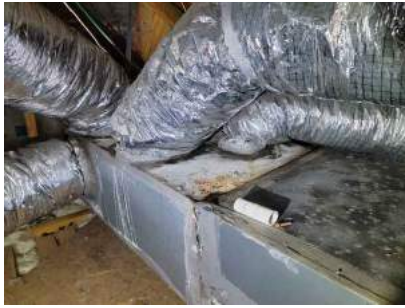
2: Streaks Plenum

Rust and corrosion including discoloration/possible microbiological growth at the exterior of a supply plenum. Informational: Condensation is possible if the insulation is missing or inadequate at the interior of the plenum / ducts and or the A/C is operated at a low temperature.

Recommendation: Contact a qualified heating and cooling contractor

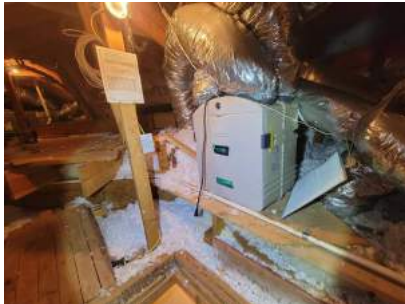
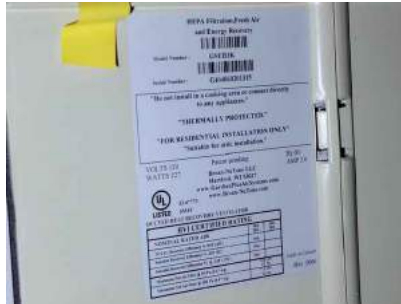
The HEPA filter and Fresh Air / Energy recovery system was unplugged without an adequate platform in place in front of the unit.

Recommendation: Contact a qualified heating and cooling contractor

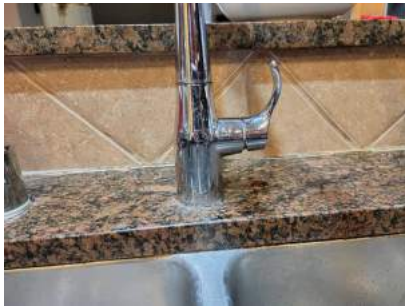
2: C-UnderM Sink

Voids were observed in the caulking detail at the undermount sink(s). Informational: IRC P2701.1

Recommendation: Contact a qualified professional.

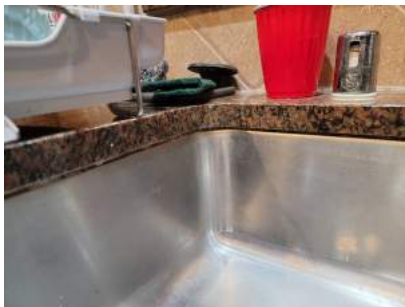
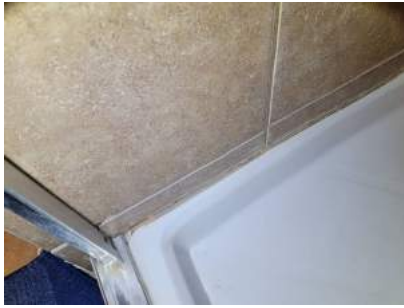
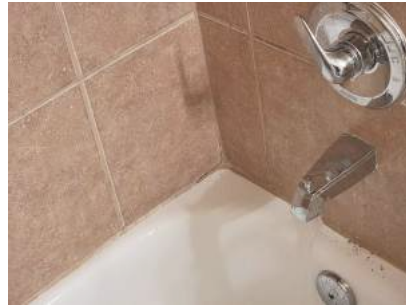
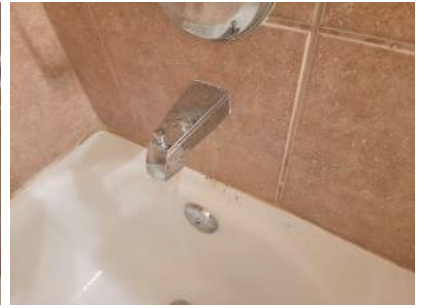
3: G&C - T/S

Cracks / voids were observed at the caulking details at the tub / shower enclosure. Informational: Prolonged water penetration can affect the underlying materials.

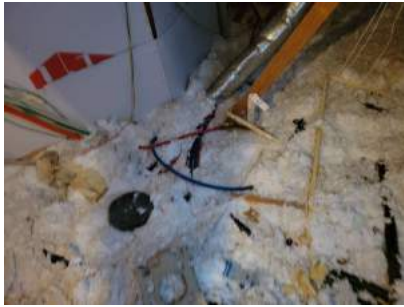
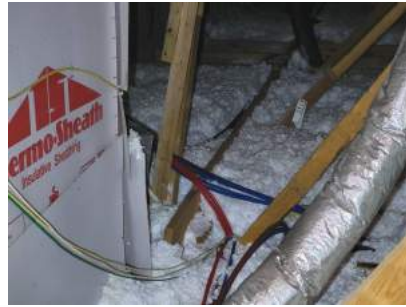
4: HB 1-Way + INS+

Missing insulation was observed at the hose bibs (outside faucets) and supply piping.

Recommendation: Recommended DIY Project

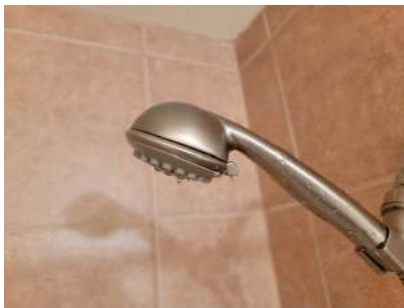
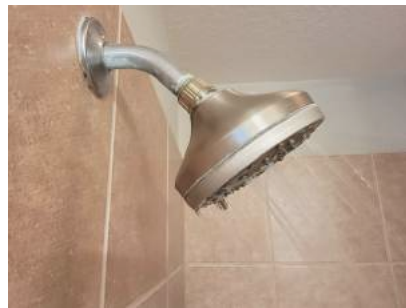
5: Leak Fixture +

Leak was noted at a fixture and or showerhead connection.

Recommendation: Recommended DIY Project

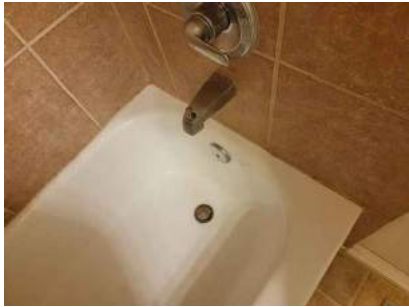
The tub stopper doesn't close.

Recommendation: Contact a qualified plumbing contractor.

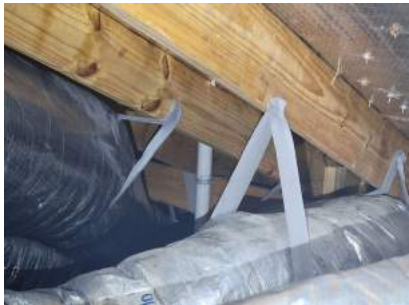
2: Metal

Metal strap is not allowed to secure PVC piping.

Recommendation: Contact a qualified plumbing contractor.

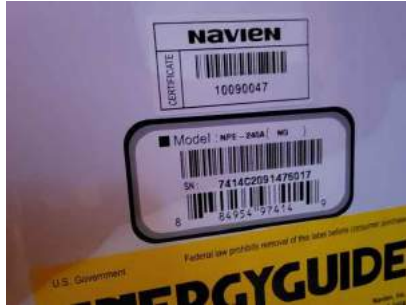
1: Maint Tankless

Records weren't observed concerning maintenance. The client is urged to contact the seller to see if it has been performed. Informational: The unit should be descaled every year or per manufacturer's installation instructions. Cleaning procedure: [Clean Procedure](#)

Recommendation: Contact a qualified plumbing contractor.

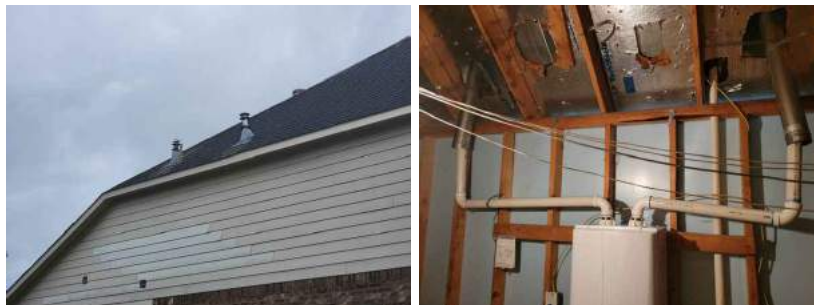
The flue has been termination into possible existing flue vents. It is unknown if these termination and apparent lack of support are allowed by the manufacturer. I would recommend contacting a plumber that installed tankless water heaters or the manufacturers representative.

Recommendation: Contact a qualified plumbing contractor.

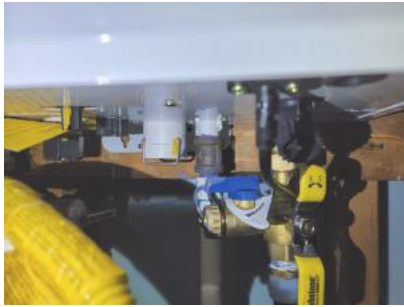
4: Condensate Loop

A straight drain line was noted and not a condensate loop as indicated in the installation instructions.

Recommendation: Contact a qualified plumbing contractor.

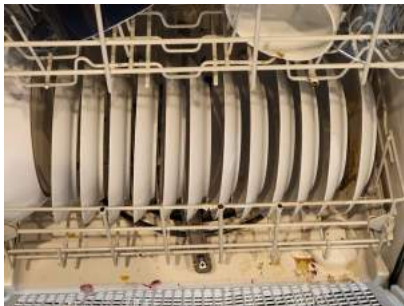
1: Rust Racks

Rust was noted on the dishwasher rack(s) and or including the tip of the prongs. Informational: TREC reporting requirement.

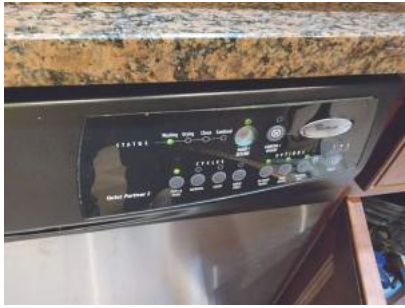
2: Cover

The cover is damaged.

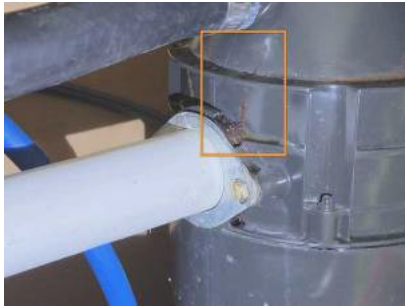
Rust and corrosion was observed and a crack was noted at the exterior of the unit.

Recommendation: Contact a qualified plumbing contractor.

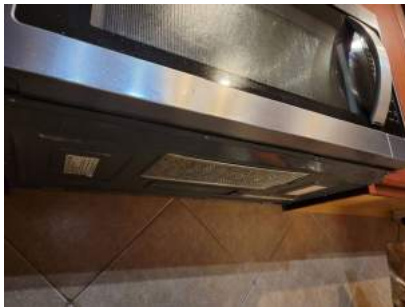
Grease was observed and the filter(s) and/or range hood requires cleaning. Informational: Grease is a combustible material.

Recommendation: Contact a qualified cleaning service.

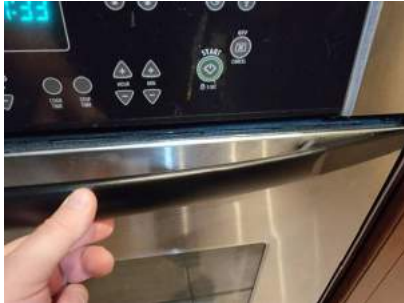
2: Loose Handle

The oven door handle is loose.

Recommendation: Contact a qualified professional.

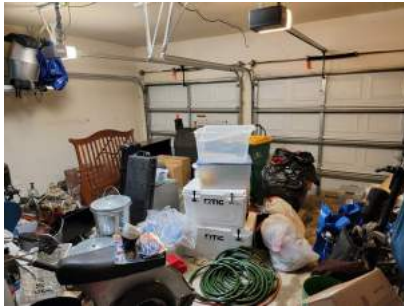
1: 2 High

The garage door operator(s) worked (right side wasn't tested due to access), however; the safety reverse sensor(s) are installed too high. Informational: The sensors should be installed to a maximum height of 6" or less and / or per manufacturer's requirements.

Recommendation: Contact a qualified garage door contractor.

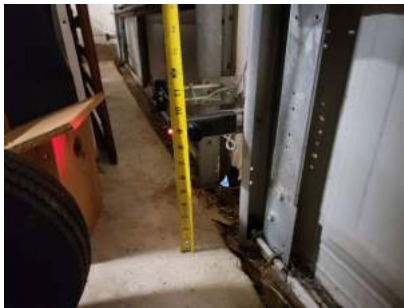
2: Block Lock

The lock isn't block. Informational: When garage door operator(s) are present the lock should be blocked.

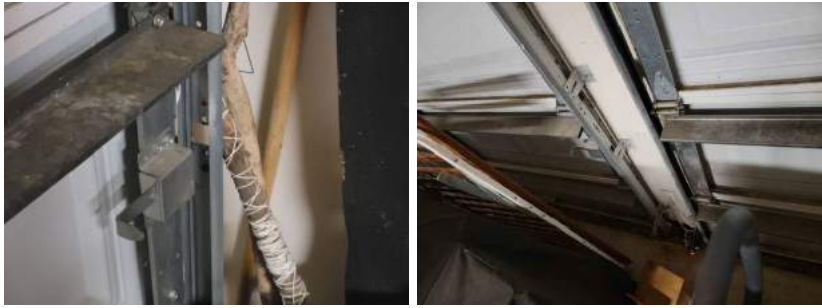
3: Handle

Handle is missing on the emergency release.

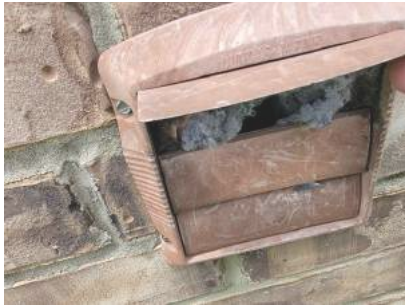
Cleaning of the backdraft damper is required. Informational: Periodic cleaning of the dryer vent to remove lint (combustible material) is recommended.

Recommendation: Contact a qualified HVAC professional.
