PROPERTY INSPECTION REPORT FORM

Salvador Garc	03/19/2024
<i>Name of client</i>	<i>Date of Inspection</i>
16918 Hall Sheperd Rd, Houston, TX 77049	
<i>Address of Inspected Property</i>	
Felix D. Angel	20185
<i>Name of Inspector</i>	<i>TREC License #:</i>
N/A	N/A
<i>Name of Sponsor (If applicable)</i>	<i>TREC License #:</i>

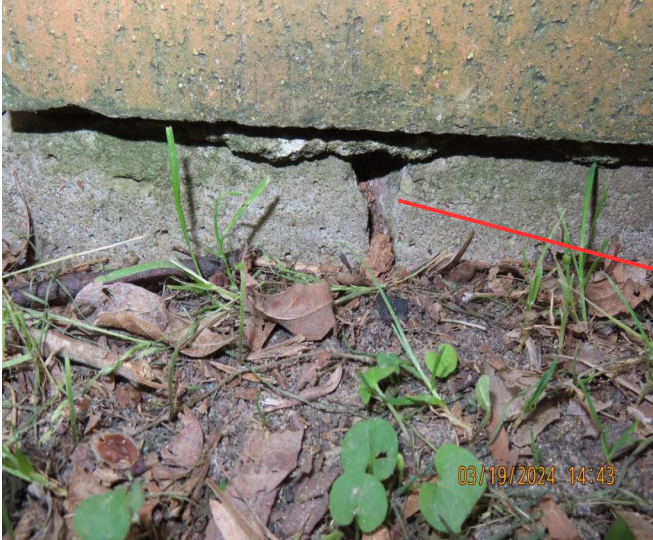
- There were cracks on multiple sides of the foundation slab and multiple settlement repairs on the exterior walls . These may be the reason for foundation repair. Recommend further investigation. Note: you have the option to consult with a structural engineer for further evaluation of the foundation slab and determine on corrective actions to be taken at this time (if any). samples

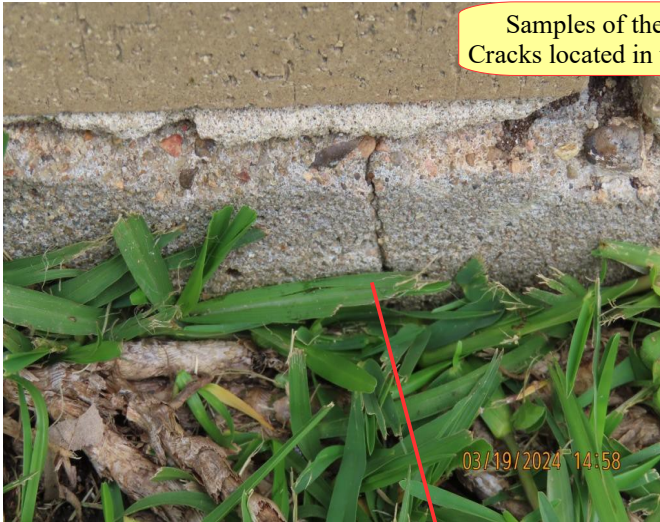
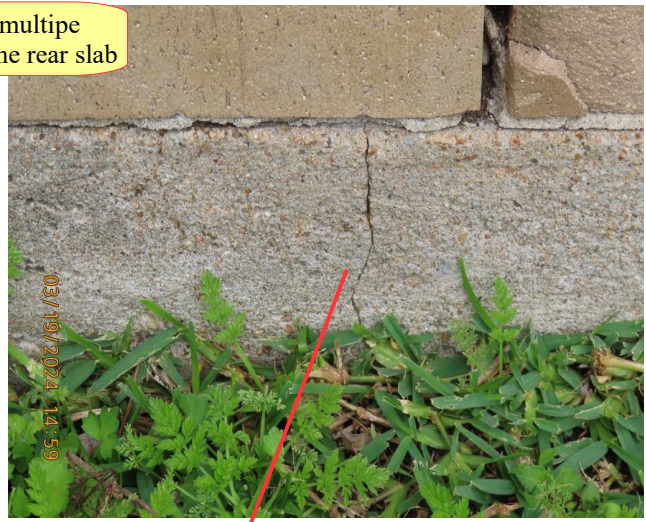
Samples of the multiple Cracks located in the rear slab

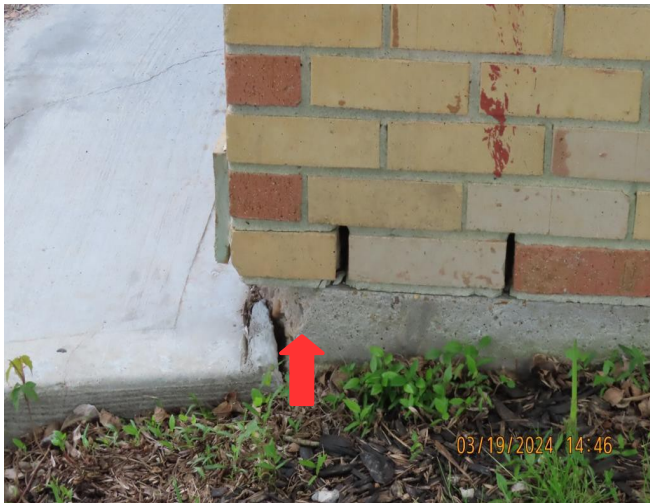
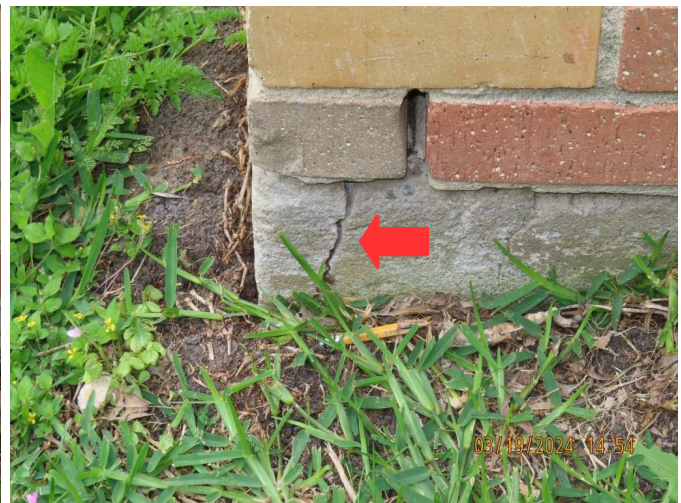
- Noted spalling on multiple corners.
Note: This usually is caused by thermal expansion of the brick wall and a typical tight connection connecting the brick and concrete surface. The brick will expand in the hot weather and will put forth a force adequate to shear the corner from the foundation. This is quite common and is not to be considered a structural defect. If concerned, consult a structural engineer for a second opinion. Recommend to properly seal gaps to avoid any further damage and deter the possible entrance of bugs, etc

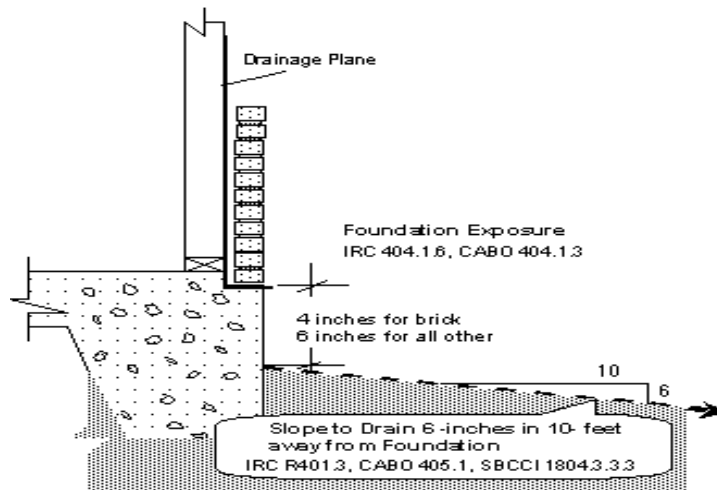
- Soil overall is of reverse grade (low spots, negative slope, etc), creating vulnerability to the accumulation of standing water at the foundation wall, a condition known to be a factor in foundation failure. Re-grading is required for a more positive drainage

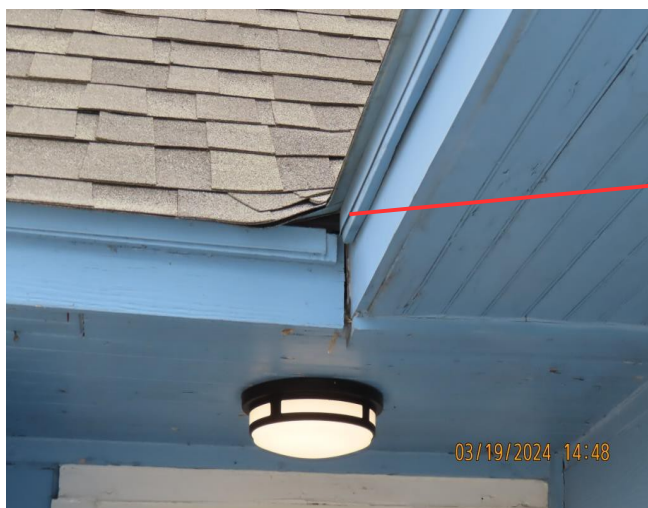
- Properly repair lifting shingles on the front valley and lifted flashing on the rear left overhang to prevent further deterioration and possible water intrusion

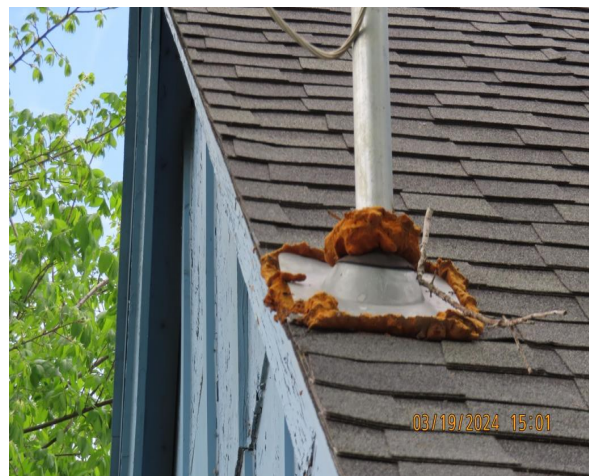
- Siding board is in contact with roof surface. There should be a 1.0” clearance. In need of repair
- Recommend replacement of foam sealant (absorbent material) on the mast for an approved and more effective type of sealant to prevent water infiltration

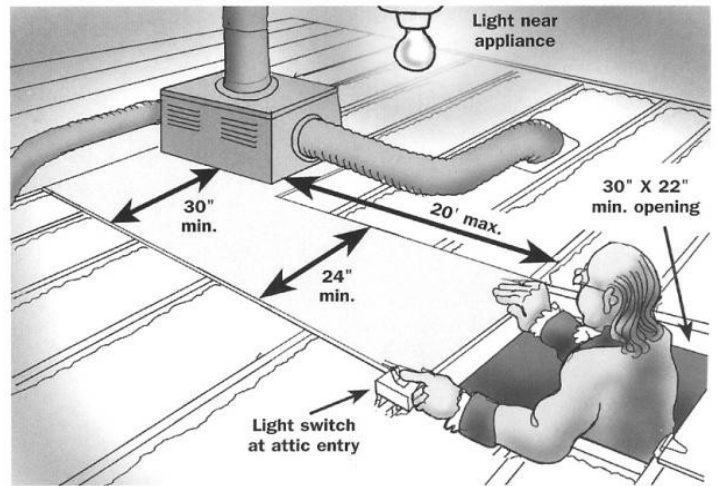
Fig. 4 • ATTIC FURNACE

- Inadequate/missing attic walkway/platform to mechanical equipment and or attic space (unsafe condition). Standards require 30" head clearance and a minimum of 24" wide solid, (No gaps or obstructions) . In need of proper repair for personal safety

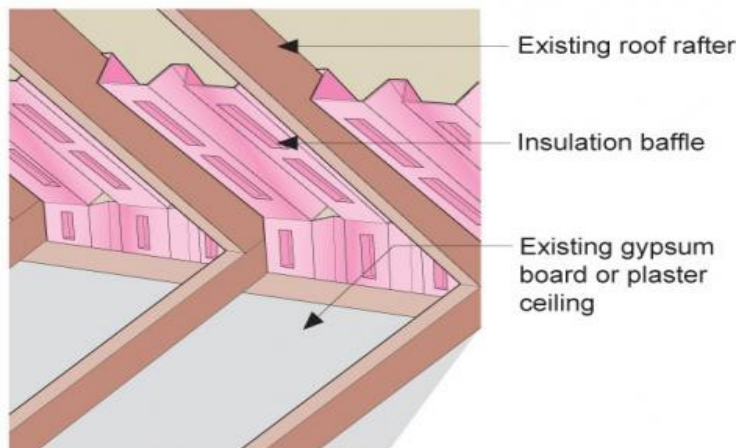
- Baffles were not evident. **Note:** Baffles provide a channel for air to flow through certain parts of the attic drawing air from outside. Install for proper attic ventilation

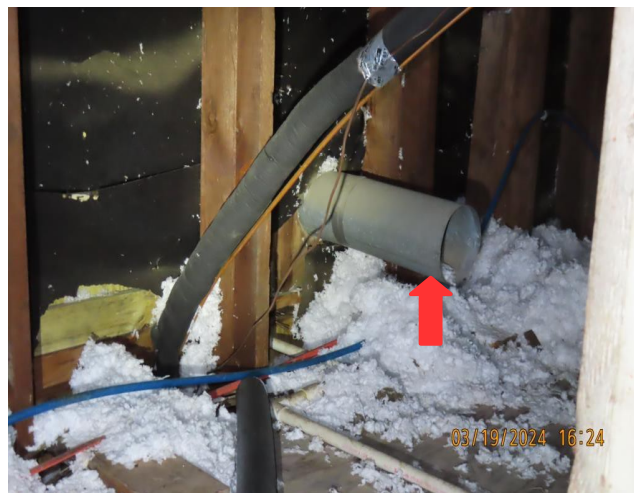
- Observed what appeared to be a section of an appliance vent venting toward the right side of the house. Investigate existing functionality. Repair as needed

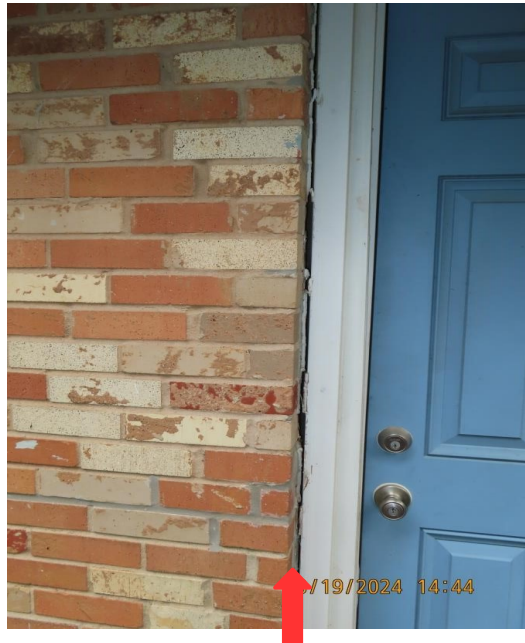
- Wall/door separation observed on the right garage exterior door. This is possibly associated with the previous or existing foundation issue. Investigate further seal gaps to prevent water infiltration

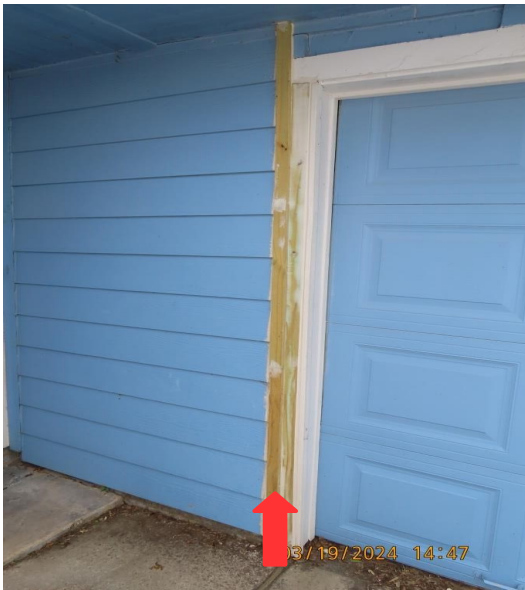
- Evidence of frame repair on left side of the garage door
- Noted what appeared to be microbial growth on the right side of the garage. Thoroughly investigate root cause and conduct proper repair to avoid further siding/frame deterioration

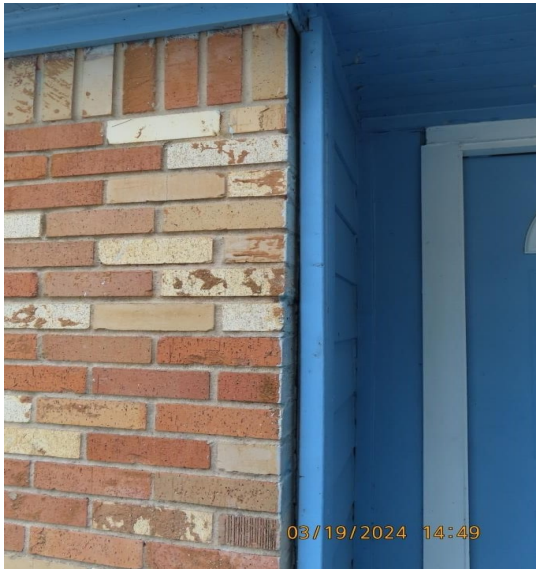
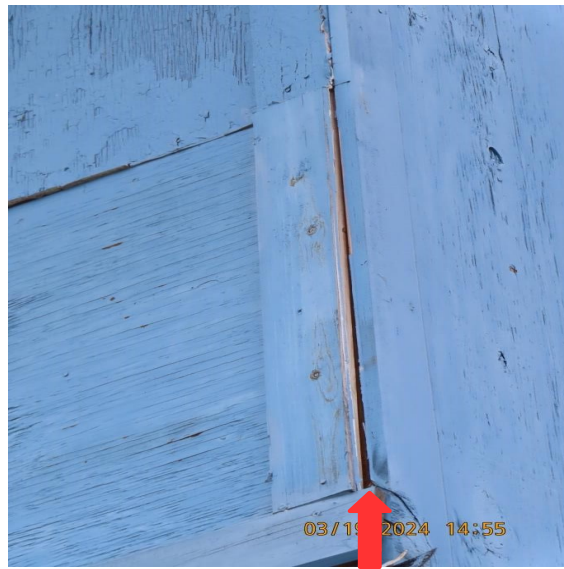
- Seal all gaps on the exterior to prevent water intrusion

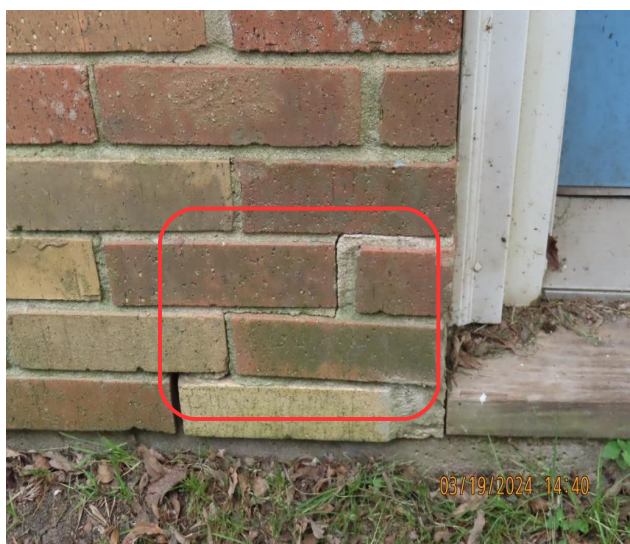
- Additional settlement cracks . Refer to “Section A” (Foundation) for corrective action details

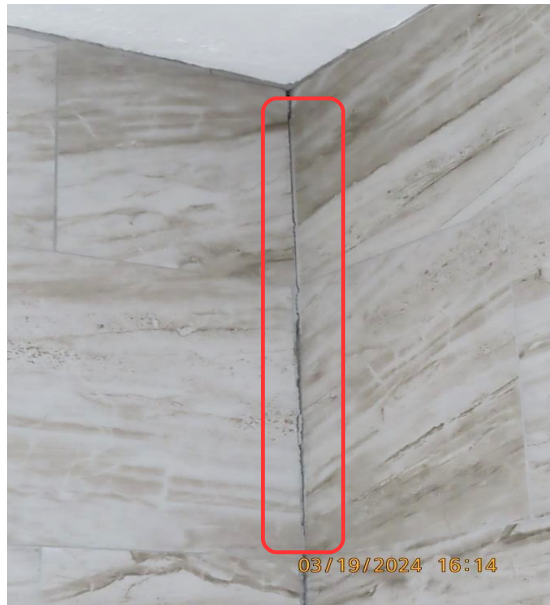
- Properly seal cracks/replace deteriorated grouts on shower enclosures to prevent water infiltration

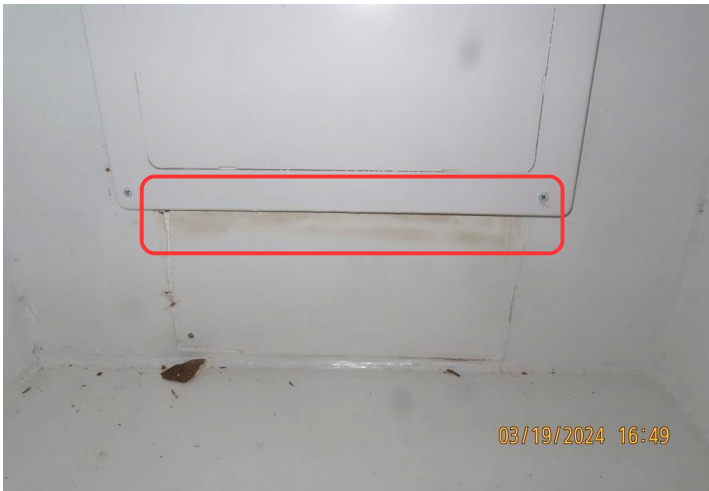
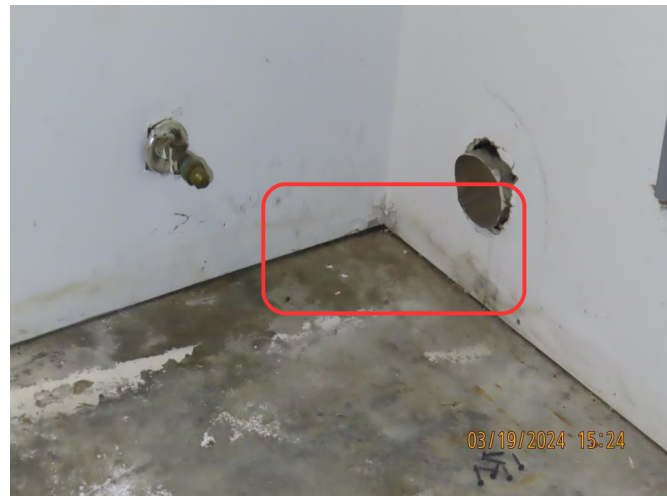
- Noted discoloration underneath one of the plumbing access. Investigate root cause and repair as needed
- Evidence of water damage in the utility room. Investigate root cause and conduct proper repairs

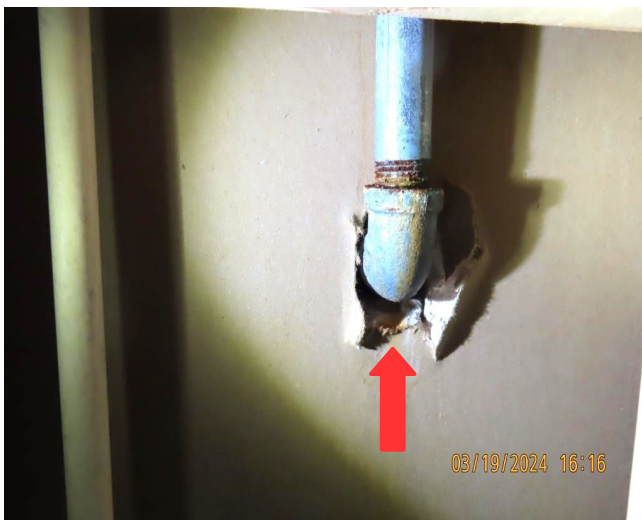
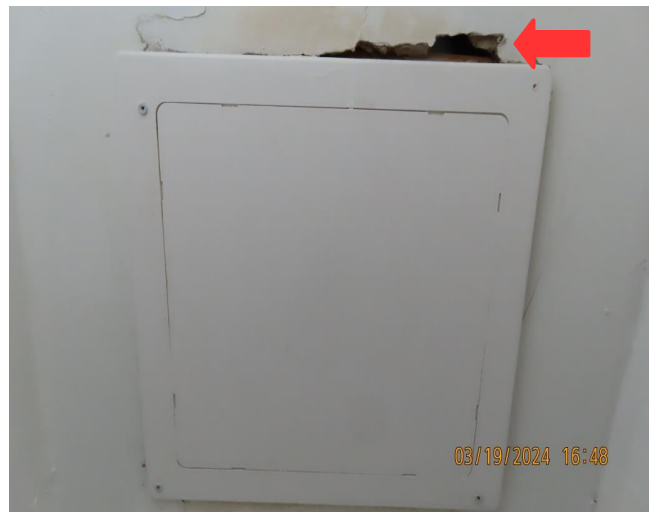
- Seal gaps in the interior for energy efficiency

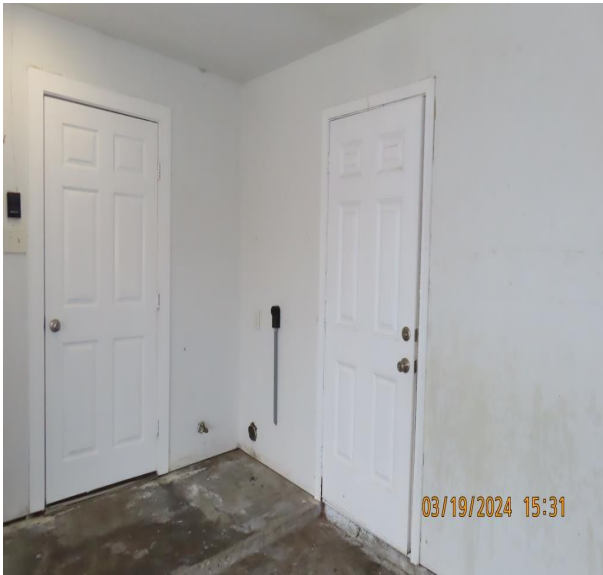
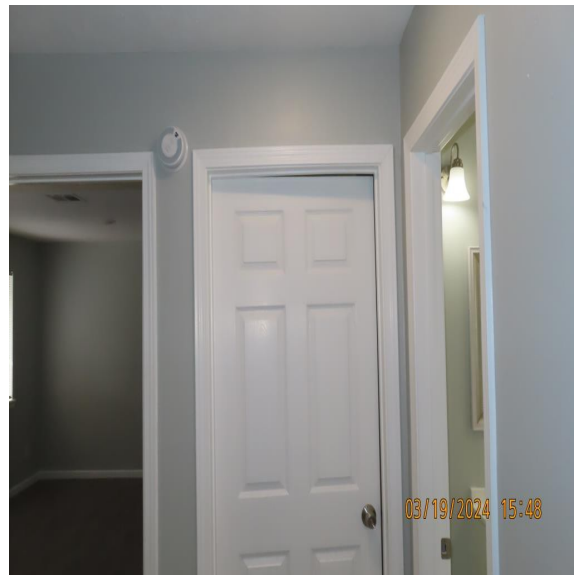
- Noticed stiffness on the garage side door and an interior door. Investigate root cause and properly repair

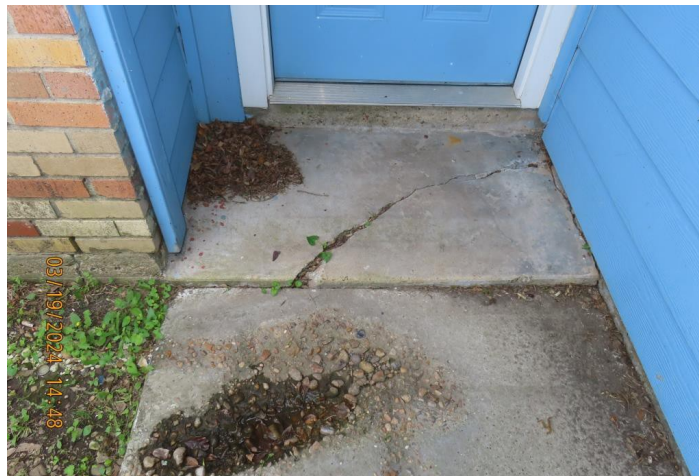
- Other: As needed, repair front door landing to prevent further deterioration

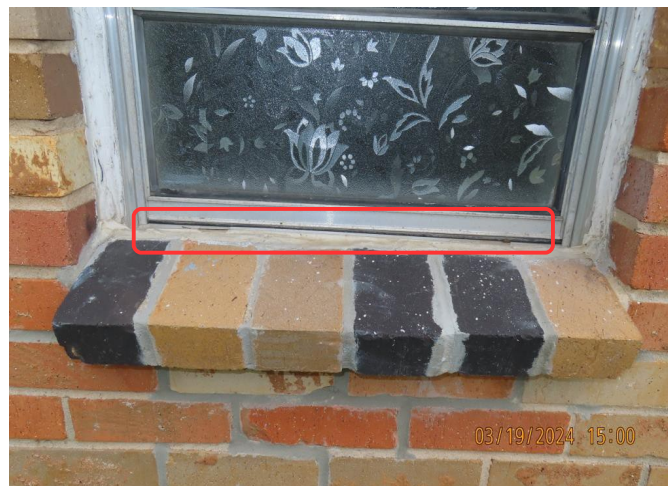
- In downstairs bathroom exterior window, the windowsill does not appear to be properly sloped and may allow standing water . In need of repair

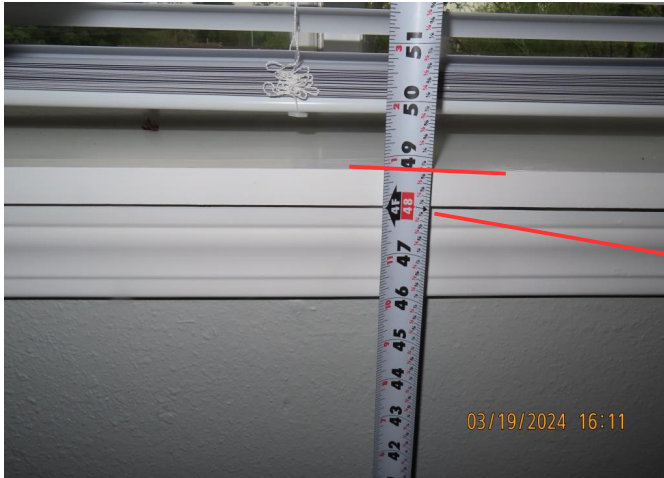
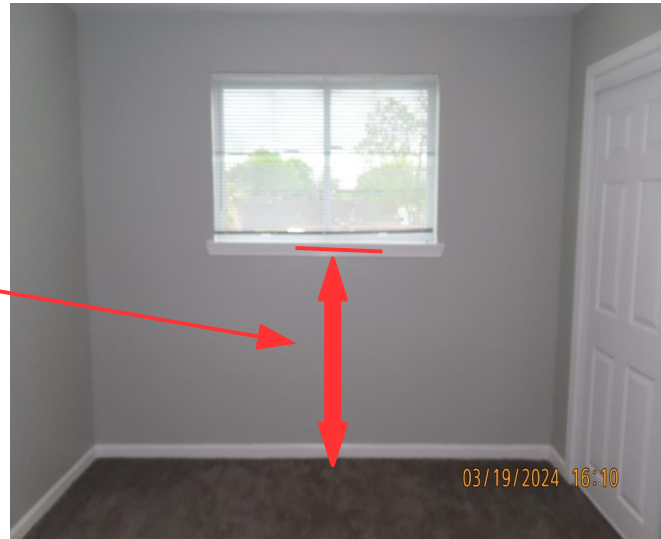
- Height of upstairs windows are out of standard: Maximum height of windowsill should be 44" above the floor. Actual is: 48.5". Repair as needed for personal safety

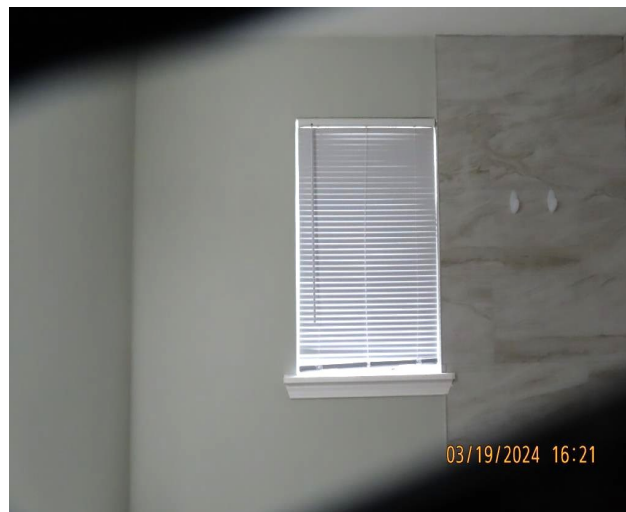
- Observed stiffness on the upstairs bathroom window. In need of proper repair

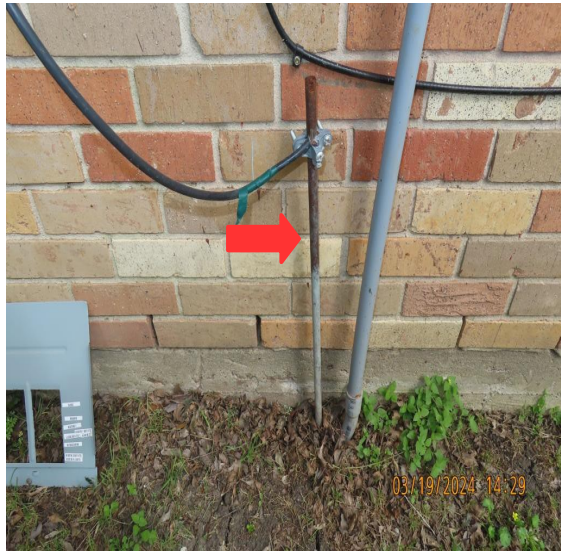
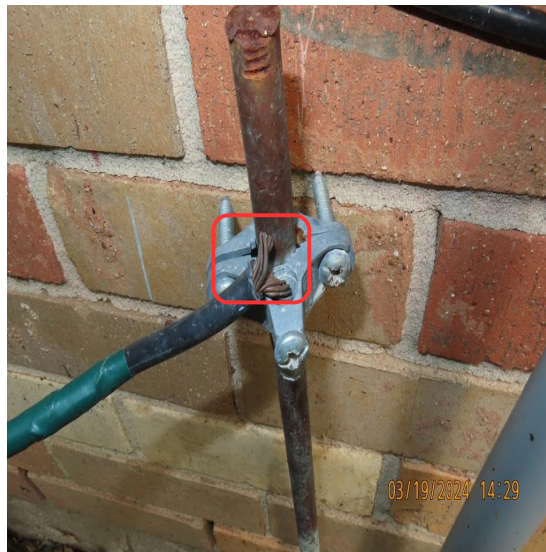
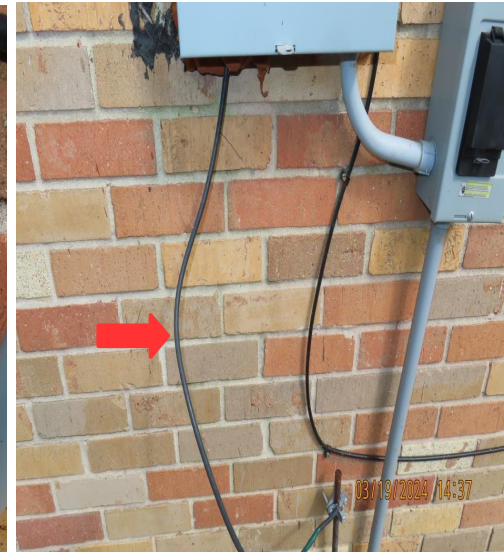
- Grounding electrode/rod length should be 8ft and entire bar should be into the earth.
- Strands are cut on the grounding cable. In need of proper repair
- Properly attach the grounding cable to the wall and enclosure adhering to current code

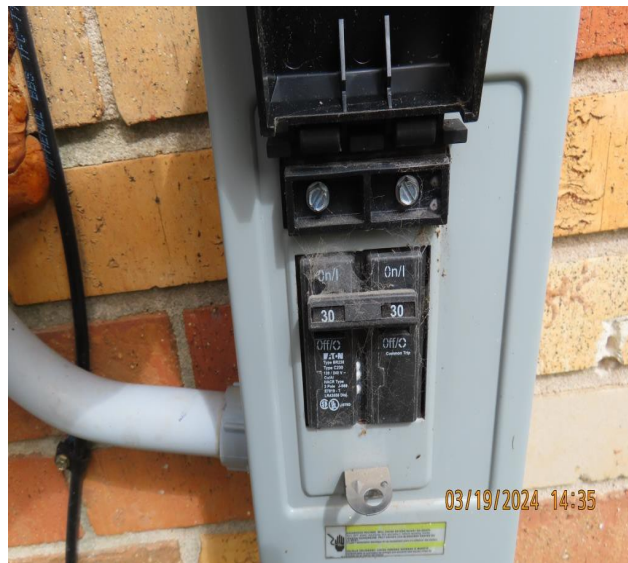
- An unlabeled c. breaker enclosure located adjacent to the main service panel. Properly label

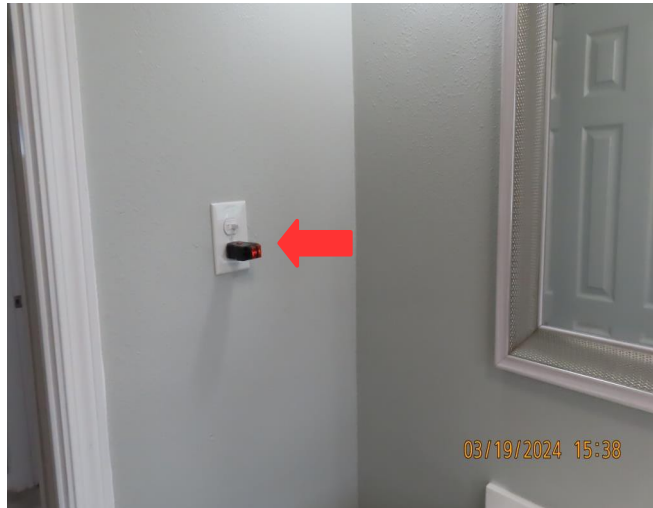
- Outlets in the two bathrooms are not gfcı protected as required.
Note: GFCIs are intended to protect persons from accidental electrocution in areas susceptible to moisture. Installations of these devices in the locations specified are recommended as safety upgrades. These locations include: All kitchen countertop receptacles, and bathroom receptacles, receptacles within 6' of water, all outdoor receptacles and all garage receptacles, including ceiling receptacles for any overhead garage door operators, except those dedicated to a fixed appliance.
Note: These devices should be tested monthly for safe and proper operation per the manufacturer.

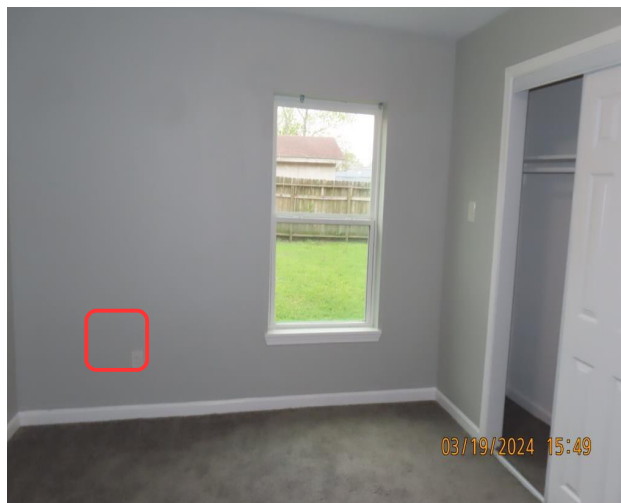
- Found defective/open ground on a rear left room outlet. Investigate further and repair as needed

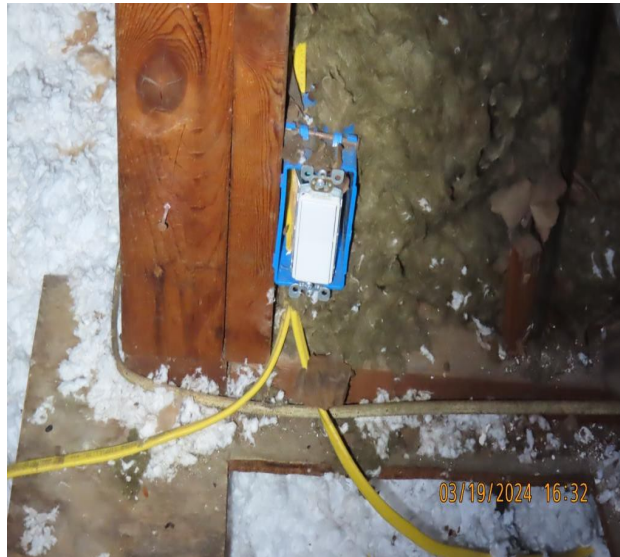
- Install missing face plate on the attic outlet for safety

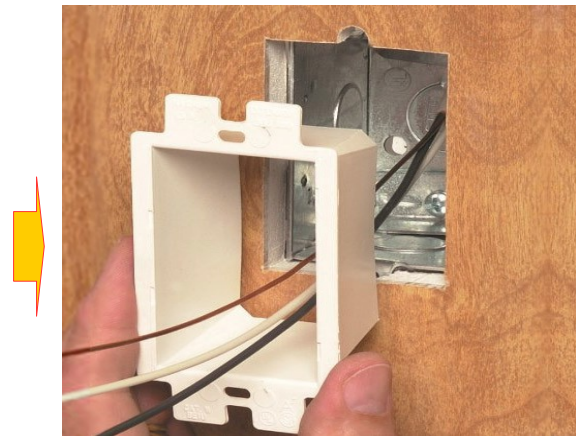
- Dining area does not appear to have sufficient outlets. No point on wall over 6 ft horizontal from receptacle/outlet. In need of repair to comply with current NEC code

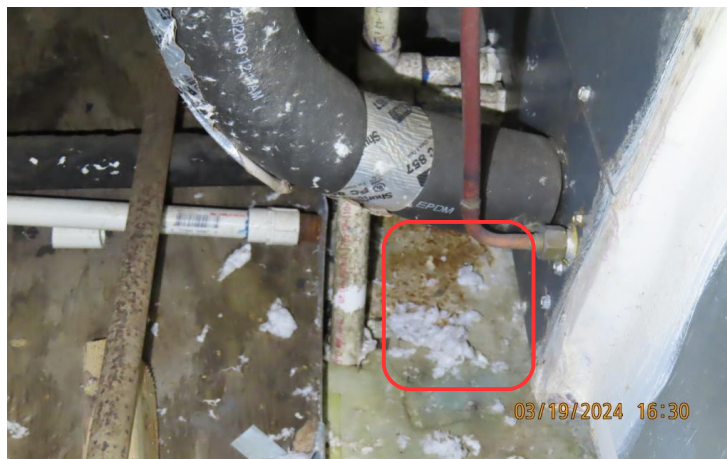
- Noticed water marks under the primary drain. Investigate further for possible condensate leak. Repair as needed

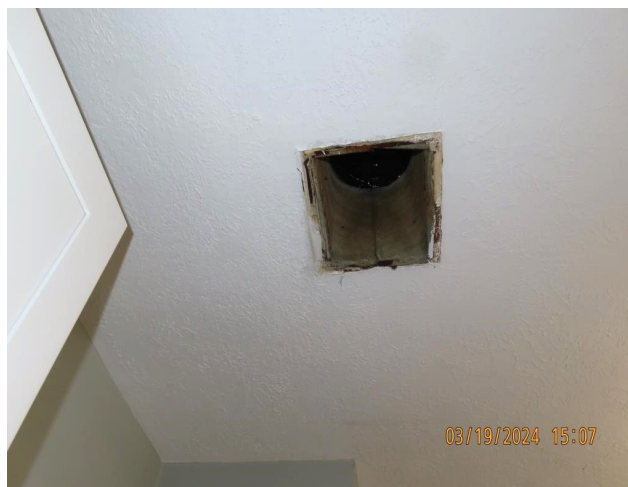
- Other: Unusual large gap between the wall and the grille. Repair as needed

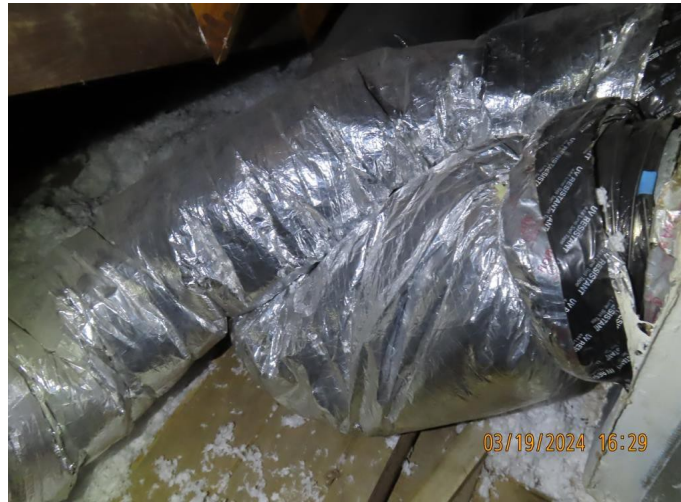
- Observed ducts in contact with each other. Provide sufficient clearance between ducts to prevent condensation

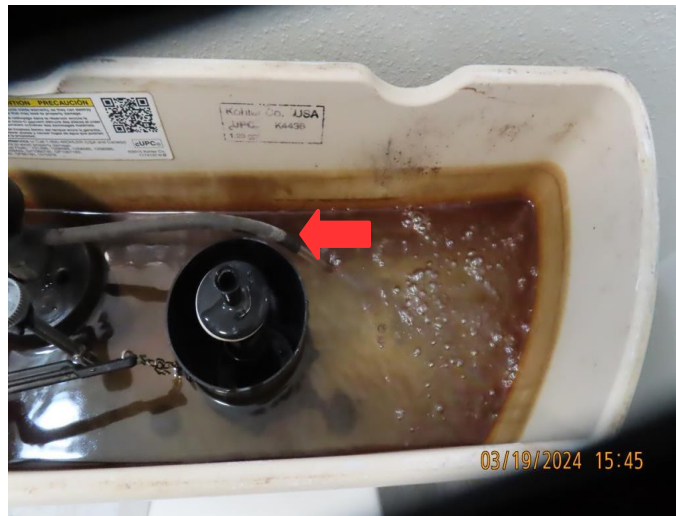
- Install filler tube onto the overflow pipe
- Secure loose toilet in at least one bathroom to prevent further deterioration.
- Noticed sediment and cloudy water in both toilets. Investigate root cause and repair appropriately

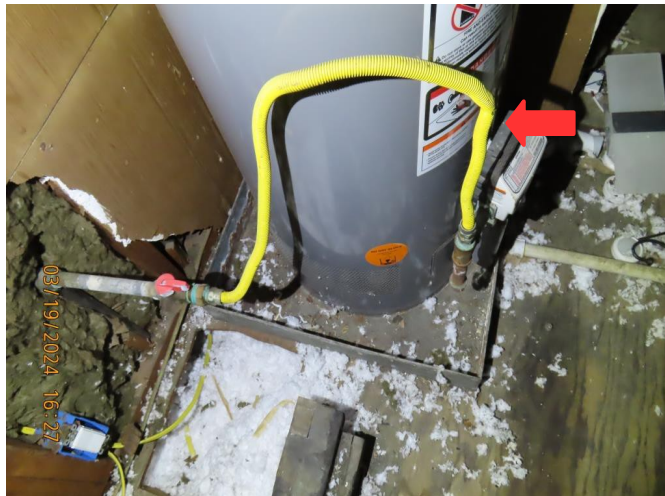
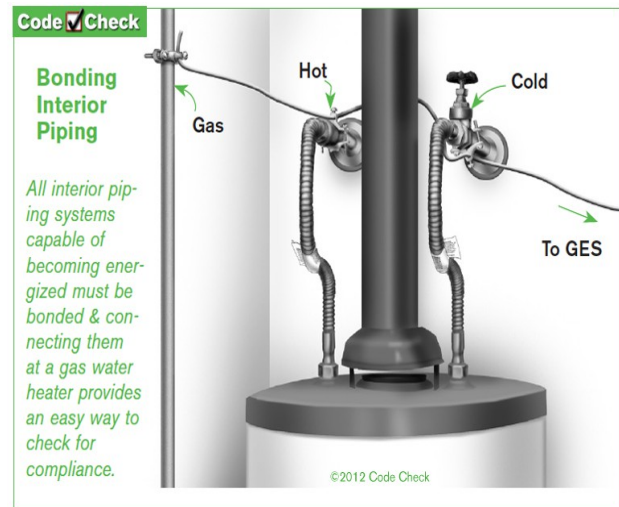
- The electrical equipment bonding of gas and water piping is not evident.
Note: The Hot and Cold water, supplying the water heater gas or electric, must have a #6 copper "Bonding Jumper" installed from one water pipe to the other water pipe

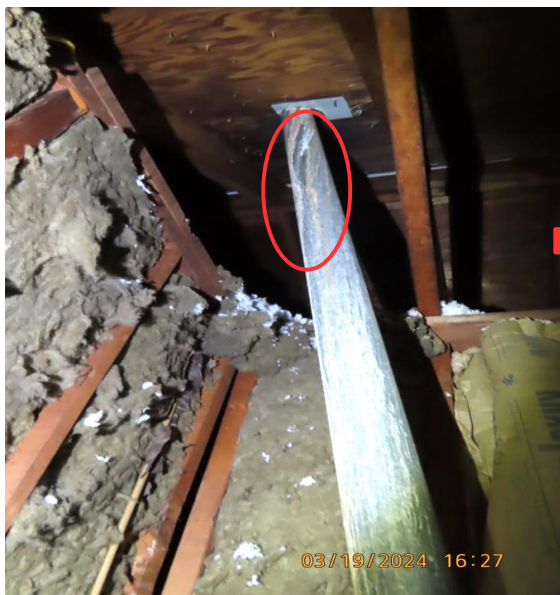
- Evidence of water leak through the flue pipe. Investigate root cause and repair appropriately
- Observed rusting connections. In need of proper repair to prevent leaks and damage to the property

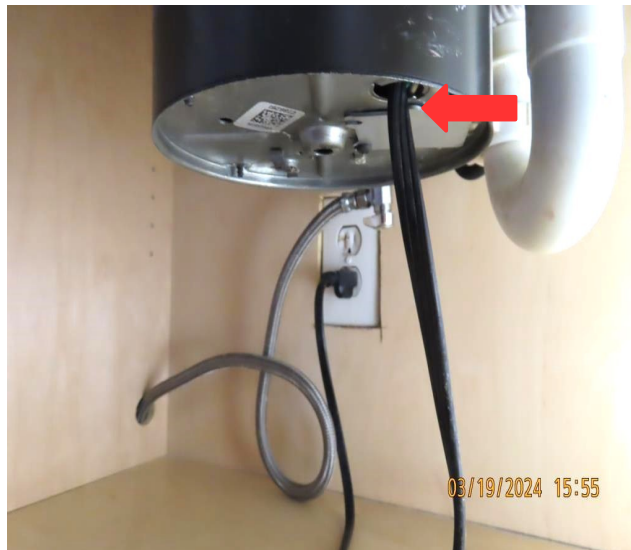
- Install missing clamp on power cord
- W. disposer did not function during testing. In need of repair

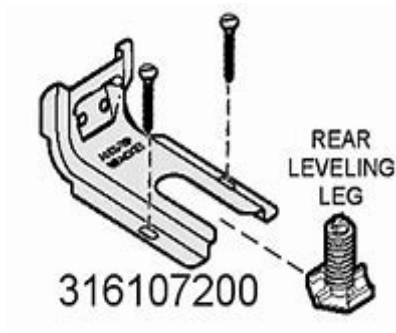
- The anti-tip bracket appeared to be missing or not properly installed. Recommend installation for child safety

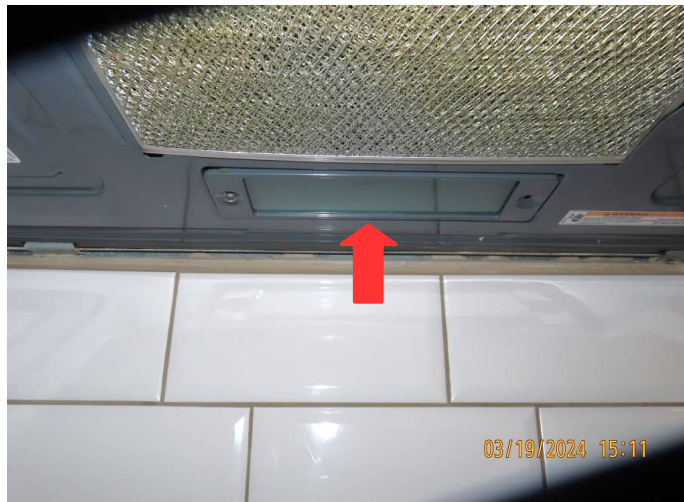
- Repair defective light
