**2328 Jackson St.
Houston 77004**

PROPERTY INSPECTION REPORT FORM

Paul Homeyer <i>Name of Client</i>	03/11/2024 <i>Date of Inspection</i>
2328 Jackson St., Houston 77004 <i>Address of Inspected Property</i>	
Ruben Santillan <i>Name of Inspector</i>	5570 <i>TREC License #</i>
<i>Name of Sponsor (if applicable)</i>	<i>TREC License #</i>

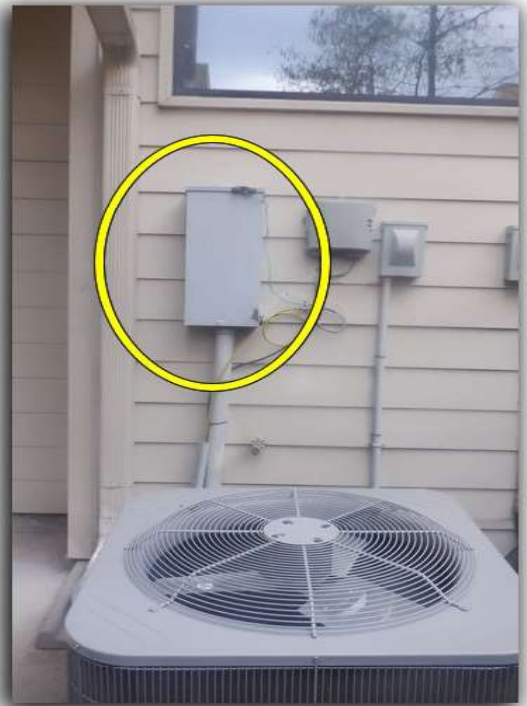
150 AMP ELECTRICAL SERVICE PANEL LOCATED AT NORTH EXTERIOR

Code requires minimum clearance to electrical service panels to be 36" in front of and 30" from side to side.

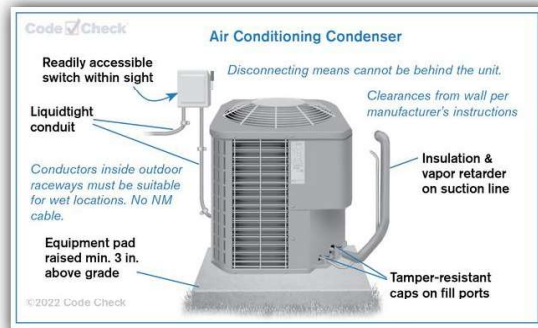
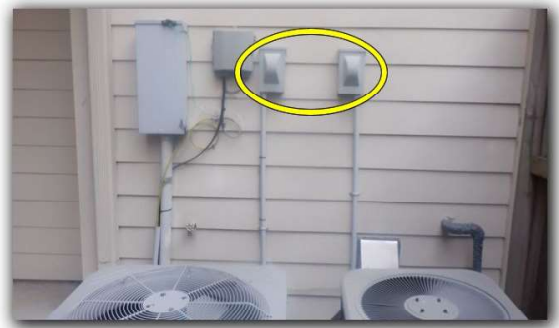
EQUIPMENT DISCONNECTS:

Code requires minimum clearance to electrical service panels (including A/C disconnects) to be 36” in front of and 30” from side to side.

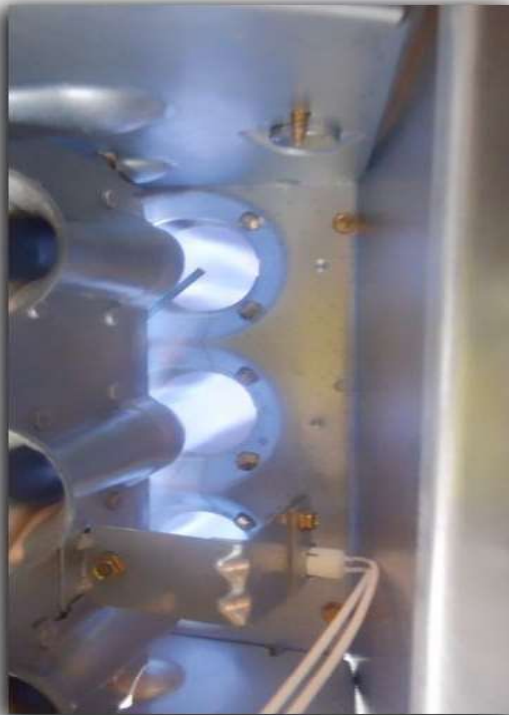
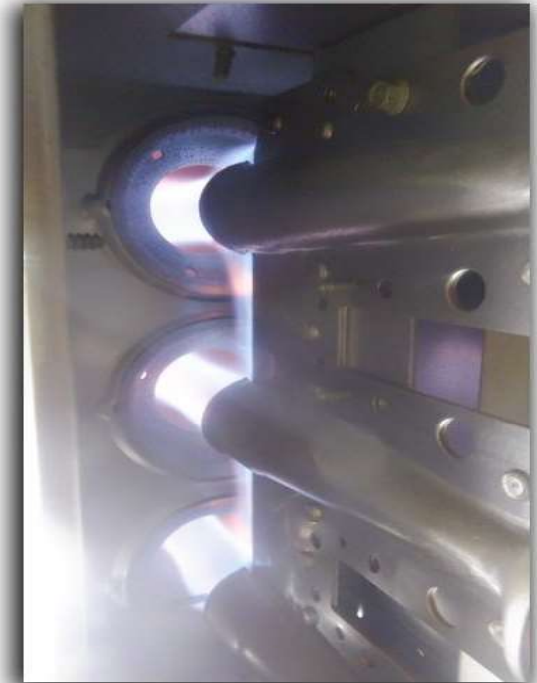
Model: 58SB0A070E171112

S/N: 0822A18317
