**Savannah Taylor  
111 Anise Tree Pl  
Spring, TX 77382**

**September 14, 2021**

## PROPERTY INSPECTION REPORT

Concerning: 111 Anise Tree Pl, Spring, TX 77382  
(Address or Other Identification of Inspected Property)

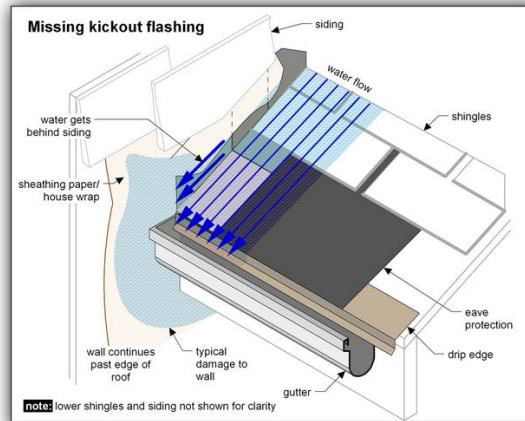
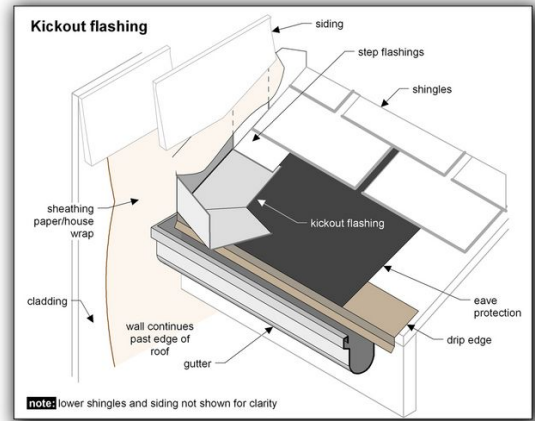
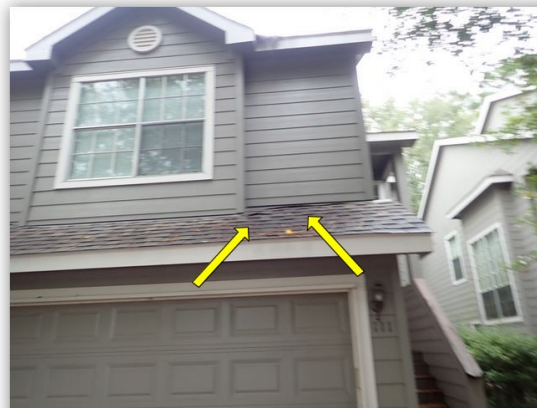
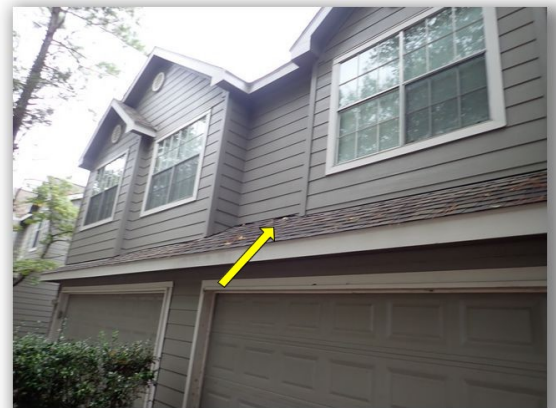
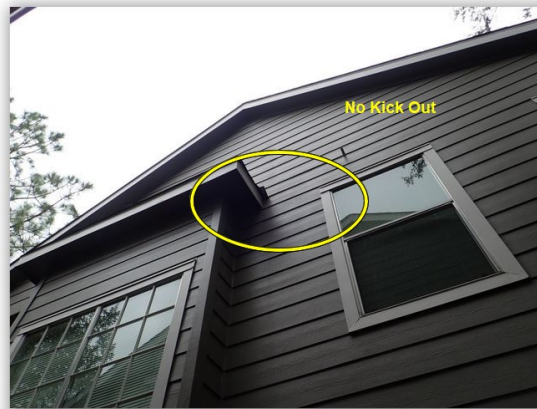
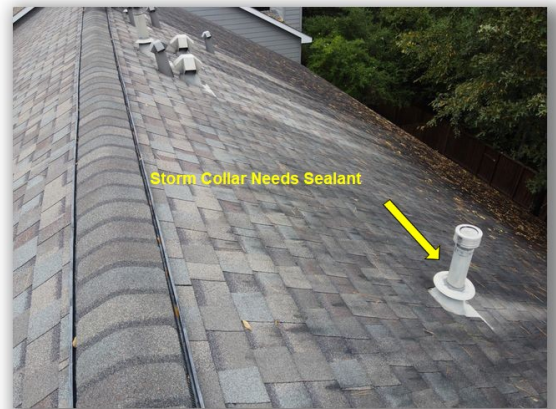
### Flashing Details

The flashing details needs to be checked, reset or repaired as necessary. The observations made to support the rendering of this opinion are listed but may not be limited to:

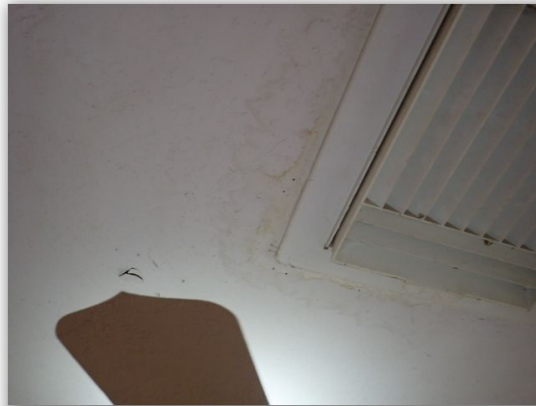
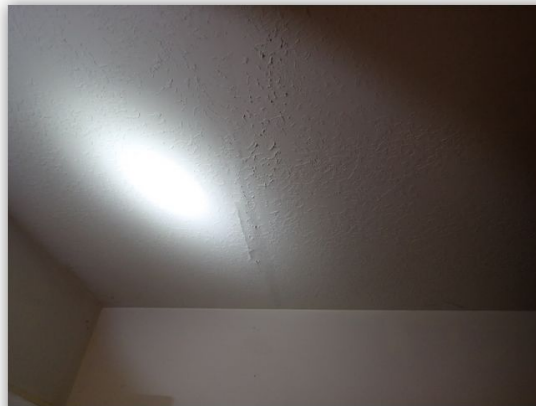
**Note:** There is evidence of painting and patching to the interior finish and prior interior finish repairs. This condition could limit the Inspectors visual observations and ability to render accurate opinions as to the performance of the structure.

**Note:** Nail heads were observed to be pushing through the interior finish in one or more locations.

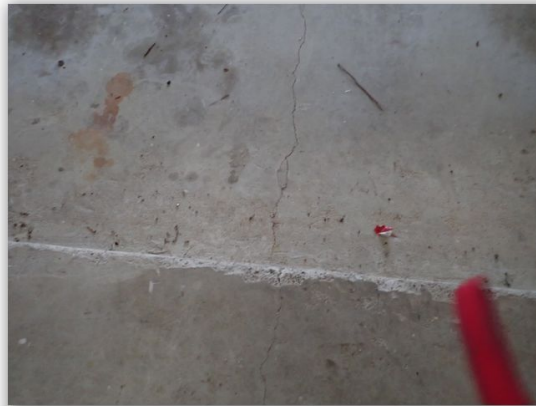
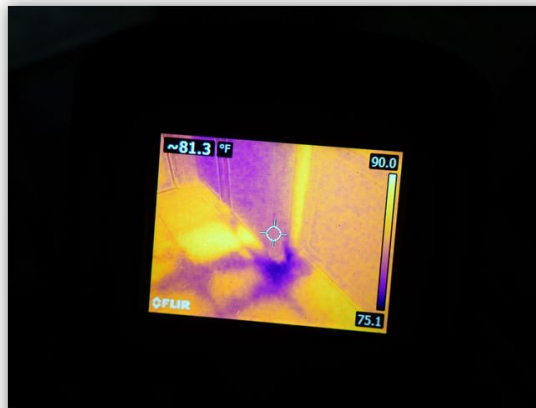
**Note:** The upstairs sub-floors (flooring) observed to squeak when walked over.

**Note:** Some cracking of the garage concrete floor finish was observed.

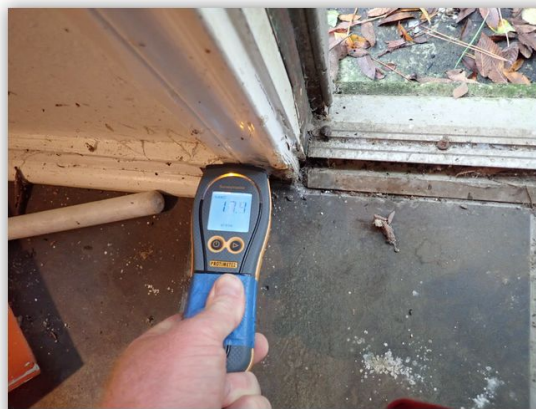
**Exterior Doors**

- Weather-stripping improvements are recommended for the backyard entry, front entry exterior door(s).
- Visible evidence of previous water intrusion was observed at and/or around the exterior backyard entry door(s). The cause and remedy should be investigated and corrected as necessary.
- The door frame has some damage to the backyard entry door.

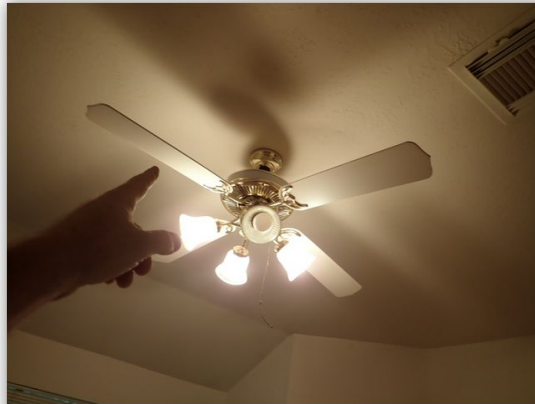
- The ceiling fan is not balanced properly and wobbles when operated in the family room.
- One or more of the light fixtures appear to be inoperative in the various locations throughout the house. This may be due to a bad bulb or some other unknown condition. This condition should be further evaluated and corrected as necessary.
- One or more of the exterior light fixtures were observed to be damaged on the west exterior wall, east exterior wall.
- One or more of the light fixtures do not appear to be functioning properly in the kitchen.
- The ceiling fan appears to be inoperative in the primary bedroom.

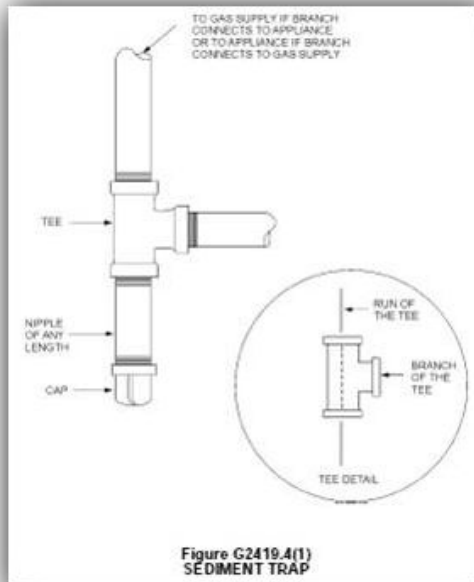
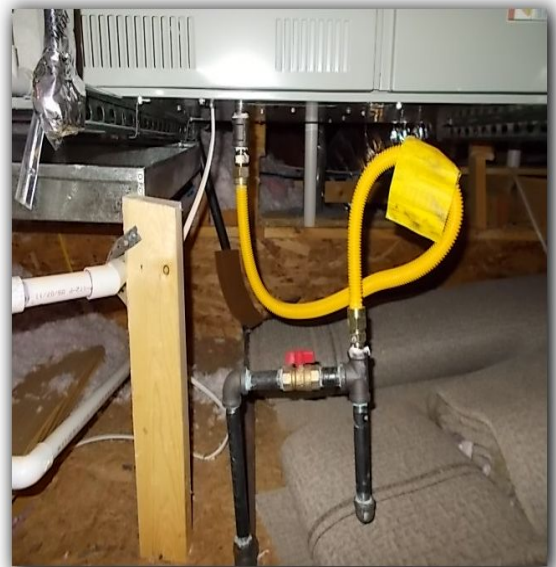
Samples of correct sediment trap installation.

- The heating equipment appears to be inoperative at the time of the inspection.
- The heater gas supply line is not equipped with a sediment trap just before the gas appliance connector. This condition does not meet current installation requirements and should be corrected.

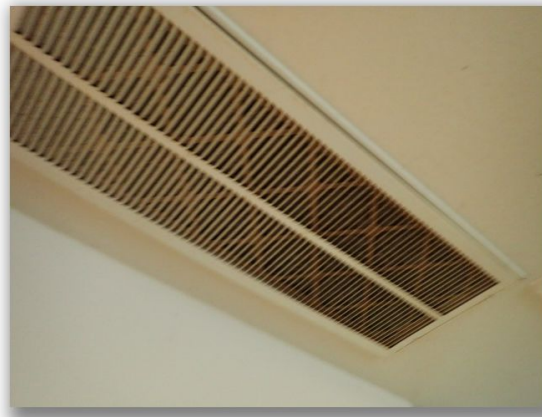
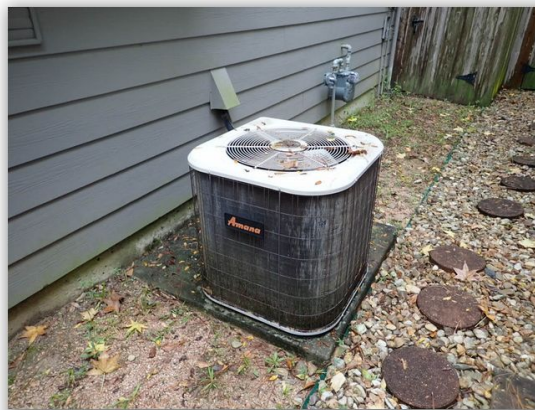
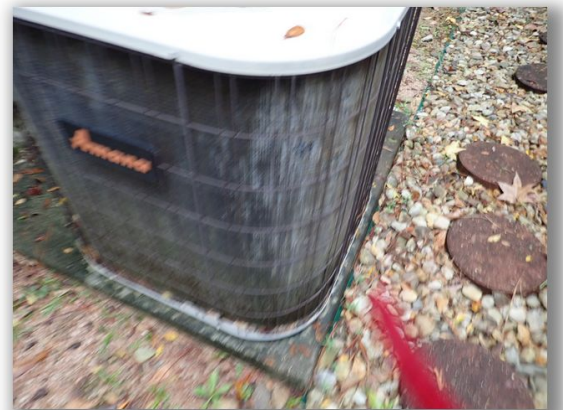
- The cooling equipment appears to have reached the end of its serviceable life expectancy.
- Damaged, deteriorated and/or missing insulation on the refrigerant lines should be repaired or replaced at the outside condenser.

- The auxiliary/secondary drain pan under the coil housing is rusted and should be replaced.
- The primary drain line is not properly insulated in the attic at the time of inspection. It is recommended to add insulation to prevent condensation build up and moisture damage.

- The outside condenser/coils have an excessive amount of rust and/or deterioration. This condition should be further evaluated and corrected as necessary.

- The fins of the outdoor portion of the air conditioning system were observed to be damaged. This condition can reduce the efficiency of the system.
- The dirty air filter should be replaced.

- The tonnage size for the condenser unit and the attic coil unit do not match. This configuration does not meet current installation recommendations and could lead to the unit not performing as intended. This condition should be further evaluated and corrected if necessary by a licensed HVAC technician.

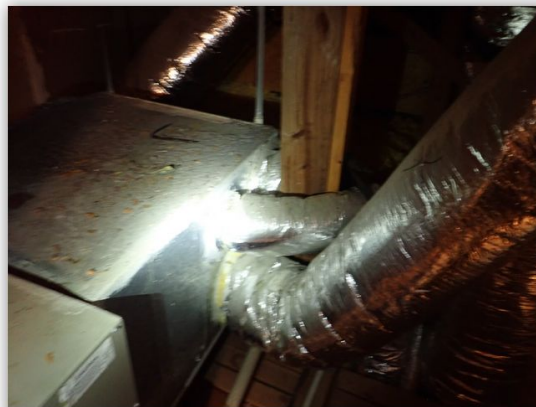
- The duct work in the attic area does not appear to be properly suspended and separated to help prevent condensation from developing. It is recommended to separate and suspend the duct work with supports in minimum intervals of 4-feet that have a minimum width of 1.5-inches.
- The air-return chase for the HVAC system is dirty and should be cleaned to help maintain good air quality.
- There is visible debris/dust and/or mildew on some of the air registers. The cause and remedy should be further evaluated. It is recommended to have the air registers and duct system cleaned for air quality purposes.

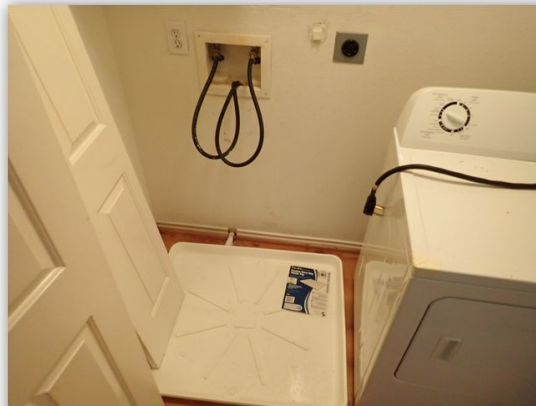
- One of the laundry connection hose bibbs has a slow leak when in the off position.

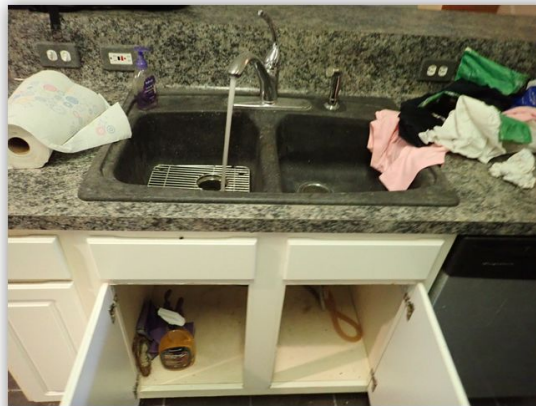
- The sprayer appears to have low water pressure. The cause and remedy should be further evaluated and corrected as necessary.

**Note:** Previous water leaks were observed at and/or around the drain connections under the sink. This would indicate previous problems and should be closely monitored and corrected when necessary.

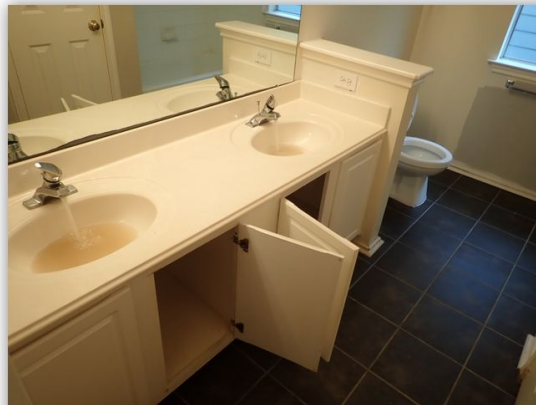
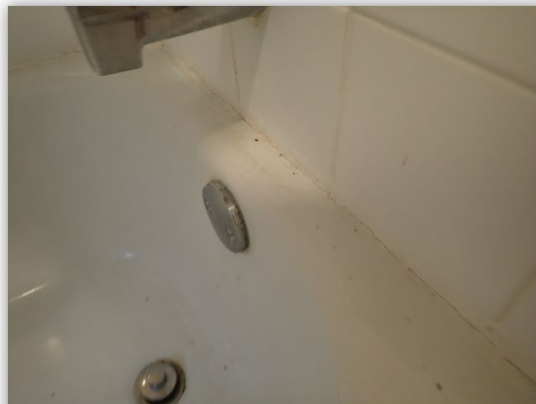
- The faucet is unusually noisy (humming) at the time of inspection. This condition should be further evaluated and corrected if necessary.
- Cracked, deteriorated and/or missing bathtub enclosure grout and/or caulking should be repaired or replaced as necessary.
- The faucet assembly is not sealed at the wall. This condition has the potential to allow water to leak back into the wall cavity.
- The bathtub has some surface damage.
- The bathtub spout leaks at the base near the wall. This condition needs to be corrected to help prevent water from leaking into the wall cavity.
- The bathtub shower head diverter is not functioning properly.

- The commode is loose at the floor mount.
- Water leaks into the commode bowl, after the tank valve ( ballcock assembly) has reset.

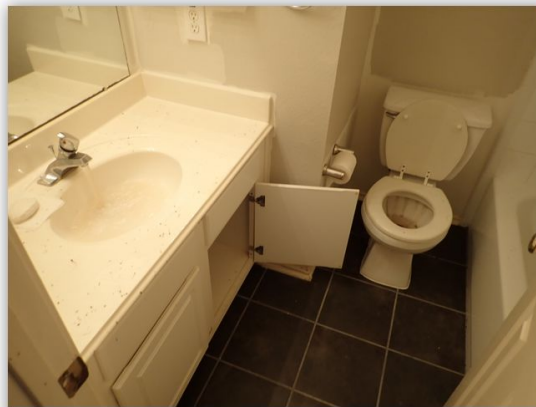
- Cracked, deteriorated and/or missing bathtub enclosure grout and/or caulking should be repaired or replaced as necessary.
- The faucet assembly is not sealed at the wall. This condition has the potential to allow water to leak back into the wall cavity.
- The faucet is unusually noisy (humming) at the time of inspection. This condition should be further evaluated and corrected if necessary.

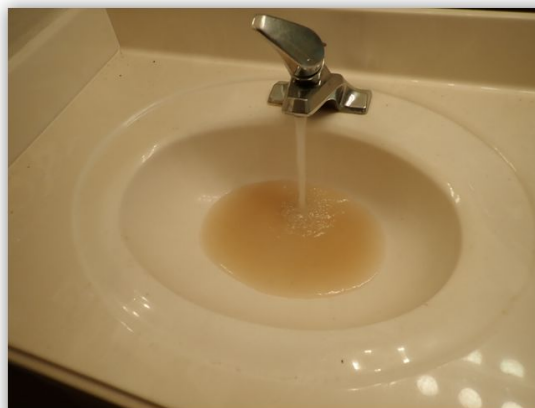
- The roof level flue storm collar needs to be properly sealed to help prevent water intrusion into the structure.
- There is brown water at the water fixtures when the hot water is operated. This is a good indicator that the water heater is near end of its life expectancy. This condition should be further evaluated and corrected as necessary.

- Some corrosion was observed on the water supply shutoff valve.
- **The water heater appears to be reaching the end of its serviceable life expectancy.**

- The attic equipment service platform is inadequate or missing. There should be at least a 30 X 30 inch floored service space in front of the service side of the equipment.

- The water heater gas supply line is not equipped with a sediment trap just before the gas appliance connector. This condition does not meet current installation requirements and should be corrected.

**Note:** There is evidence of prior leakage on or around the water heater housing. This should be closely monitored.

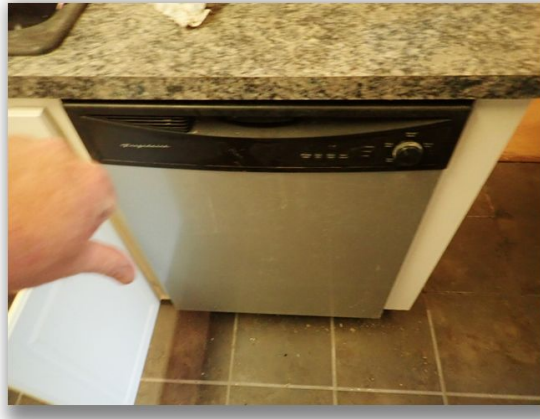
- The dishwasher was inoperative at the time of this inspection.

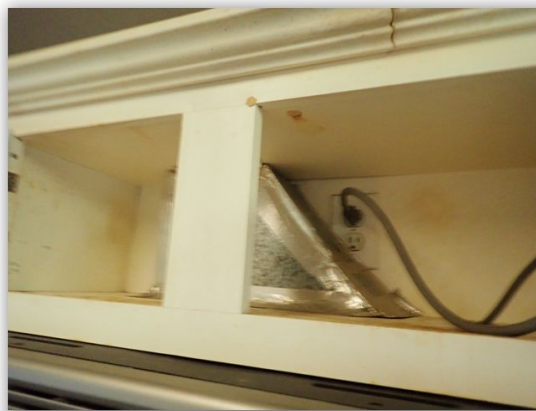
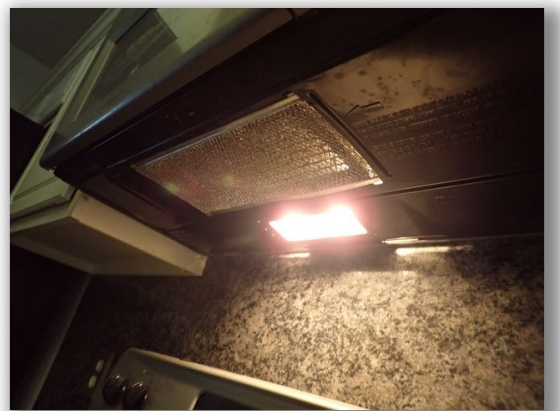
This component appears to be performing adequately at the time of this inspection.

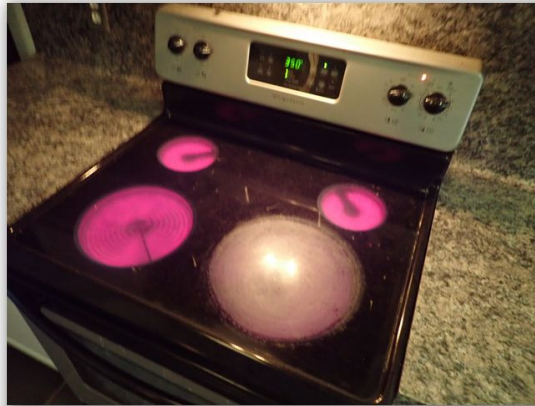
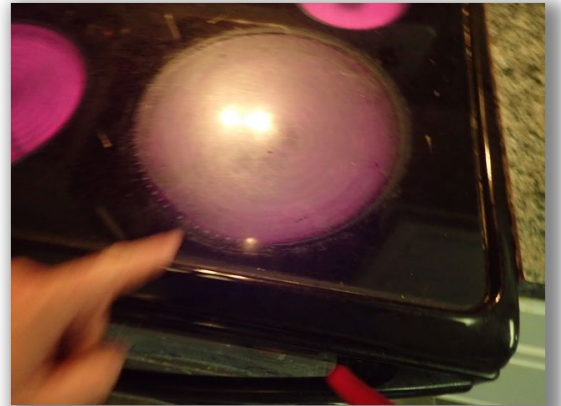
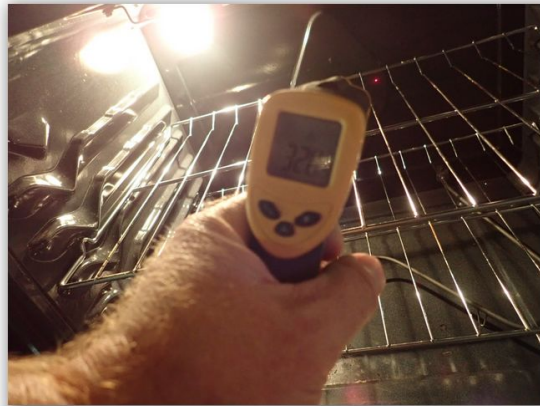
- The range can be easily tipped over and should be equipped with an anti-tip device, for safety.
- The temperature of the oven was checked at 350 degrees. The temperature rose to 320 degrees and held that temperature.
- The cooktop surface was observed to be damaged.

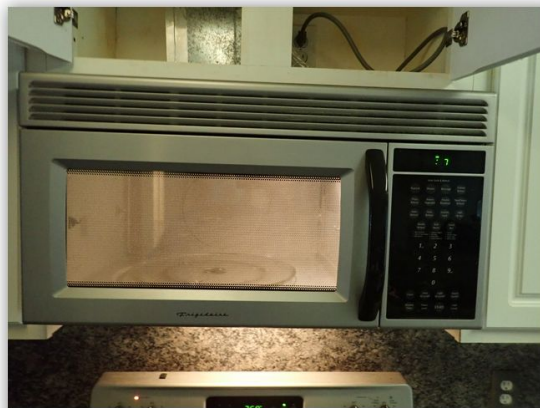
This component appears to be performing adequately at the time of this inspection.

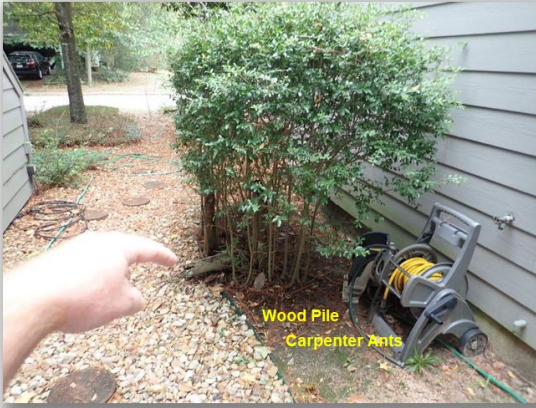
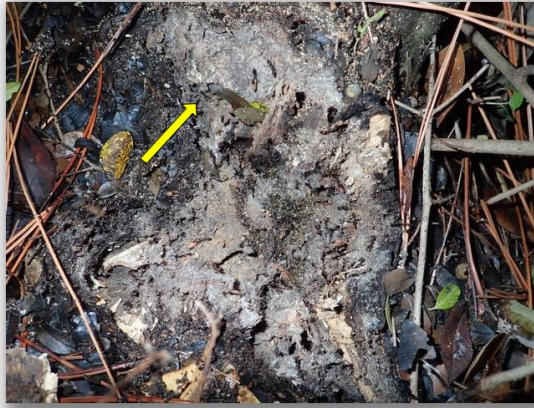
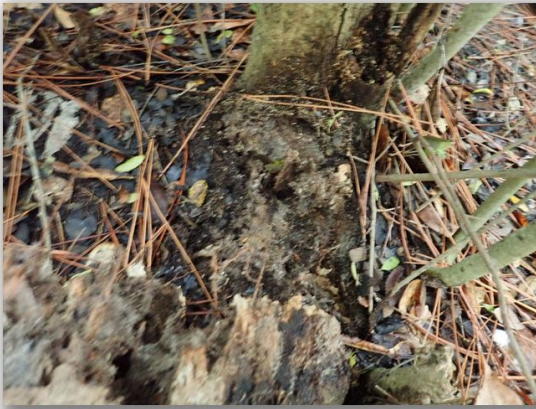
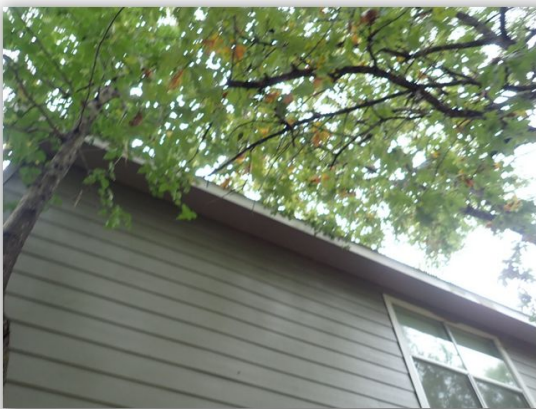
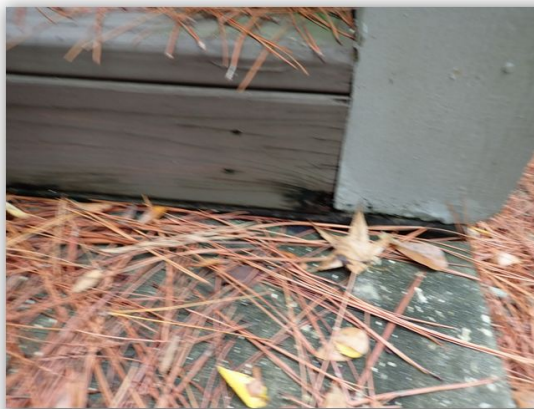
A-Action Home Inspection Group  
(713) 730-3151 www.a-actionhouston.com  
V.D.I.R. Provided By: Sharpeye Pest Control Lic.#0773025  
Inspection Date: 9/14/2021  
Technician: Brendan Hirshey - 0765323  
Active Infestation: ( ) No  Yes Type: Carpenter Ants  
Corrective Actions: ( ) No  Yes Type: WI EXT.  
**No Treatment Performed at the Time of This Inspection**  
**Do Not Remove Structural Pest Control Board Regulation Sec. 599**
