5934 Patridge Drive

Property Inspection Report

9/26/2023

**PERFORMANCE
INSPECTIONS, PLLC**

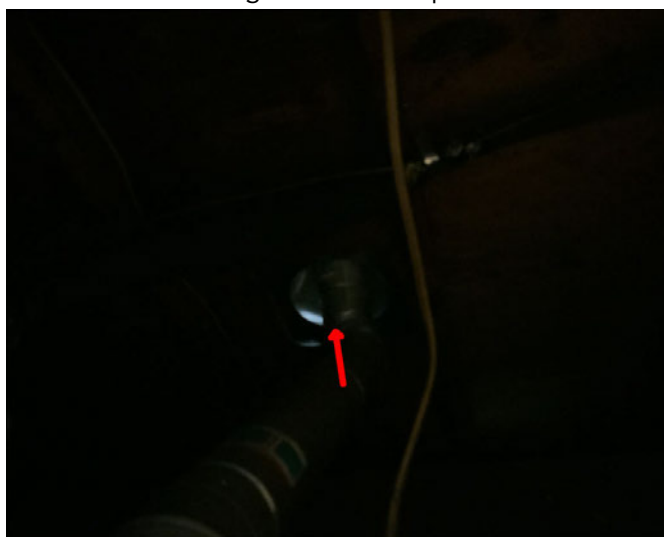
Roof jacks and flue pipes need seal improvements

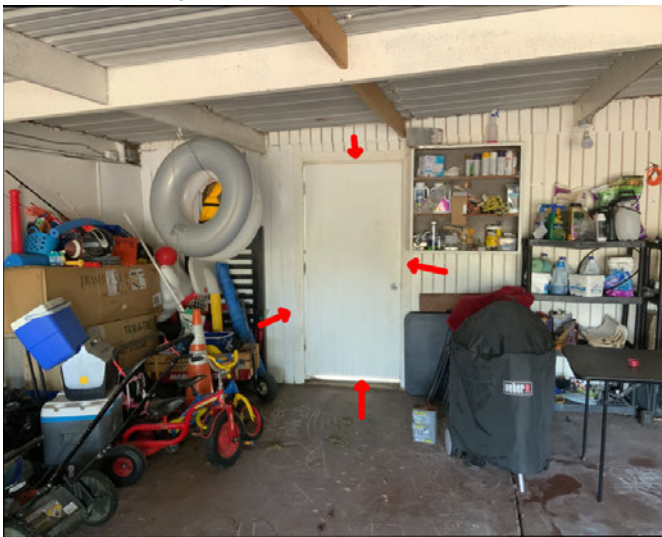
Door seals needed at garage door

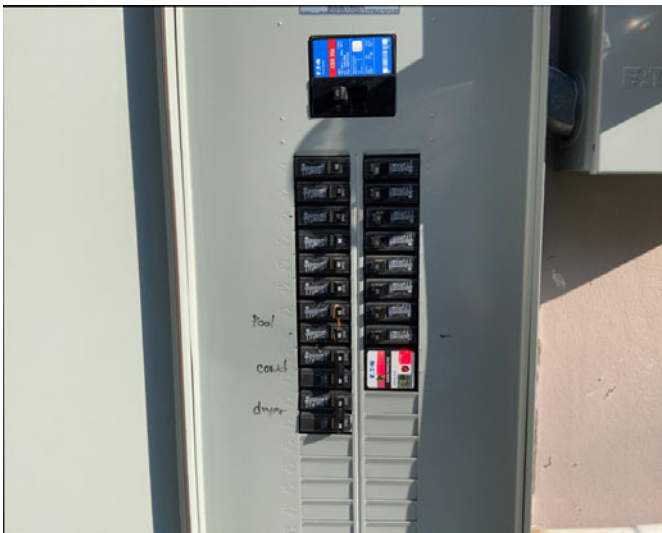
Labeling is required

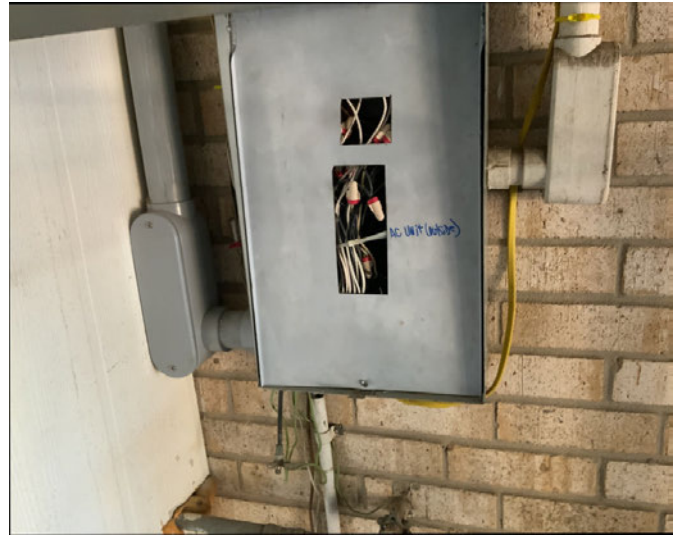
Abandoned old panel in garage

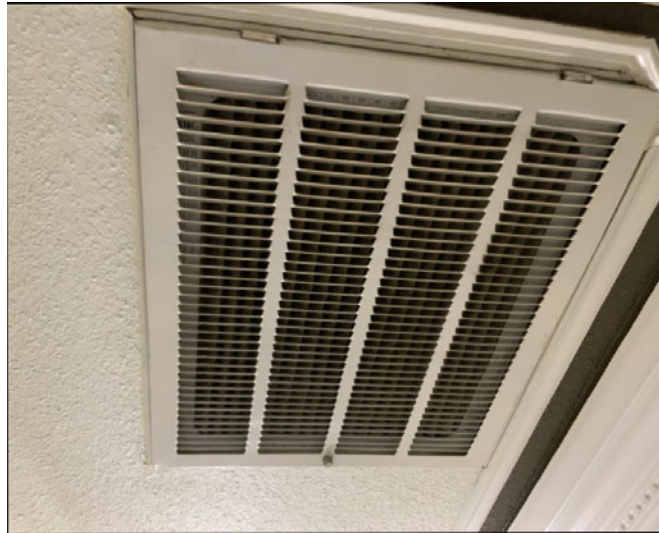
- The dirty air filter should be replaced.
- The heating system requires servicing.

Dirty air filters

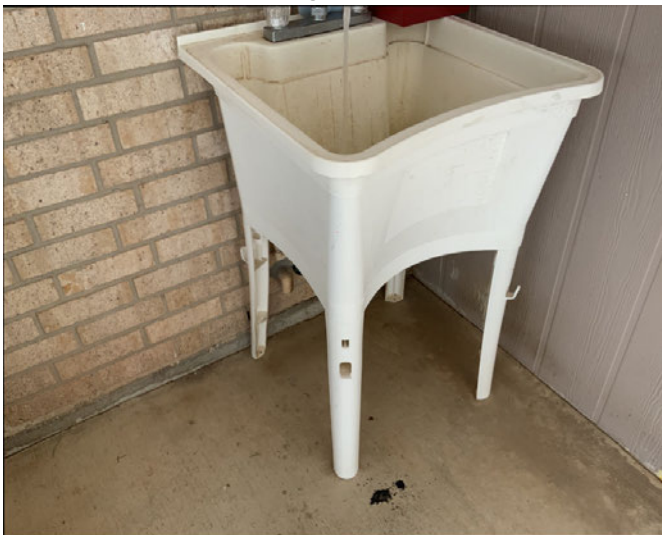
Laundry tub not mounted

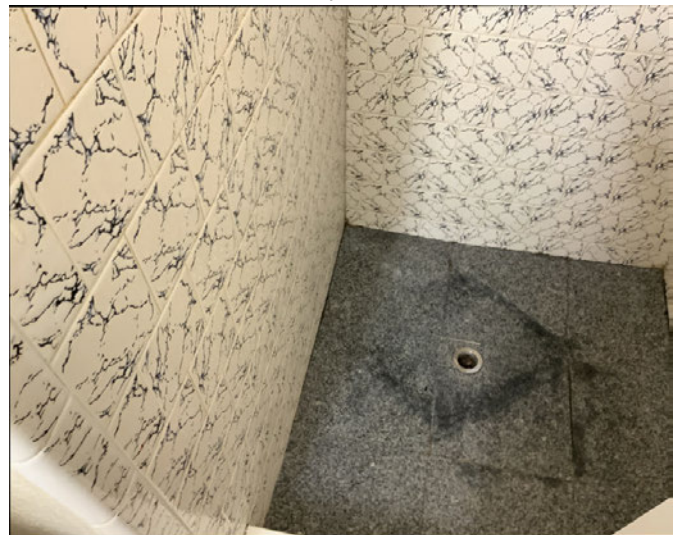
Caulking improvements needed at showers

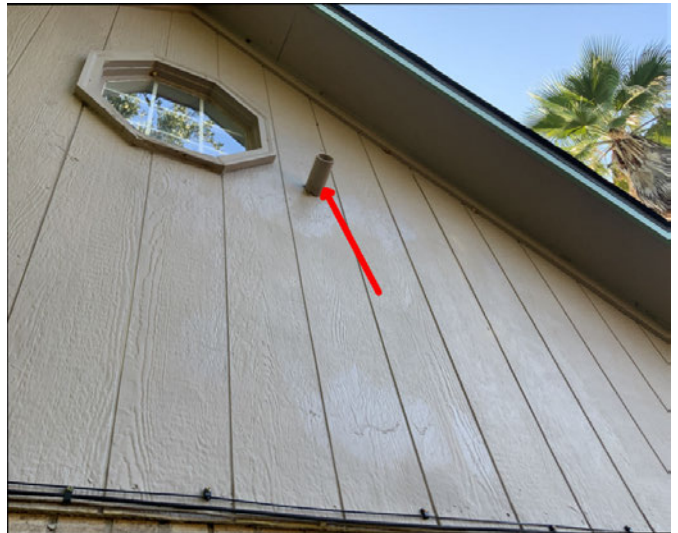
Proper venting required

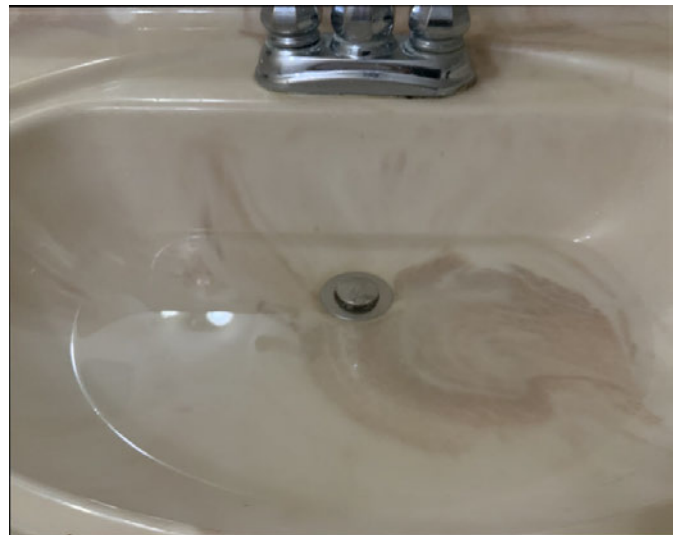
Slow drain at primary bathroom
