**From The Ground Up**  
**Professional Home Inspections**

# PROPERTY INSPECTION REPORT FORM

Rodney Spell <i>Name of Client</i>	02/20/2023 <i>Date of Inspection</i>
4795 Old Spurger Hwy, Silsbee, TX 77656 <i>Address of Inspected Property</i>	
Troy Priddy <i>Name of Inspector</i>	7259 <i>TREC License #</i>
<i>Name of Sponsor (if applicable)</i>	<i>TREC License #</i>

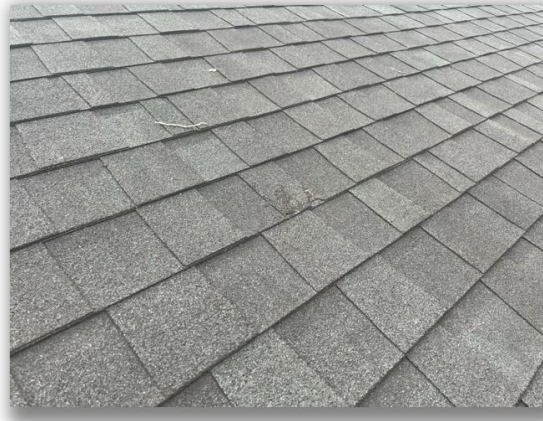
- There is excessive algae/moss growth on the roof covering on the south side of the roof covering. This can cause damage to shingles when not cleaned.

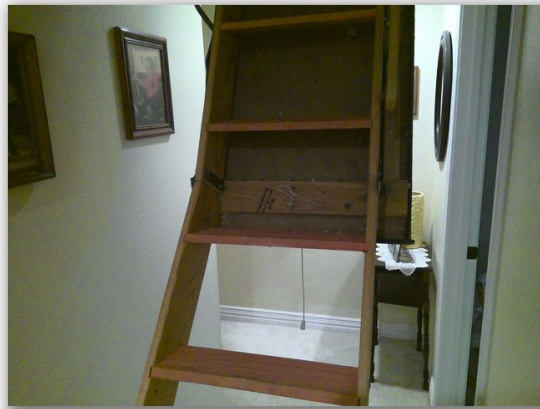
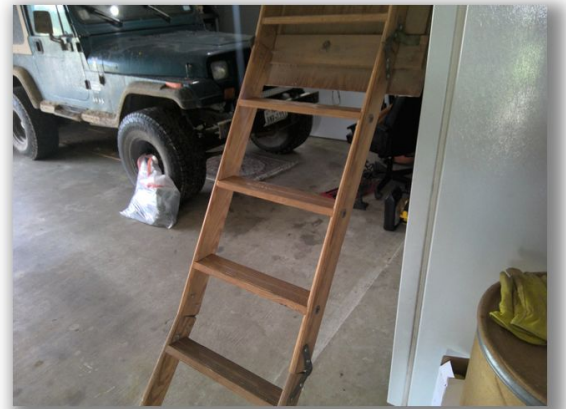
- The attic ladders in the bedroom hallway and garage are not properly installed and do not sit flush at the hinges when opened.

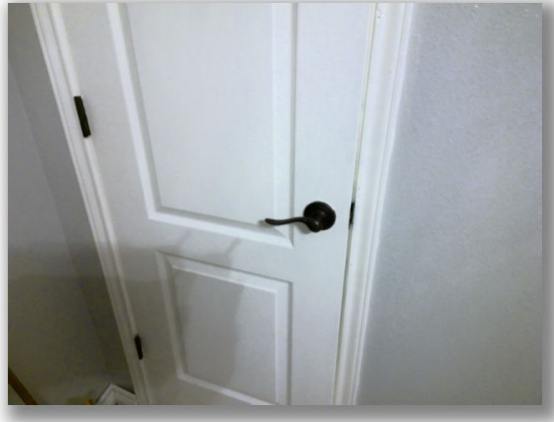
- The door is missing to the rear middle bedroom closet.

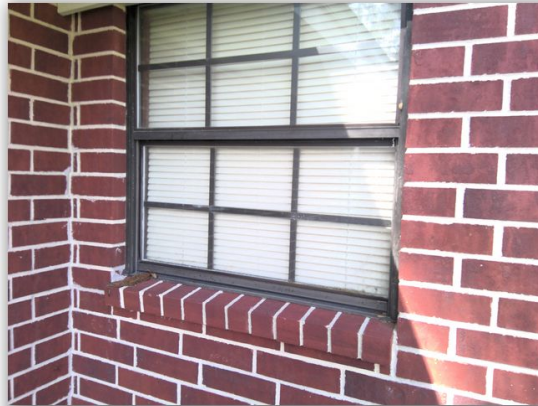
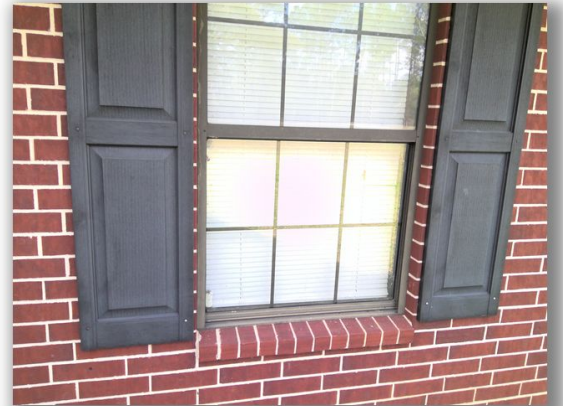
- One or more of the thermal pane windows were observed to have lost their seals. This has resulted in condensation or a fog like film to develop between the panes of glass. The thermal pane windows no longer function as designed when they loose their seal and replacement may be necessary. The windows that have noticeably lost their seals are listed but may not be limited to the following: master bathroom, hall bathroom, living room, study and front corner bedroom.

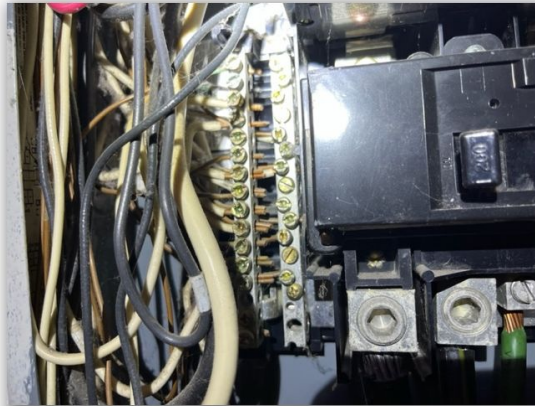
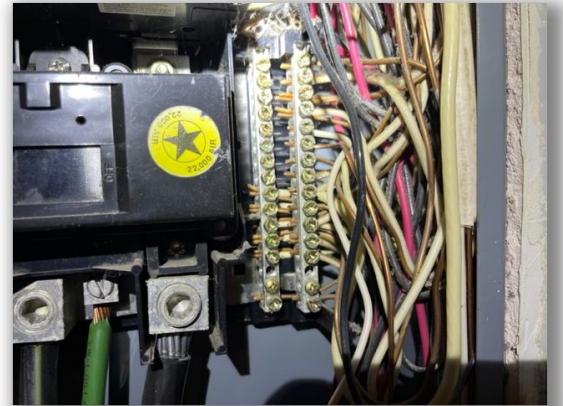
- The wires entering the electrical cabinet are not properly secured or protected from the sharp edges of the cabinet.

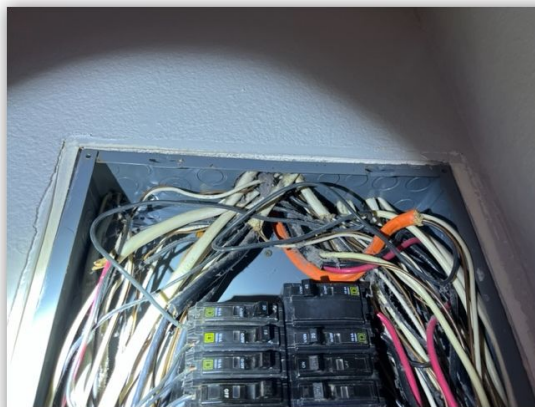
- The electrical cabinet does not appear to be properly bonded to the electrical system.

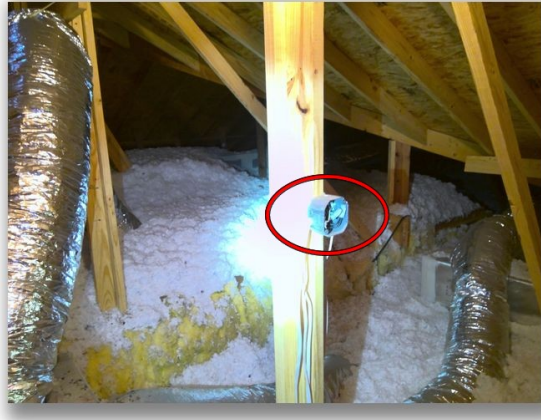
should be properly enclosed. Open junction box(es) were located over the laundry room.

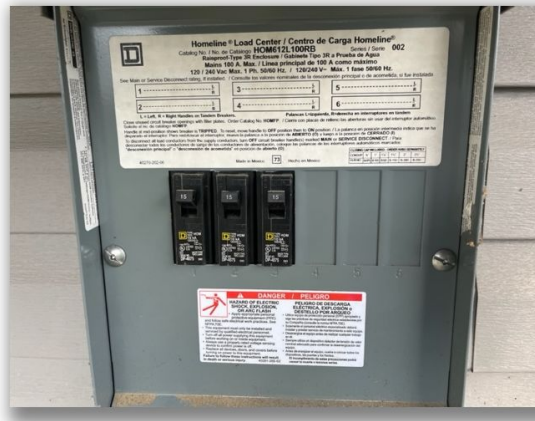
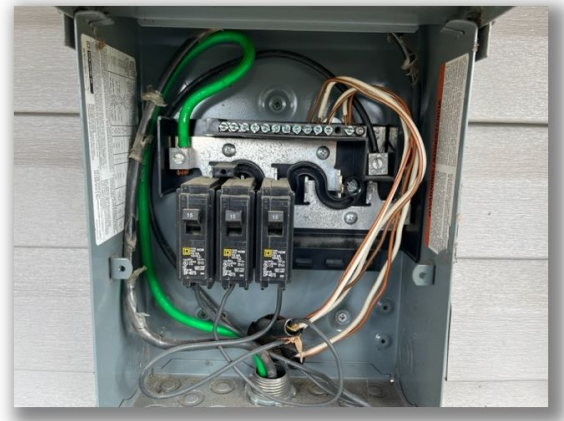
- The breakers (overcurrent devices) in the electrical panel are not properly labeled.
- The main service entrance lugs are not capped and properly protected.

- The wires entering the electrical cabinet are not properly secured or protected from the sharp edges of the cabinet.

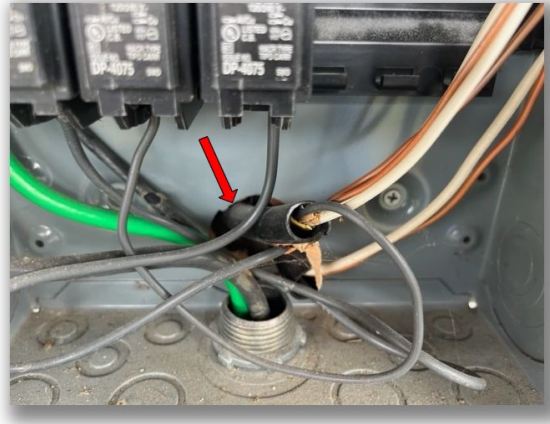
- One or more of the neutral and ground wires in the electrical cabinet were observed to be double lugged (i.e. two wires under one screw).
- The ground wires and the neutral wires are not properly separated in the sub-panel electrical cabinet. The neutral wires should be on their own isolated bus bar and the ground wires should be connected to the sub-panel cabinet. Although the sub-panel is functional, it does not meet current National Electrical Code standards.

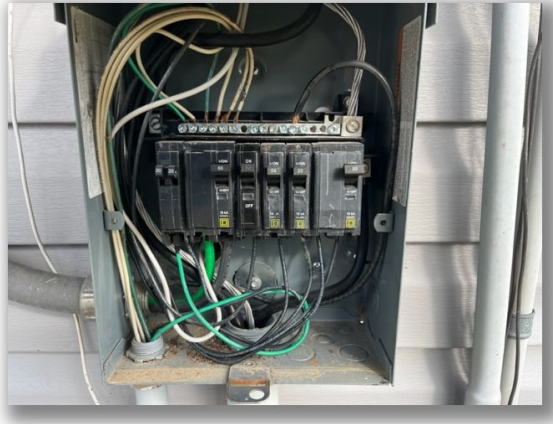
- The main service entrance lugs are not capped and properly protected.

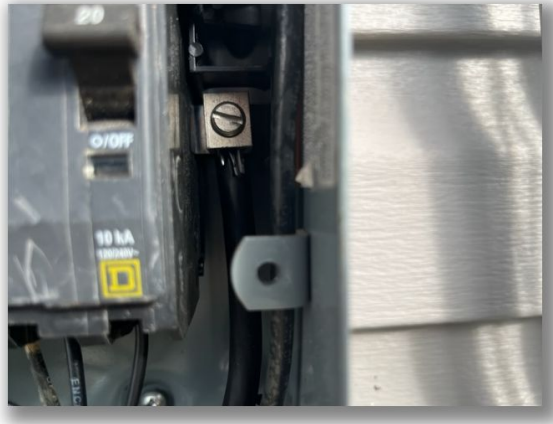
- The ground wires and the neutral wires are not properly separated in the sub-panel electrical cabinet. The neutral wires should be on their own isolated bus bar and the ground wires should be connected to the sub-panel cabinet. Although the sub-panel is functional, it does not meet current National Electrical Code standards.

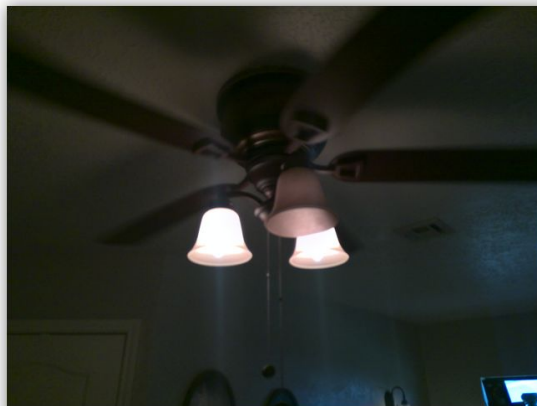
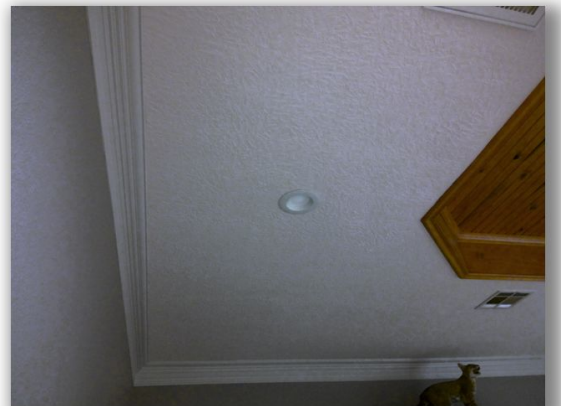
- There are not enough smoke alarms located in the home. Under current building standards, there should be a smoke alarm located in each sleeping room, outside each separate sleeping area in the

immediate vicinity of the sleeping rooms, and on each additional story of the dwelling.

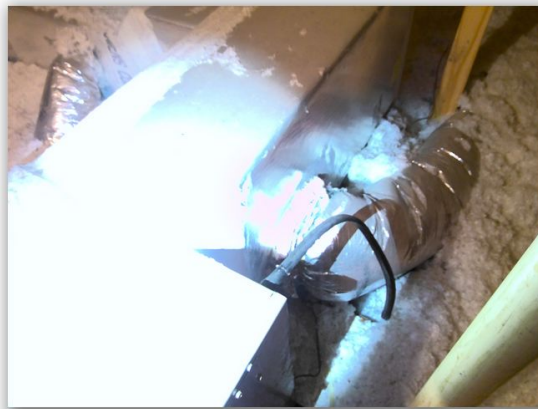
- The exposed electrical service wires to the heating equipment should be enclosed in conduit.
- I was unable to locate or observe a service disconnect at or around the heating unit.

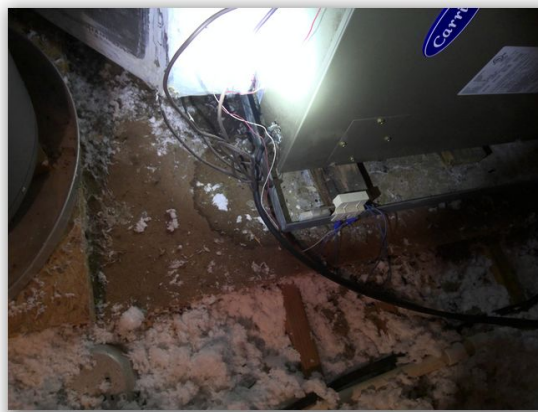
- The exposed electrical service wires to the heating equipment should be enclosed in conduit.
- I was unable to locate or observe a service disconnect at or around the heating unit.

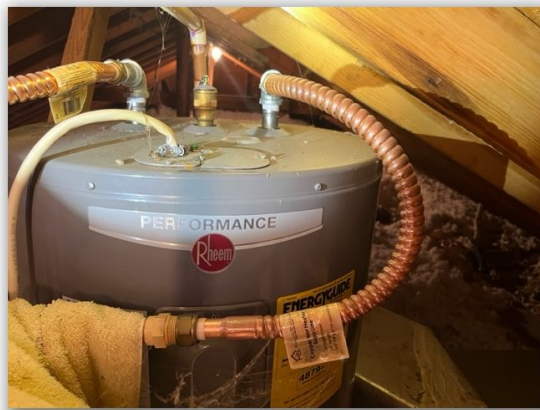
- The temperature and pressure relief (TPR) valve discharge pipe is running in an upwards direction in one or more locations. The TPR discharge pipe should run gravitationally downwards at all points.

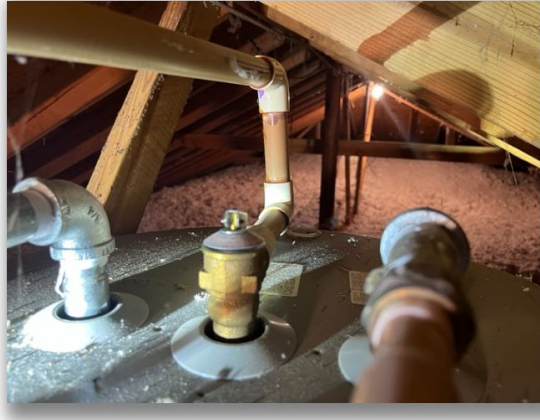
- The electrical wiring to the water heater is exposed and should be enclosed in conduit.
- I was unable to locate or observe a service disconnect at or around the heating unit.

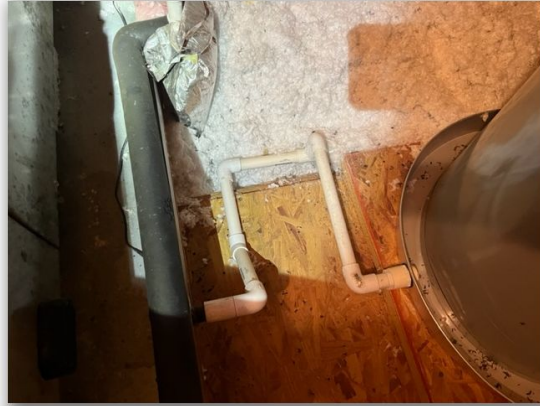
- There is no temperature and pressure relief valve (TPR) discharge pipe in place at the time of this inspection. For safety reasons, it is recommended that a TPR valve discharge pipe be installed. Under current building standards, the discharge pipe should run downward to the exterior of the structure, turn downward, and terminate within 6-inches of the ground.

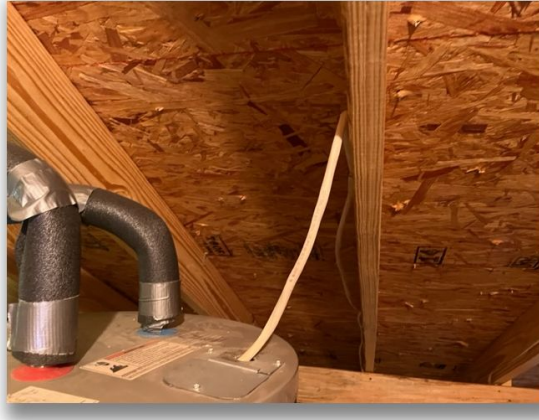
- There is no expansion tank present on the cold water supply line on top of the water heating equipment.

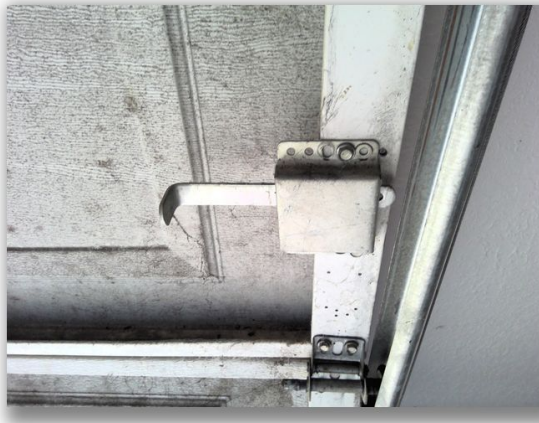
- When an automatic garage door opener is in use, the manual lock should be disabled or removed.
