STRUCTURAL INSPECTION

8924 Live Oak Grove Lane
Houston Tx 77080

AUGUST 6, 2020

REF: CONDITION OF PROPERTY SURVEY

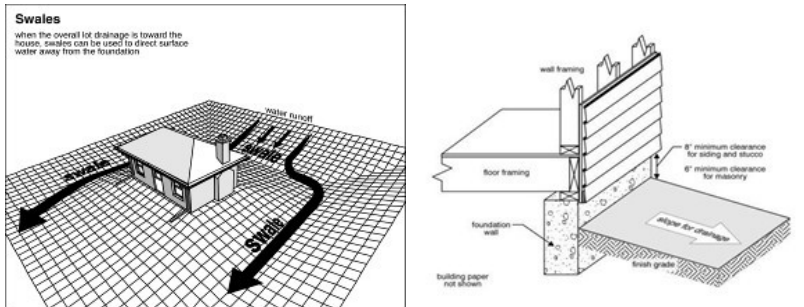
Perimeter Grading/Drainage: Appeared adequate draining towards front

The perimeter drainage around the property appeared to generally be adequate, with drainage generally towards the front of the property. It could not be determined with certainty if water would pool at any localized low areas around the property. Further investigation with the homeowner is recommended to determine if there are any drainage problems or standing water after a rain.

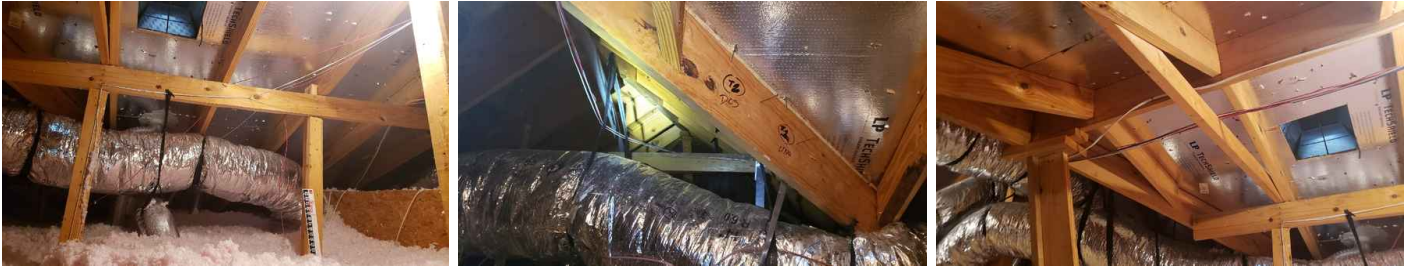
Attic Framing: Viewed from attic access walkway

The attic space was viewed only from the areas determined by the inspector to be safely accessible from the access walkway.

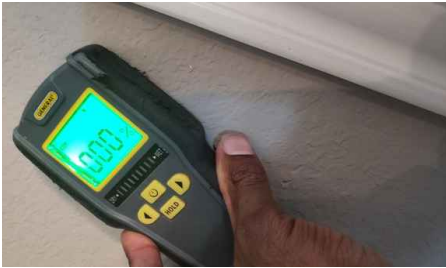
7.1.1 Water Penetration

Water Penetration: Not Visible - Moisture Meter

No visual evidences of water penetration to the interior of the structure were observed at the time of the inspection. It is pointed out that this statement is based upon the limitations of a visual inspection, without the moving or removal of items causing visual obstruction, including, but not limited to, furniture, furnishings, floor or wall coverings, foliage, soil, etc.

We checked around all window and door openings with a moisture meter, and found no evidence of elevated moisture at the time of the inspection.

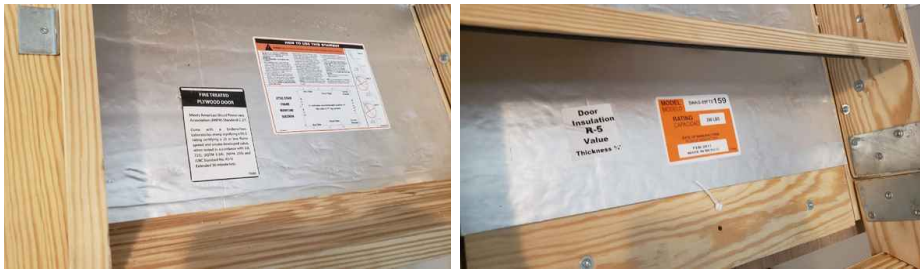
Viewed from attic decking

The attic was entered and was viewed from the access decking provided in the attic. The walkway decking was adequate, and no repairs are needed.

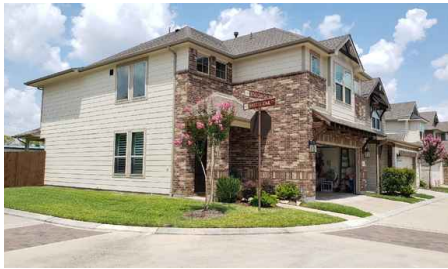
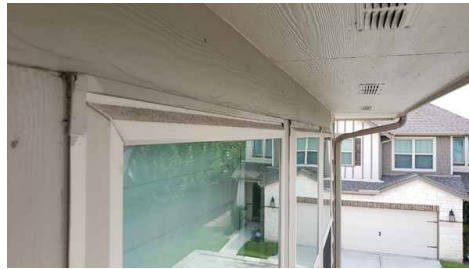
9.2.1 Fiber Cement Siding

Siding Material

Brick Veneer, Cement Siding
