PROPERTY INSPECTION REPORT FORM

TEWOGBOLA JOLAOSO <i>Name of Client</i>	12/23/2023 <i>Date of Inspection</i>
6414 KIMBALL MILL LN., Houston, TX 77084 <i>Address of Inspected Property</i>	
Stephen Perry <i>Name of Inspector</i>	7854 <i>TREC License #</i>
 <i>Name of Sponsor (if applicable)</i>	 <i>TREC License #</i>

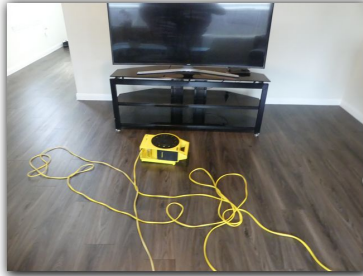
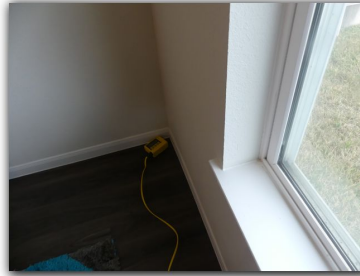
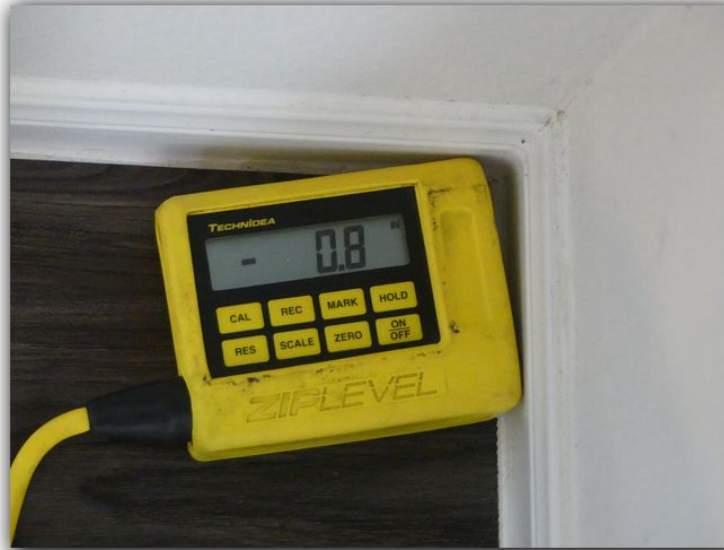
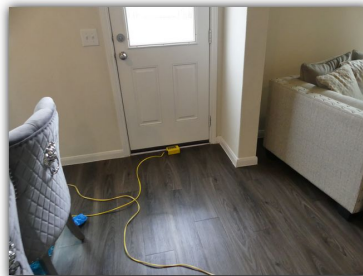
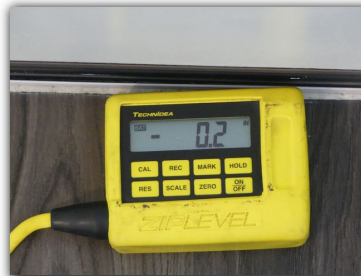
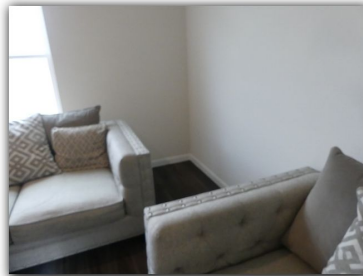
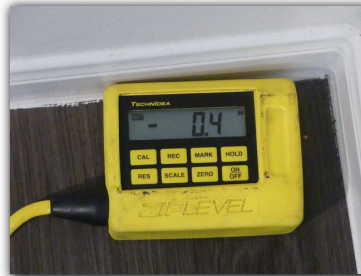
- Structural movement and/or settling noted; however, the foundation is supporting the structure at this time.**

AFTER CAREFUL EVALUATION OF THE DATA OBTAINED THAT THE FOUNDATION ELEVATION/SLOPE IS WITHIN ACCEPTABLE TOLERANCES. THERE WAS SHOWING -.8" TENTHS OF AN INCH LOW AT THE BACK LEFT CORNER OF THE HOME IN THE BREAKFAST AREA AND -.6" TENTHS OF AN INCH LOW ON THE FRONT SIDE OF THE HOME AT THE FRONT DOOR. THESE TOLERANCES MAY INDICATE SOME MINOR SETTLEMENT. HOWEVER, THESE TOLERANCES ARE NOT CONSIDERED EXCESSIVE. RECOMMEND MONITORING FOR ANY FURTHER SIGNS OF

STRUCTURAL SETTLEMENT.

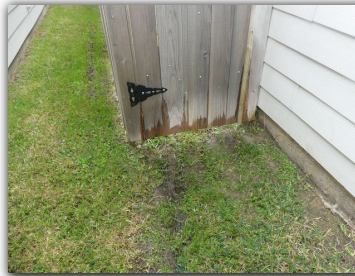
Improper drainage from foundation****(Deficiency)****

There is a French drain system present as is recommended. However, would also recommend improvements such as rocks and gravel installed on both side of the home and also around the full perimeter by a landscape and irrigation expert.**(Deficiency)******

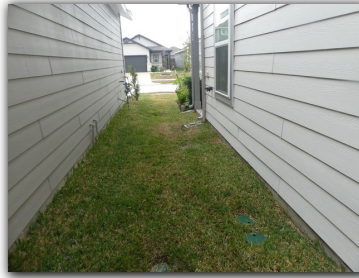
Recommend all gutter terminate directly to the French drain system for improved drainage. (Deficiency)****

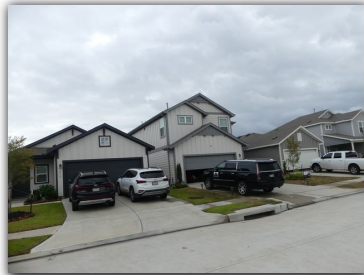
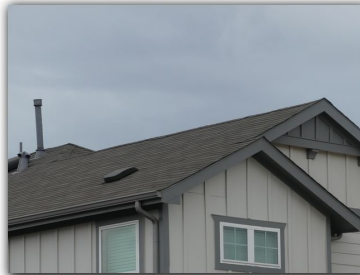
- **THERE IS SOME RAISED SHINGLES DUE TO PROTRUDING NAILS THAT NEEDS TO BE REPAIRED BY A ROOFING EXPERT.** (Deficiency)****

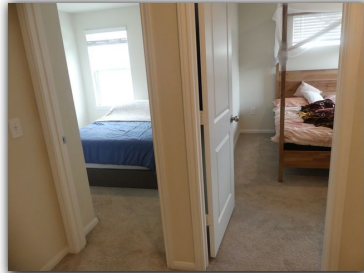
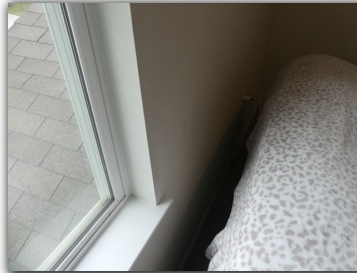
Signs of Structural Settling

- **SOME DRYWALL CRACKS AND/OR PATCHED/PAINTED OVER CRACKS IN SOME LOCATIONS** (Deficiency)** (Upstairs secondary bedroom front corner)**
- **SEPARATIONS TRIM BOARDS, STAIRWELL** (Deficiency)****
- **INDICATING STRUCTURAL SETTLEMENT THAT NEEDS TO BE PATCHED/FINISHED/TEXTURED AND MONITORED FOR ANY FURTHER CRACKING**

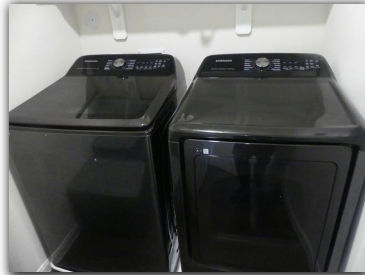
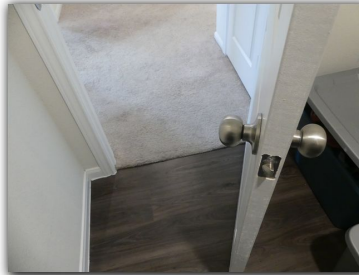
Doors rub, stick or hit frames: Laundry room door is rubbing on the frame and not latching, hard to close. In need of repair by a door repair expert and can be a sign of structural settlement and/or improper installation. ** (Deficiency) **

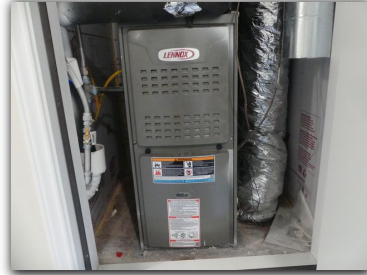
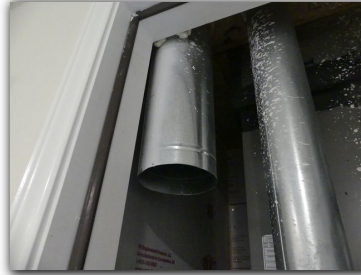
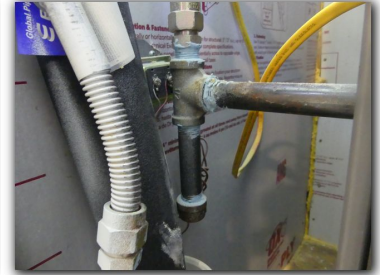
- THE FURNACE WAS TESTED AND FUNCTIONING PROPERLY.**
- GAS FURNACES ARE RECOMMENDED TO HAVE THE HEAT EXCHANGER EVALUATED FOR CRACKS THAT CAN BE A SAFETY HAZARD BY A LICENSED HVAC PROFESSIONAL. HEAT EXCHANGERS ARE OUTSIDE THE SCOPE OF INSPECTION DUE TO DISMANTLING THAT IS REQUIRED.**

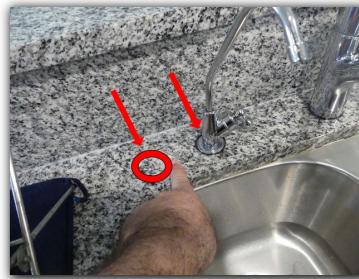
Sink leaks into cabinet below (Deficiency)****

- **The drain line is disconnected from the original location at the sink counter top hanging loose under the sink and**

was replaced with a filtered water dispenser. When operating the dishwasher for a short period of time and/or the sink there was water draining out under the sink. In need of repair by a plumber/appliance repair expert. ** (Deficiency) **** (another hole needs to be cored through the counter top to provide for the dishwasher drain vent and the separate filtered water dispenser) **** (Deficiency) ******

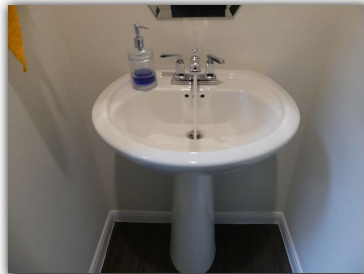
- **Sink handles are difficult to turn on and off at several sinks and the half bath hot water side was not able to turn at all. Recommend repairs or fixture replacement for the bath sinks by a plumber. **** (Deficiency) ******

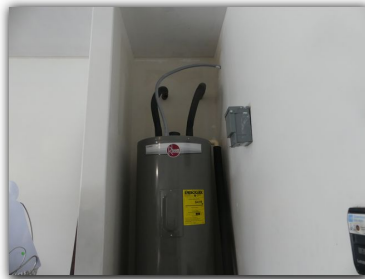
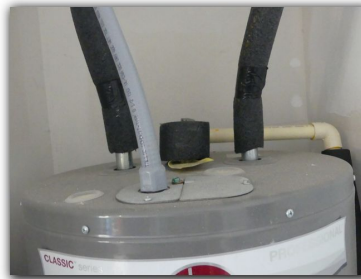
- 1. FOR ROUTINE MAINTENANCE IT IS RECOMMENDED TO PARTIALLY DRAIN THE TANK ANNUALLY AND REPLACE THE T&P RELIEF VALVE EVERY 5-6 YEARS**

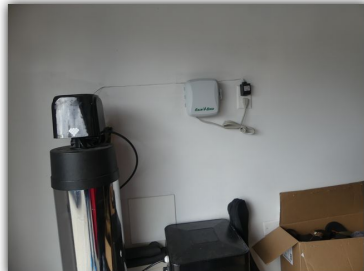
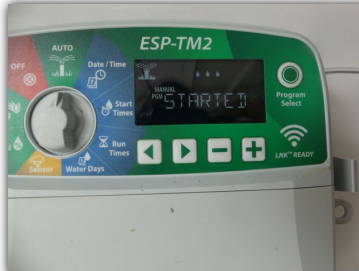
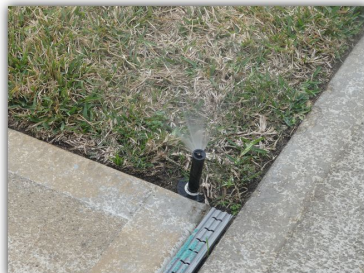
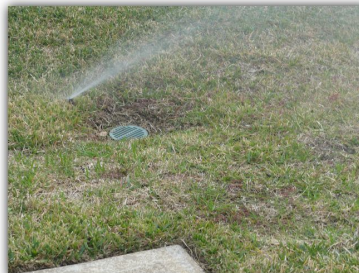
THE LAWN SPRINKLER SYSTEM WAS TESTED MANUALLY AT EACH ZONE AND WAS FUNCTIONING PROPERLY.
