RESIDENTIAL INSPECTION REPORT

3936 Galleon Galveston TX 77554

By: Keith Holderfield - TREC #24000 11/04/2021 9:00 am

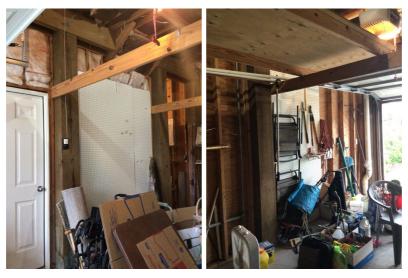
Type of Foundation(s): Stilts/Pilings

Foundation Inspected with Digital Level:

measured areas did not indicate any variations that, in this inspector's OPINION, indicated any need for invasive repairs to the foundation.

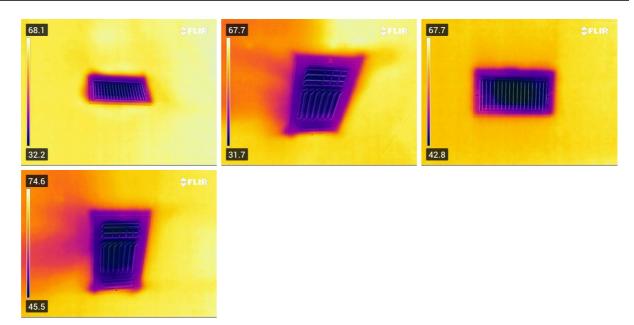
Temperature difference (delta) - First Floor: 19° Temperature difference (delta) - Second Floor: 17°
