## PROPERTY INSPECTION REPORT

Report # 21268

Concerning: 104 Franklin St Clute, TX 77531  
(Address or Other Identification of Inspected Property)

By: Kenny Boulton November 4, 2021  
TREC Professional Inspector Lic.# 698 (Date)

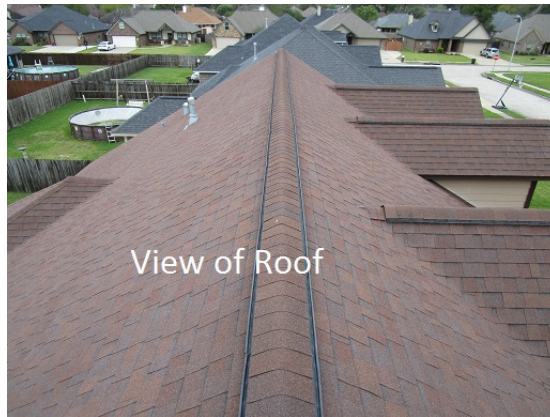
**FLASHING**

The missing flashing on the right side of the left front entry brick column to roofing connection should be installed. Roofing should not terminate at the brick without being flashed at the connections.

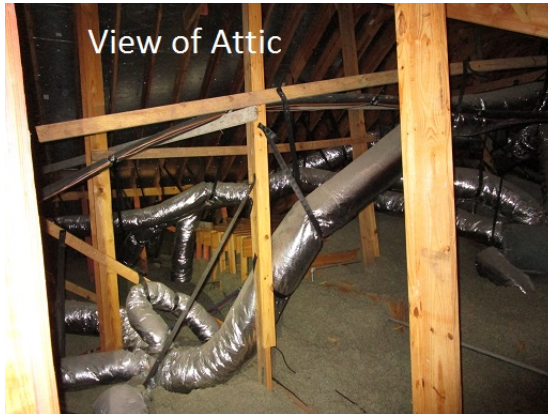
VIEW OF ATTIC

ROOF STRUCTURE

The attic stairs are marginally secured at the mount in the ceiling. The installation of 16p nails or 3" lag screws from the attic stairs into the rough-in opening is recommended instead of regular screws.

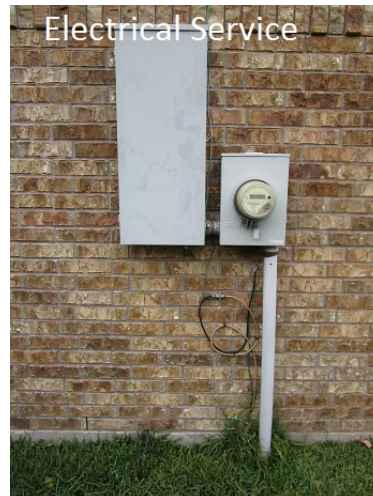
ELECTRICAL SERVICE

All circuits should be properly identified instead of the generic Lighting/Outlets. The Arc Fault Interrupter (AFI) breaker protection have been installed for the bedroom but are missing for the living areas. An arc-fault circuit interrupter is device intended to provide protection from the effects of arc faults by recognizing characteristics unique to arcing and by functioning to de-energize the circuit when an arc fault is detected.
