Inspection Report

**1114 W. 5th St.
Freeport, TX 775 41**

**Jeff M. Spencer, TREC #6365
6502 Spencer Drive
Freeport, TX 77541
979-482-3895
jmsinspections@att.net**

PROPERTY INSPECTION REPORT FORM

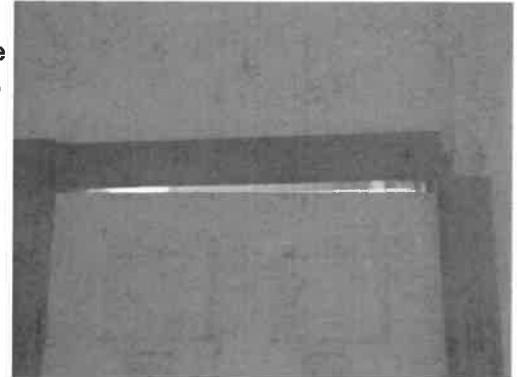
Desiccant seals have failed on the right lite unit and the left sash unit of windows on the front wall of the den, causing fogging and condensation on interior pane surfaces of double-pane glass units. The condition cannot be corrected without replacement of affected double-pane glass units.
